# **Redundant Agricultural Buildings at Newhouse Farm, Hall Road, Great Bromley, Essex. CO7 7TP**

## **Heritage Assessment and Impact Statement**

**September 2020**

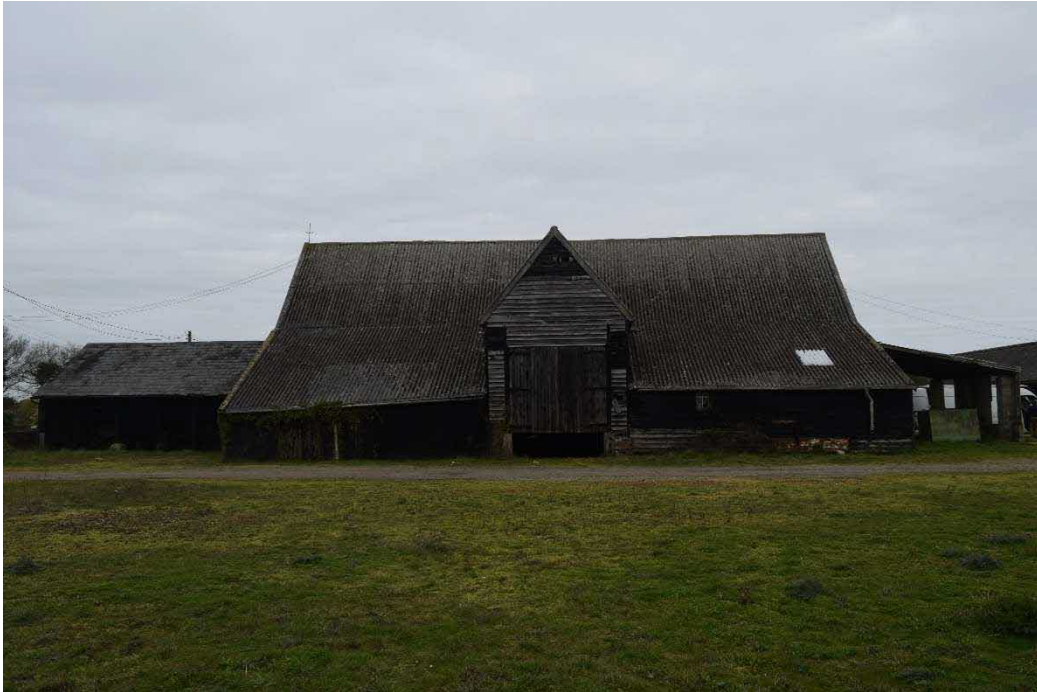
Figure 6: South-East elevation of the barn.

4.1.1 The large South-East barn dates to the late C18 and is probably contemporary in date with the 1780 works to Great Bromley House.

The 5-bay timber-framed and weatherboarded barn is seated on a high redbrick plinth wall and has an original central midstrey with a double draft doorway opposite the main barn doors in the North-West elevation of the barn. The original threshing floor which extends through the length of the midstray was laid with Gault bricks set on edge. The original floor is still in situ. The bays to left and right of the central threshing bay are roughly equal in size, and all of the bays are open to the roof.

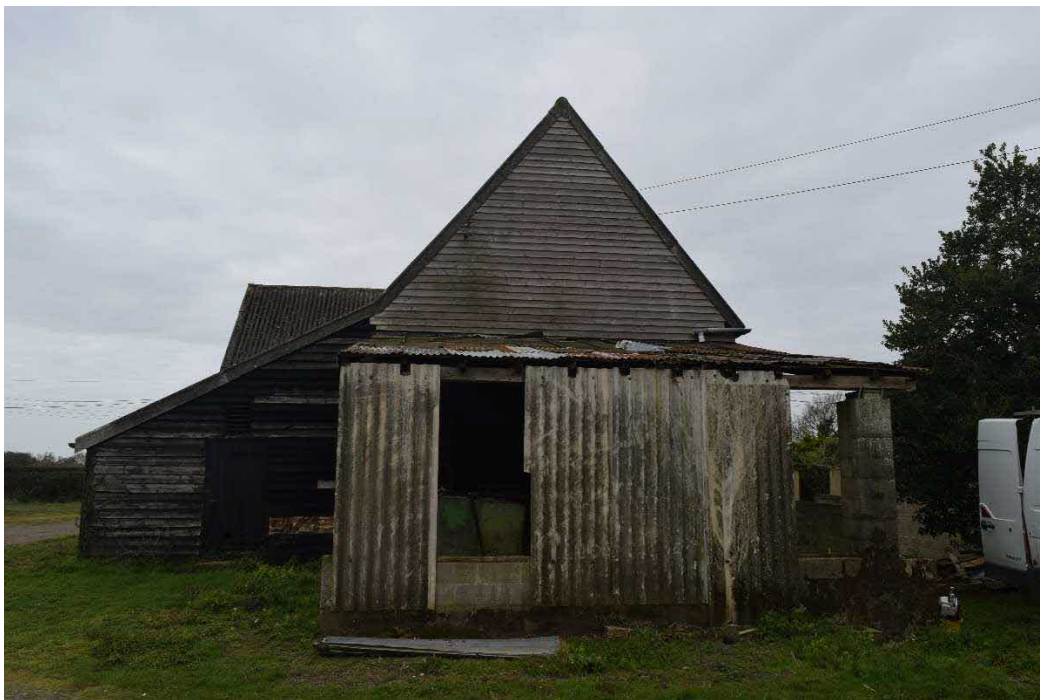
Figure 7: North-East elevation of the barn.

There is an inserted pedestrian doorway in the North-East gable end of the barn.

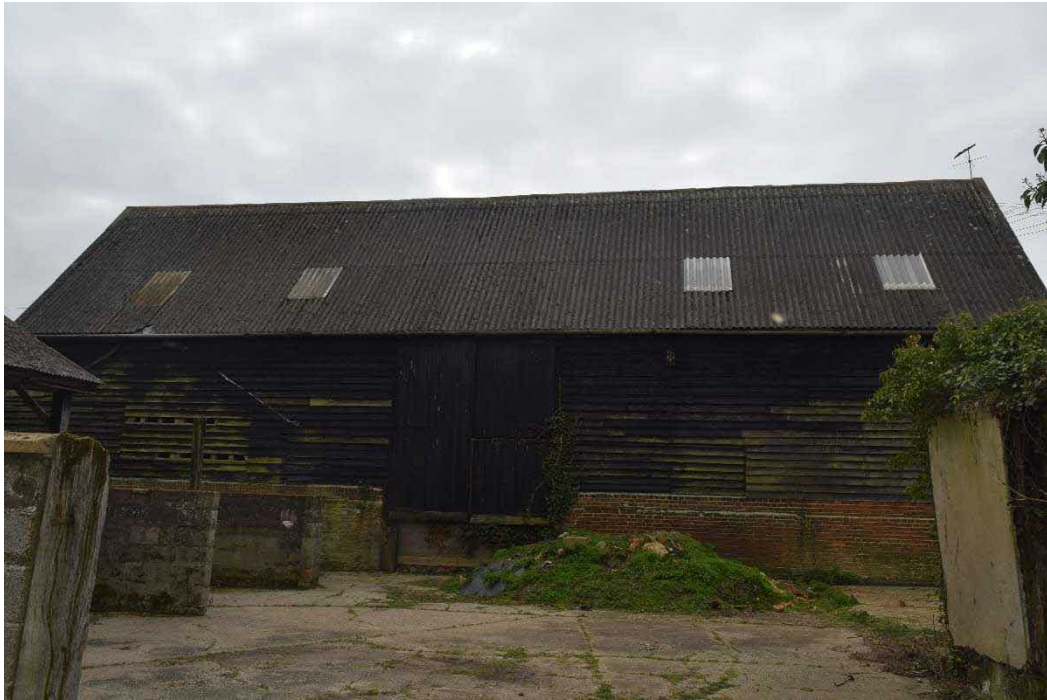
**Figure 8: North-West elevation of the barn.**

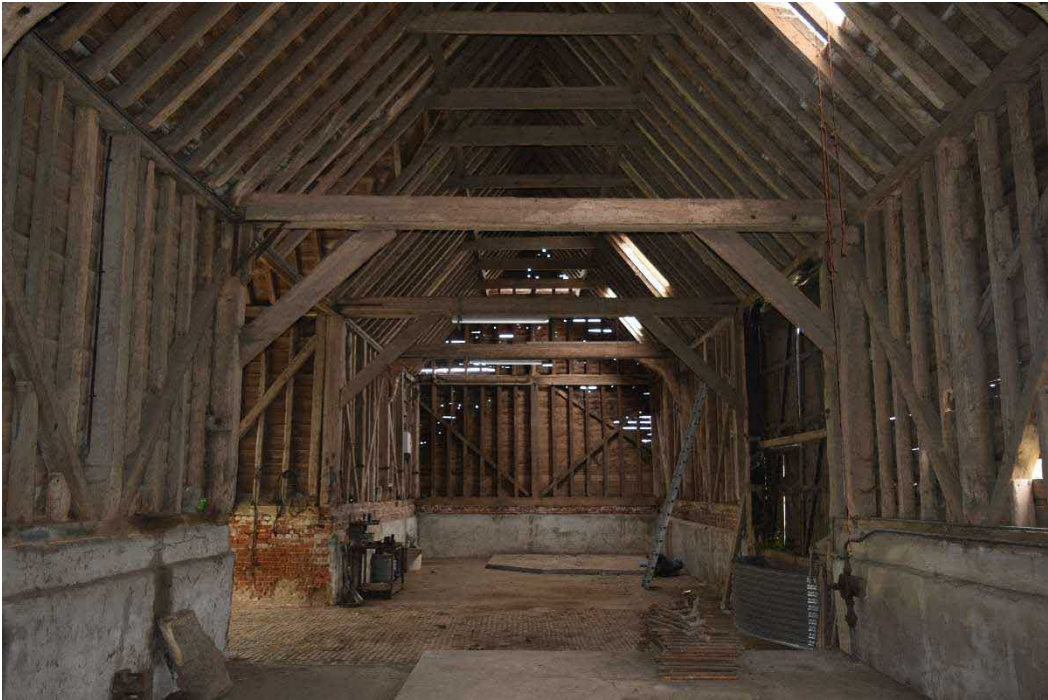
**Figure 9: South-West internal elevation of the barn.**

The frame assemblage contains very few reused timbers. The wall framing is very typical for the period and is made up of a central principal stud flanked by common studwork with diagonal primary bracing extending from the head of the principal posts to the base of the principal studs. The bracing is tenoned and pegged into principal posts and wallplates. Only the principal members are pegged but all of the common studwork are tenoned into the wall and soleplates. The wallplates are jointed with face halved and bladed scarf joints.

There are two traditions of transverse bracing over the barn. The trusses flanking the threshing bay has traditional long straight braces tenoned and pegged into the tiebeams and principal post. The remaining trusses have kneebracing which became more widely used during the C18.

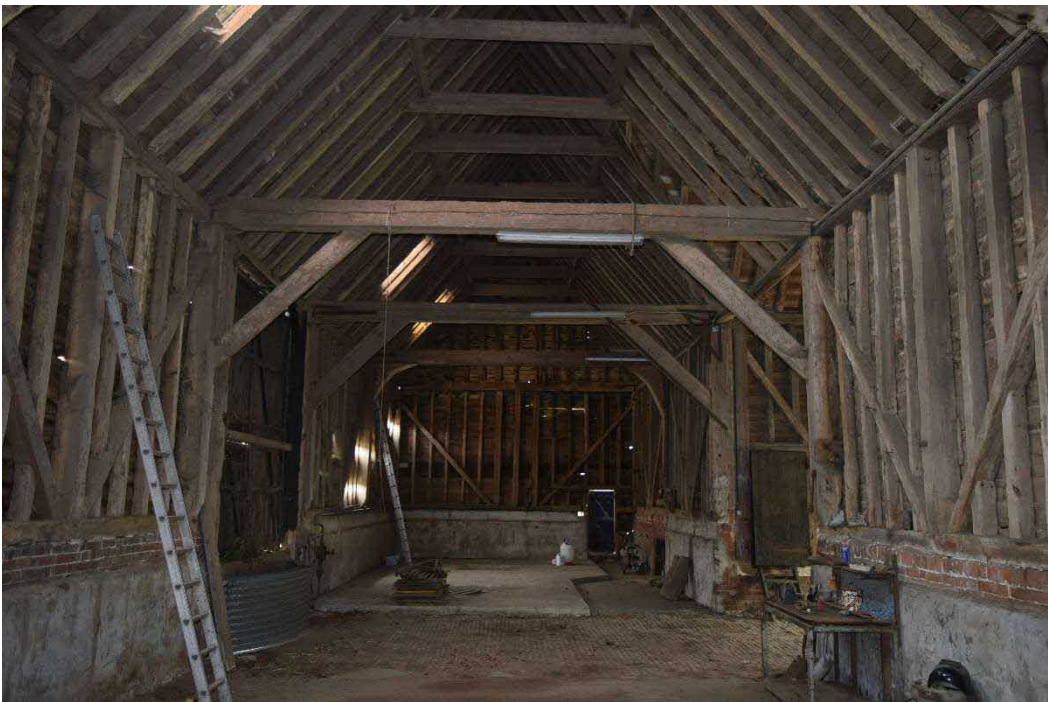
**Figure 10: North-East internal elevation of the barn.**

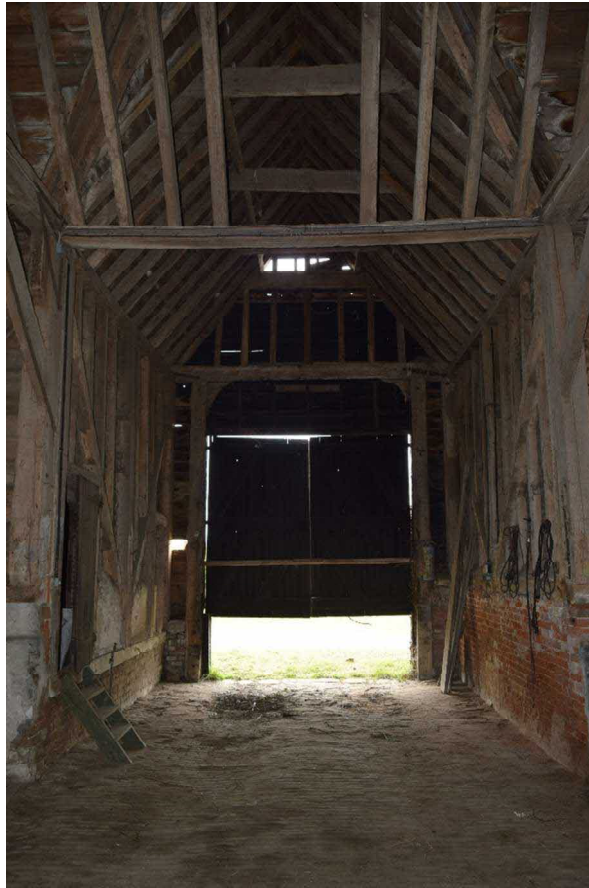
**Figure 11: Internal view of the midstrey on the South-East elevation of the barn.**

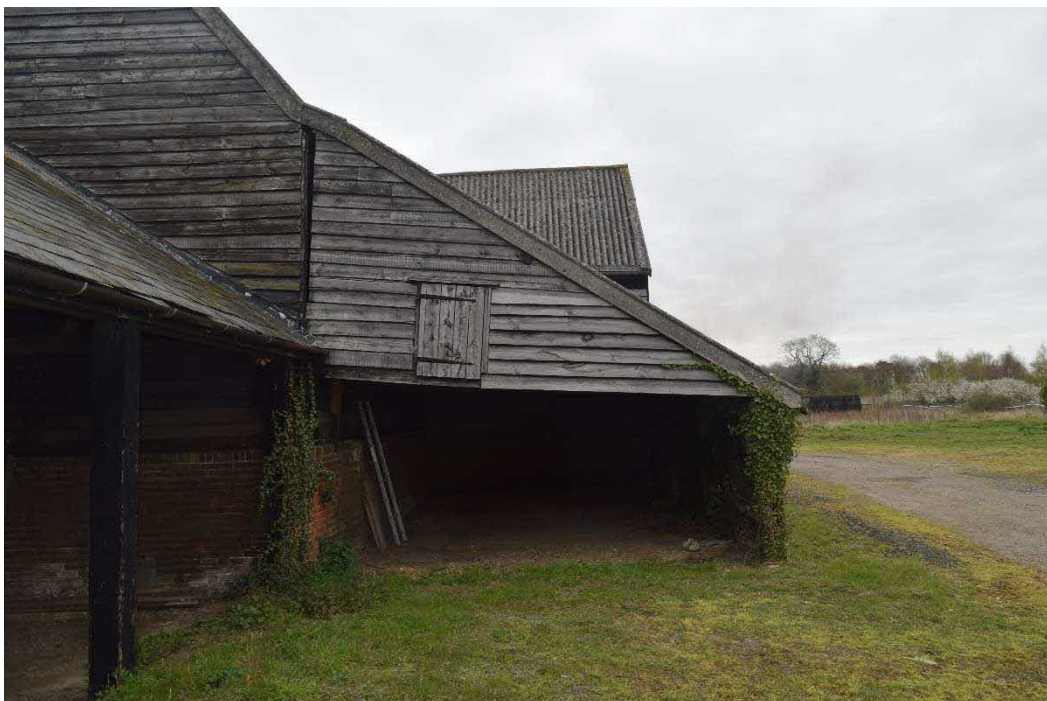
**Figure 12: Carshed outshot on the South-East elevation of the barn.**

There are two outshots attached to the South-East elevation of the barn. The outshot at the South-West end of the barn was built between 1839 and 1875. It appears to have served as a cartshed. There is a pitching door in the South-West elevation of the outshot suggesting that it contained a loft floor. The outshot at the North-East end of the barn was constructed between 1875 and 1881. The lean-to is divided into two sections. The North-East end section contains a granary with external access. The other section adjacent the midstrey appears to have served as a chaff house and later a workshop/office which was accessed through a doorway in the North-East wall of the midstrey. The granary and workshop are timber-framed with brick nogged infill panels.

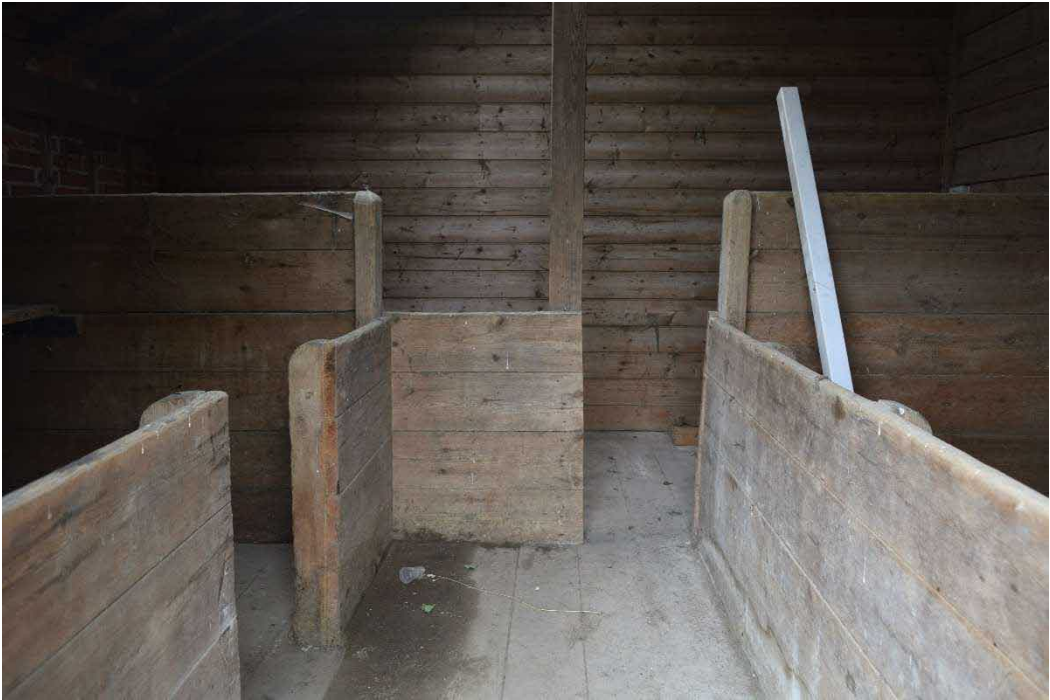
**Figure 13: Granary outshot on the South-East elevation of the barn.**

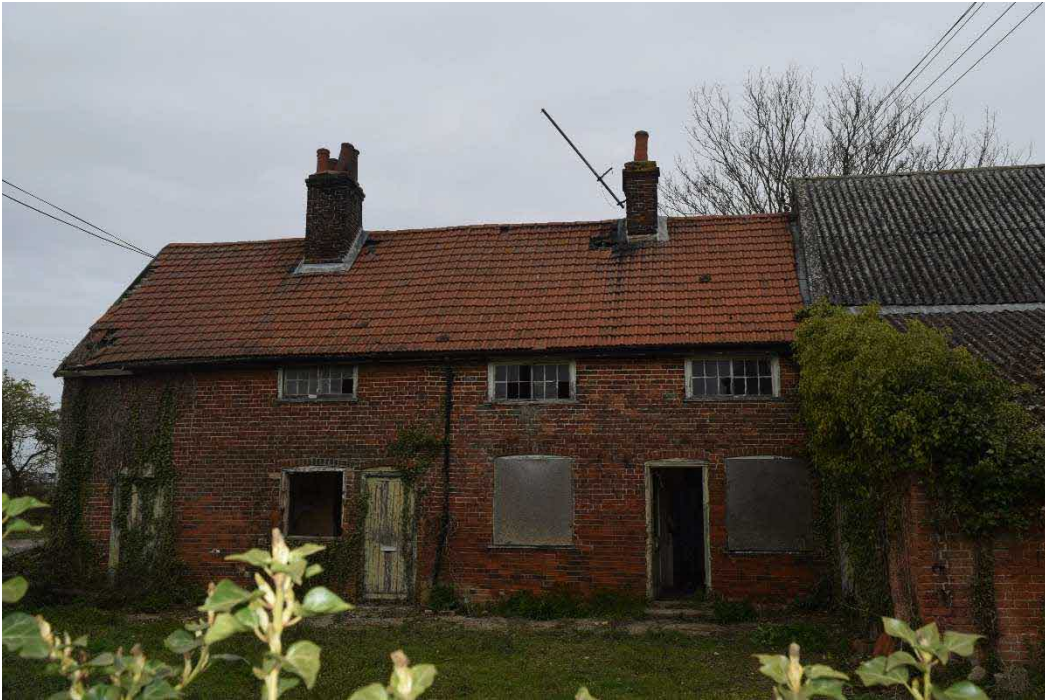
**Figure 15: South-East (front) elevation of the workers cottages.**

4.2.1 **Workers Cottages** – At the North-West end of the farmyard there are two semi-detached workers cottages dating to the late C18 or early C19. The cottages face towards the South-East and into the farmyard but are enclosed by a brick boundary wall. The range of cottages was constructed in red brickwork with a Flemish bond and double roll clay tiles to the roof. The doors and windows at ground floor level have arched brick heads. The surviving cross casement windows at ground floor level are boarded up. The range has horizontal sliding sash windows at first-floor level. These windows typically date to the late C18 or early C19.

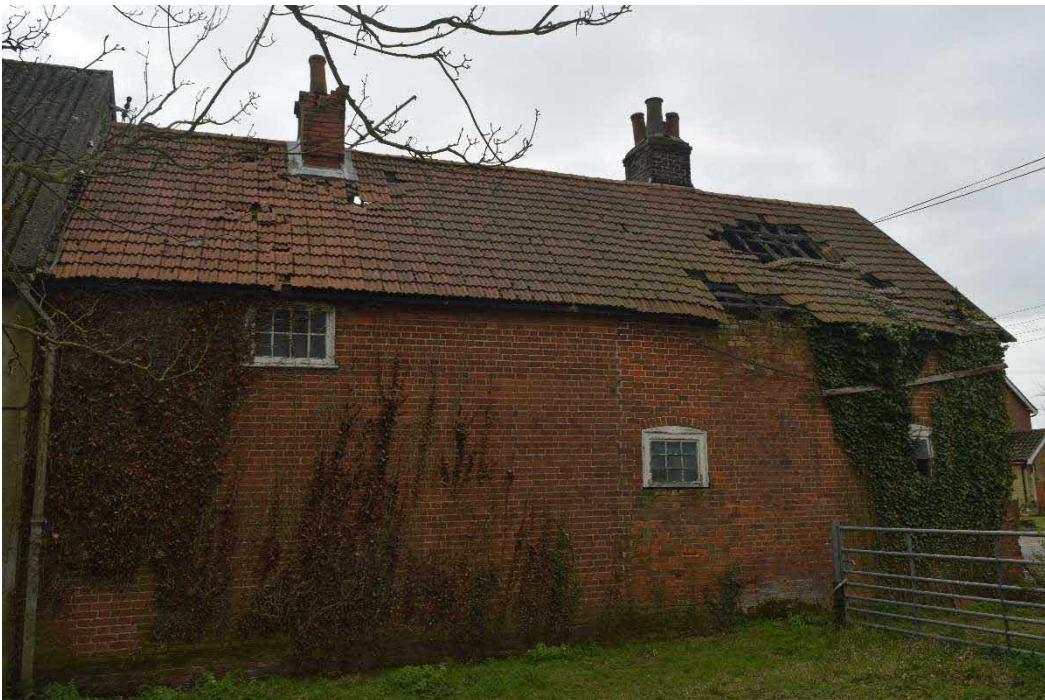
**Figure 16: North-West (rear) elevation of the workers cottages.**

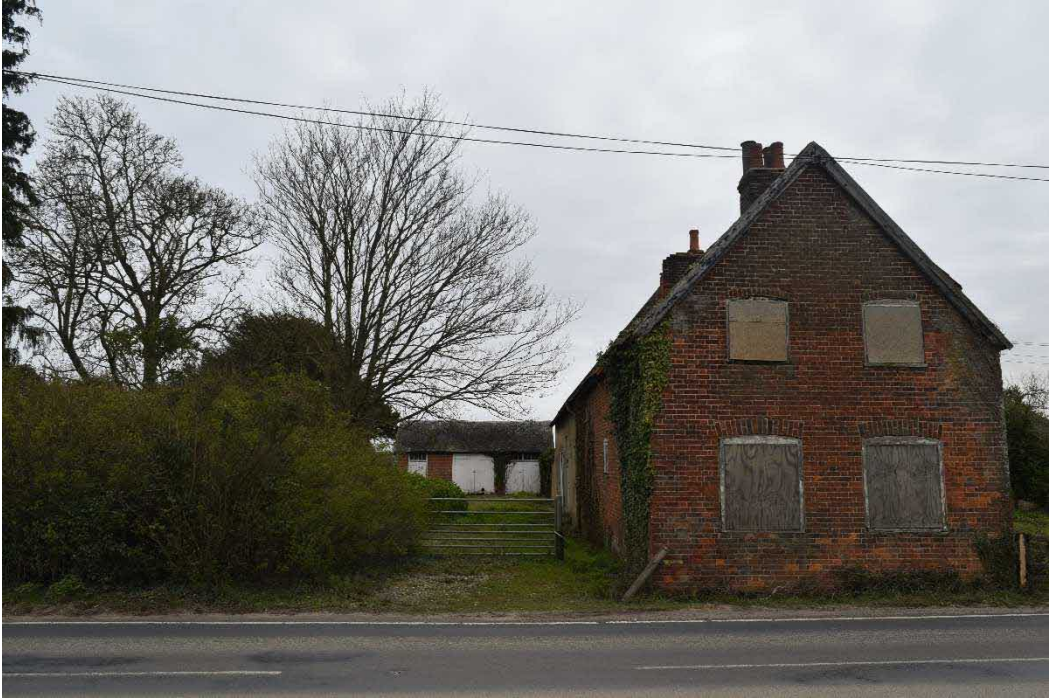
**Figure 17: South-West gable end of the workers cottages.**

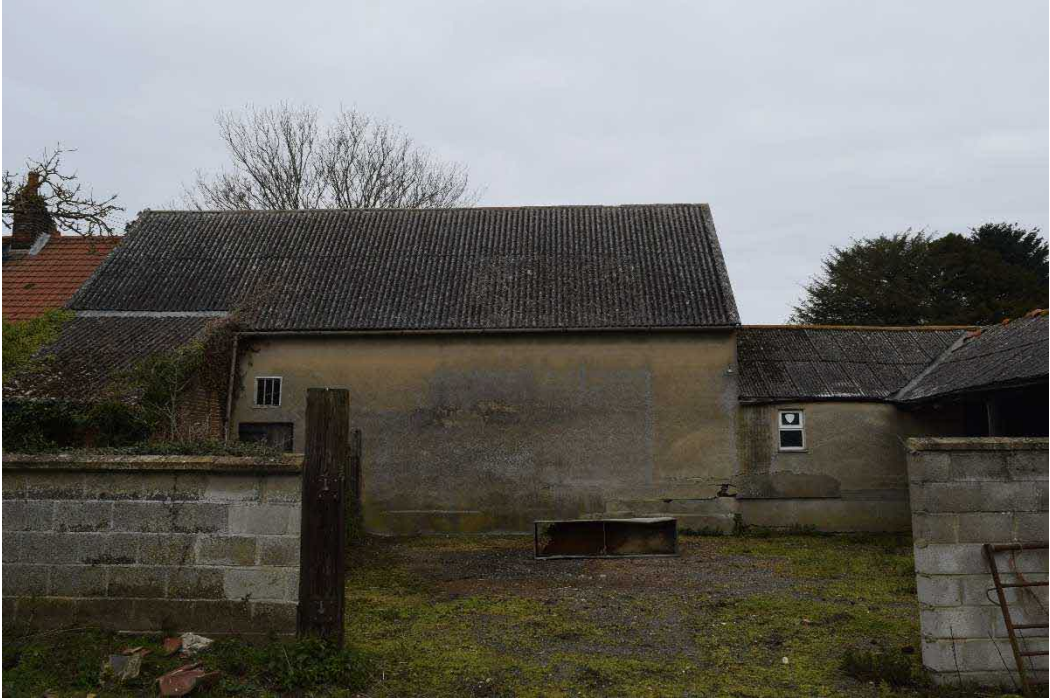
**Figure 21: South-East elevation of the stable barn.**

4.2.2 **Stable Barn** – The 4-bay timber-framed stable barn is the earliest surviving agricultural building on the site. The assemblage of the barn appears to suggest a C17 date of construction. The barn was constructed with midrails, primary braced studwork, jowled principal posts and arch braces to the tiebeams. The framing of the barn was repaired and altered in places. The barn was constructed for the purposes of both animal housing and threshing. The two bays at the North-East end of the barn served as a neat (calf) and cowhouse as suggested by the low level of the original headrail to the barn door in Bay 3 from the South-West. There is a midrail in the opposite wall rather than a draft doorway which confirms that this section of the barn was used for animal housing. There was likely a partition wall between bays 2 & 3 which was later removed and a hayloft over bays 3 & 4. The floor of the barn was formed with brick, some set on edge to form drainage channels. Sections of the barn floor was later covered with concrete. Only a small section of the original flooring is evident in bays 3 & 4. The front and back walls to Bay 2 locate the original threshing floor and barn doors. The original barn door openings were later blocked and a partition wall inserted to form a stable and cross passage with opposite pedestrian doorways in the South-West end of the barn. A hayloft with a ladder stair was inserted over the stable. The roof over the barn was constructed with a clasped side purlin roof structure with diagonal bracing between the tiebeams and principal rafters. A good proportion of the original common rafters have survived but appears to have been rearranged during a repair phase to the barn. The roof is covered with corrugated asbestos roof sheeting. The barn is clad in weatherboarding but cement rendered was applied over the cladding on the exterior of the barn.

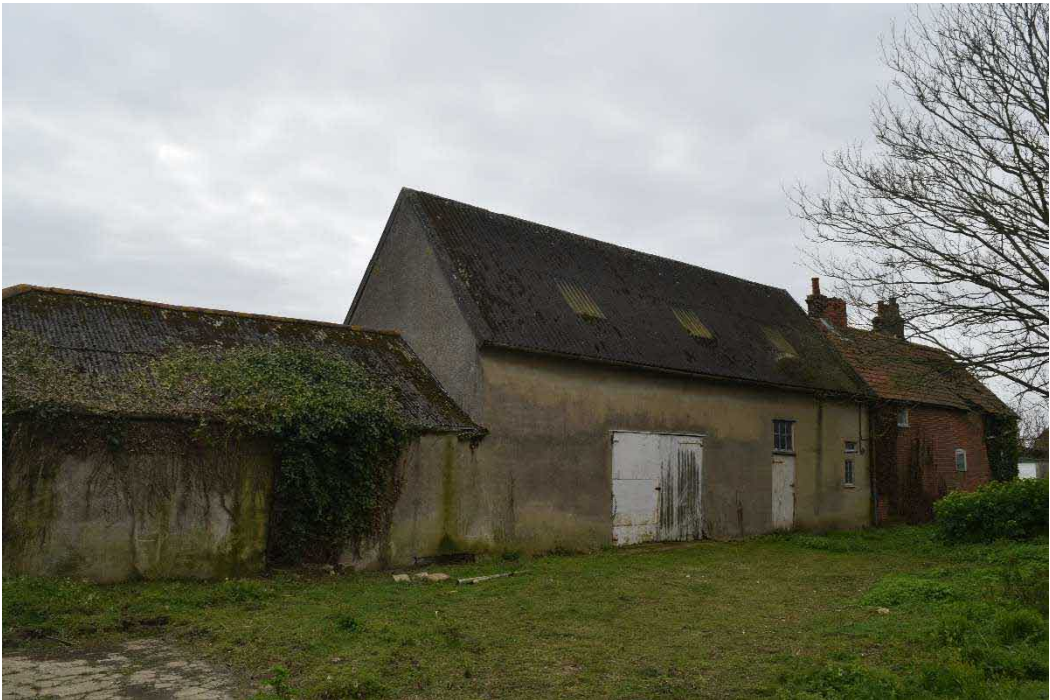
**Figure 22: North-West elevation of the stable barn.**

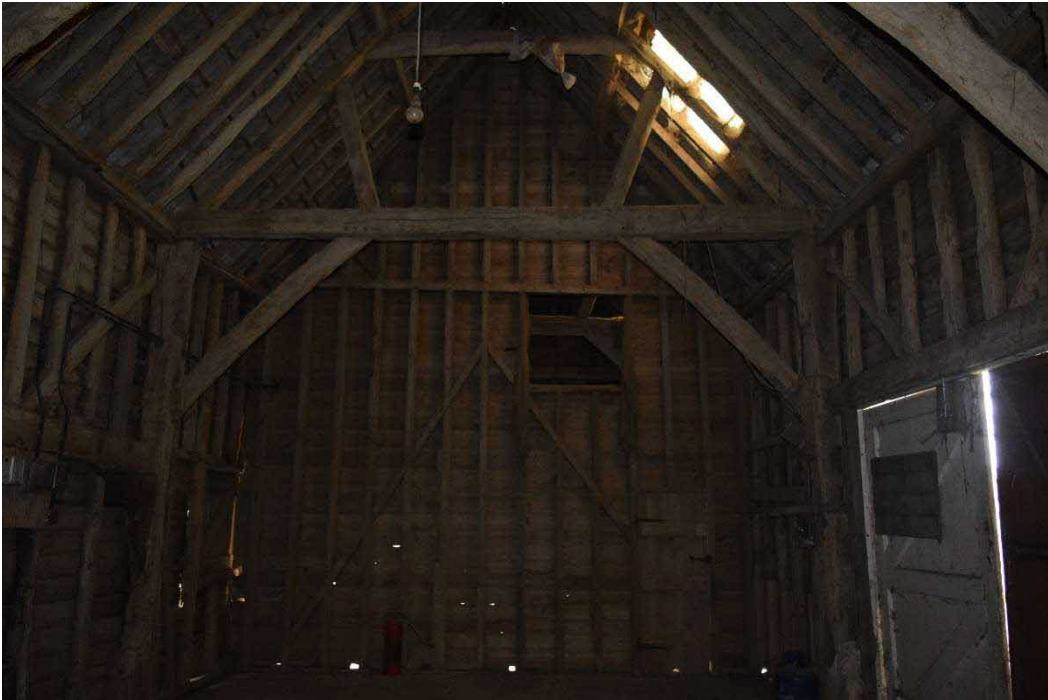
**Figure 23: Interior view of the stable barn towards the South-West, showing the inserted partition wall.**

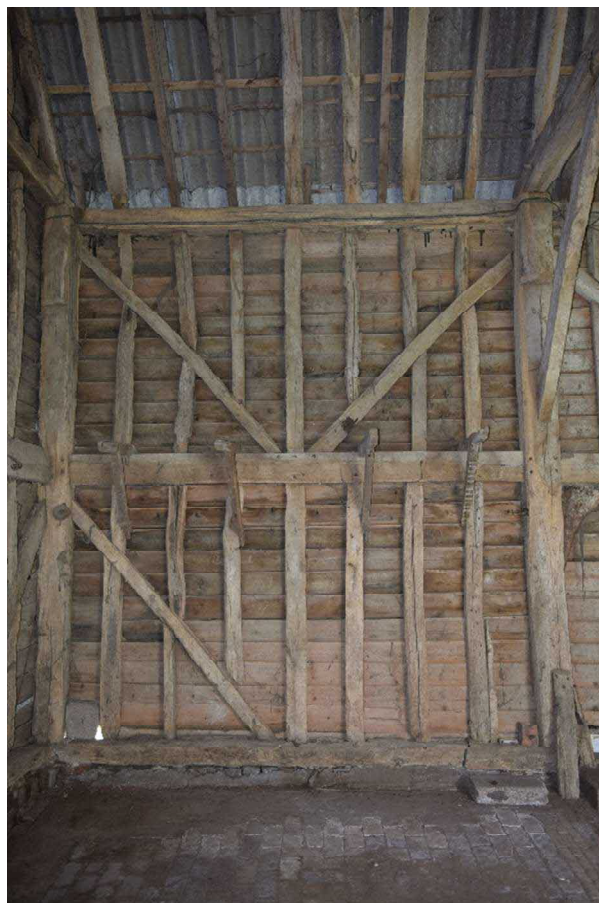
**Figure 24: Wall framing assemblage.**

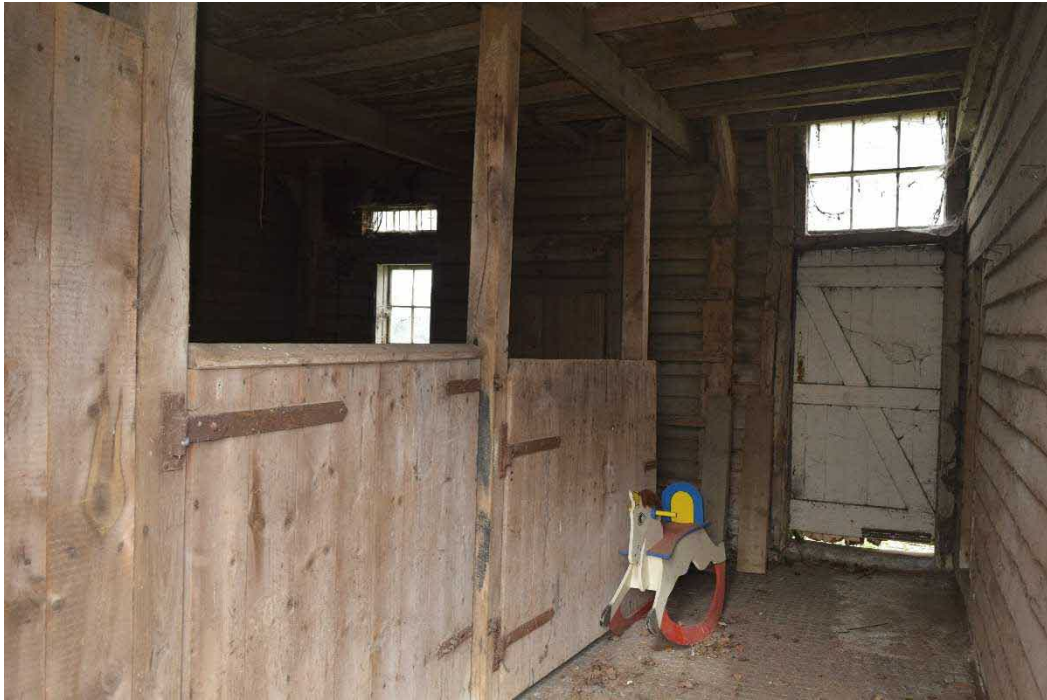
**Figure 25: Stables at the South-West end of the barn with hayloft over.**

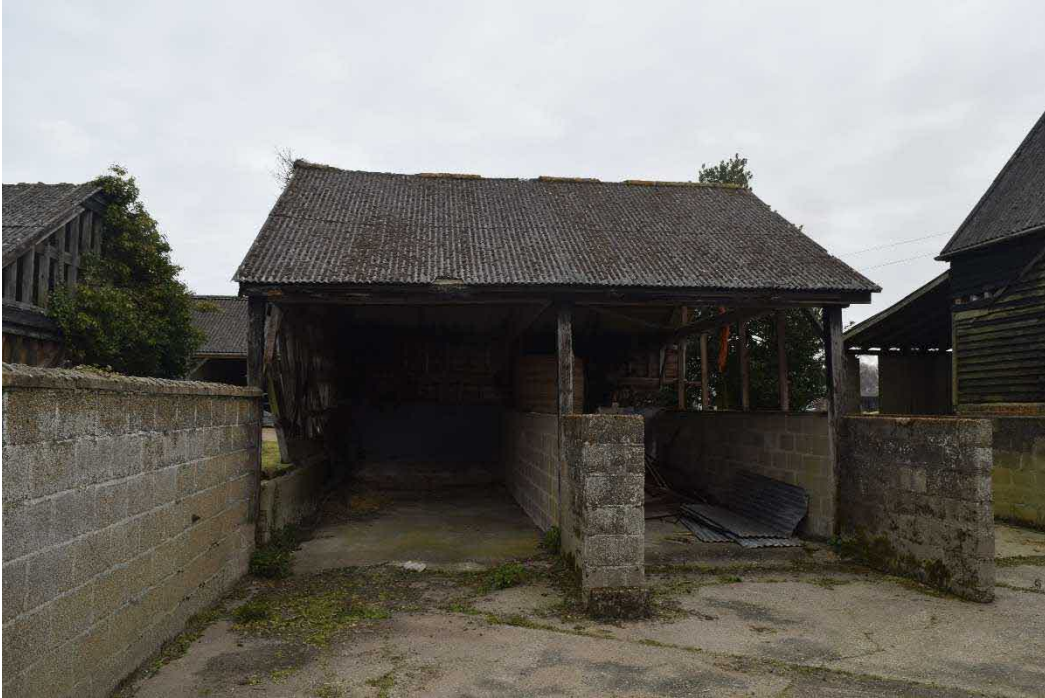
**Figure 26: C20 Open fronted shelter shed formerly attached to the barn.**

4.2.3 **Shelter Shed** – The primary braced timber-framed open-fronted shelter sheds which formed the North-East boundary of the courtyard were rebuilt during the C20. The shelter shed at the South-East end of the yard was entirely rebuilt. The opposite shed was enlarged to the North-West and the roof structure raised. At the North-East end, the shed is attached to an enclosed animal shed. The latter was formerly open to the shed but was later enclosed. The shed housed chickens during its last use. The shed was subdivided into two sections. The South-West section is attached to the C17 stable barn, and there is a pedestrian doorway leading from the shed into the barn. The roofs over both sheds are covered with corrugated asbestos roof sheeting. There is a C20 3-bay timber-framed and weatherboarded animal shelter attached to the rear elevation of the North-East shelter shed. It was probably in use as a piggery or cowshed. The roof structure is covered with corrugated metal roof sheeting but is in a dilapidated state.

- 6.8. The C20 open-fronted shelter shed attached to the North-East end of the barn has partially collapsed. This structure will be replaced by a new timber-framed carport.

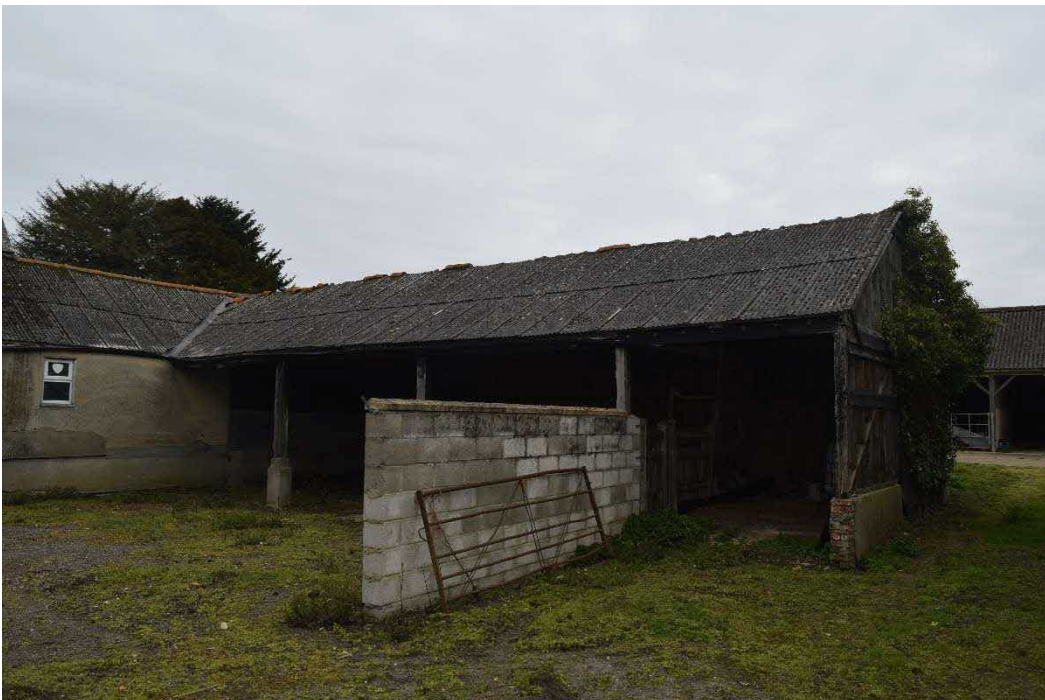
**Figure 27: C19/C20 Open fronted shelter shed partly rebuilt.**

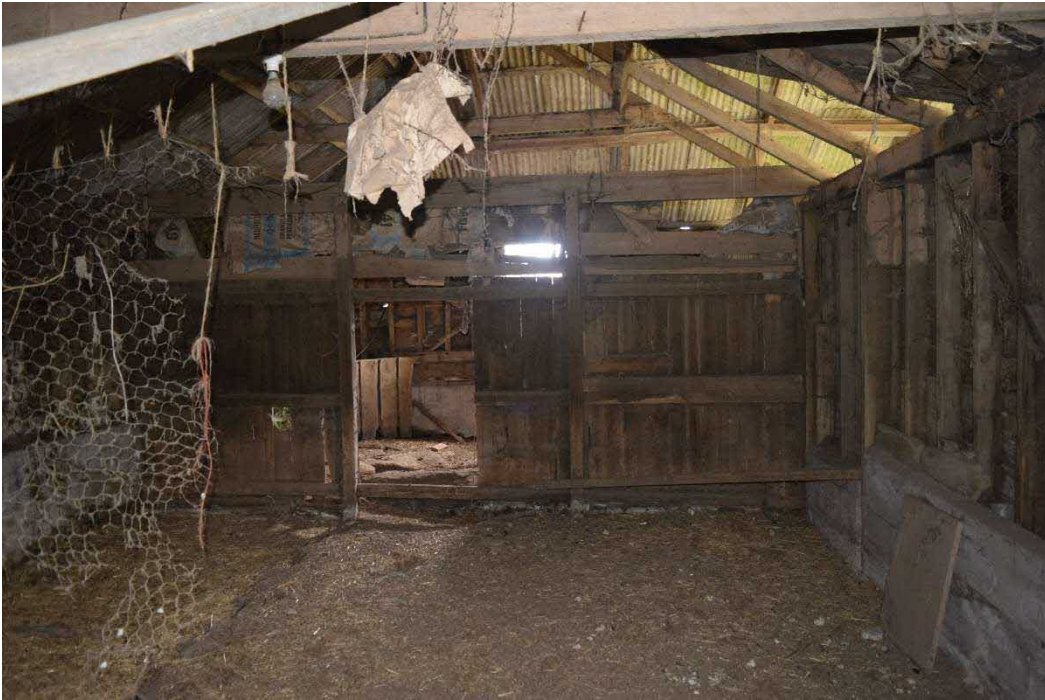
**Figure 28: Shed attached to the North-East end of the C19/C20 open-fronted shelter shed.**

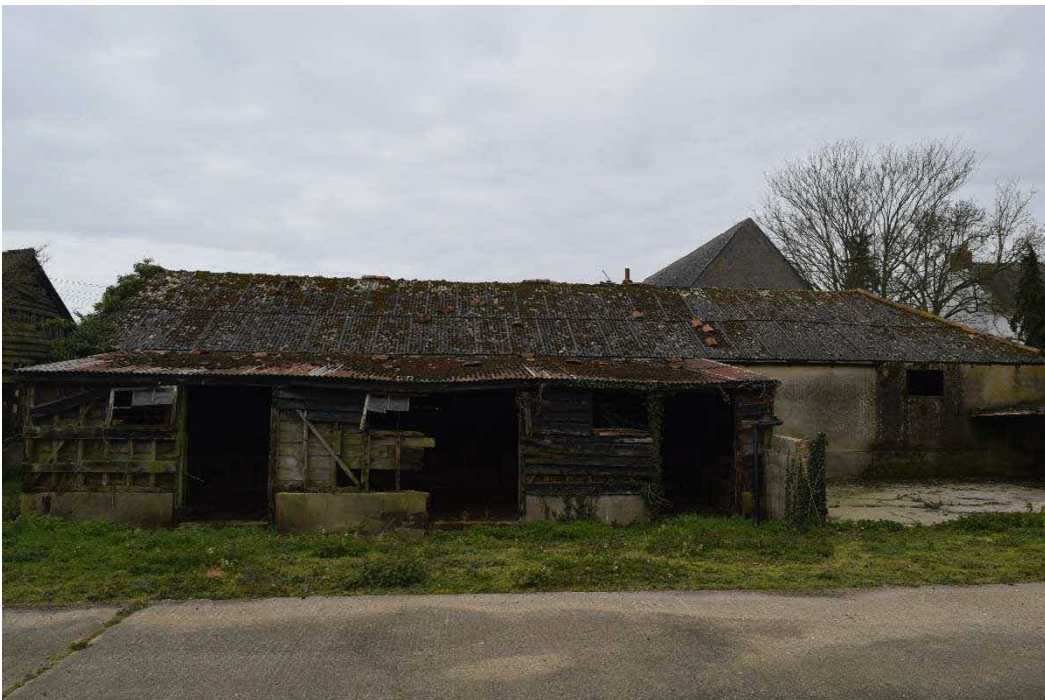
**Figure 29: 3-Bay animal shelter attached to the rear of the North-East end shelter shed.**

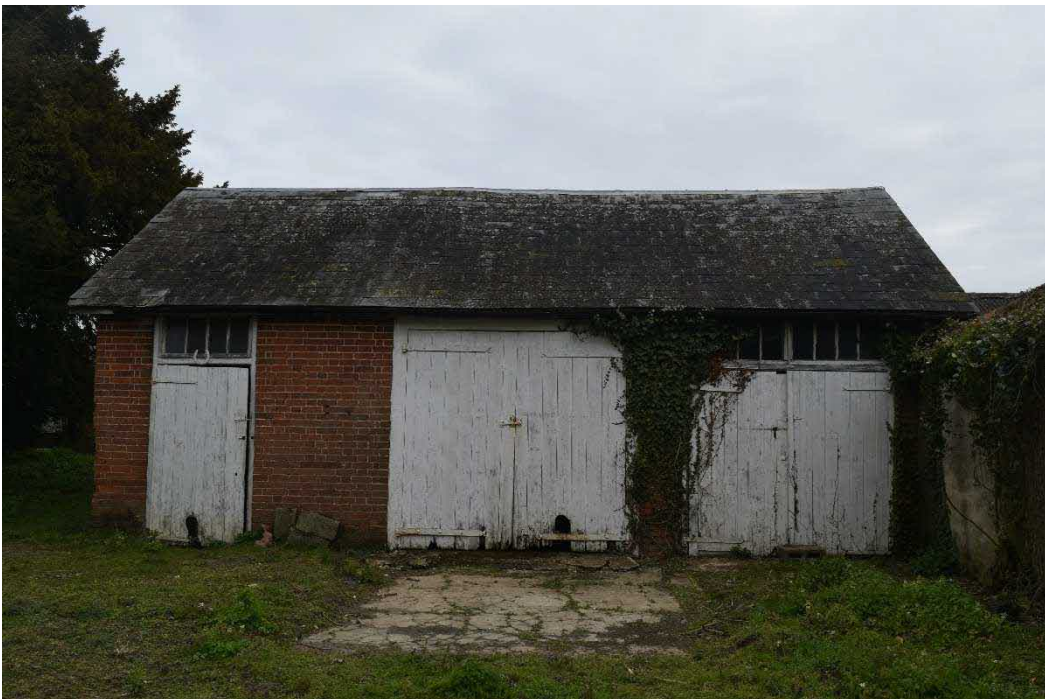
**Figure 30: South-West elevation of the Workshop.**

4.2.4 **Workshop** – The redbrick and slate covered workshop and storage building was constructed between 1875 and 1881. The building formerly served as a cartshed, stable and storage building to Great Bromley House. However, there is evidence suggesting that the rear part of the building was also used as an animal shelter during the C19 and C20. The frontage of the building contains two double garage doors to right and a pedestrian doorway to left. The latter leading into a stable, now store, which has a 16-pane sash in the North-West elevation of the building. In the same elevation there is a doorway to left leading into a store, used as an animal shelter at some stage. There is a doorway and three small windows in the North-East elevation of the building. The rear store was also originally used as an animal shelter. The two rear rooms are interlinked. During the C20 the cartshed was used as a garage and workshop as suggested by the pit in the left hand side of the garage. The garage is lit by a small double casement window in the South-East wall of the building. The underside of the roof structure was lined with matchboarding.

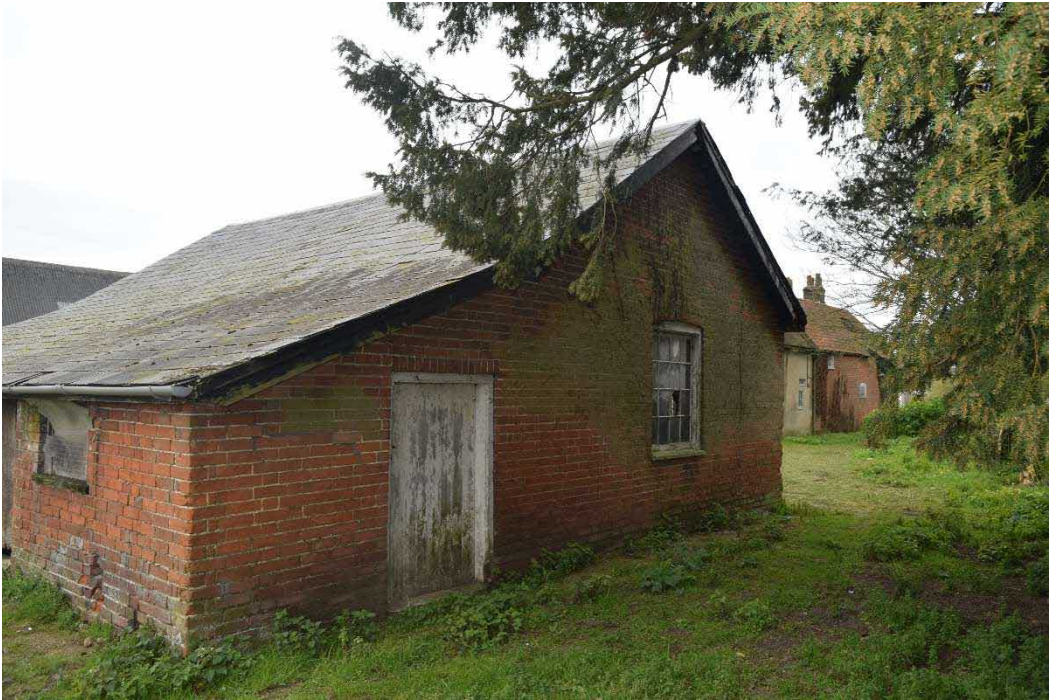
**Figure 31: North-West facing elevation of the workshop.**

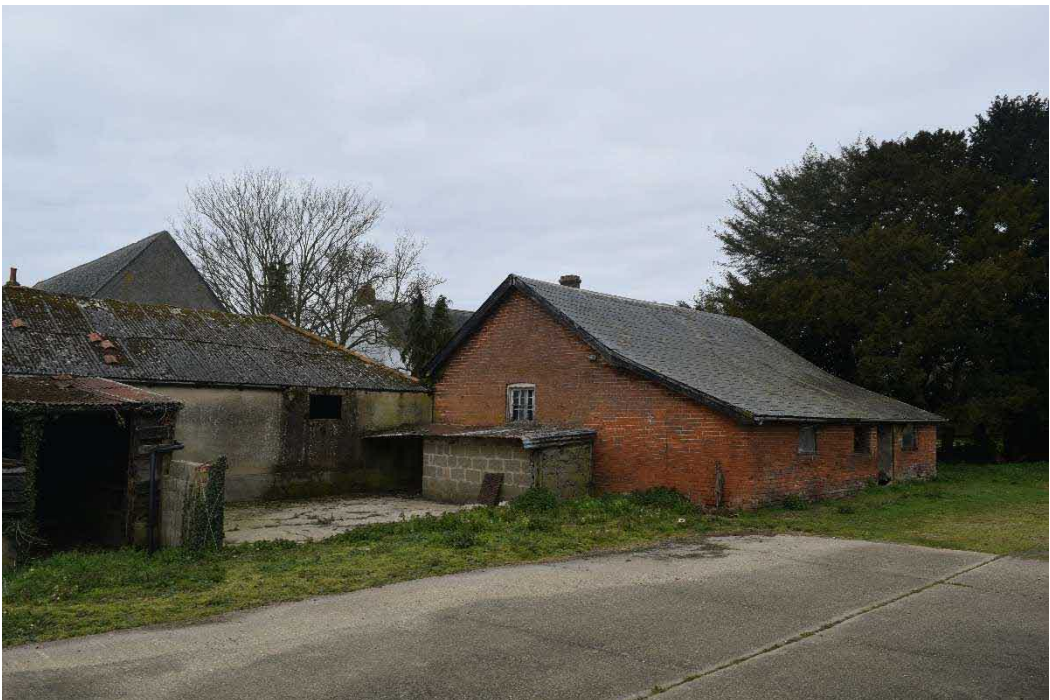
**Figure 32: North-East and South-East elevations of the workshop.**

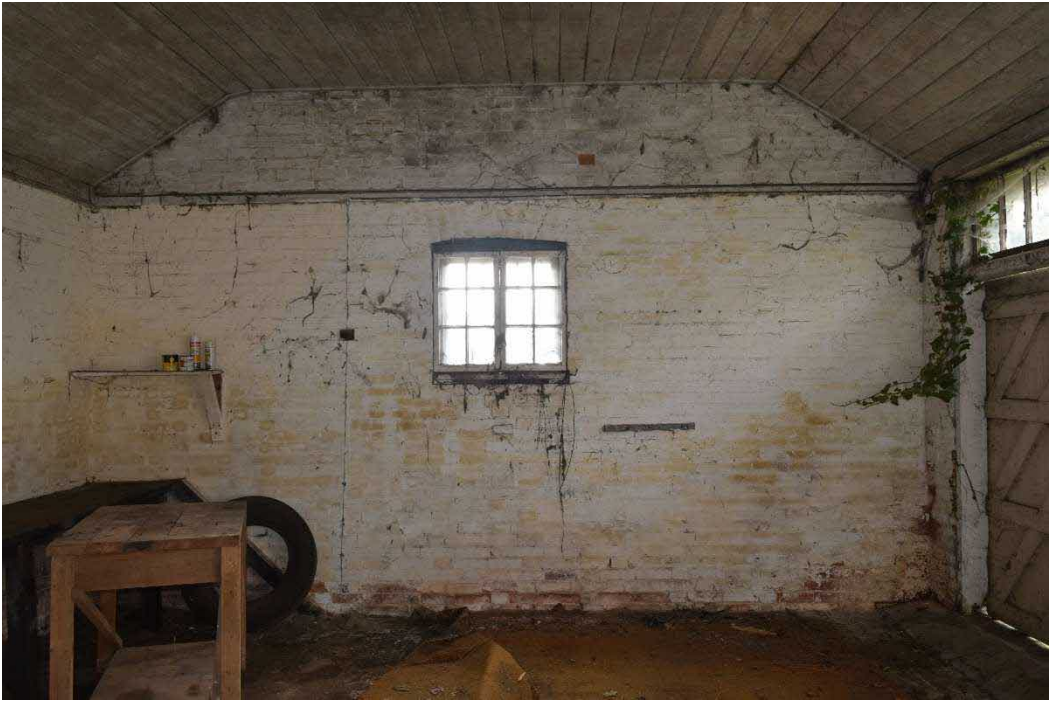
**Figure 33: Interior of the workshop.**
