**Document:** Remediation Verification Report

**Project:** Needham Market Quarry

**Reference No.:** GN17820\_RV39

## NEEDHAM MARKET QUARRY (Plots 84-86 & 90-95)

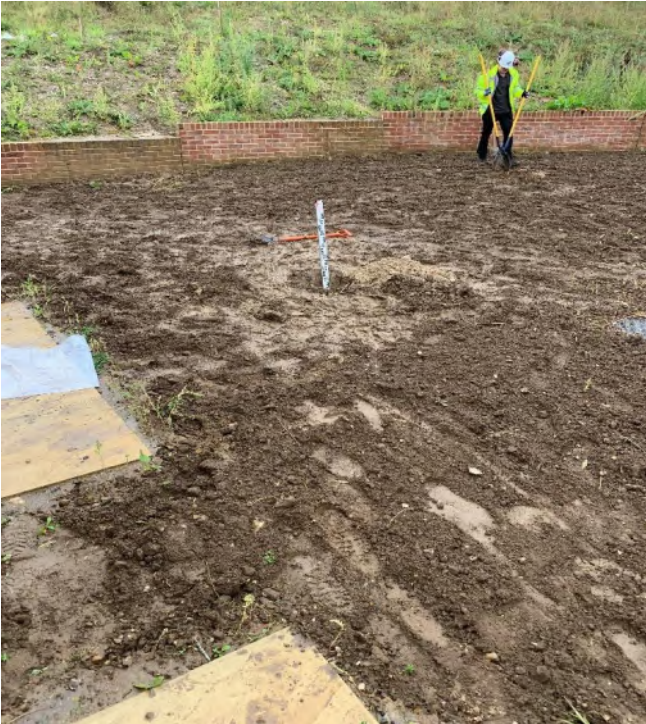
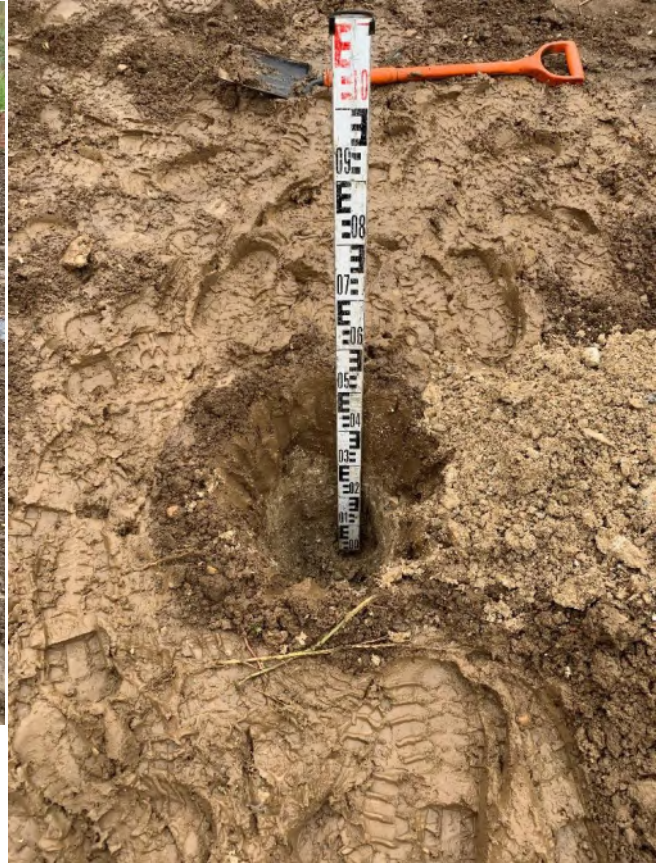
The materials encountered within plots 86, 90 and 93 were considered suitable for use as subsoil from visual inspection. The dark material identified elsewhere on site that contained low levels of contaminants was not encountered in the soft landscaping surrounding plots 86, 90 or 93 and is therefore not considered likely to be encountered within plots 84-86 and 90-95.

The thickness of suitable soil was recorded to be at least 600mm within the trial pits completed.

**Photographs 1-2**, taken on the 01<sup>st</sup> September 2023 showing examples of hand dug trial pits and the nature of the subsoil and topsoil within the soft landscaping of plot 86 (back garden).

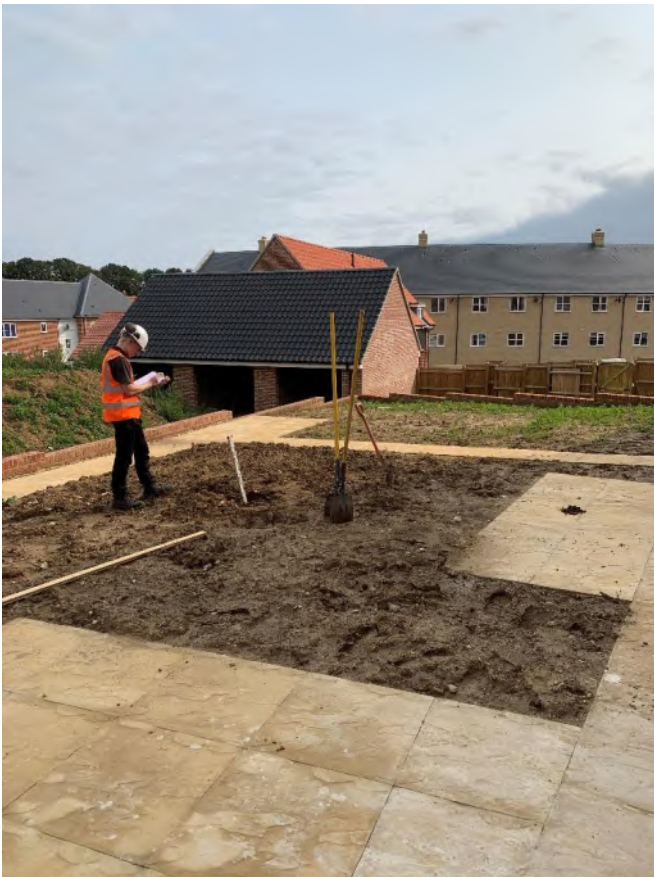
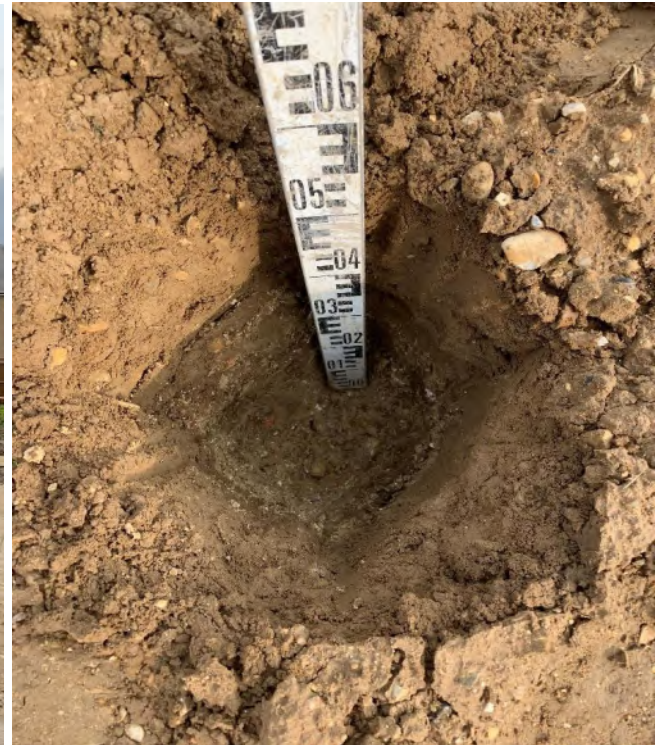
**Photographs 3-4**, taken on the 29<sup>th</sup> August 2023 showing examples of hand dug trial pit and the nature of the subsoil and topsoil within the soft landscaping of plot 90 (back garden).

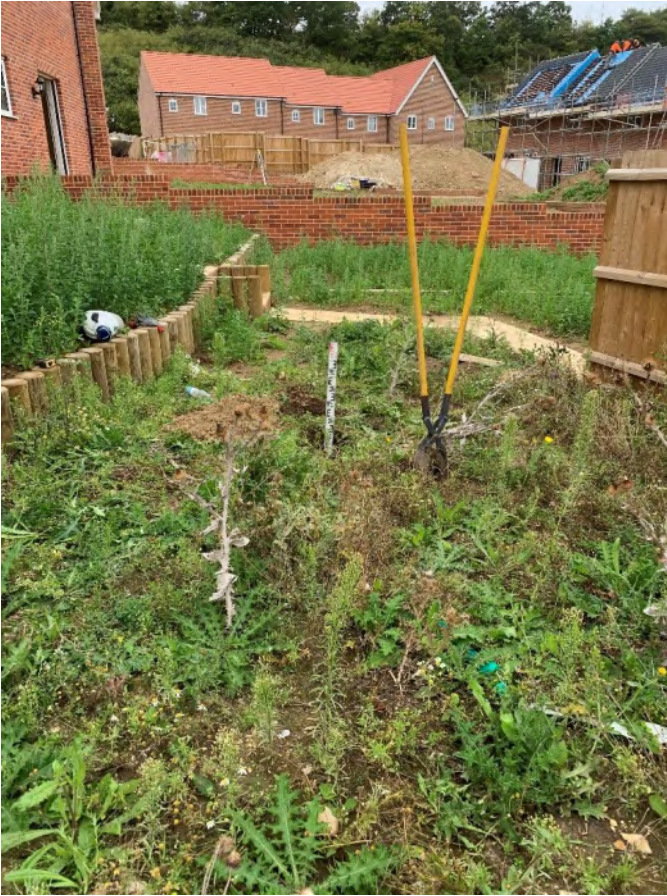
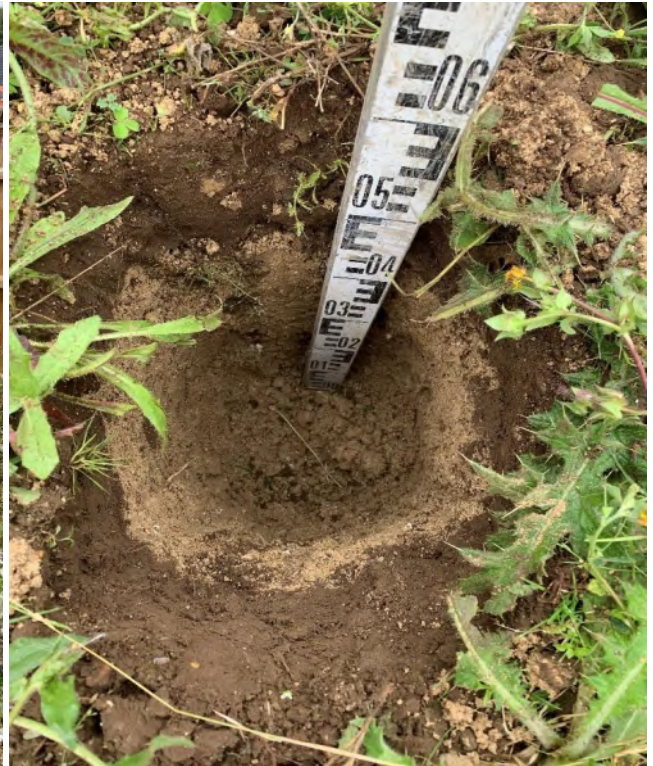
**Photographs 5-6**, taken on the 29<sup>th</sup> August 2023 showing examples of hand dug trial pits and the nature of the subsoil and topsoil within the soft landscaping of plot 93 (front and back garden).

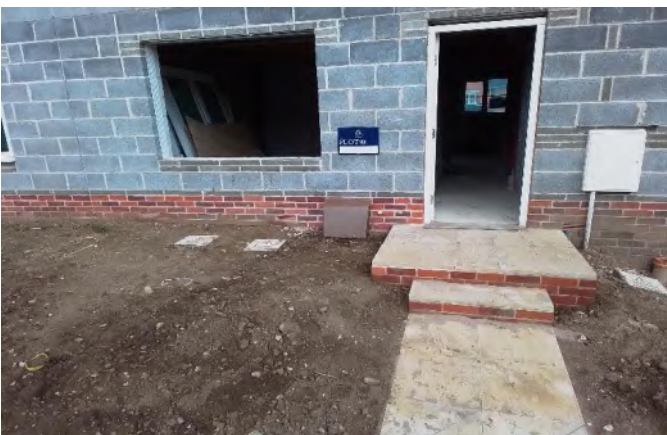
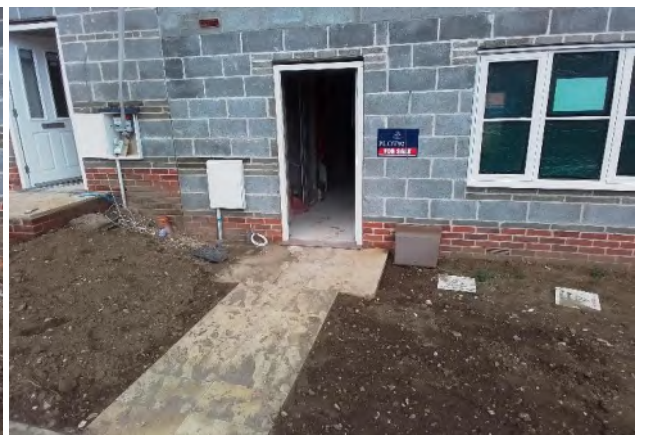
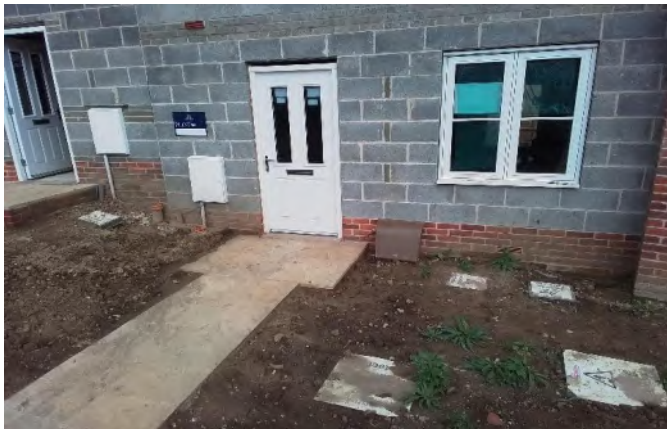
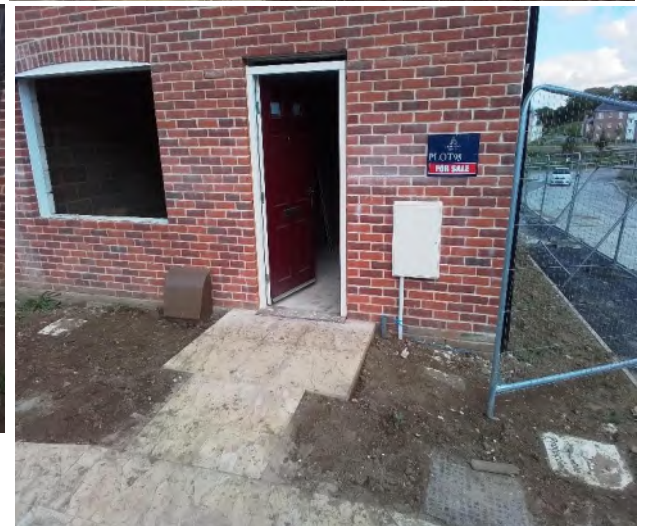
- Concrete edging was observed adjacent to footpaths and curb sides at approximately 45° angle.
- At the time of the site visit topsoil had not been placed within the front gardens of plots 90-95. However, since our site visit HH have provided photographs of the topsoil being placed within the front gardens of these plots, which have been reviewed and are deemed suitable.

**Client Supplied Photographs 7-10**, taken on the 14<sup>th</sup> September 2023 showing topsoil placement within the front gardens of plots 90-95.
