Document: Remediation Verification Report

Project: Needham Market Quarry

Reference No.: GN17820_RV36

REMEDIATION VERIFICATION REPORT
FOR REMEDIAL ACTIVITY
AT
NEEDHAM MARKET QUARRY (Plots 112-117)

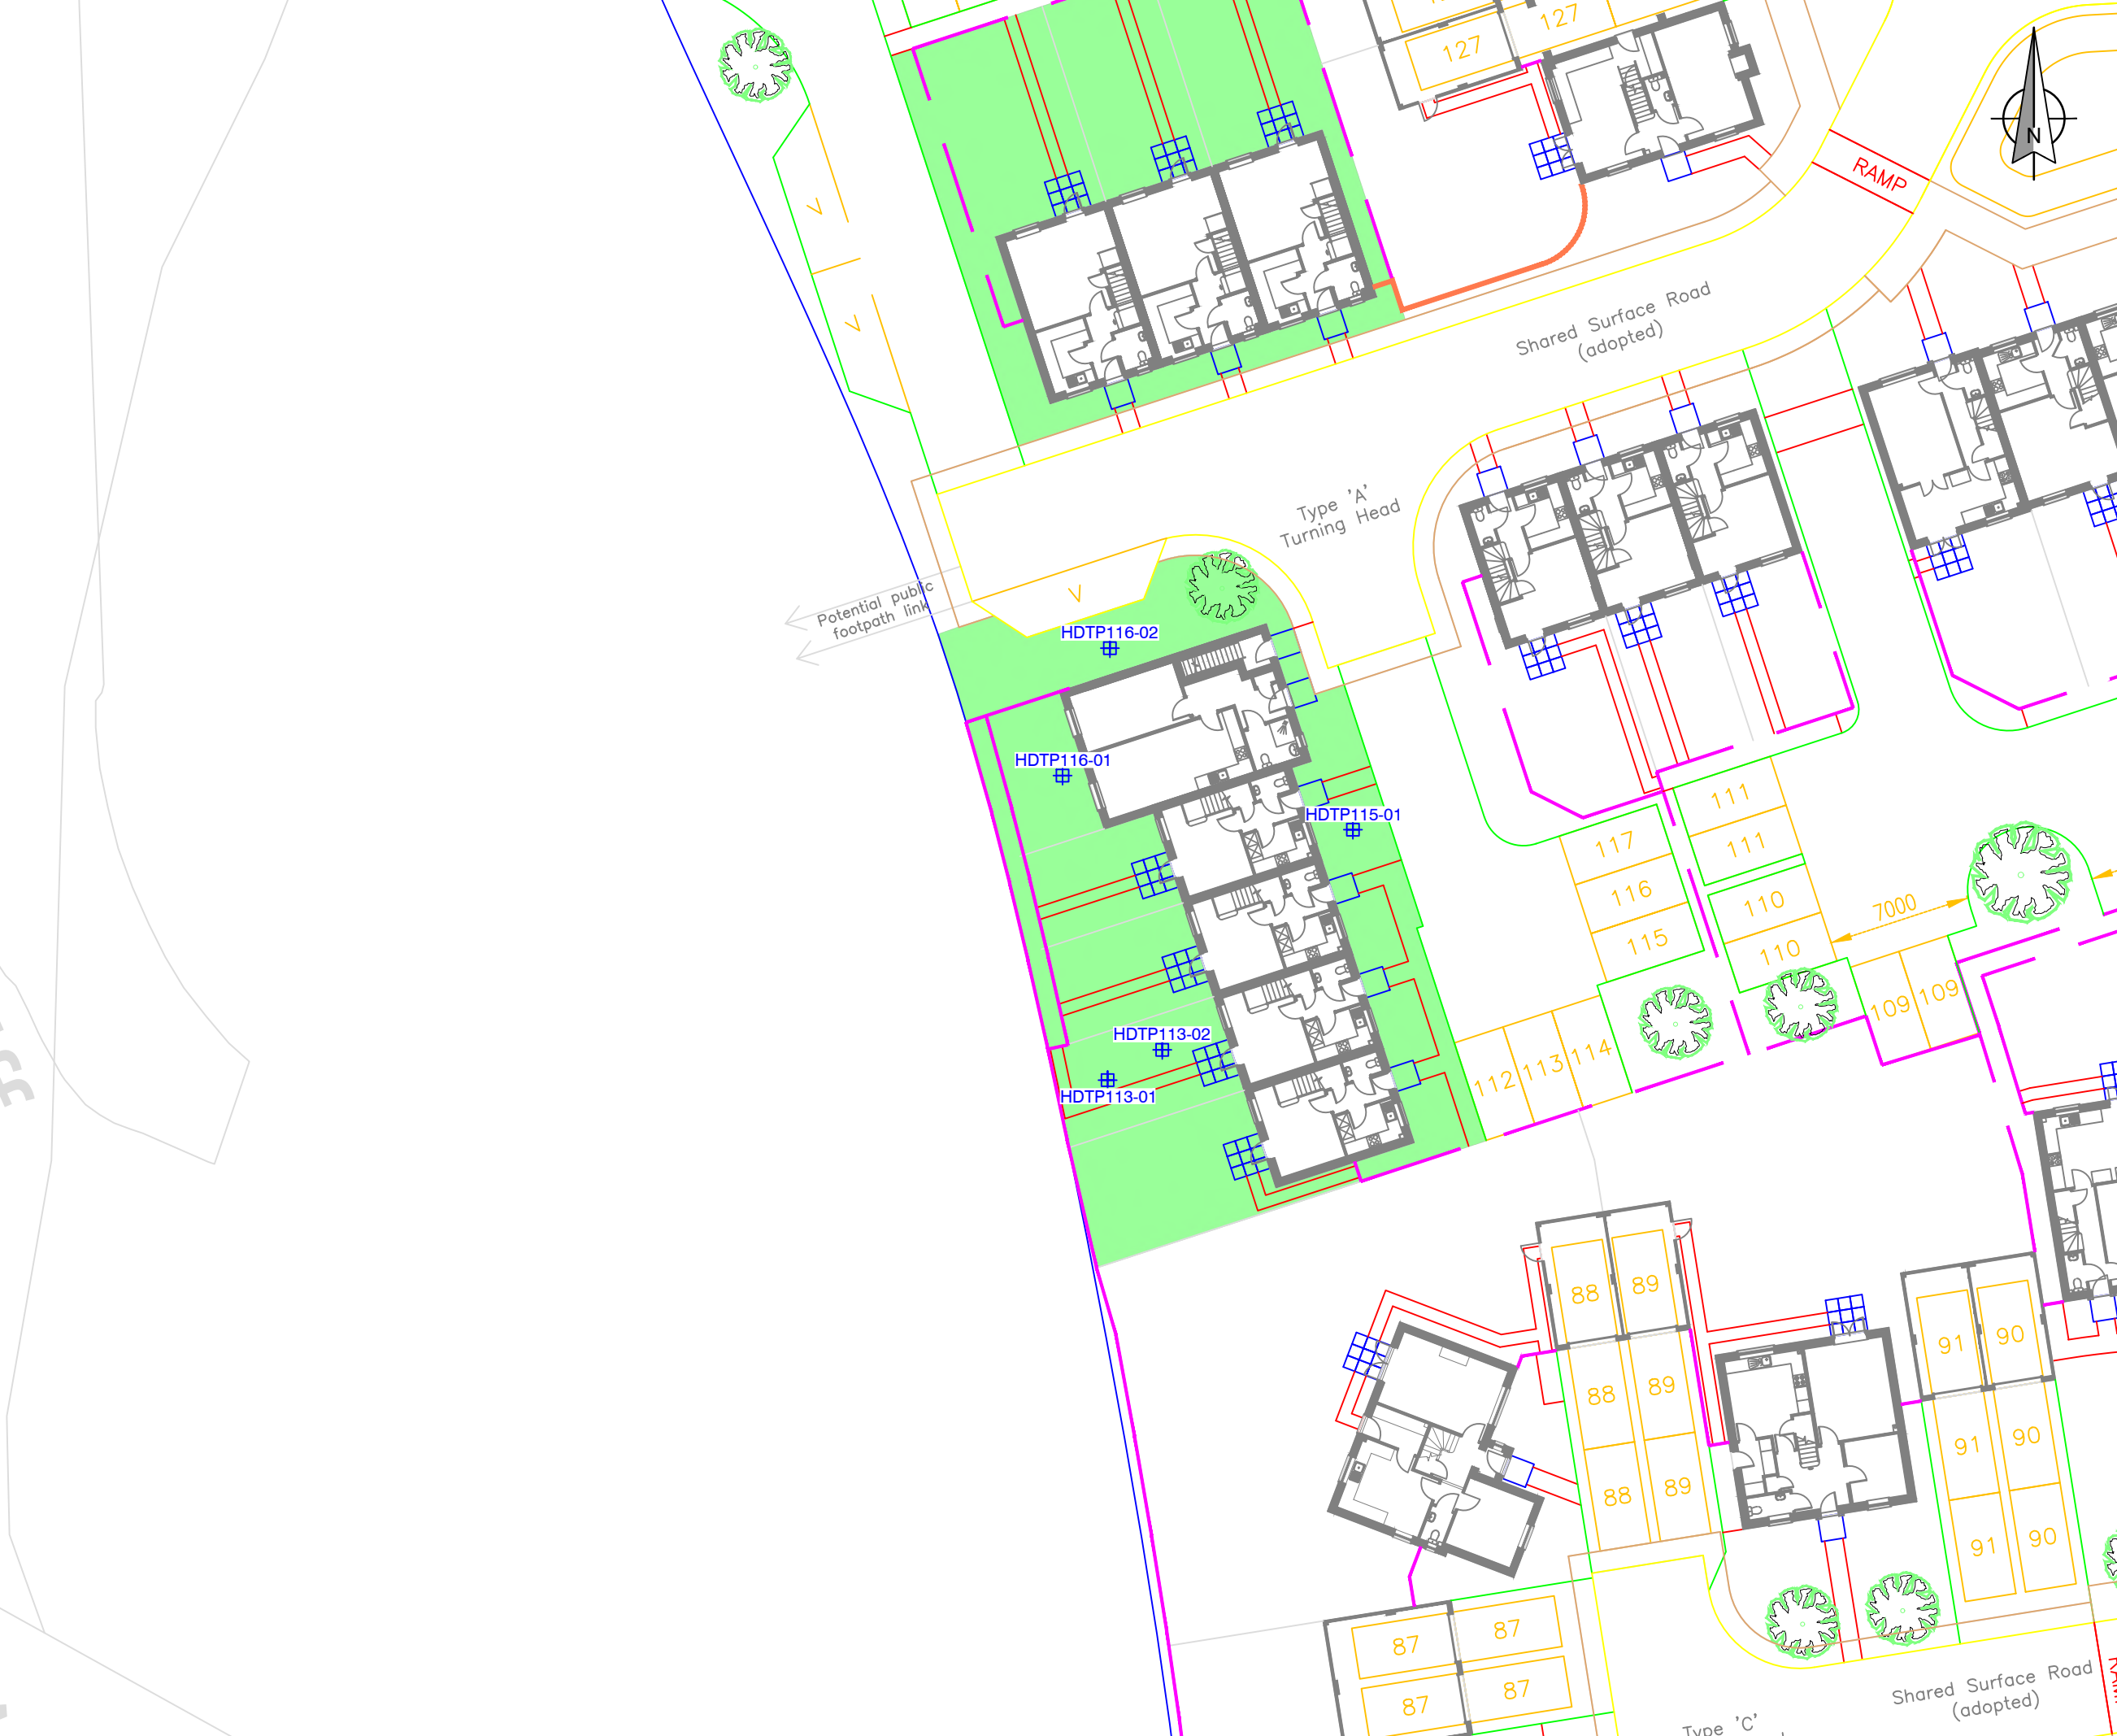
- HDTP113-01 Hand Dug Trial Pit
- Acceptable Cover System

Client : Hopkins Homes Ltd		
Project : Needham Market Quarry		
Job No : GN17820	Date : January 2023	
Drawing Title : Fieldwork Location Plan - Plot 112-117		
Drawing No : GN17820 - DR502am		
Scale : 1:300 @ A3		
Drawn by : RW	Checked by : MR	
Eastings : 609360	Northings : 254020	
Revision history		
Rev	Date	Revision Data

The fieldwork locations are shown on drawings GN17820-DR502am included within the appendix. Hand excavated trial pits were undertaken to record the thickness and physical descriptions of the materials present and to confirm material suitability.

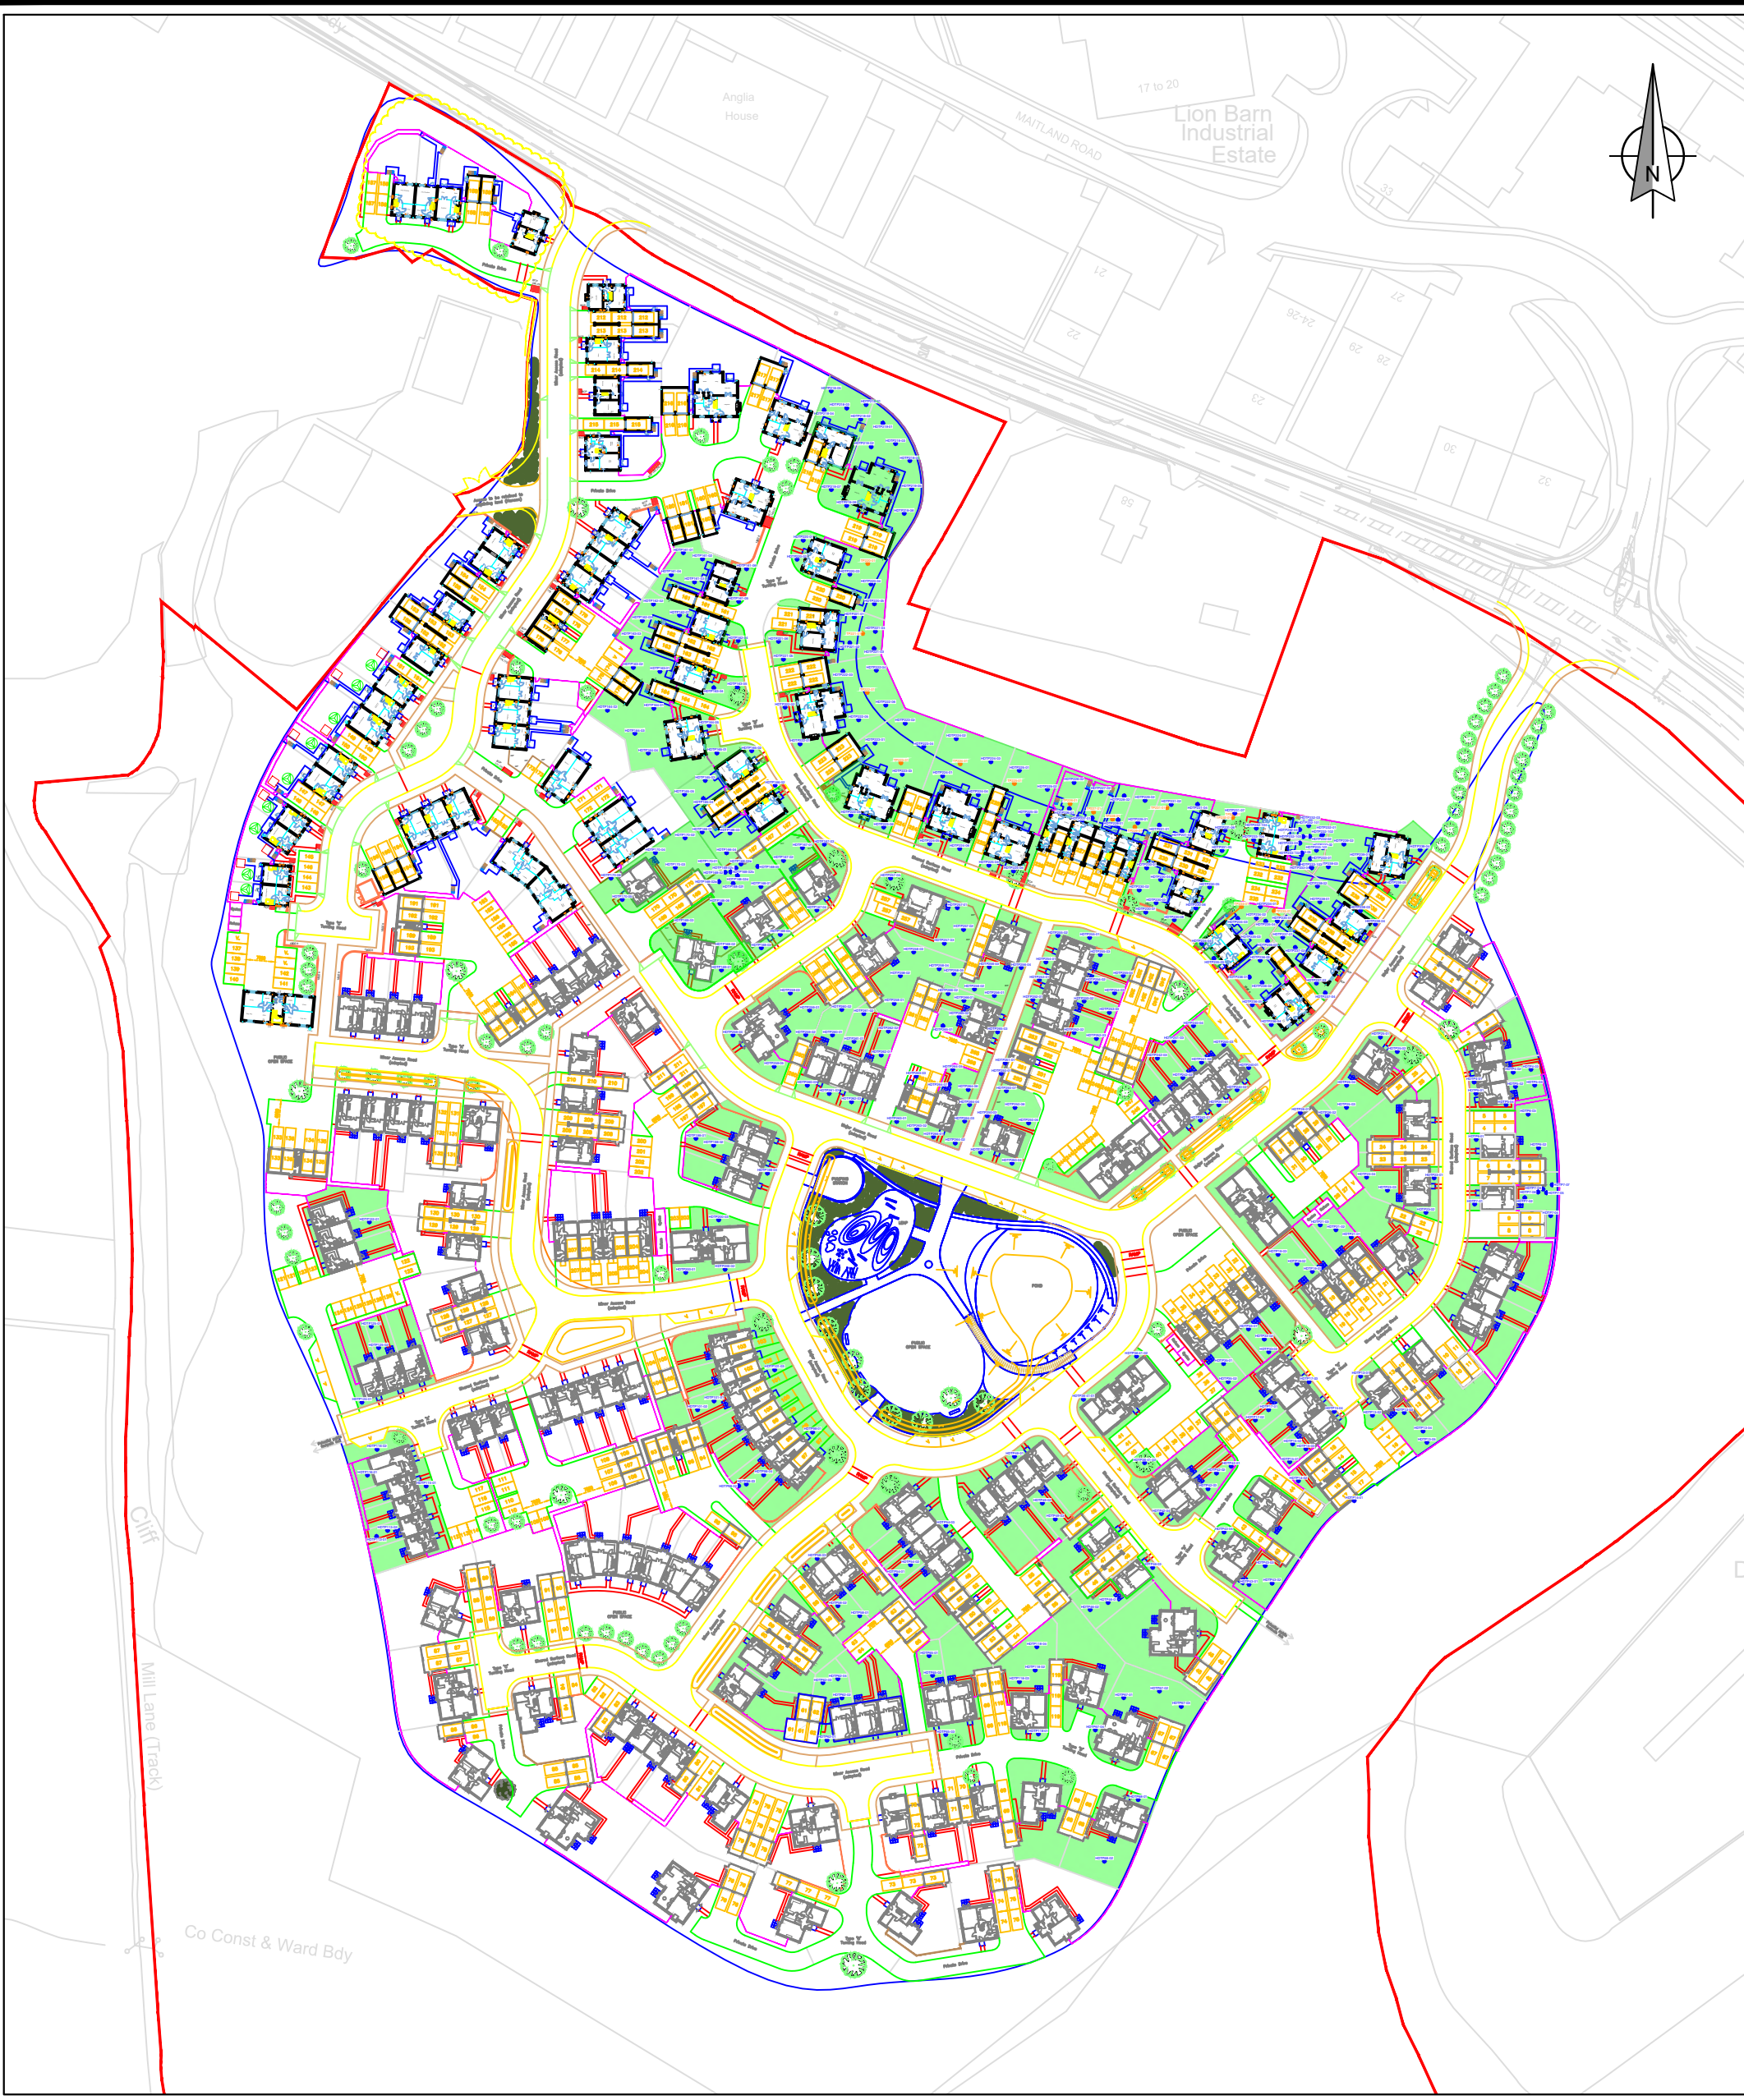
Plots 3-69, 96-103, 118, 119, 121-126, 161-170, 197-203 and 218-266 have previously been validated and are shown as green on appended drawing GN17820-DR502 which shows a summary of the validation completed to date. The requirement for remediation in other plots is currently being assessed and the remediation undertaken as appropriate. Further remediation verification reports are in production for additional affected plots/areas on the whole development, as each area is built and remediated. These include plots 1, 2, 70-95, 104-111, 120, 127-136, 184-193 and 204-211.

Client : Hopkins Homes Ltd		
Project : Needham Market Quarry		
Job No : GN17820	Date : January 2023	
Drawing Title : Fieldwork Location Plan		
Drawing No : GN17820 - DR502		
Scale : 1:1500 @ A3		
Drawn by : RW	Checked by : MR	
Eastings : 609480	Northings : 254090	
Revision history		
Rev	Date	Revision Data
R36	16/01/2023	Fieldwork locations for Plots 112-117 added

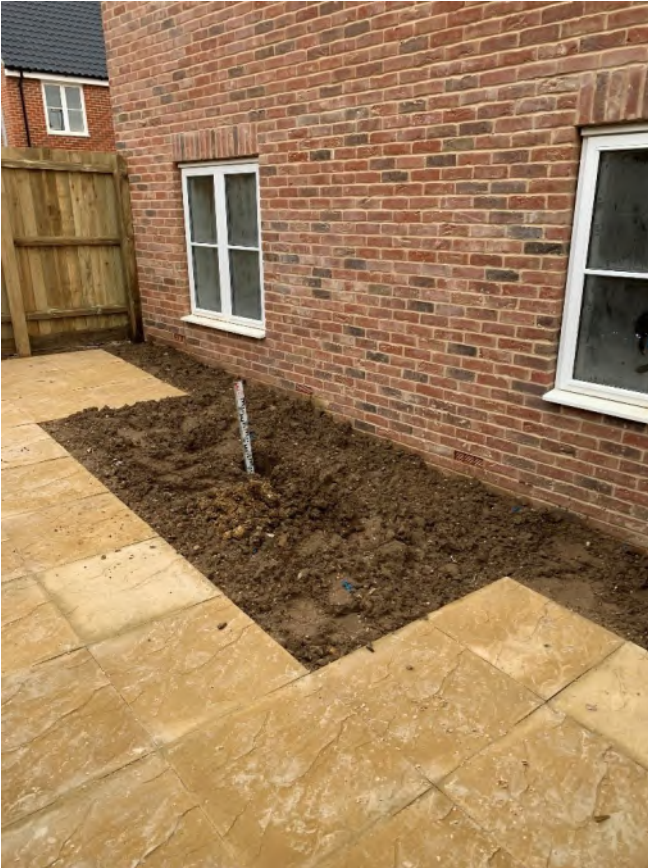
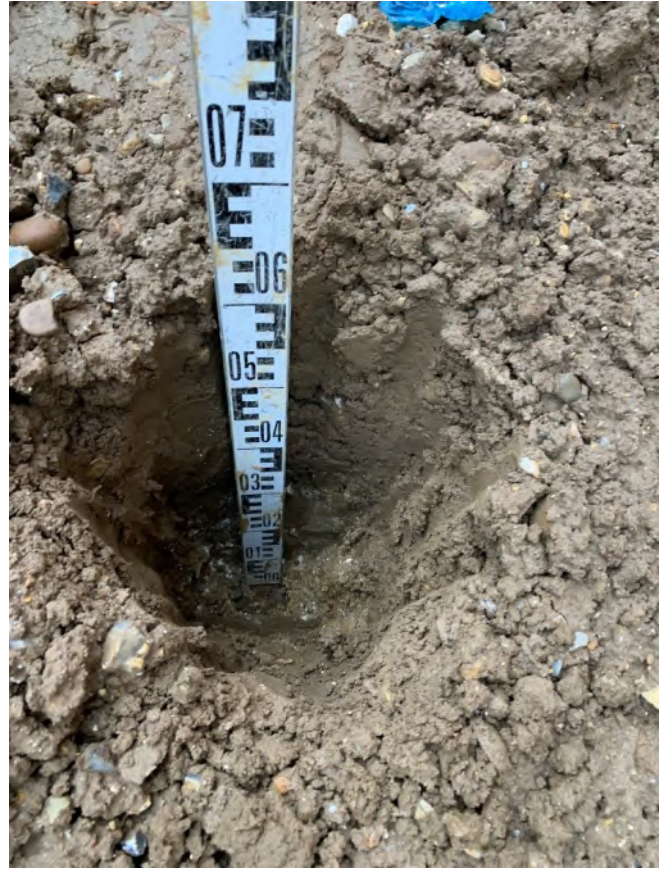
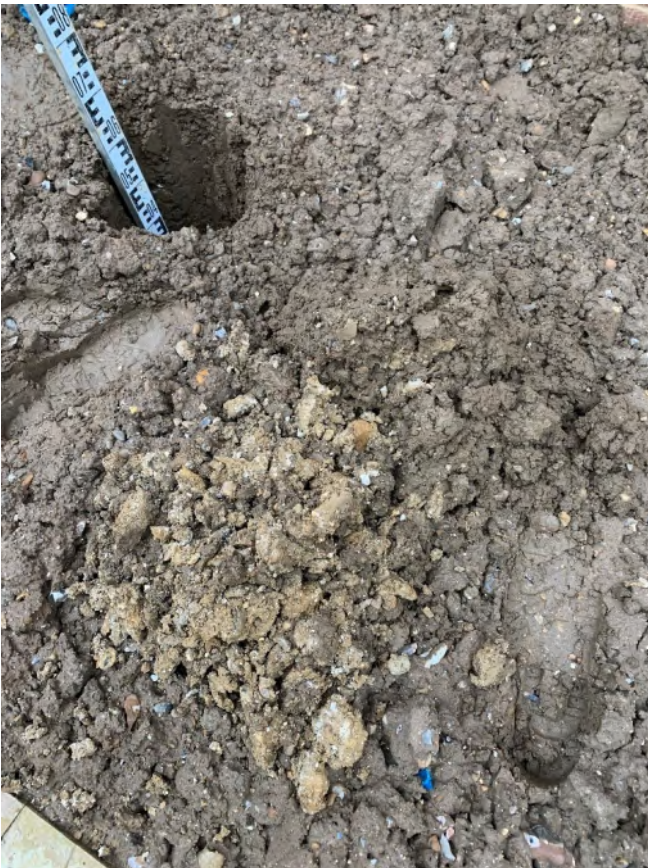
- MADE GROUND. Yellowish brown slightly sandy gravelly clay. Gravel is sub-angular to sub-rounded fine to medium flint and chalk.
- MADE GROUND. Greyish brown slightly gravelly very sandy clay. Gravel is sub-angular to sub-rounded fine to medium flint and chalk.

During the verification works, the material was generally described as brown slightly gravelly slightly clayey to silty fine to medium sand. Gravel is angular to rounded fine to coarse flint. This recent description is generally consistent with the previous description, allowing for some variability, and therefore has been confirmed as the same material. This material was used for the topsoil (ground level up to 400mm depth) within the soft landscaping areas surrounding plots 112-117. The minimum thickness of 150mm of topsoil was encountered in all of the trial pits during the verification exercise.

Photographs 1-3, taken on the 13th January 2023 showing examples of hand dug trial pits and the nature of the subsoil and topsoil within the soft landscaping of plot 116/117.

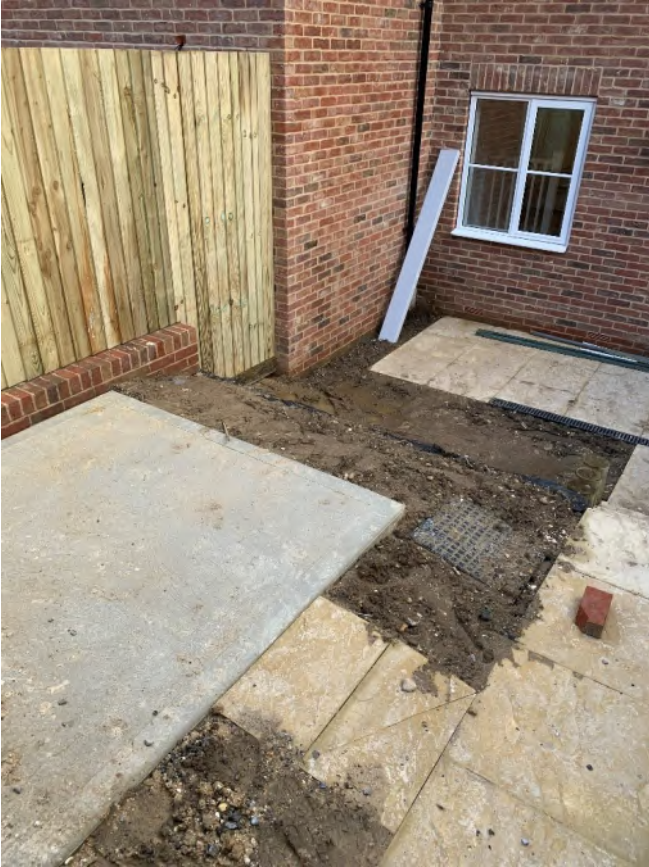
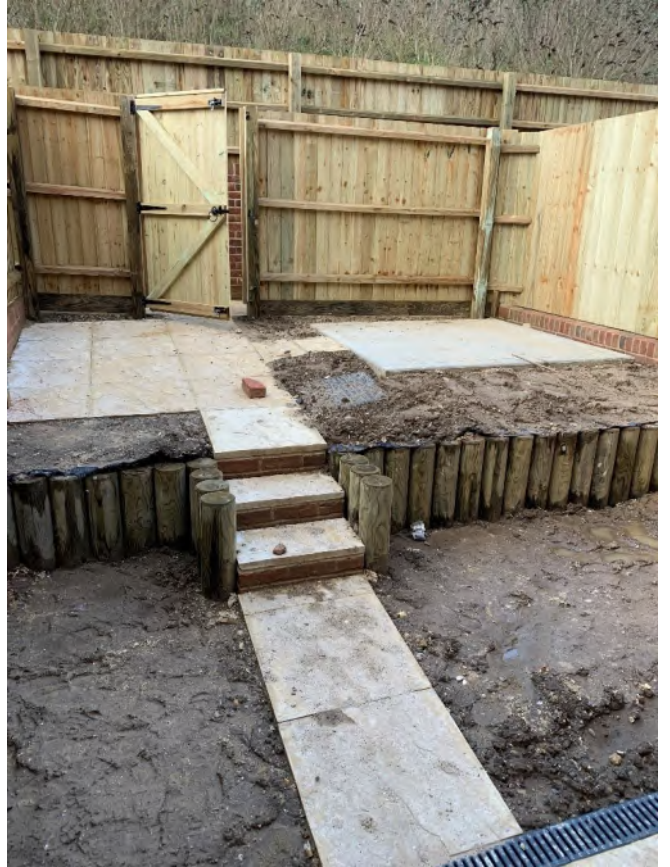
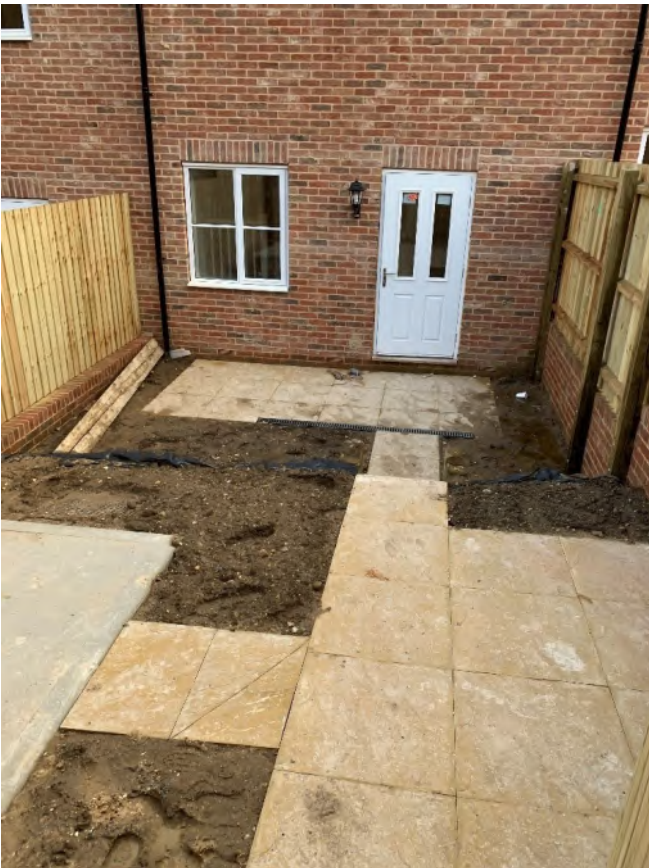
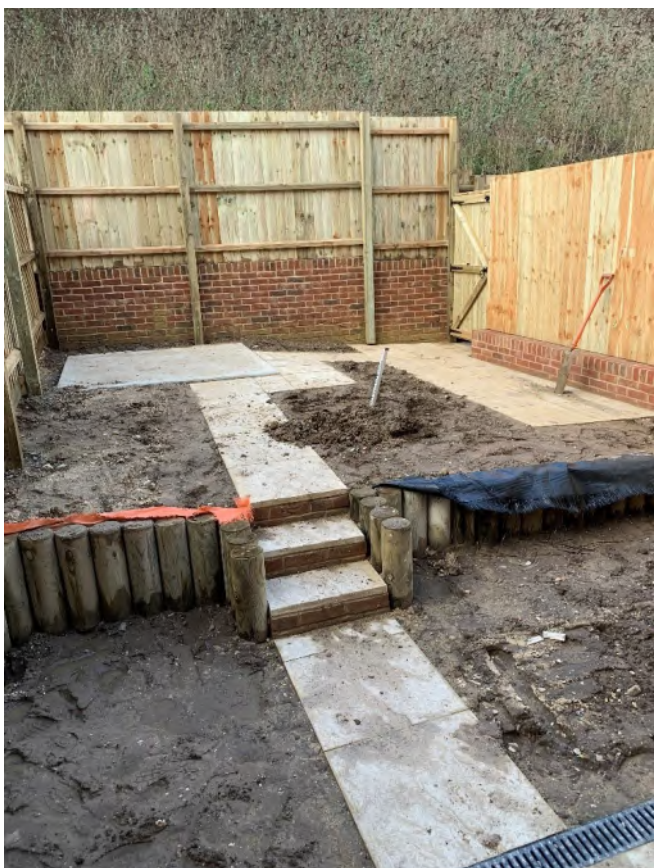
- The rear gardens of plots 112-117 were terraced with two elevations. A small wooden retaining post retaining wall separated the two levels. Across the rear gardens, a larger area of hardstanding was present than is shown on the appended drawing GN17820-DR502am. This is shown on the appended photosheet.

Photographs 4-7, taken on the 13th January 2022 showing the rear gardens of plots 112-115.

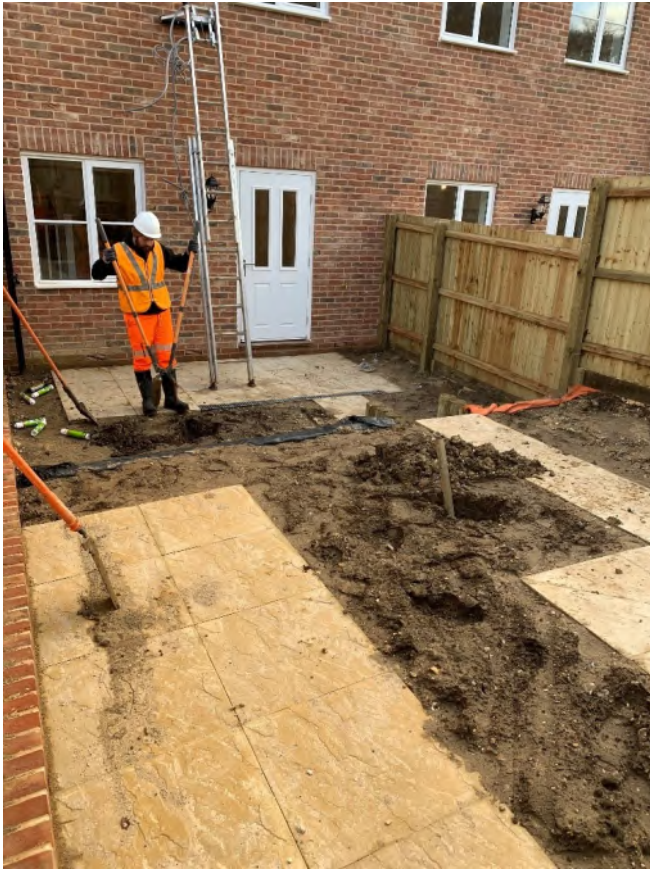
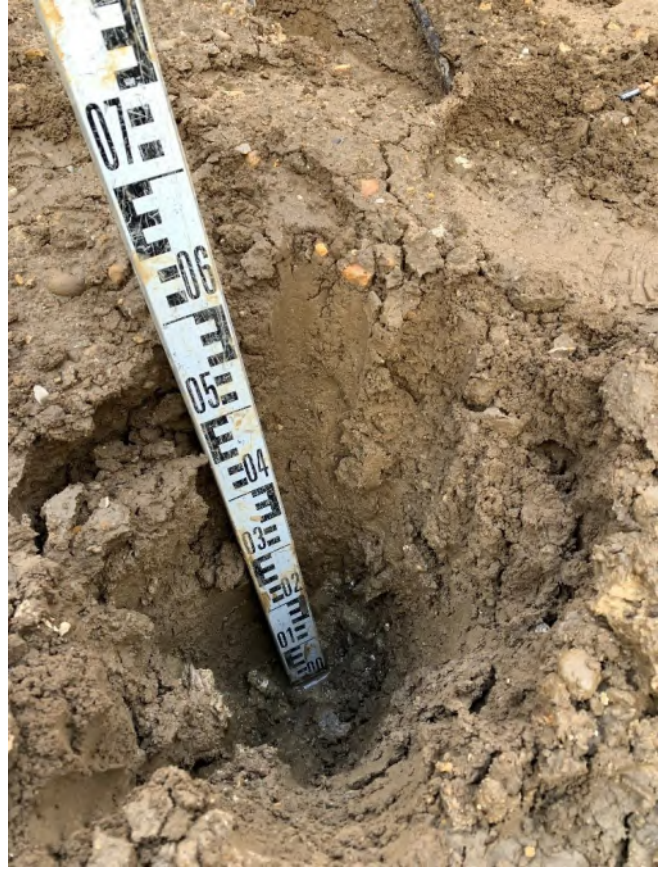
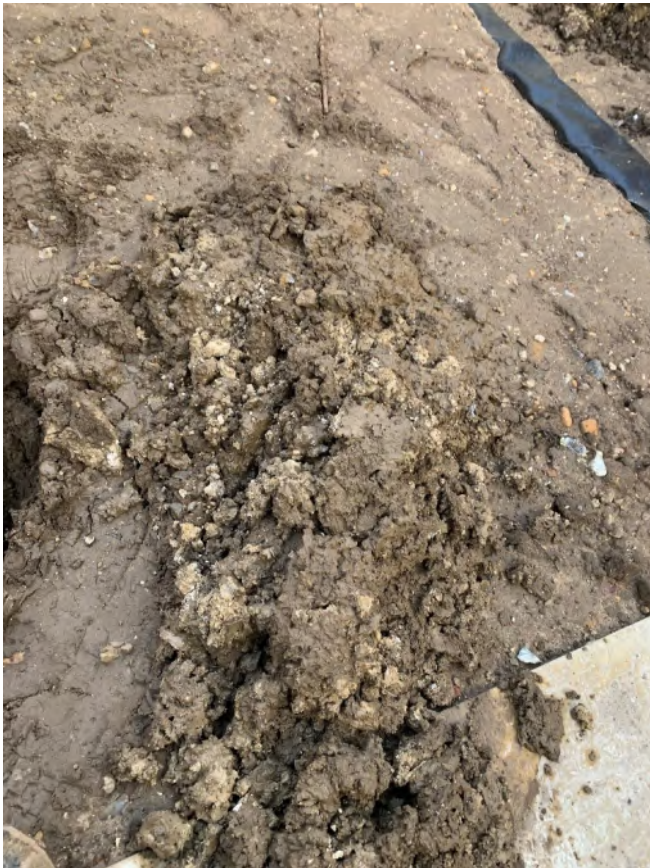
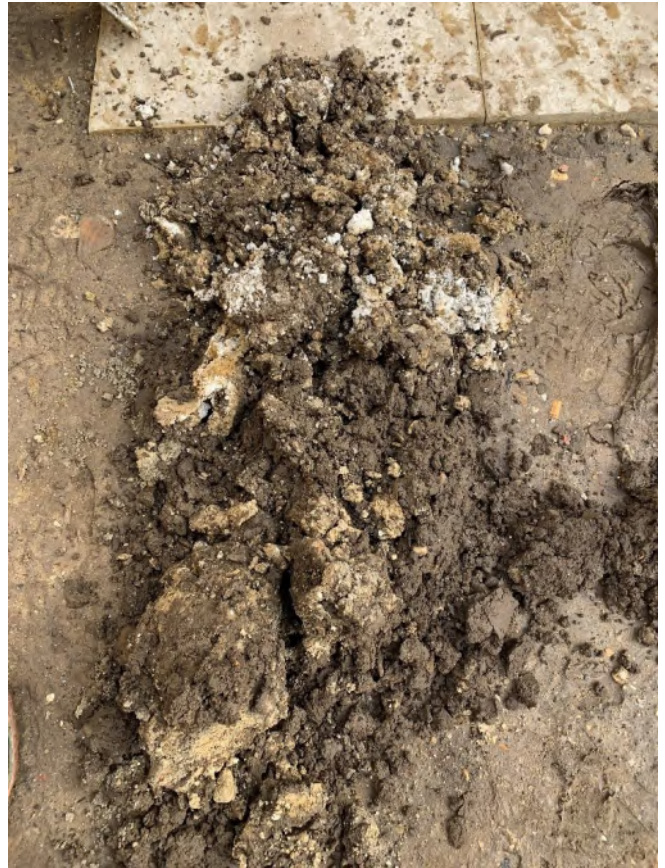
Photographs 8-11, taken on the 13th January 2023 showing examples of hand dug trial pits and the nature of the subsoil and topsoil within the soft landscaping of plot 113 (representative of plots 112-117).

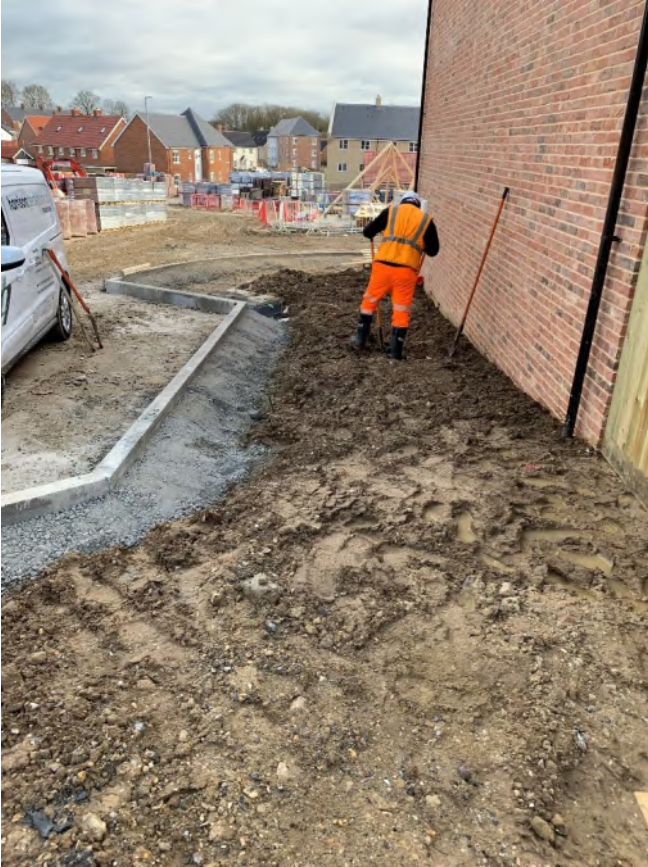
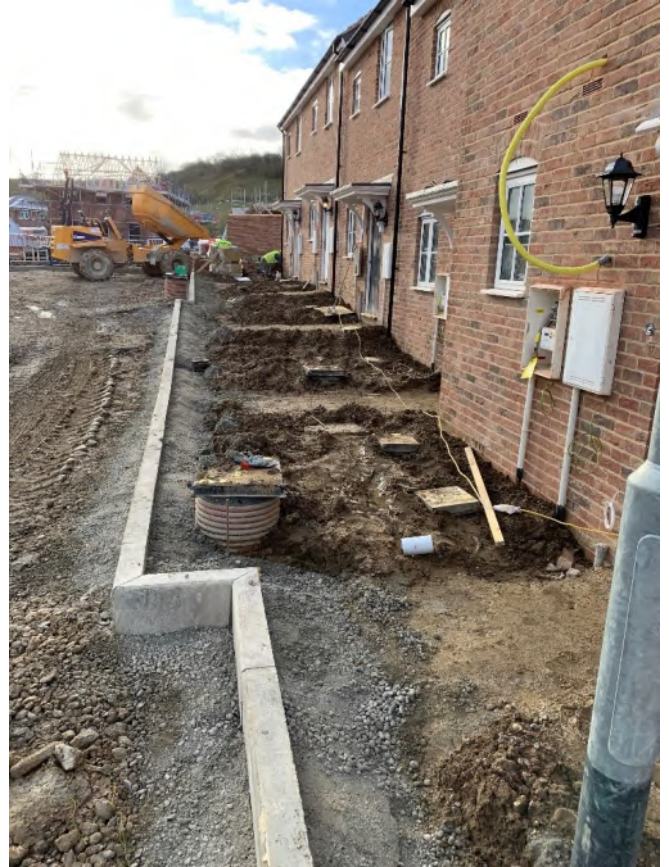
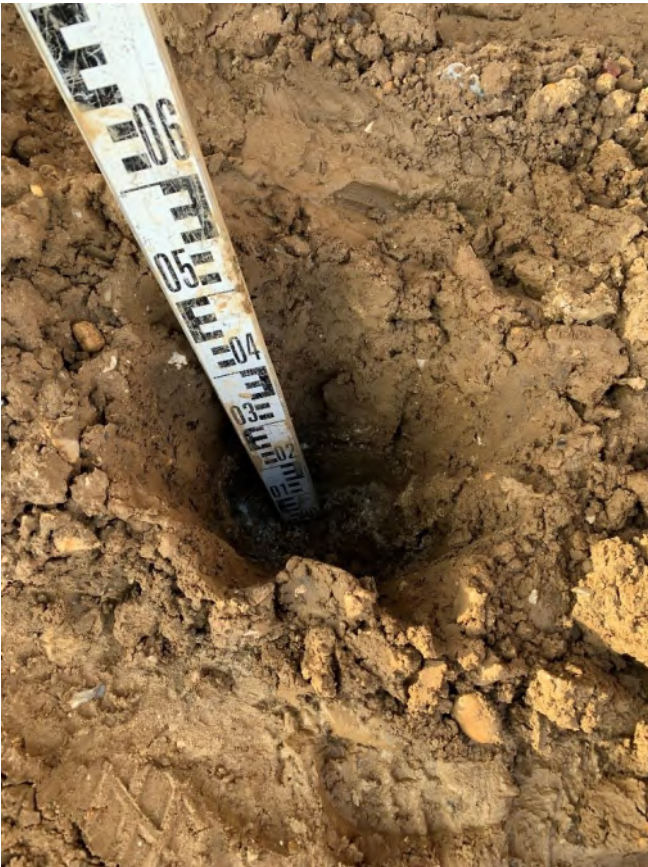
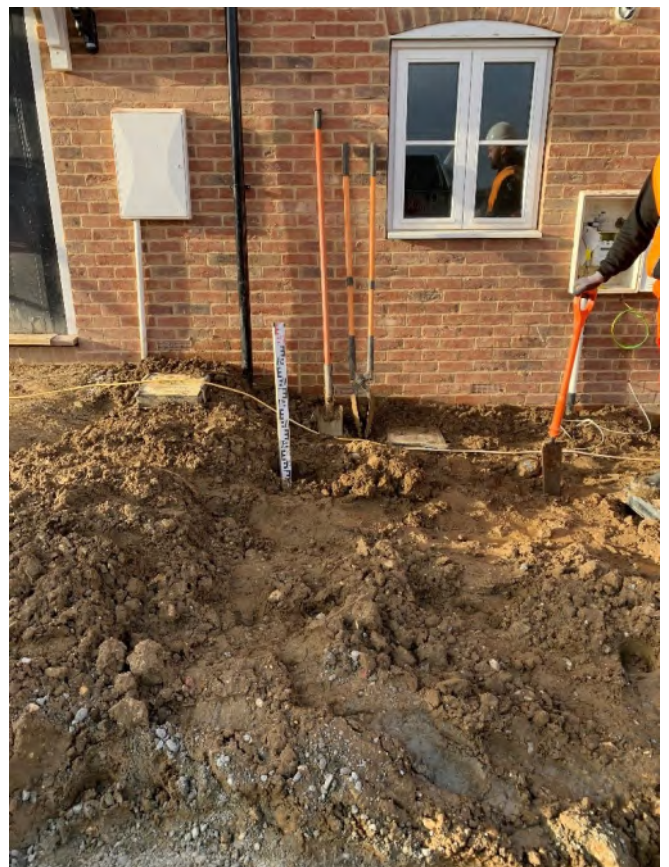
Photographs 12-15, taken on the 13th January 2023 showing examples of hand dug trial pits and the nature of the subsoil and topsoil within the soft landscaping of plot 114 (representative of plots 112-117).
