**Document:** Remediation Verification Report

**Project:** Needham Market Quarry

**Reference No.:** GN17820\_RV31

**VERIFICATION REPORT**  
**FOR REMEDIAL ACTIVITY**  
**AT**  
**NEEDHAM MARKET QUARRY (Plots 57-60)**

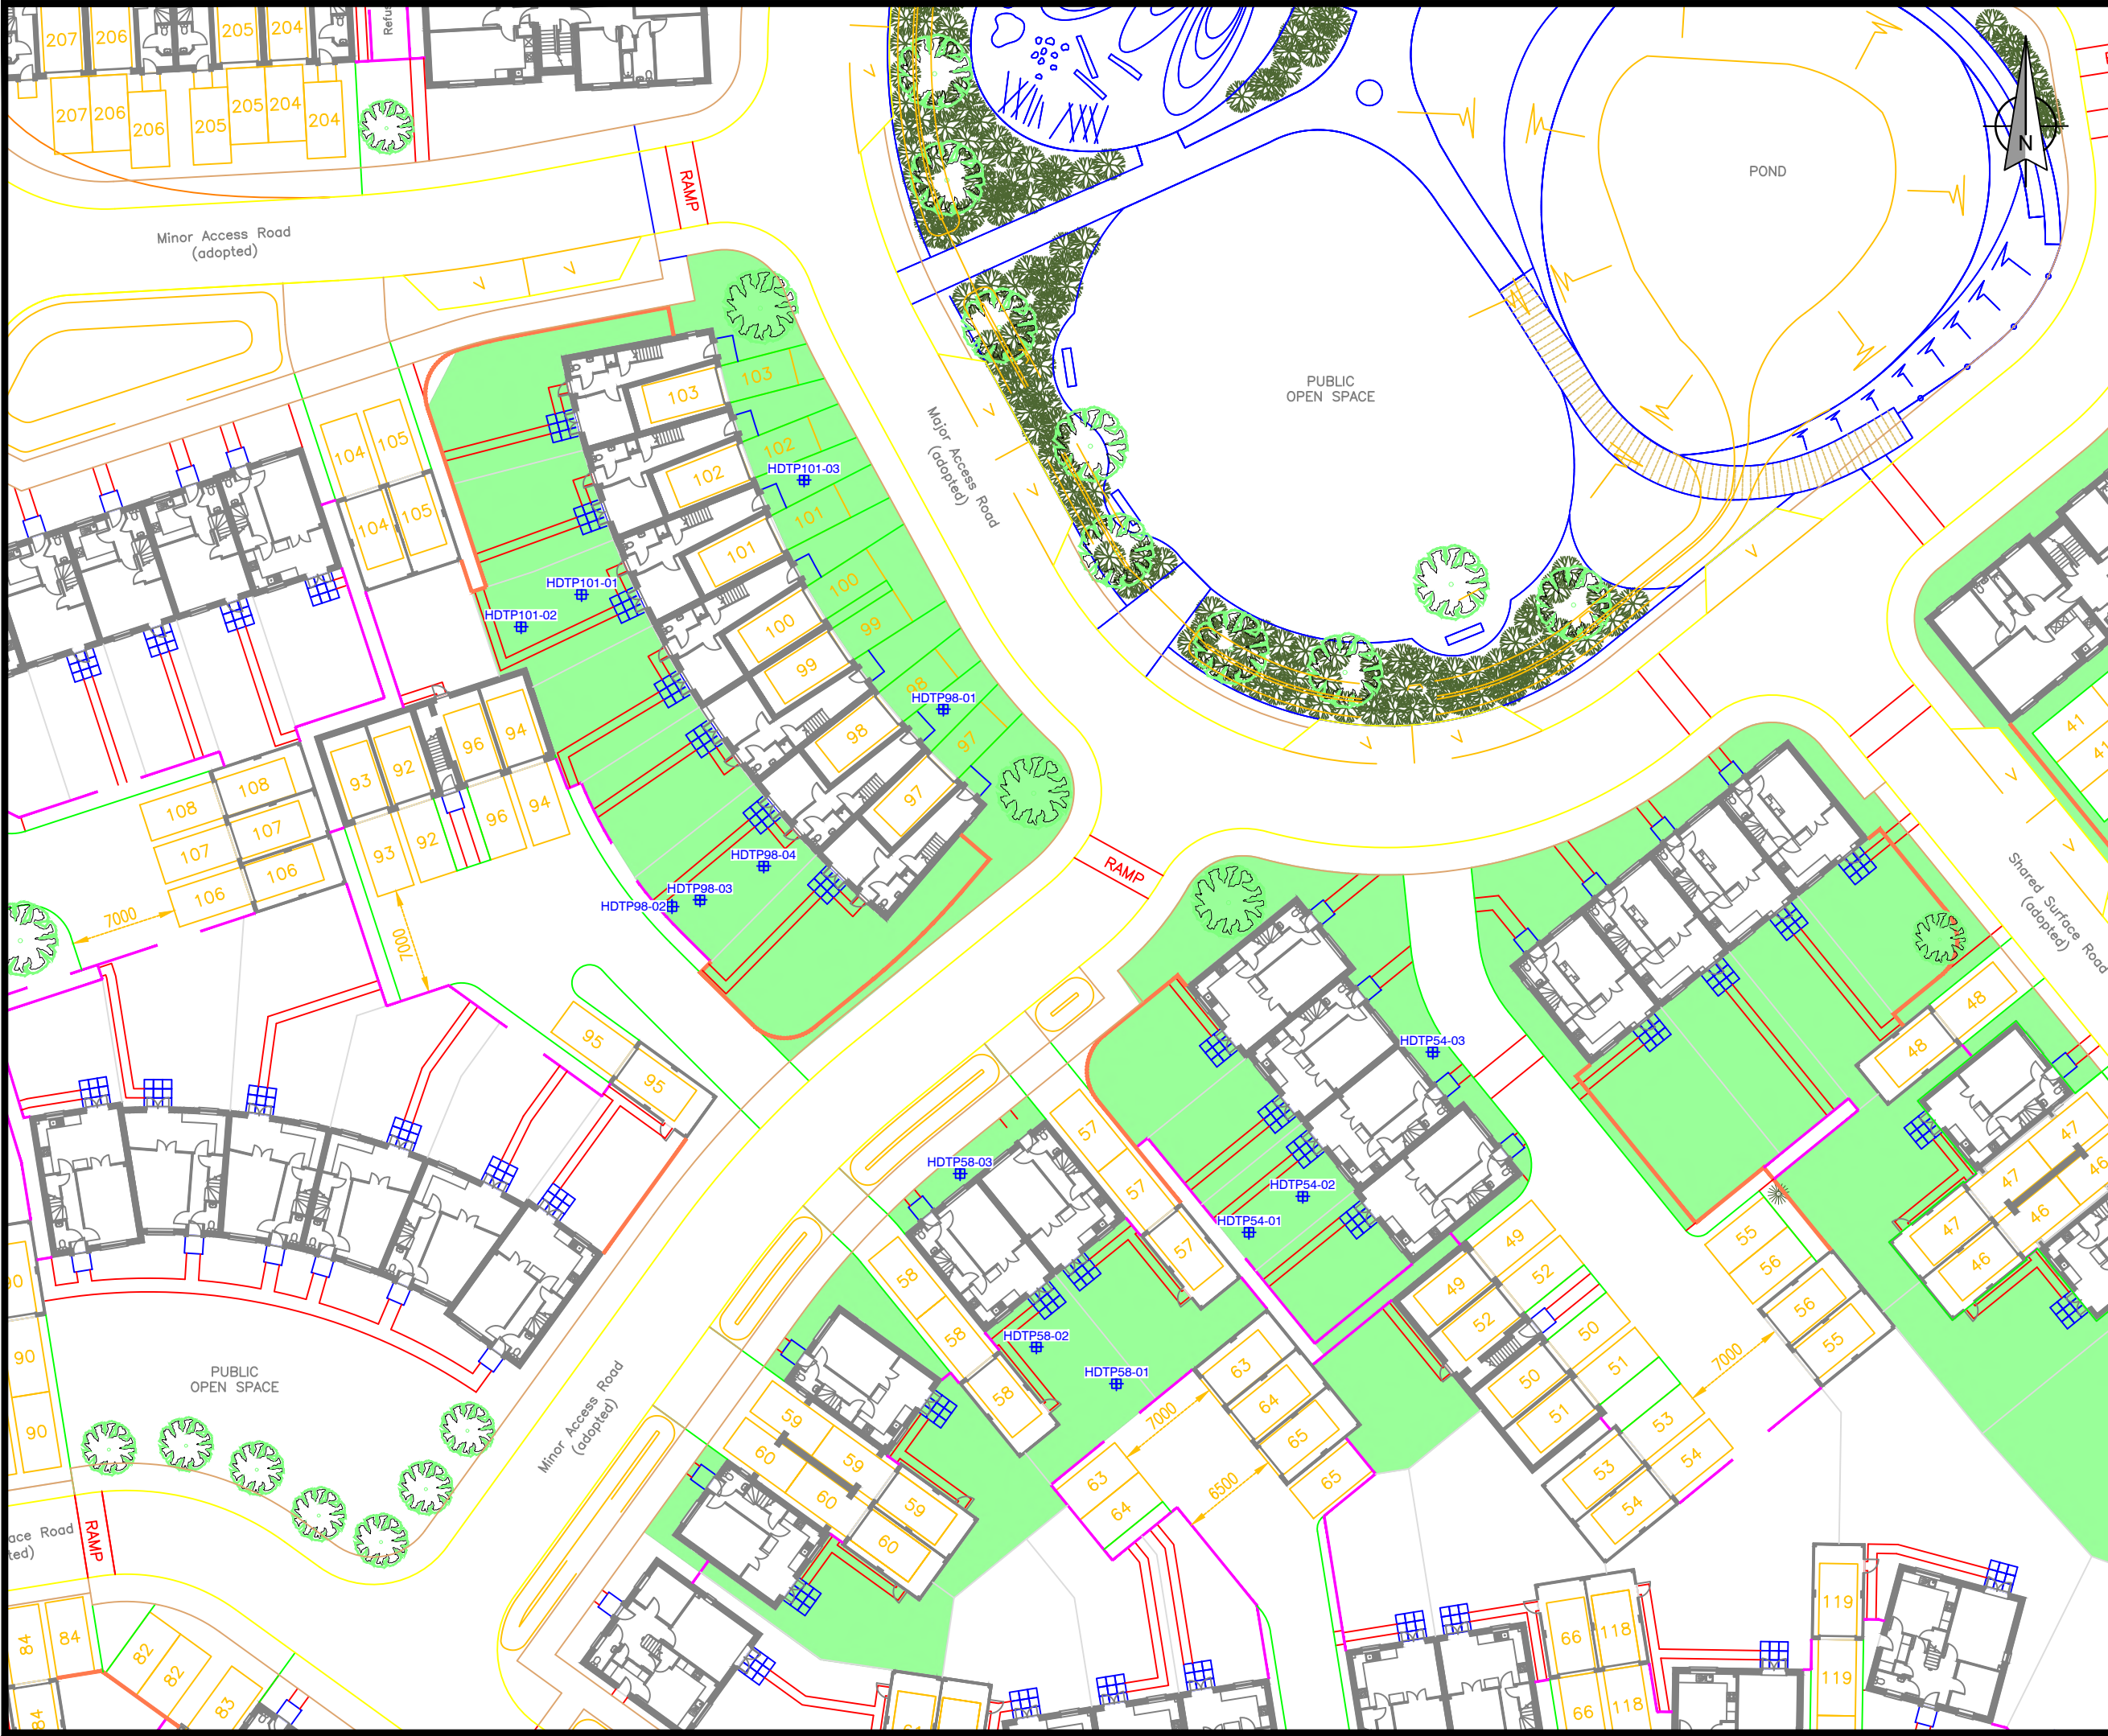
Client : Hopkins Homes Ltd  
 Project : Needham Market Quarry  
 Job No : GN17820 Date : July 2022  
 Drawing Title : Fieldwork Location Plan - Plots 57-60  
 Drawing No : GN17820 - DR502ag  
 Scale : 1:400 @ A3  
 Drawn by : RW Checked by : CD  
 Eastings : 609460 Northings : 254030

- HDTP54-01 Hand Dug Trial Pit
- Acceptable Cover System

The fieldwork locations are shown on drawing GN17820-DR502ag included within the appendix. Hand excavated trial pits were undertaken to record the thickness and physical descriptions of the materials present and to confirm material suitability.

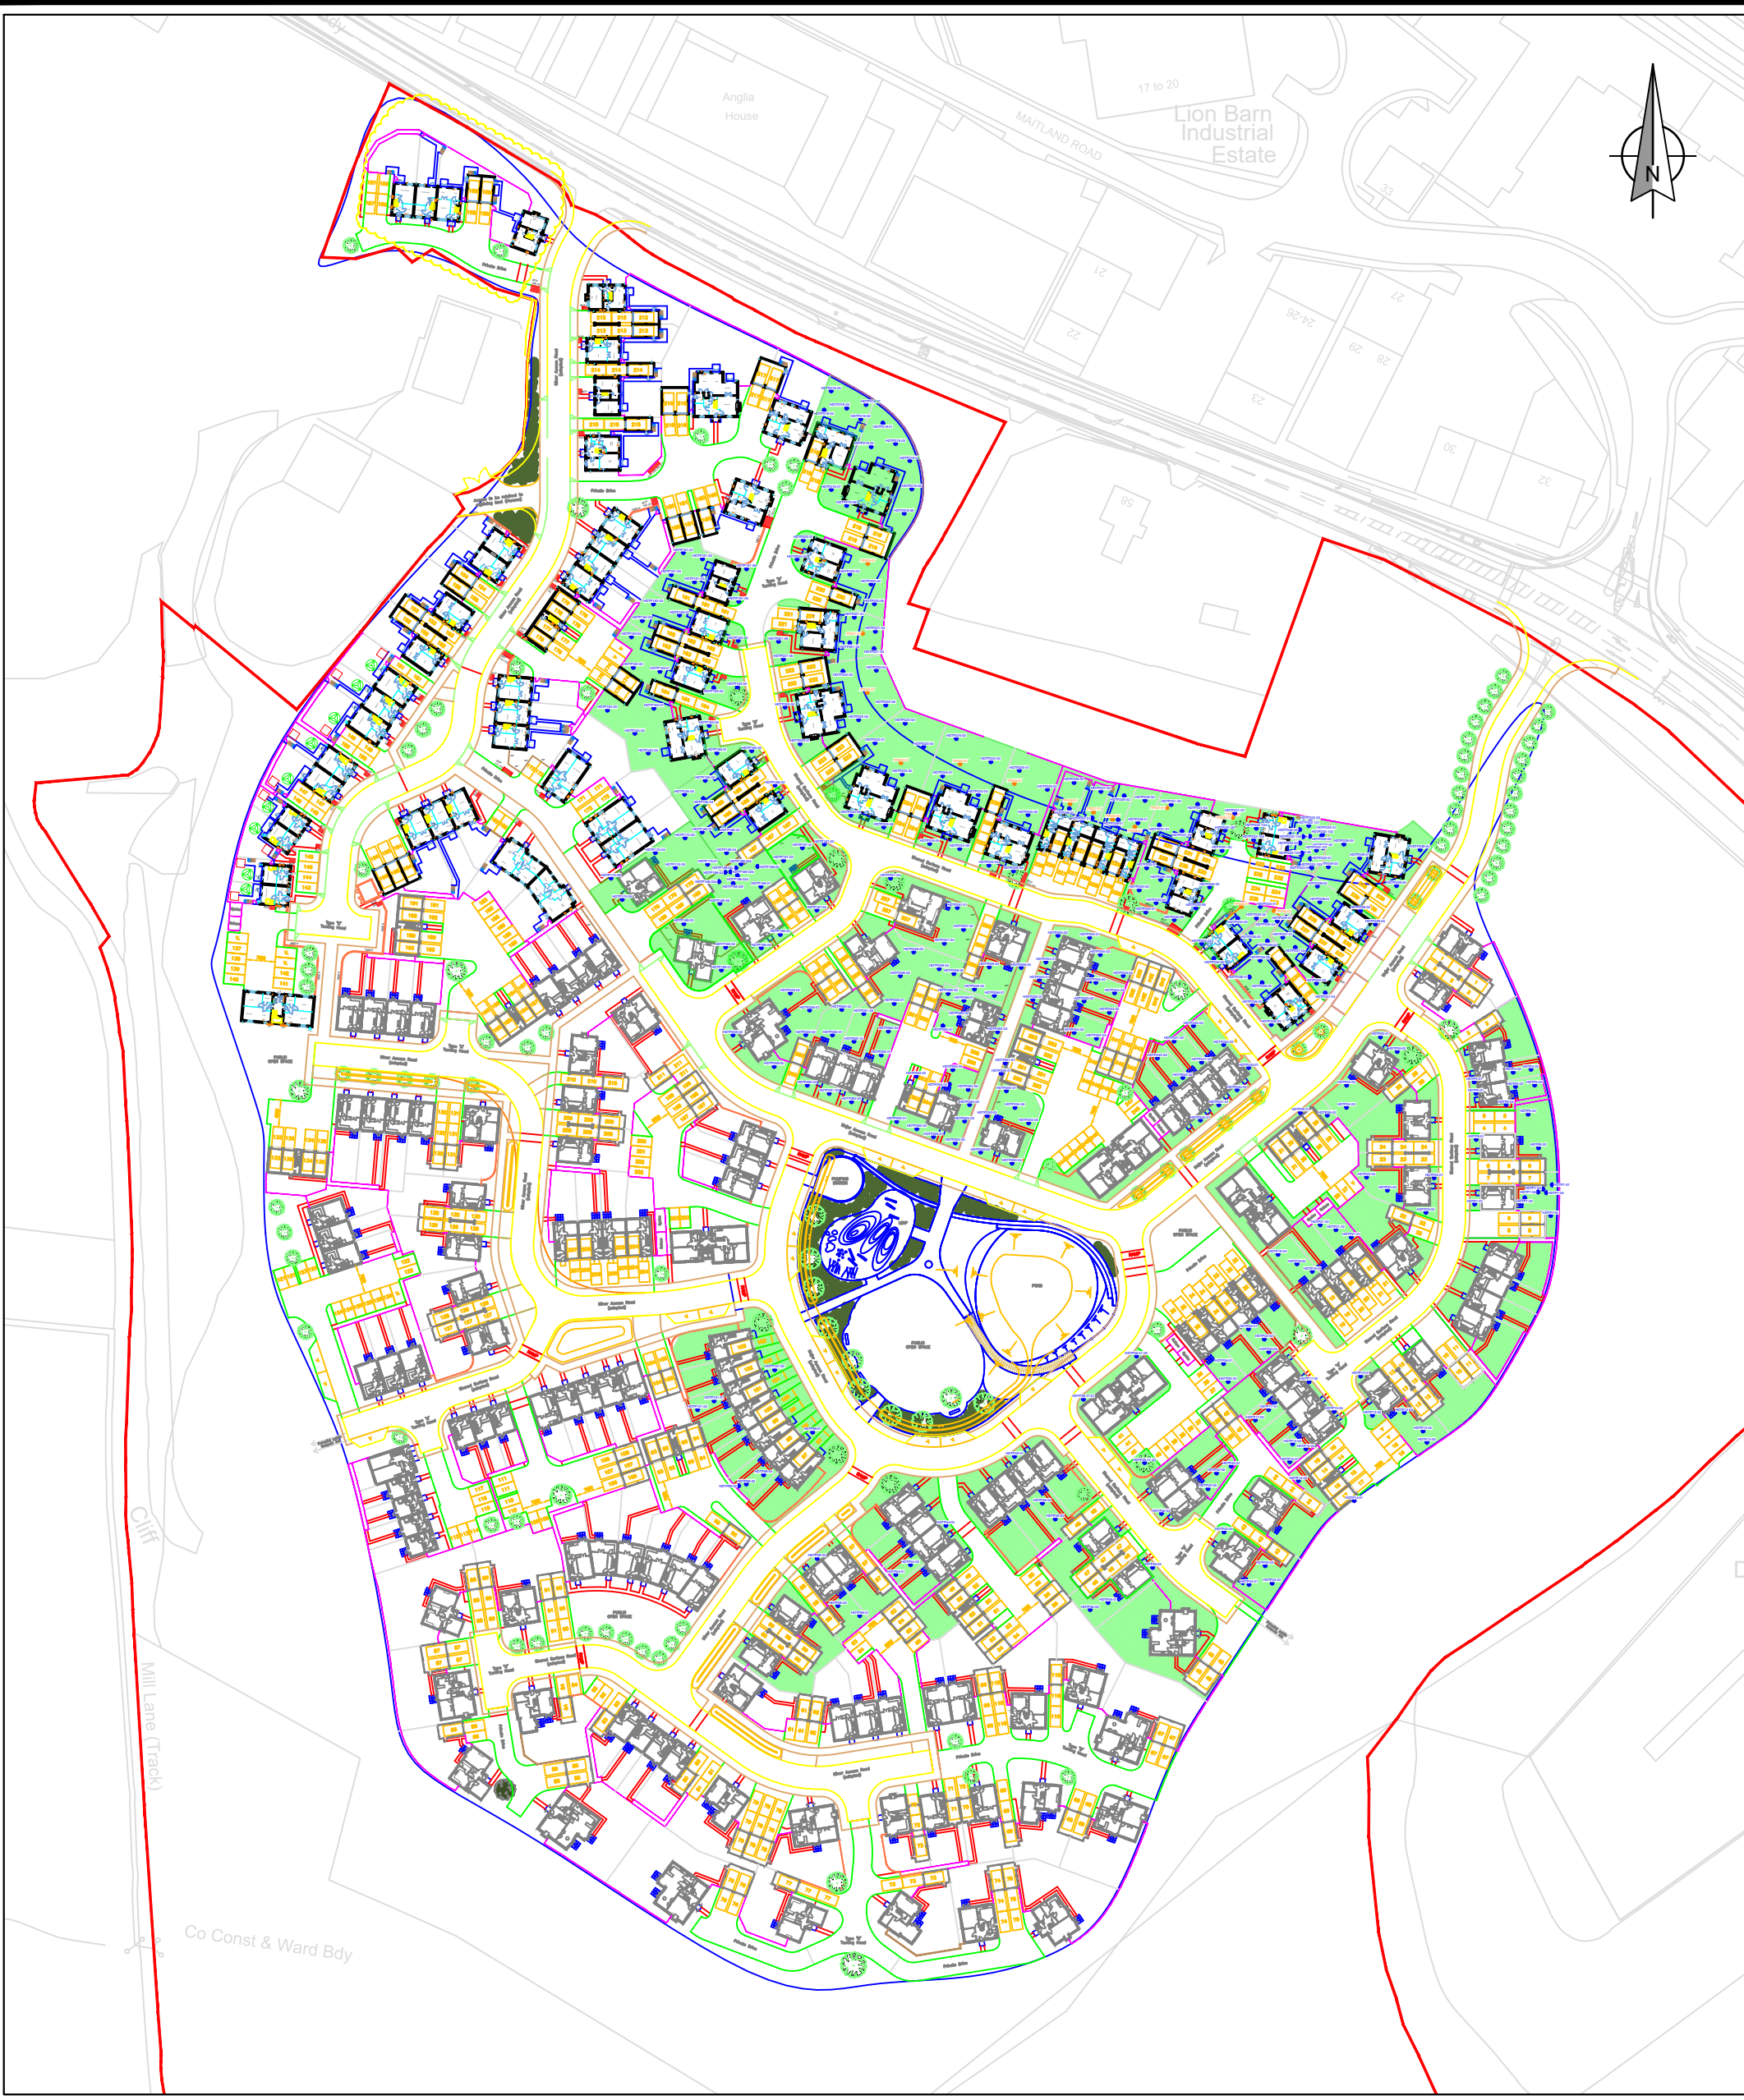
<b>Key :</b>	
	Site Boundary
	HDTP220-01 Hand Dug Trial Pit
	TP220-01 Machine Excavated Trial Pit
	Acceptable Cover System

Plots 3-56, 97-103, 161-170, 218-266 have previously been validated and are shown as green on appended drawing GN17820-DR502 which shows a summary of the validation completed to date. The requirement for remediation in other plots is currently being assessed and the remediation undertaken as appropriate. Further remediation verification reports are in production for additional affected plots/areas on the whole development, as each area is built and remediated. These include plots 1, 2, 61-96, 104-136, 184-193 and 197-211.

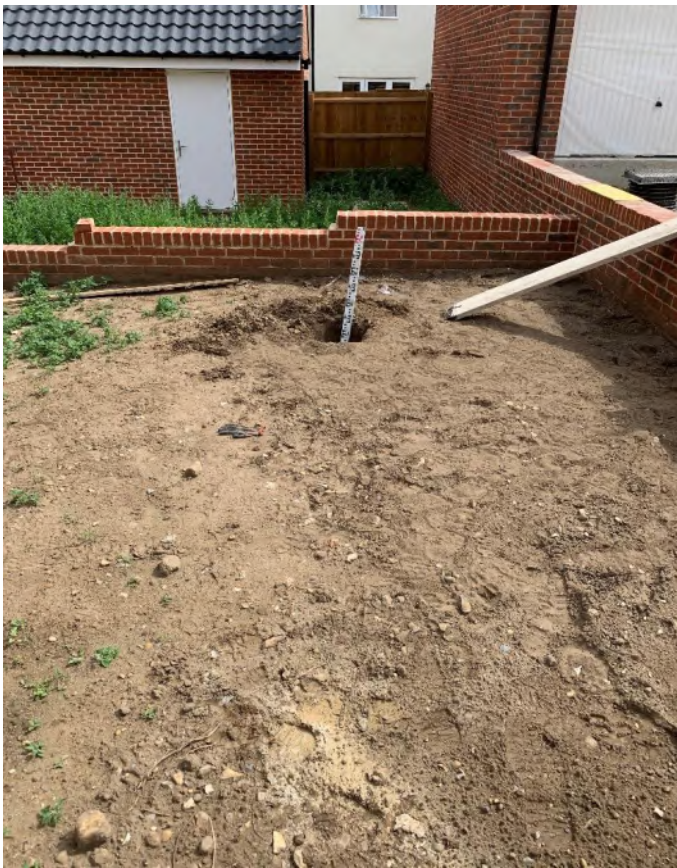
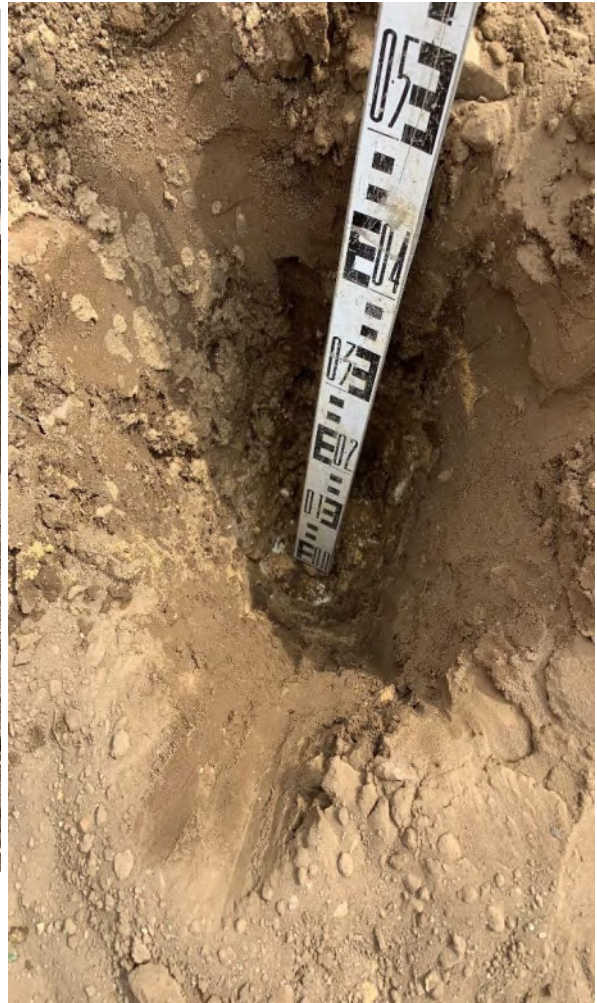
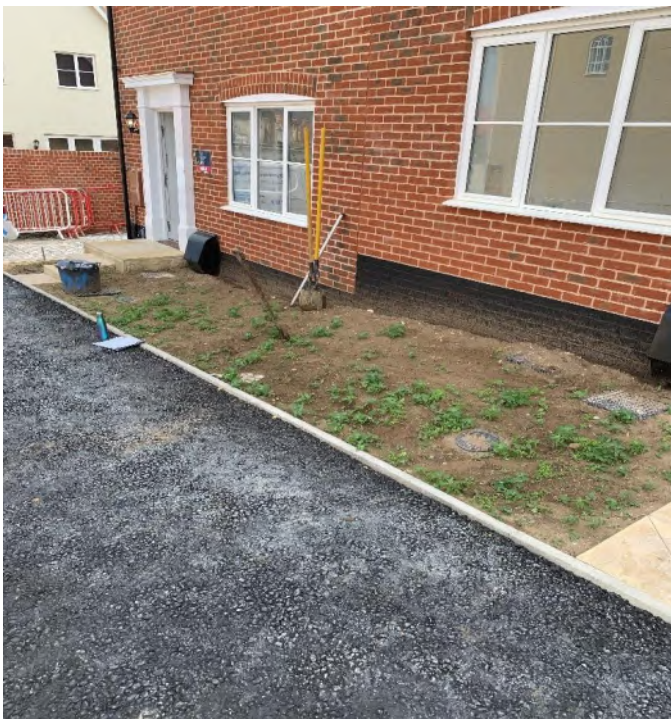
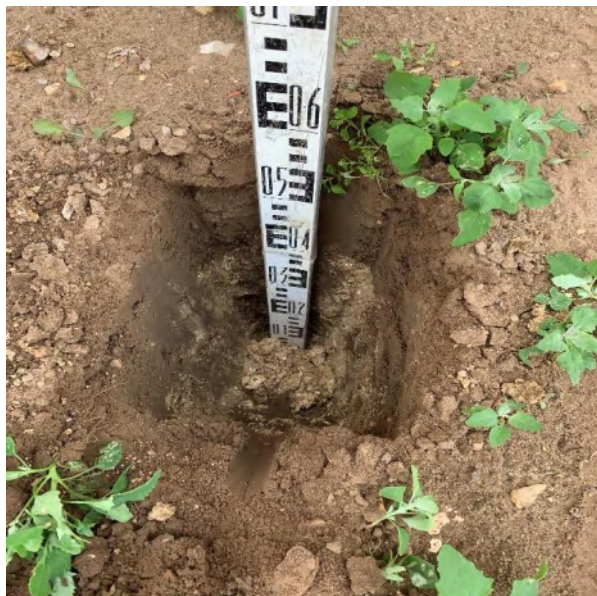
**GN17820 – Needham Market Quarry  
Verification Report 31 - Photo Sheet 1**

The material was generally described as made ground consisting of light brown mottled orange sandy gravelly clay. Gravel is sub-angular to sub-rounded fine to coarse brick, flint and chalk.

During the verification works, the material was generally described as dark brown slightly gravelly silty fine to medium sand. Gravel is sub-angular to subrounded fine to coarse flint. This recent description is generally consistent with the previous description, allowing for some variability, and therefore has been confirmed as the same material. This material was used for the topsoil (ground level up to 300mm depth) within the soft landscaping areas surrounding plots 57-60. The minimum thickness of 150mm of topsoil was encountered in all of the trial pits during the verification exercise, excluding the pits where topsoil was to be placed/was being placed at the time of the verification works.

The thickness of suitable soil was recorded to be at least 600mm in all of the trial pits. Following the site visit HH have provided photographs of the topsoil being placed in the gardens where topsoil had not been placed during the site visit, which have been reviewed and are deemed suitable.

**Photographs 1-4**, taken on the 23<sup>rd</sup> June 2022 showing examples of hand dug trial pits and the nature of the subsoil and topsoil within the soft landscaping in the back and front garden of plot 58 (representative of plots 57-60).
