Document: Remediation Verification Report

Project: Needham Market Quarry

Reference No.: GN17820_RV35

NEEDHAM MARKET QUARRY (Plots 118, 119, 67-69)

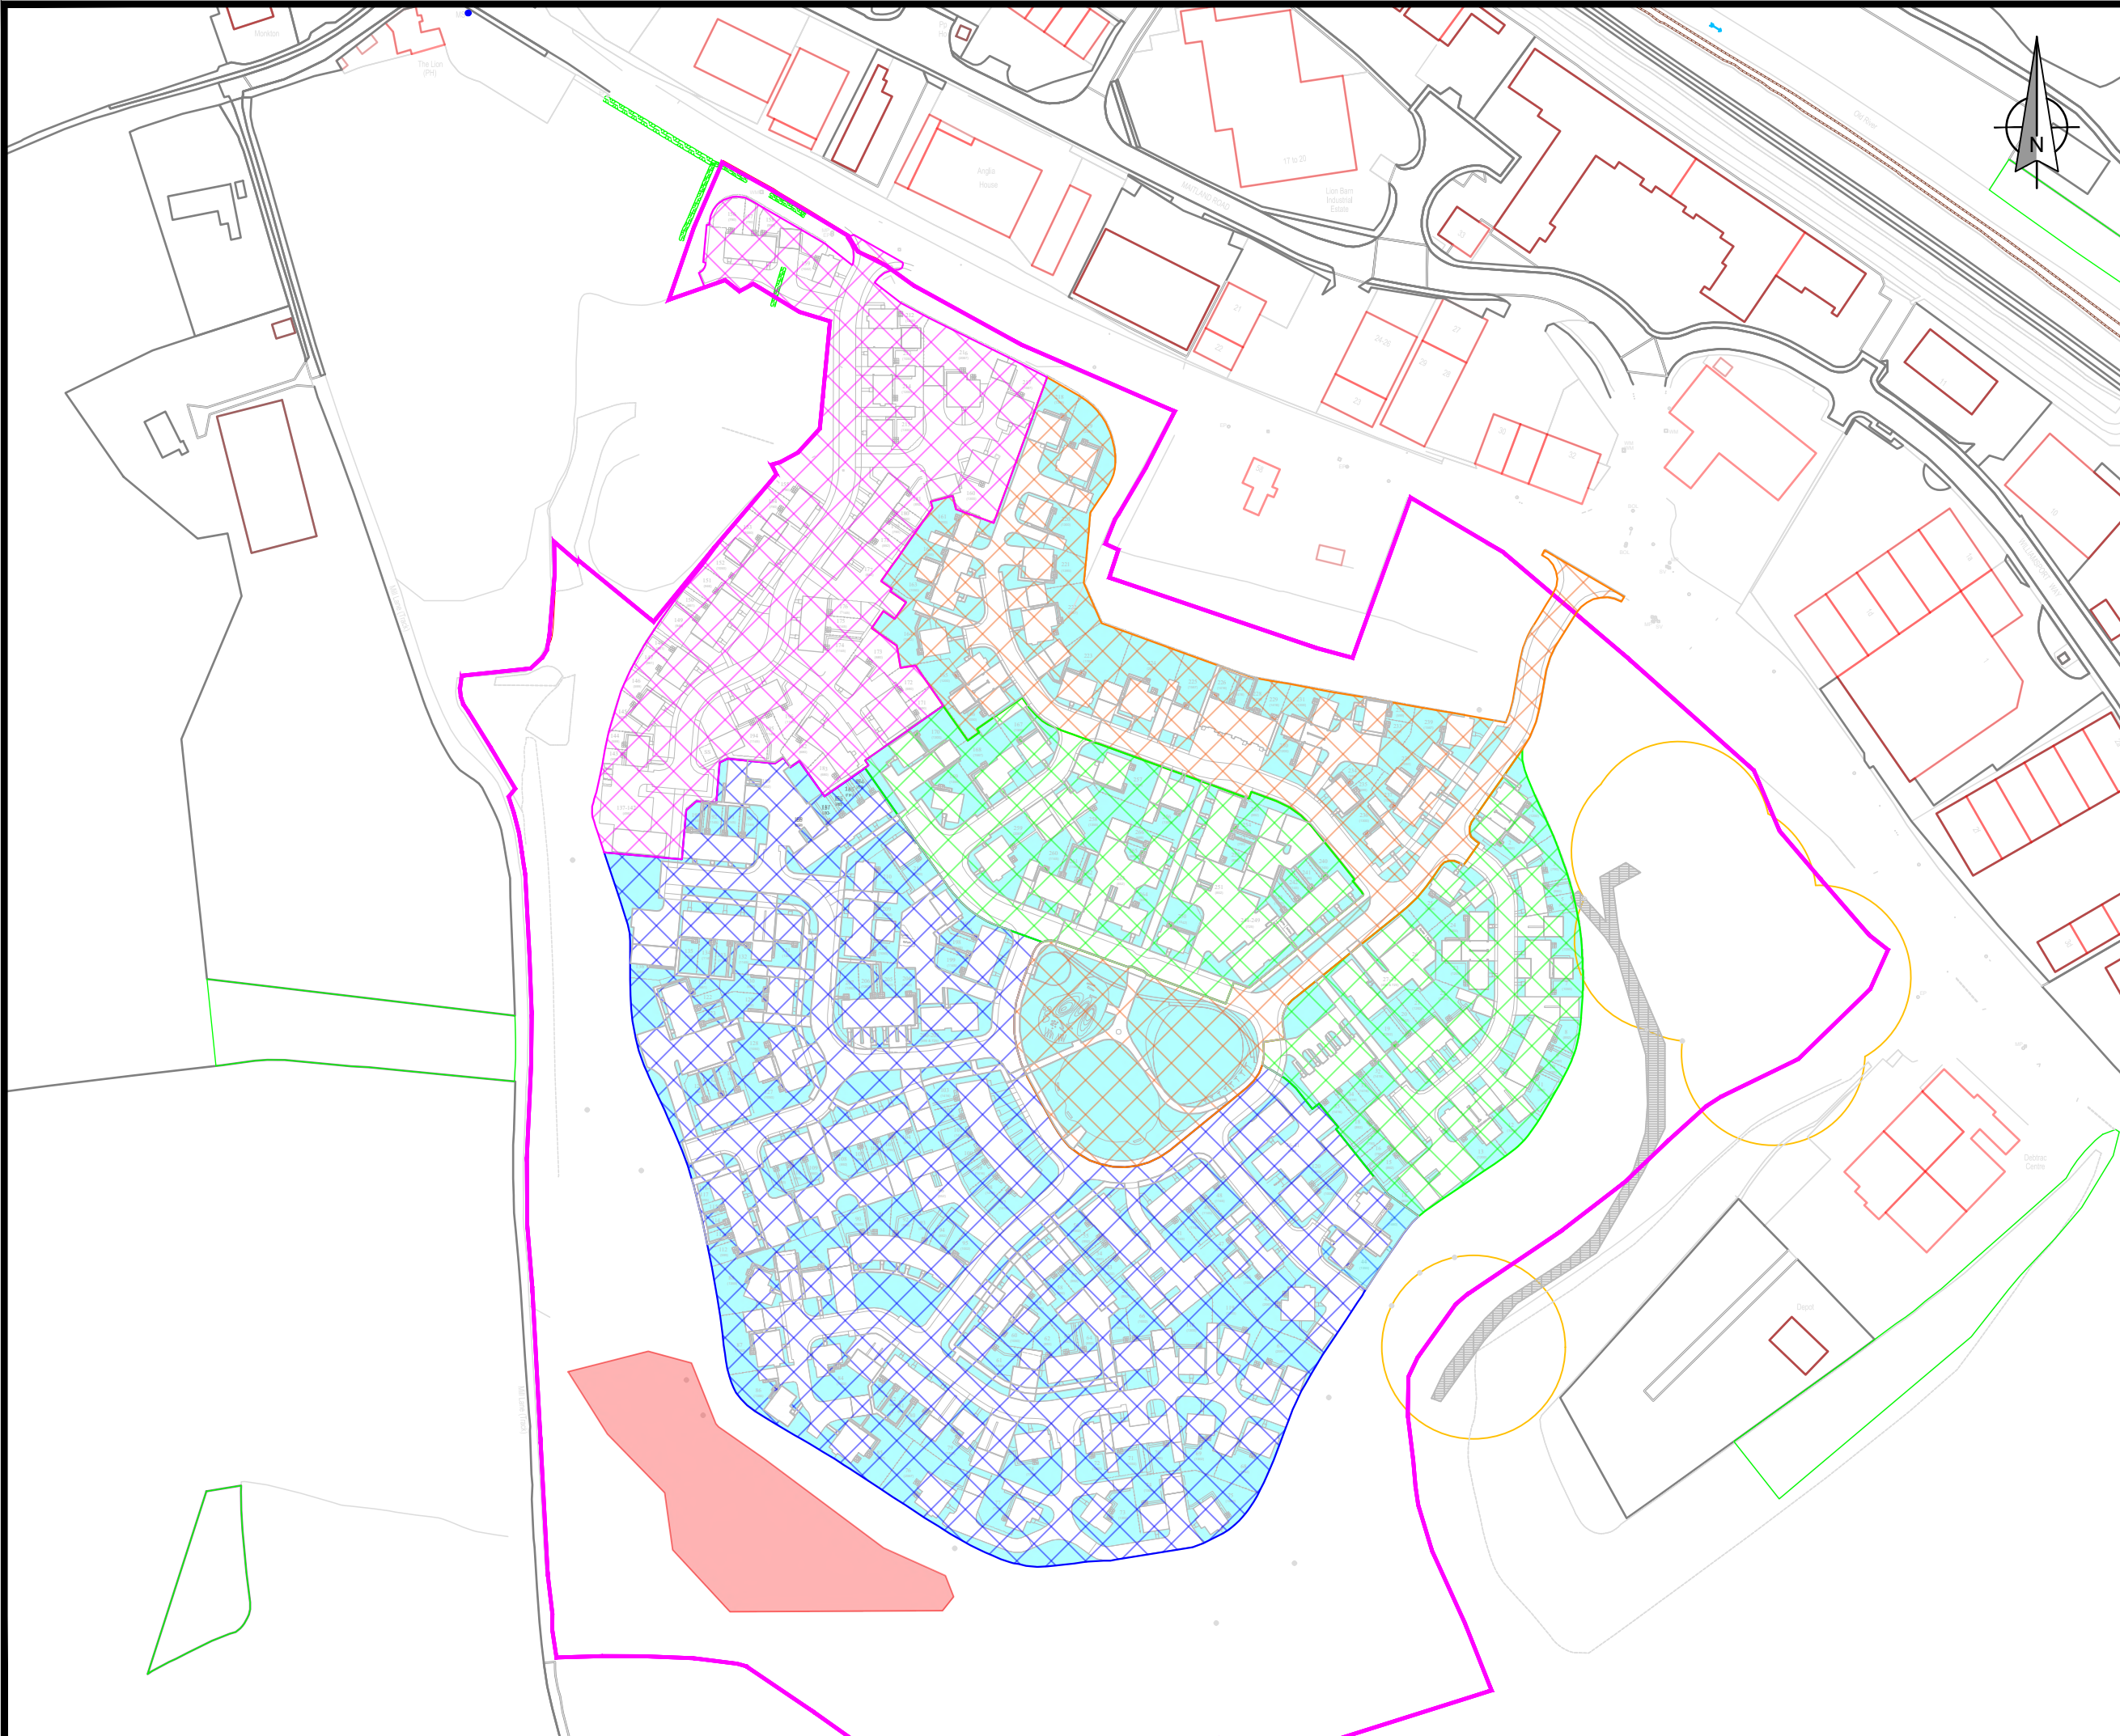
The plots which require validation of the suitability of the soils in gardens and soft landscaping can be identified in drawing GN17820_DR402 (appended to this report), which highlights the development phasing plan (phases 1A, 1B, 2 and 3). Specifically, plots which require confirmation of the suitability of the near-surface soils, and the need for a soil cover, includes plot numbers 1-136, 161-170, 184-193, 197-211, 218-266 and soft landscaping areas in these development phases.

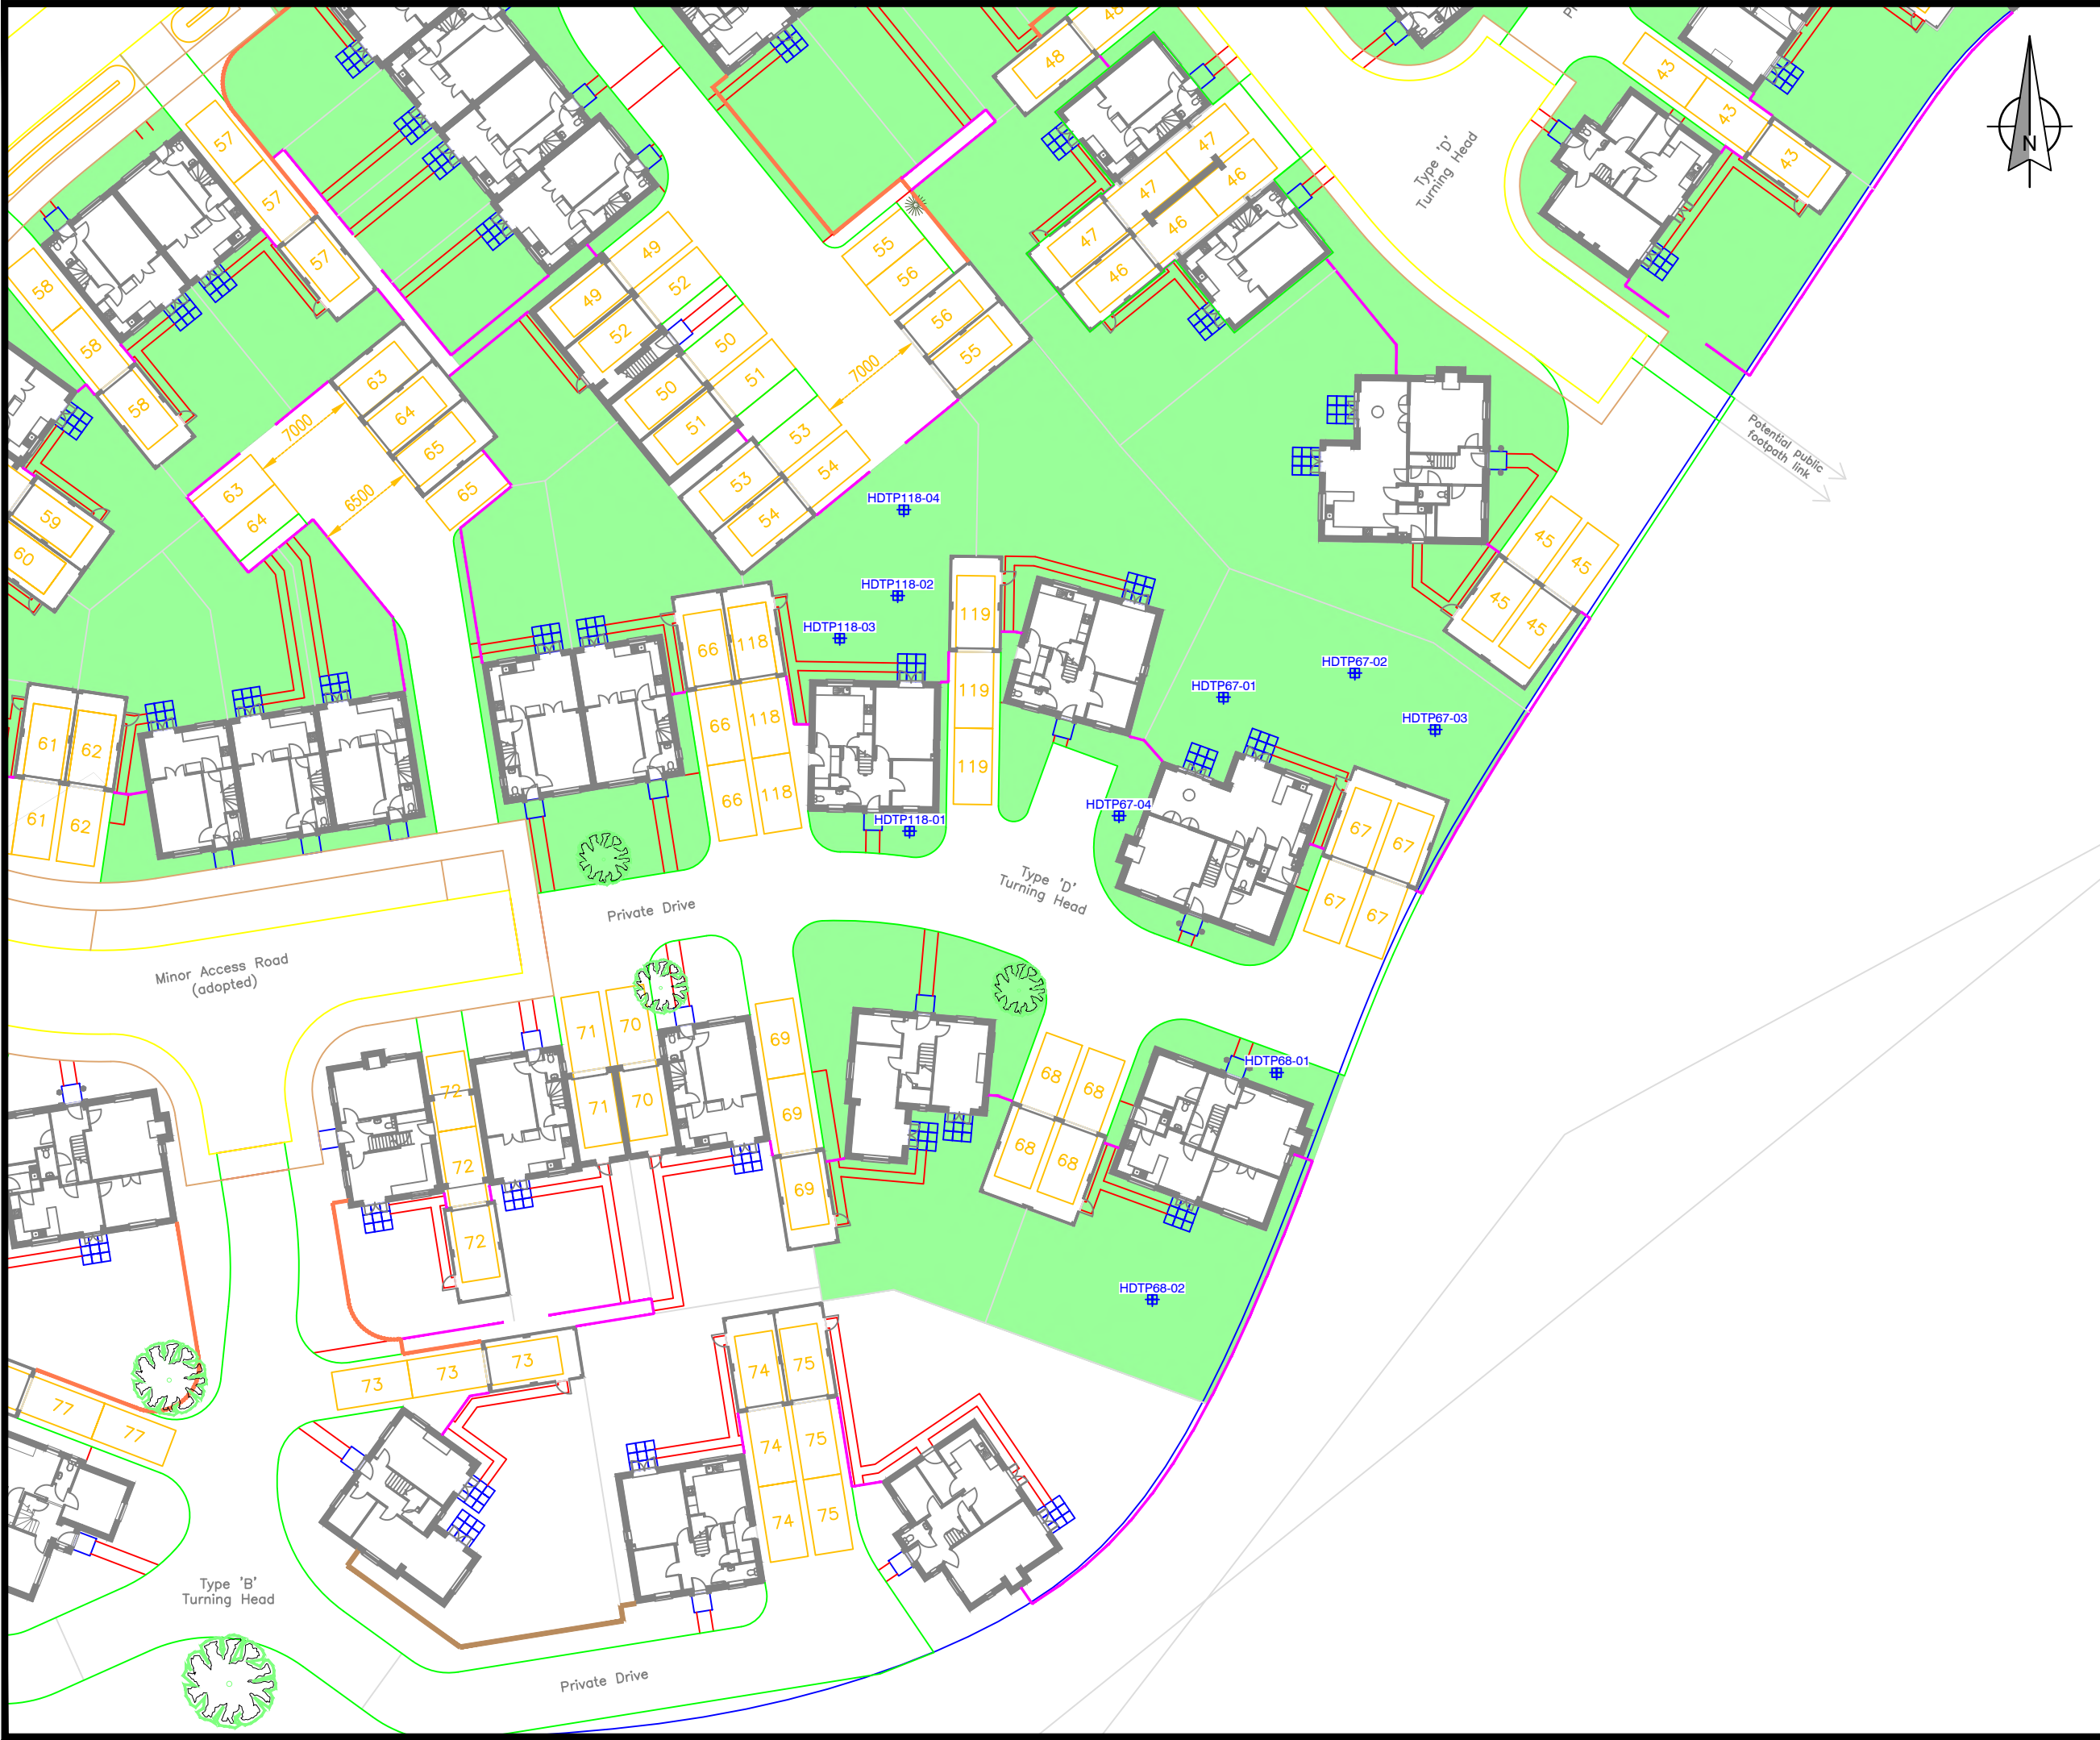
The fieldwork locations are shown on drawings GN17820-DR502a included within the appendix. Hand excavated trial pits were undertaken to record the thickness and physical descriptions of the materials present and to confirm material suitability.

- HDTP67-01 Hand Dug Trial Pit
- Acceptable Cover System

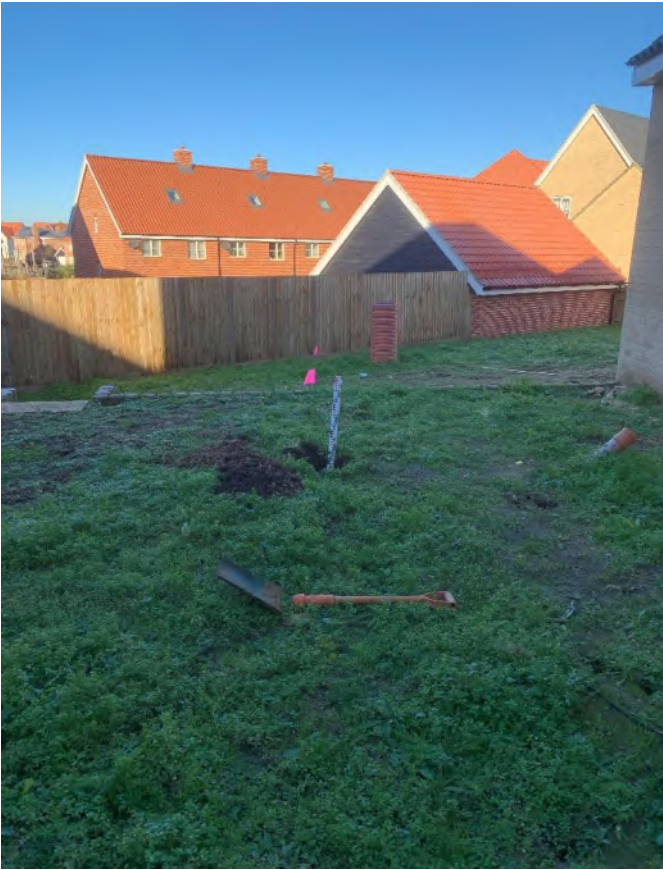
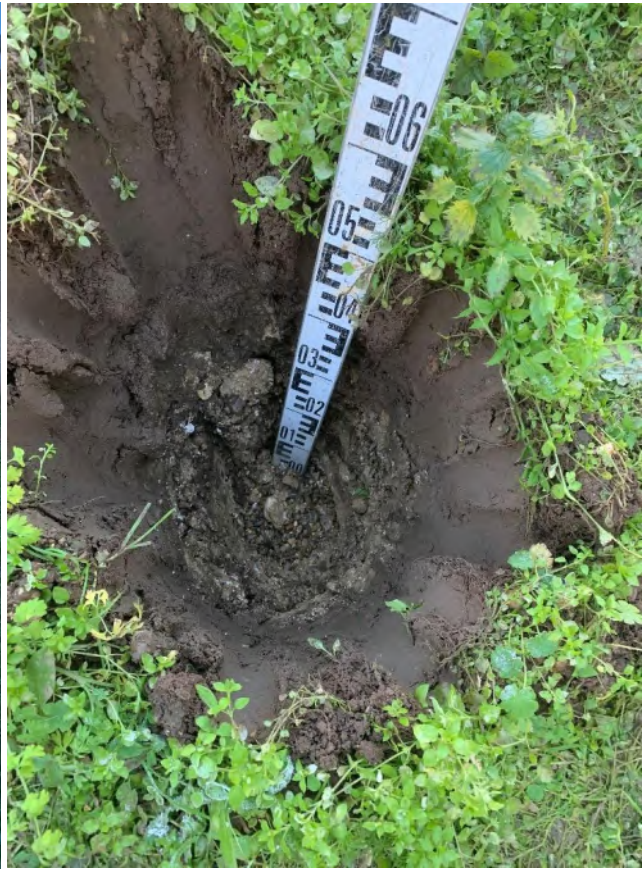
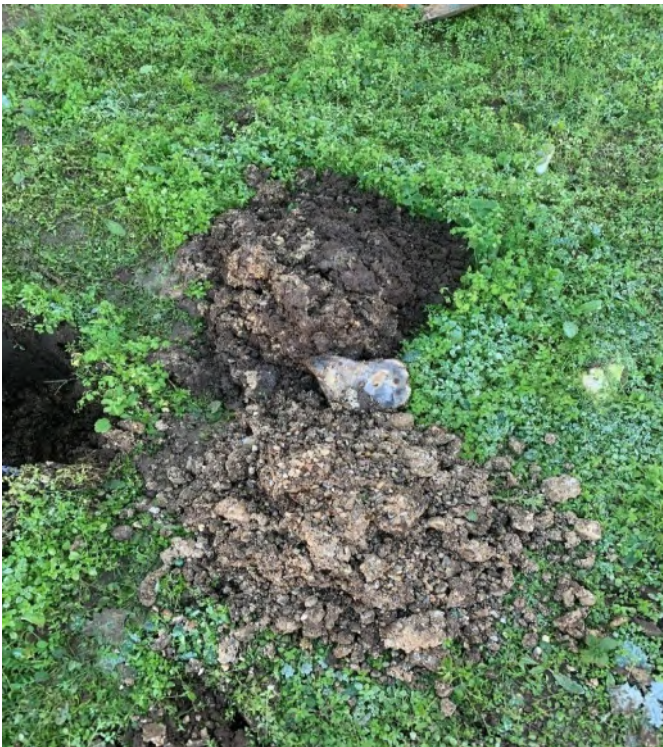
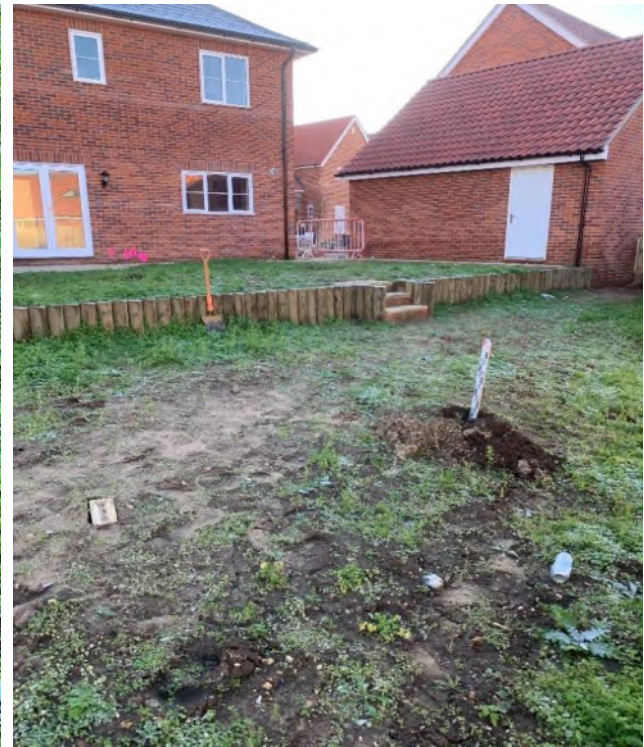
Photographs 1-4, taken on the 08th December 2022 showing examples of hand dug trial pits and the nature of the subsoil and topsoil within the soft landscaping of plot 118 (representative of plots 118, 119 and 67-69).

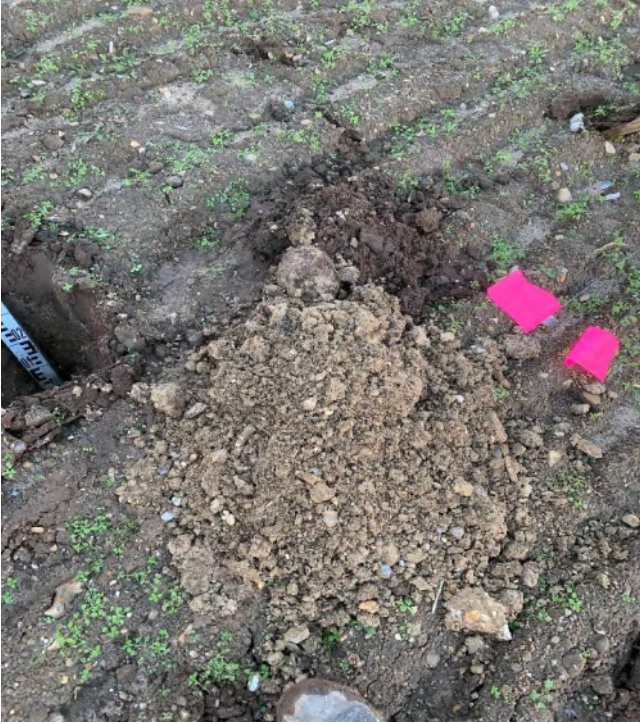
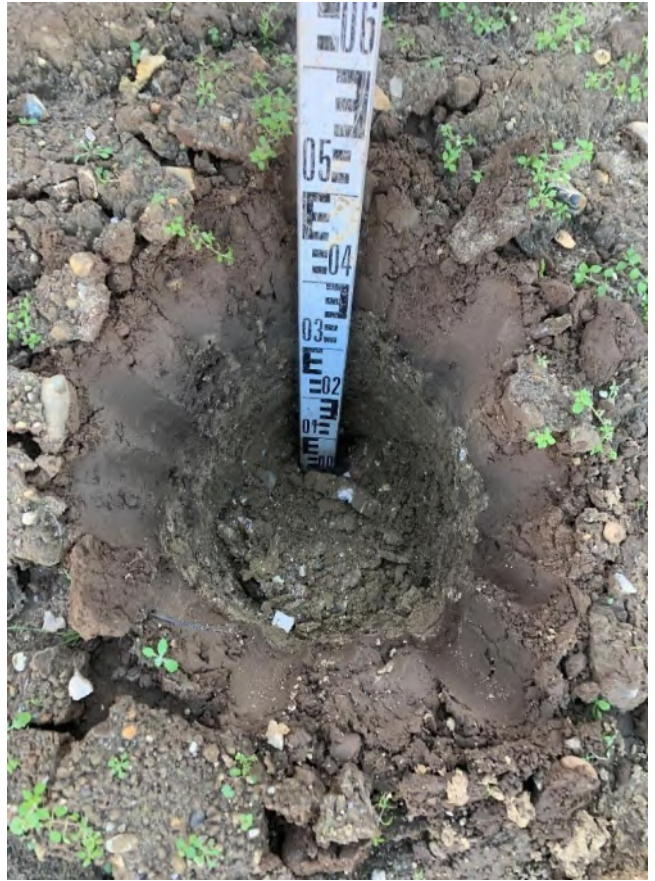
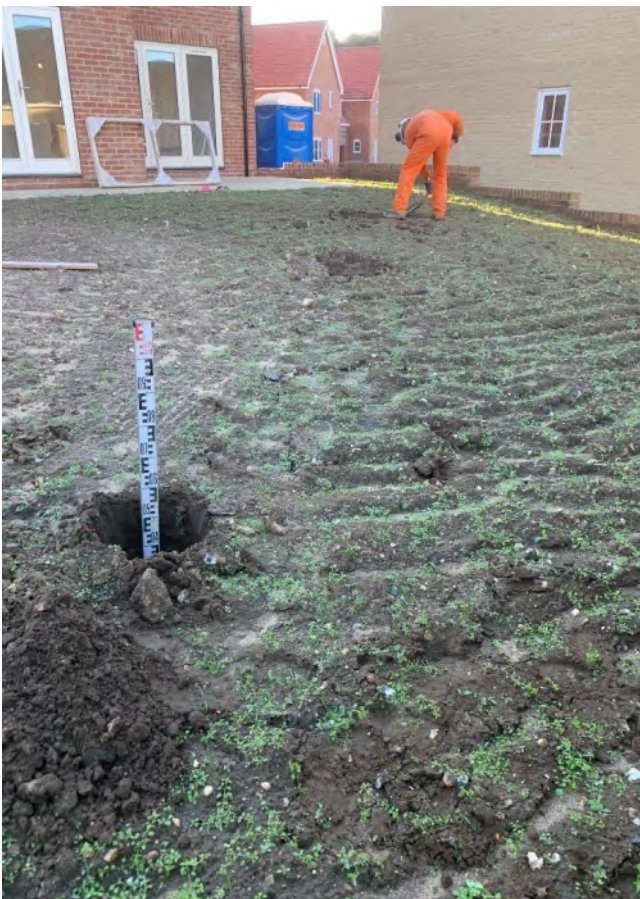
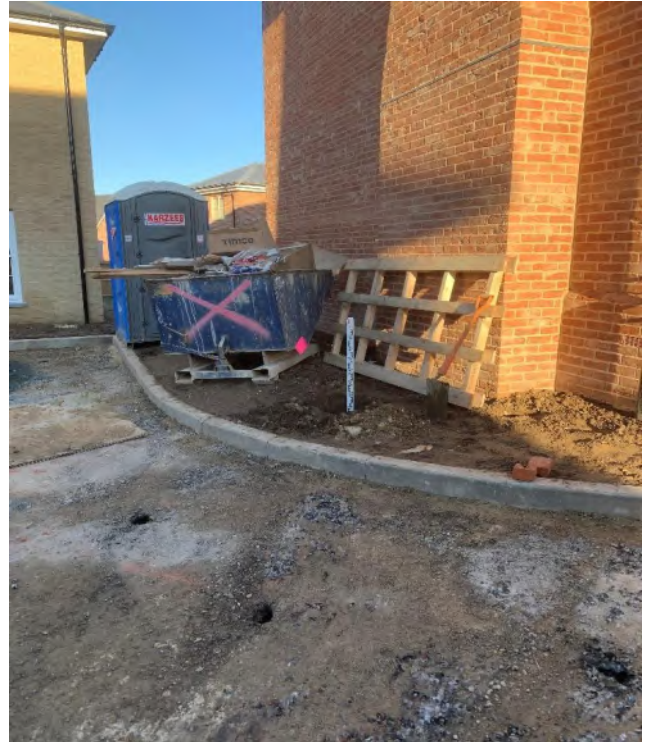
- Concrete edging was observed adjacent to footpaths and curb sides at approximately 45° angle.
- A maximum depth of excavation of 400mm was completed within HDTP67-04 due to the dense strata noted at this depth. On visual examination of the material at this depth it is very unlikely that the darker unsuitable material is present and therefore the soils are considered satisfactory for these plots. In addition, pits HDTP67-01, HDTP67-02 and HDTP65-03 excavated in the same plot all reached a depth of 600mm and did not encounter the darker unsuitable material.

Photographs 5-8, taken on the 08th December 2022 showing examples of hand dug trial pits and the nature of the subsoil and topsoil within the soft landscaping of plot 67 (representative of plots 118, 119 and 67-69).

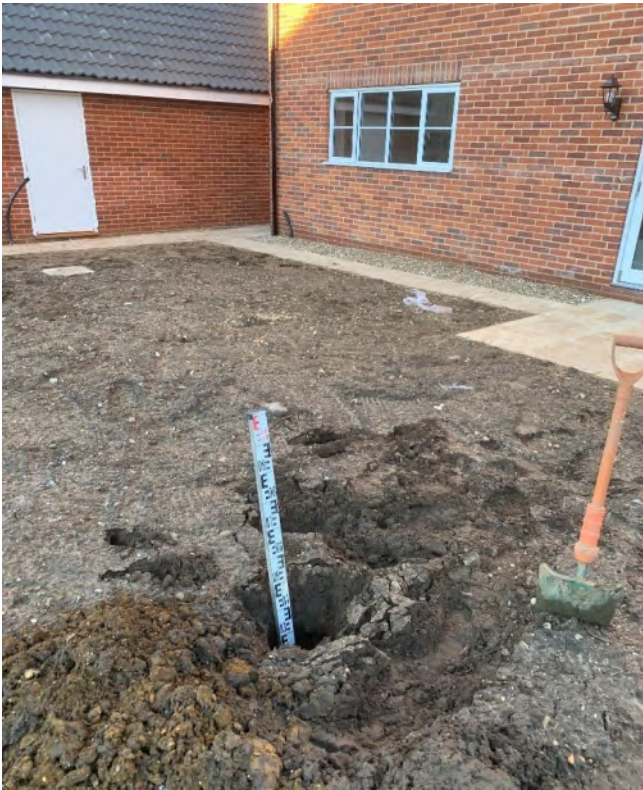
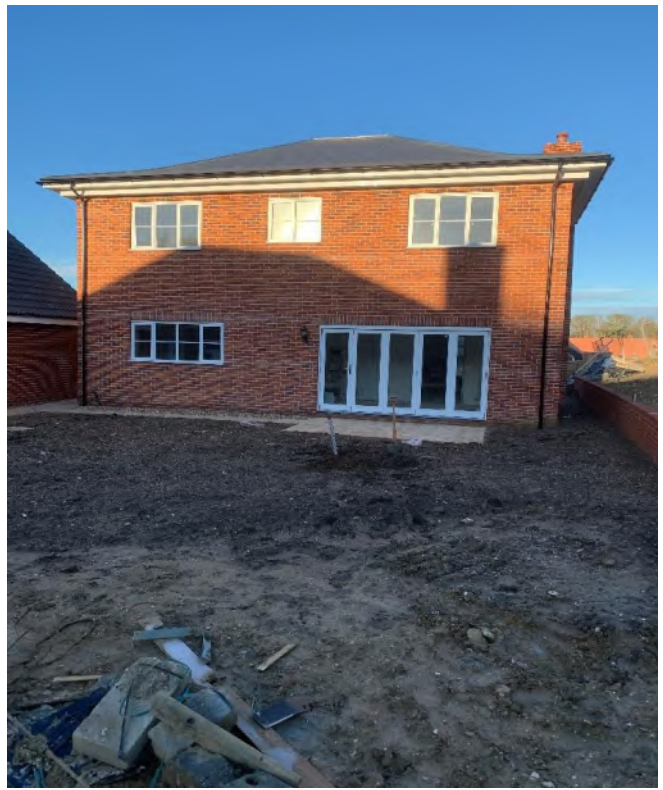
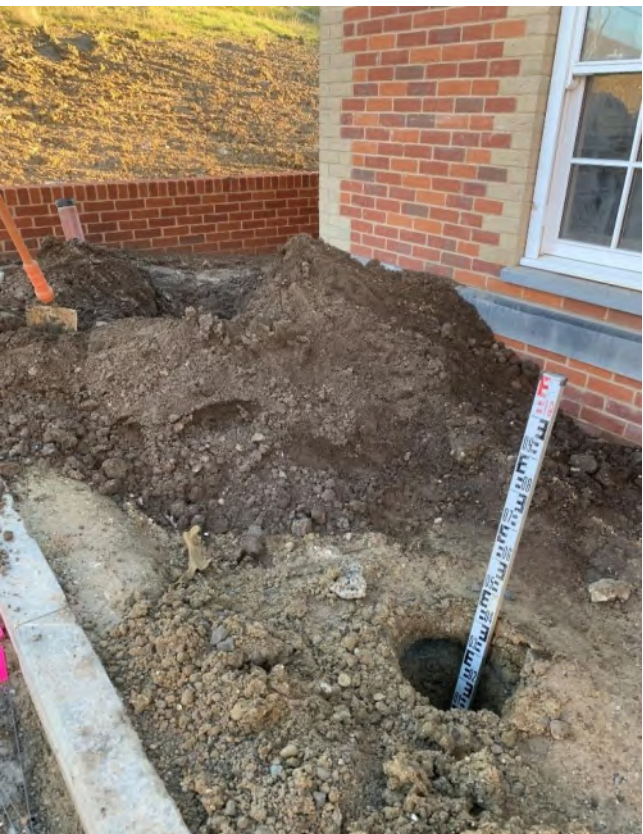
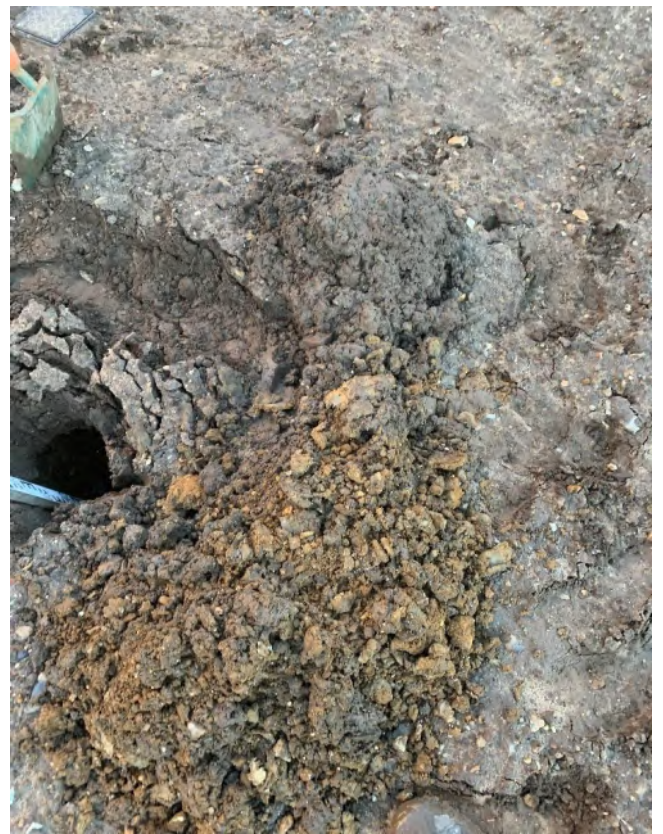
- A thin layer of grey gravelly silty sand was encountered within the made ground of HDTP68-01. This material is not consistent with the much darker material previously observed further to the north of the site. The greyish material observed is not considered to be of concern.

The materials encountered were considered suitable for use as subsoil from visual inspection. Occasional concrete, brick or flint cobbles were noted. A thin layer of grey gravelly silty sand was noted within hand dug trial pit HDTP68-01. The gravel within this was noted to be granite. This material is not consistent with the much darker material and is therefore not considered a cause for concern. The dark material identified elsewhere on site that contained low levels of contaminants was not encountered in the soft landscaping surrounding plots 118, 67 and 68 and is therefore not considered likely to be encountered within plots 118, 119 and 67-69.

Photographs 9-12, taken on the 08th December 2022 showing examples of hand dug trial pits and the nature of the subsoil and topsoil within the soft landscaping of plot 68 (representative of plots 118, 119 and 67-69).
