Document: Remediation Verification Report

Project: Needham Market Quarry

Reference No.: GN17820_RV34

NEEDHAM MARKET QUARRY (Plots 65, 66, 121-126)

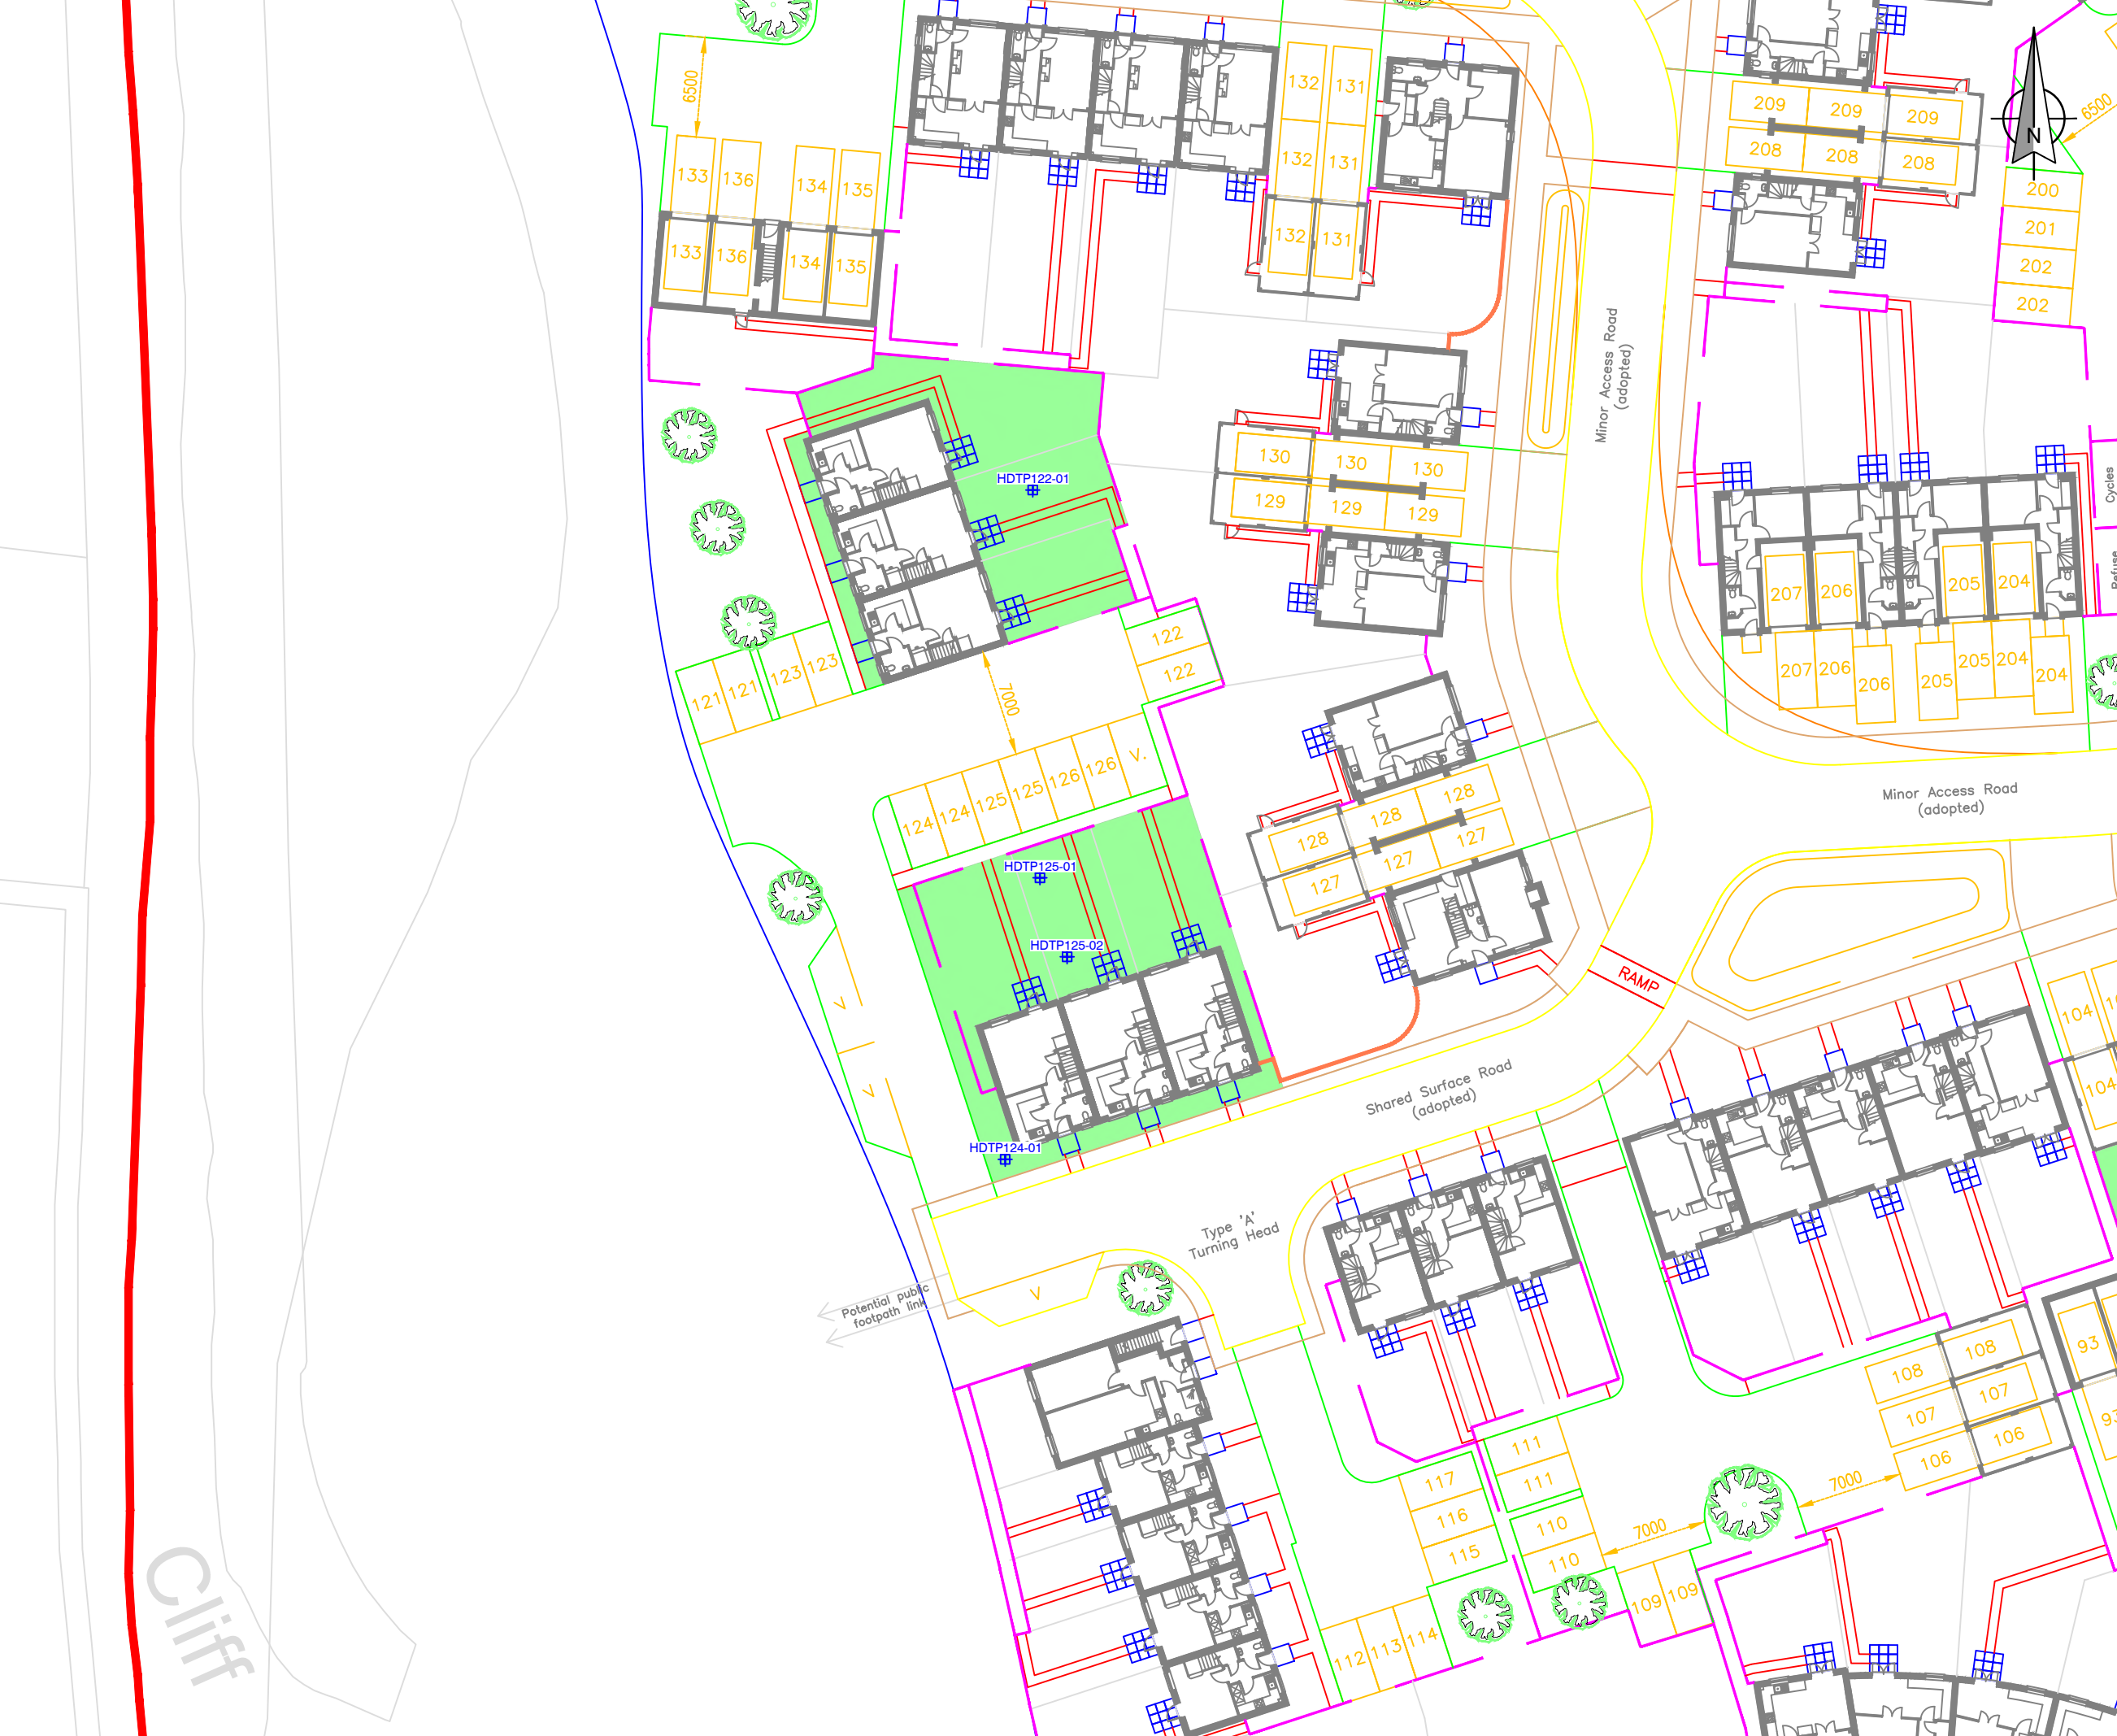
- Hand Dug Trial Pit
- HOTP122-01 Hand Dug Trial Pit
- Acceptable Cover System

Client : Hopkins Homes Ltd
 Project : Needham Market Quarry
 Job No : GN17820 Date : September 2022
 Drawing Title : Fieldwork Location Plan - Plot 122, 124 & 125
 Drawing No : GN17820 - DR502ak
 Scale : 1:400 @ A3
 Drawn by : RW Checked by : CD
 Eastings : 609350 Northings : 254080

The fieldwork locations are shown on drawings GN17820-DR502aj and GN17820-DR502ak included within the appendix. Hand excavated trial pits were undertaken to record the thickness and physical descriptions of the materials present and to confirm material suitability.

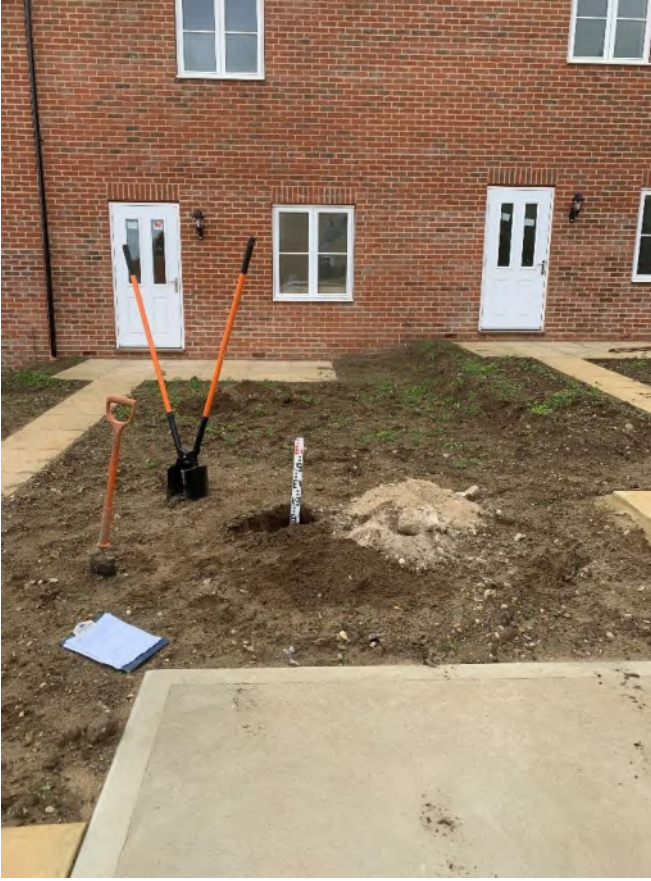
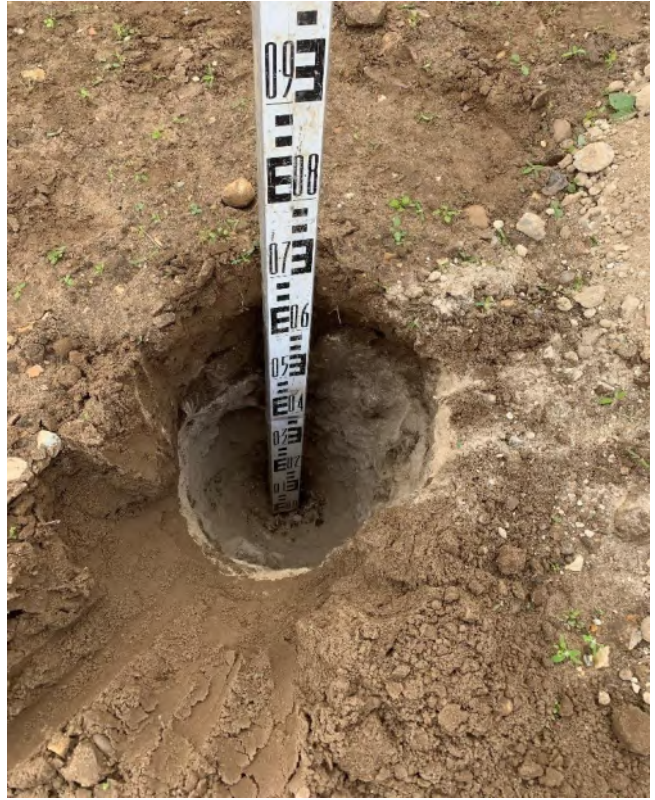
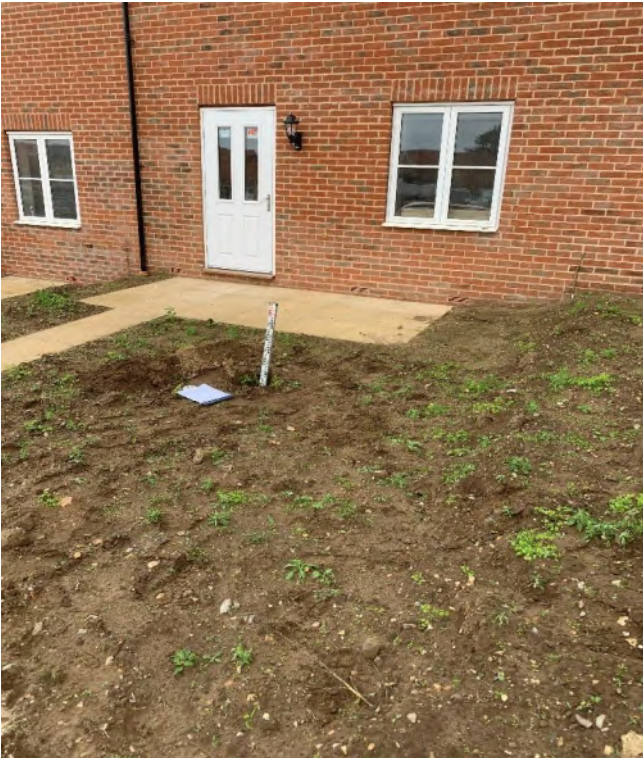
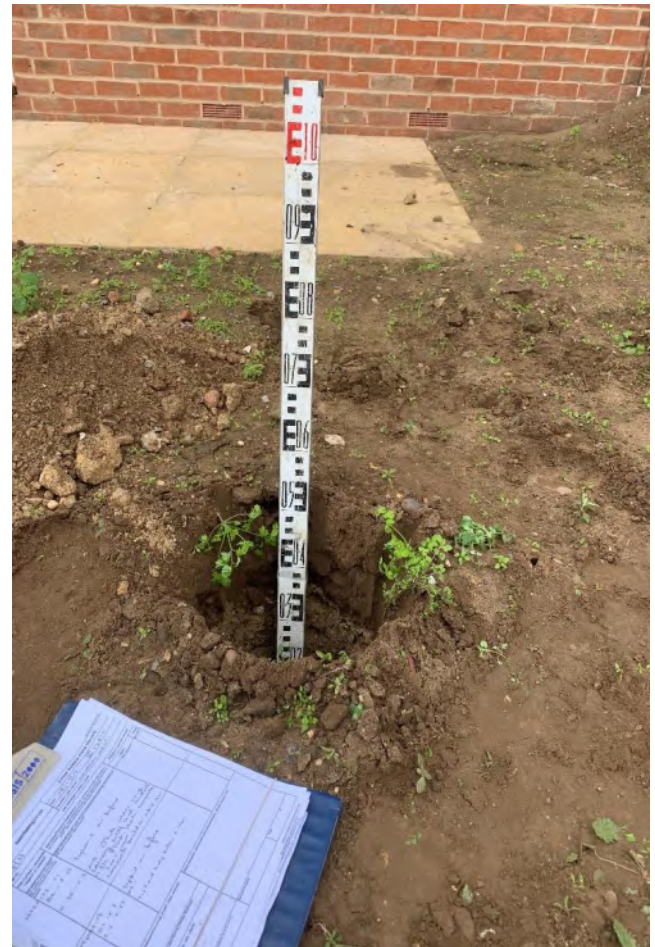
Photographs 5-8, taken on the 28th September 2022 showing examples of hand dug trial pits and the nature of the subsoil and topsoil within the soft landscaping of plots 122 and 125 (representative of plots 121-126).

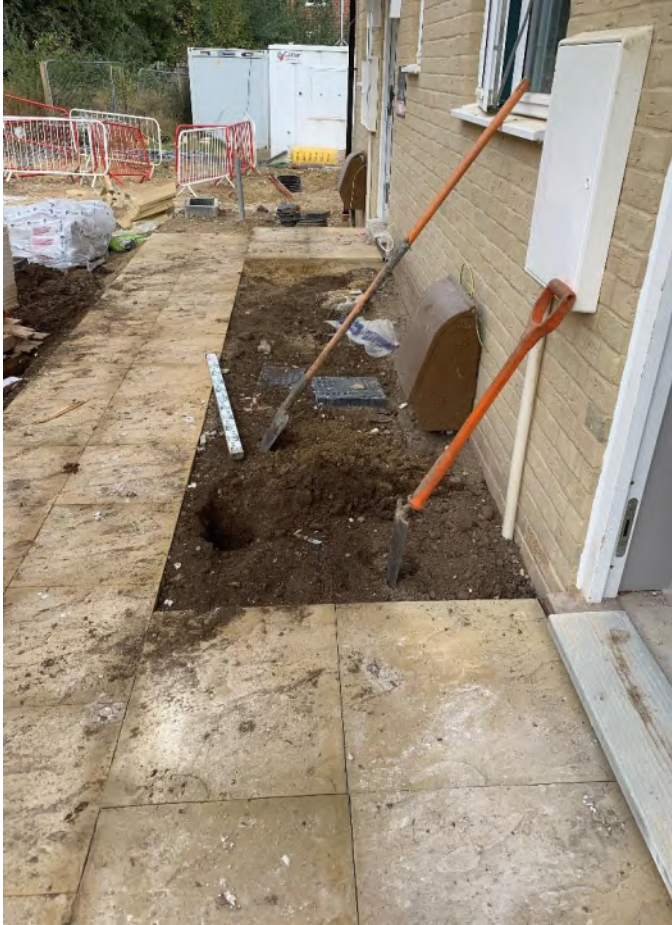
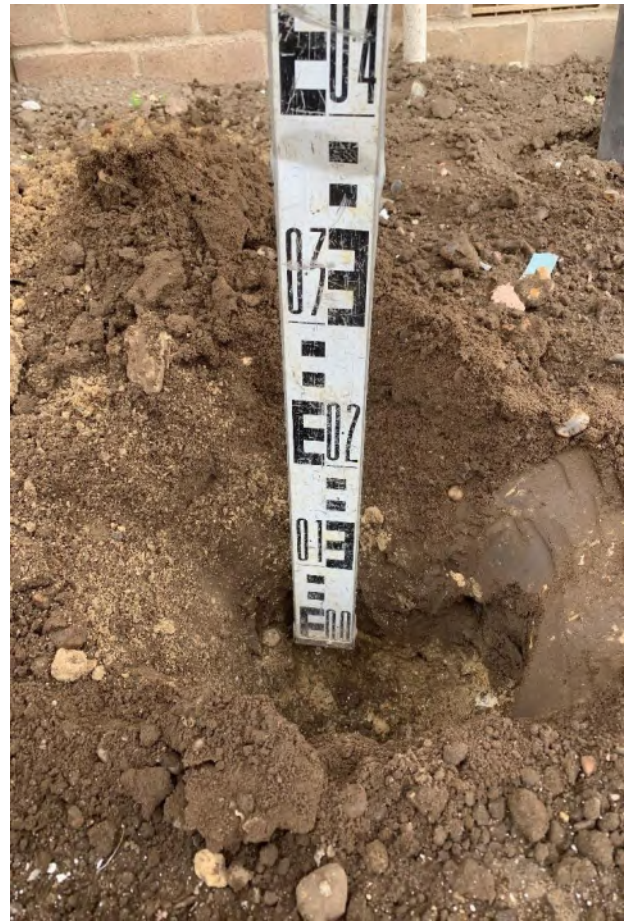
- Concrete edging was observed adjacent to footpaths and curb sides at approximately 45° angle.
- HGE undertook a hand dug trial pit within the small front garden of plot 122 and provided a photograph of the encountered topsoil material, which is included on the photosheet in the appendix. It was deemed not safe to continue deeper in this location due to the front gardens of plots 121-123 being very small with evidence of several underground services, therefore further trial pitting in this area was not deemed possible. A suitable thickness of topsoil was noted to be present across the front gardens of plots 121-123 (200mm).

Photographs 9-10, taken on the 28th September 2022 showing the topsoil thickness (200mm) within the front gardens of plot 122 (representative of plots 121-123).
