**Document:** Remediation Verification Report  
**Project:** Needham Market Quarry  
**Reference No.:** GN17820\_RV38  
**Date:** June 2023  
**Prepared for:** Hopkins Homes Limited

**REMEDIATION VERIFICATION REPORT**  
**FOR REMEDIAL ACTIVITY**  
**AT**  
**NEEDHAM MARKET QUARRY (Plots 76-83)**

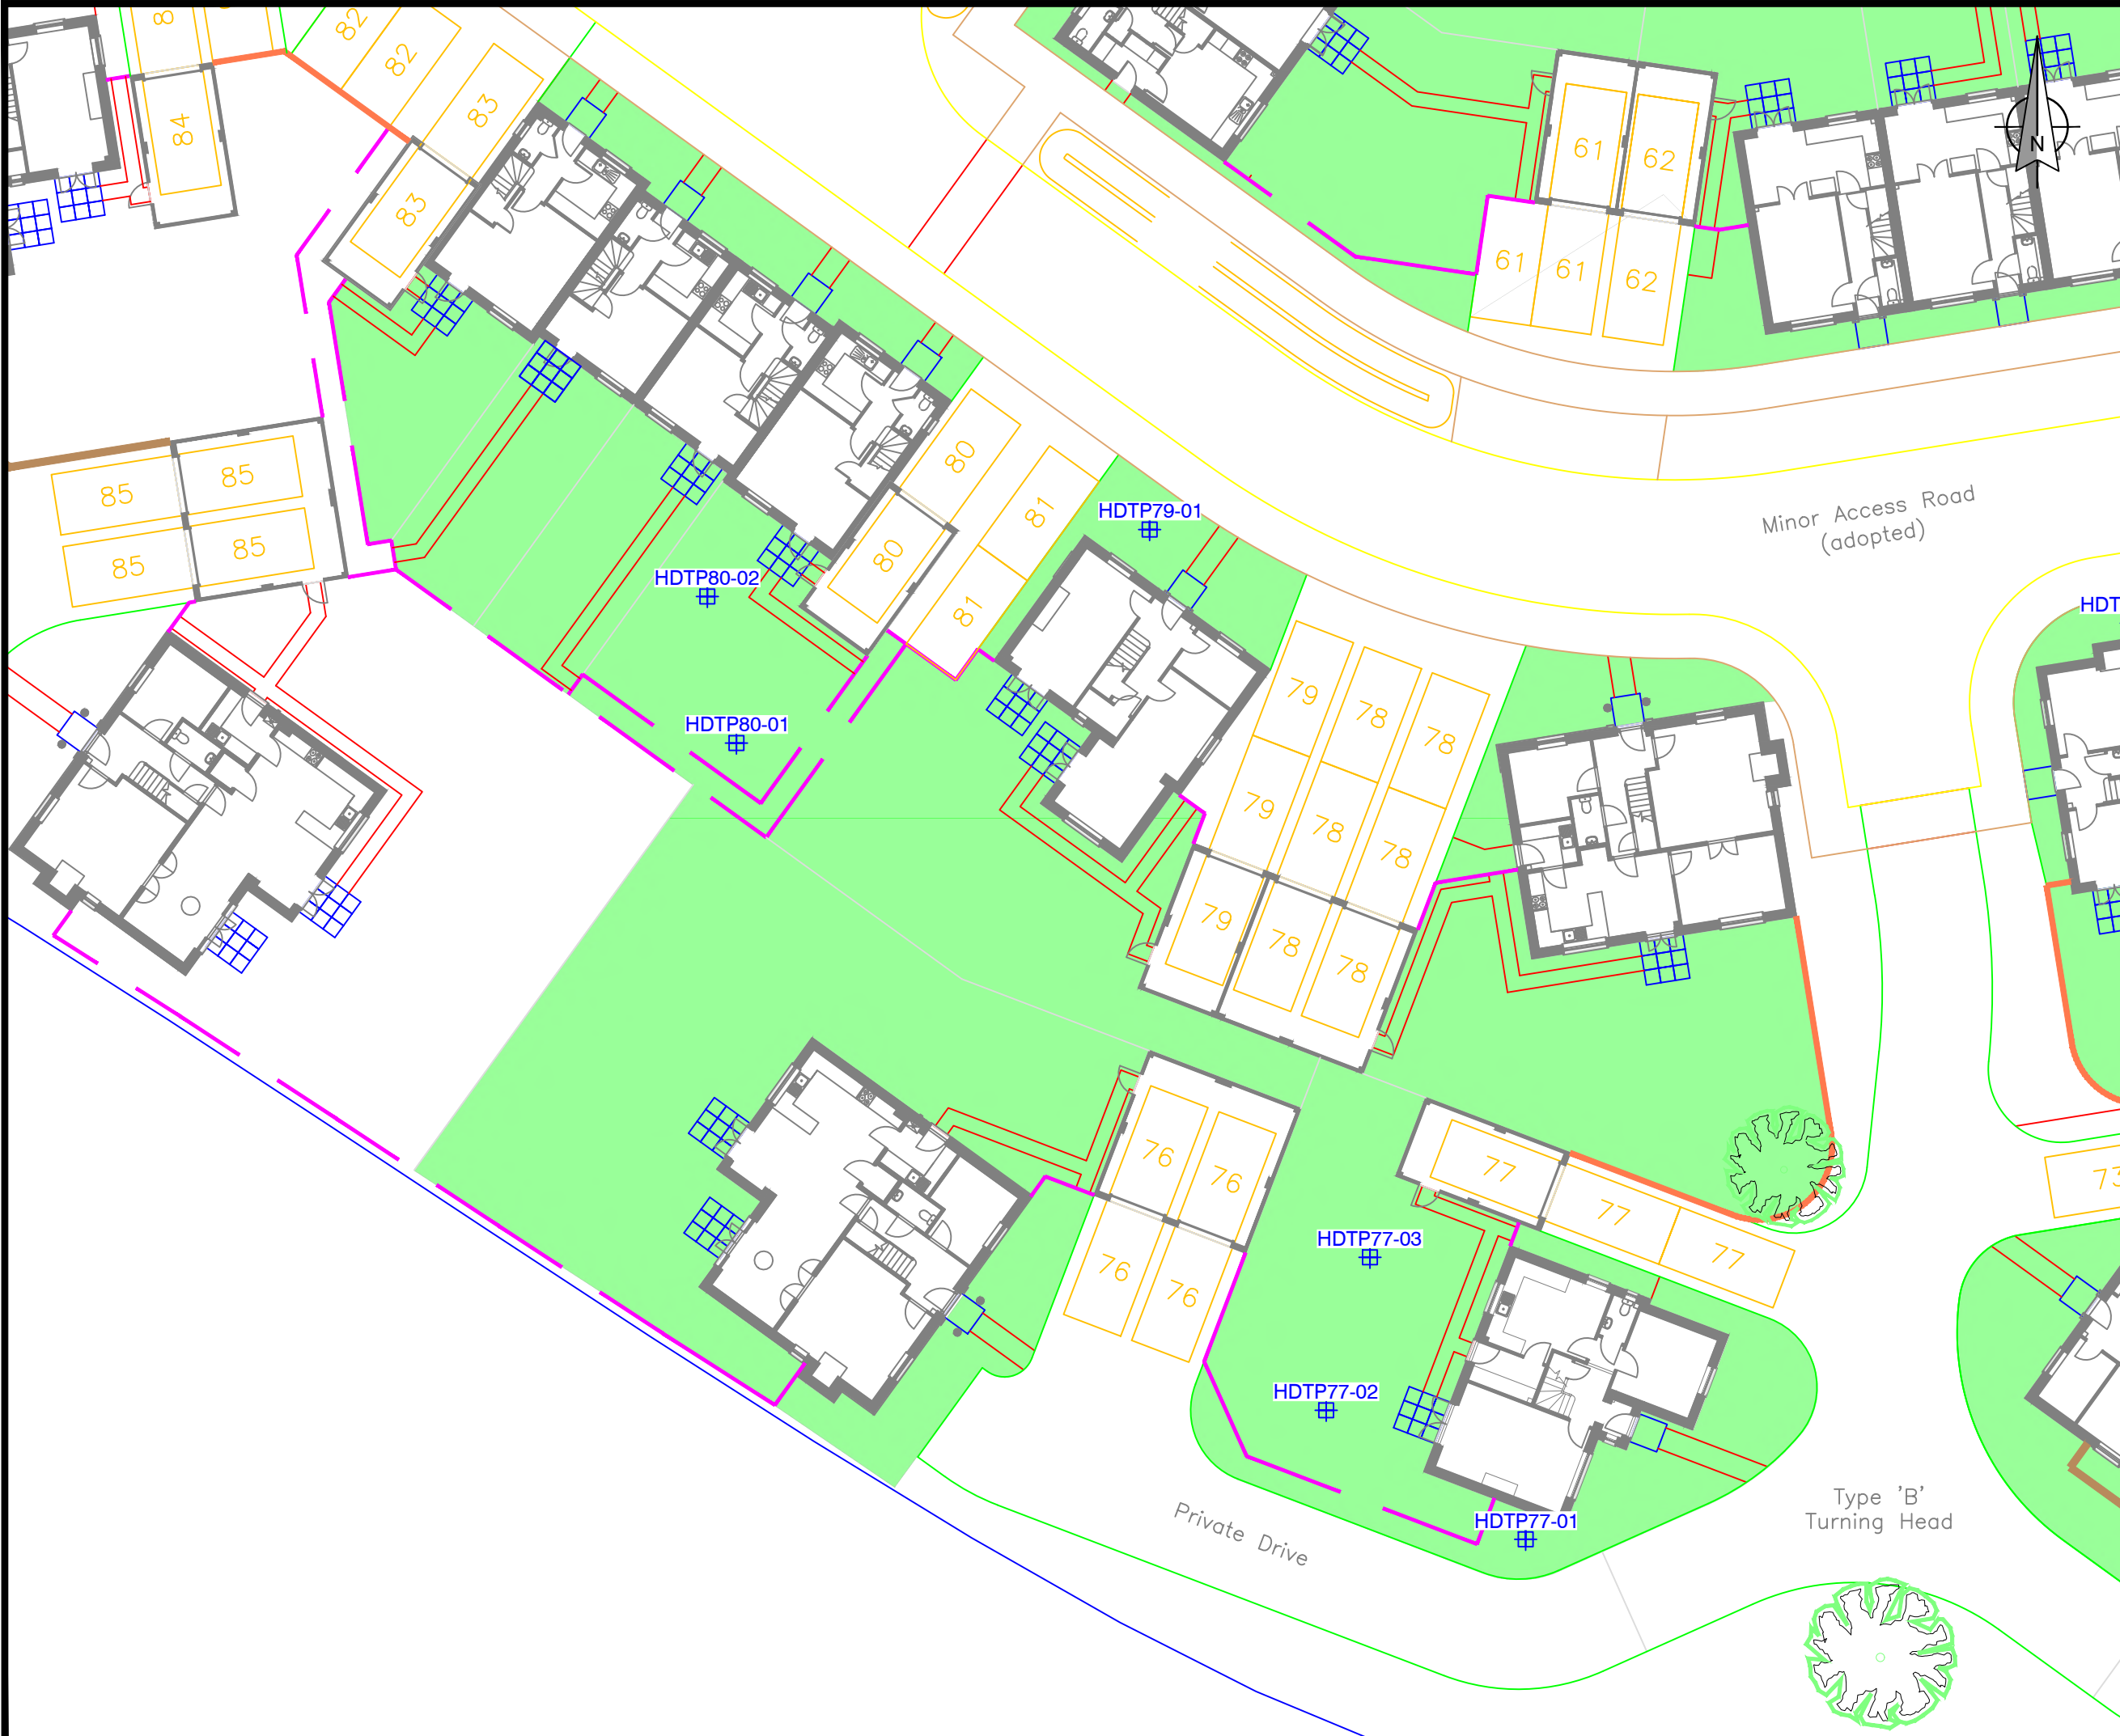
- HDTP77-01 Hand Dug Trial Pit
- Acceptable Cover System

Client : Hopkins Homes Ltd  
 Project : Needham Market Quarry  
 Job No : GNI7820 Date : May 2023  
 Drawing Title : Fieldwork Location Plan - Plot 76-83  
 Drawing No : GNI7820 - DR502ao  
 Scale : 1:250 @ A3  
 Drawn by : RW Checked by : CD  
 Eastings : 609430 Northings : 253940

The fieldwork locations are shown on drawings GN17820-DR502ao included within the appendix. Hand excavated trial pits were undertaken to record the thickness and physical descriptions of the materials present and to confirm material suitability.

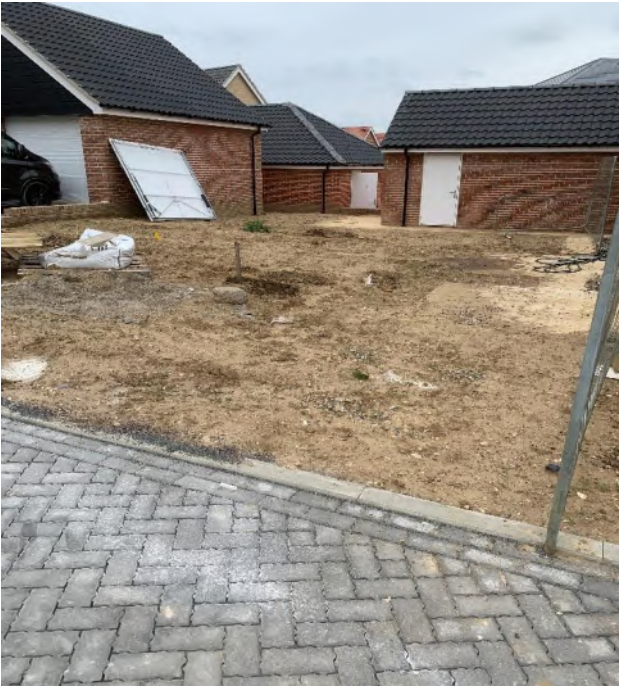
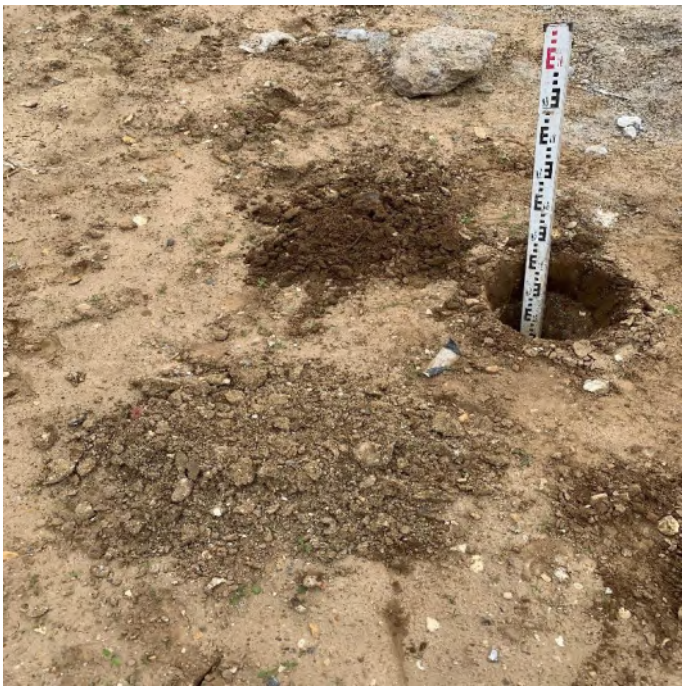
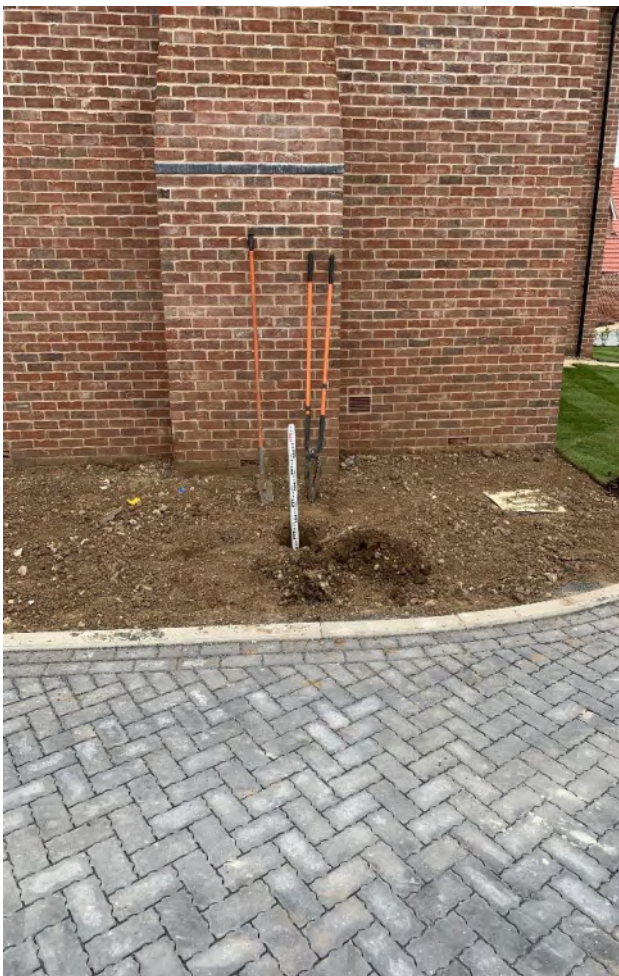
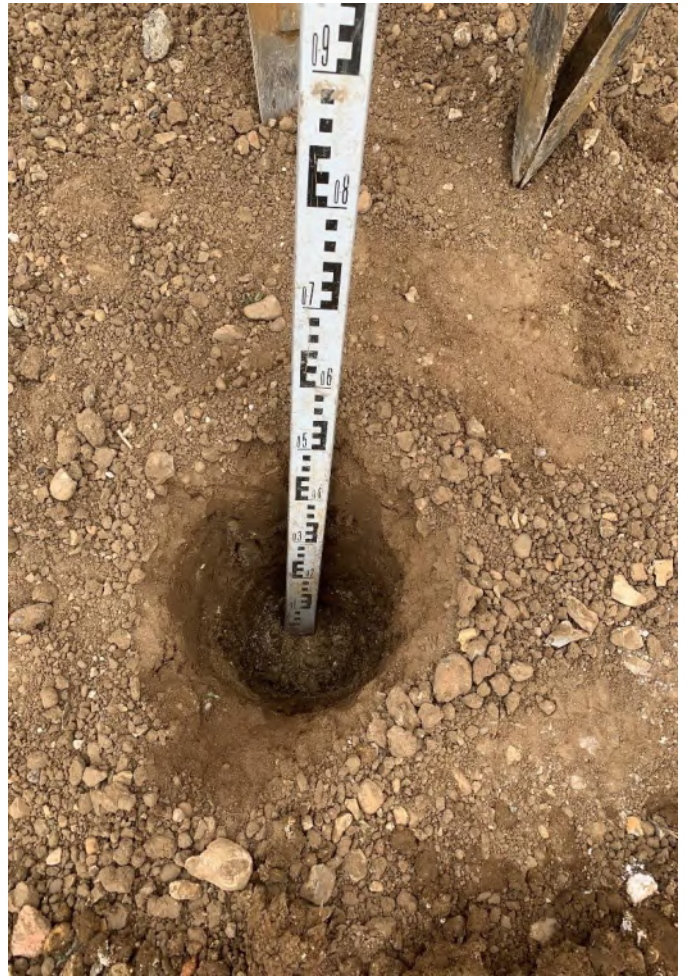
The materials encountered within plot 77 and 79 were considered suitable for use as subsoil from visual inspection. The dark material identified elsewhere on site that contained low levels of contaminants was not encountered in the soft landscaping surrounding plots 77, 79 or 80 and is therefore not considered likely to be encountered within plots 76-83.

**Photographs 1-4**, taken on the 19<sup>th</sup> May 2023 showing examples of hand dug trial pits and the nature of the subsoil and topsoil within the soft landscaping of plot 77 (back and front garden).

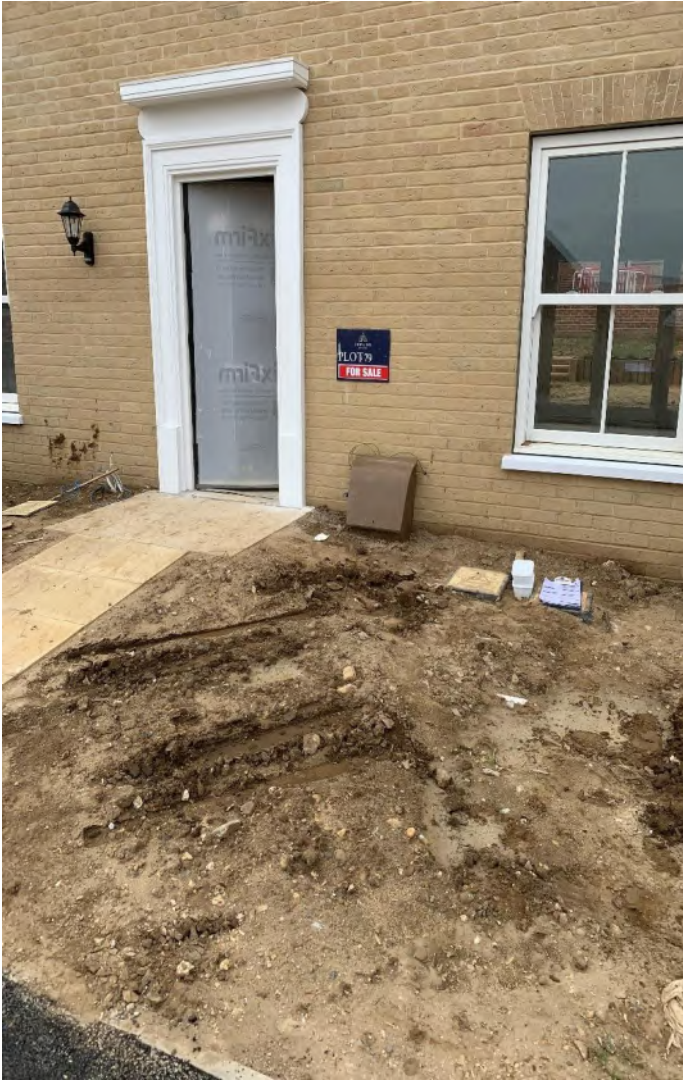
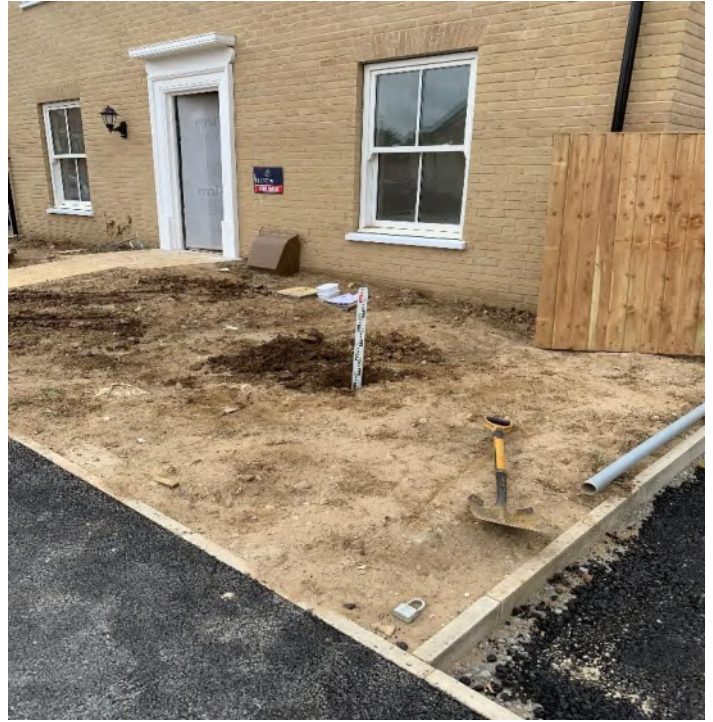
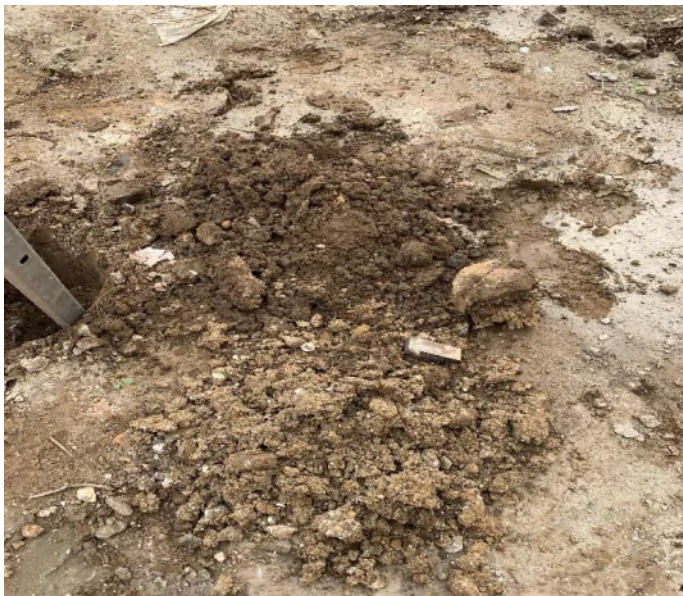
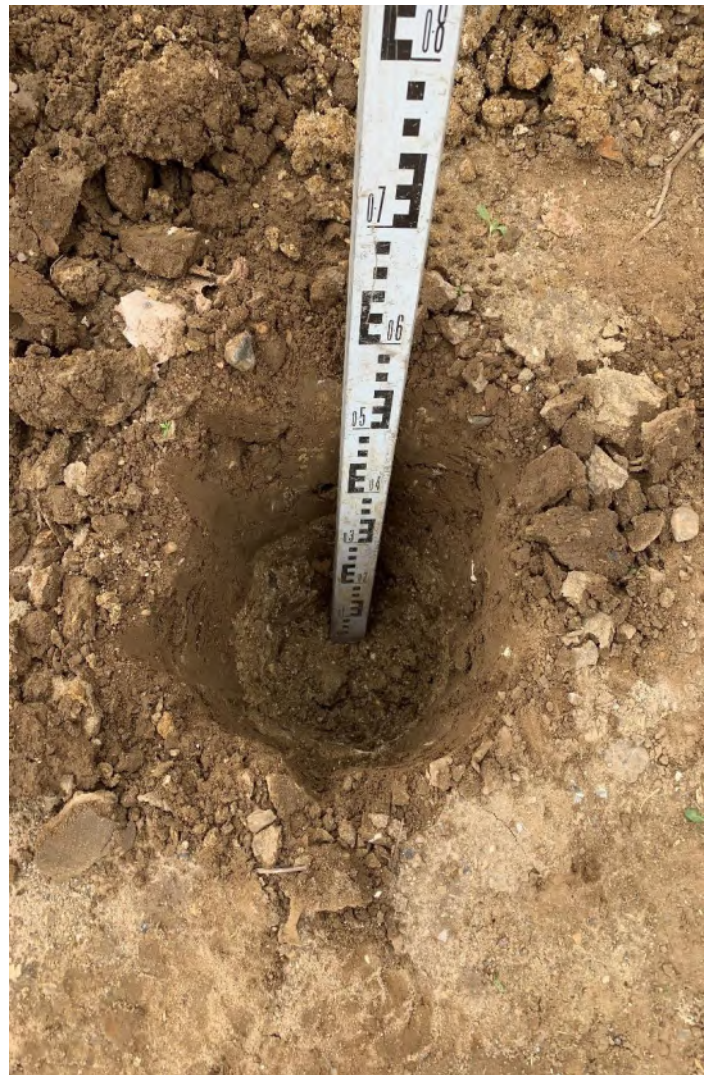
**Photographs 5-8**, taken on the 19<sup>th</sup> May 2023 showing examples of hand dug trial pits and the nature of the subsoil and topsoil within the soft landscaping of plot 79 (front garden).

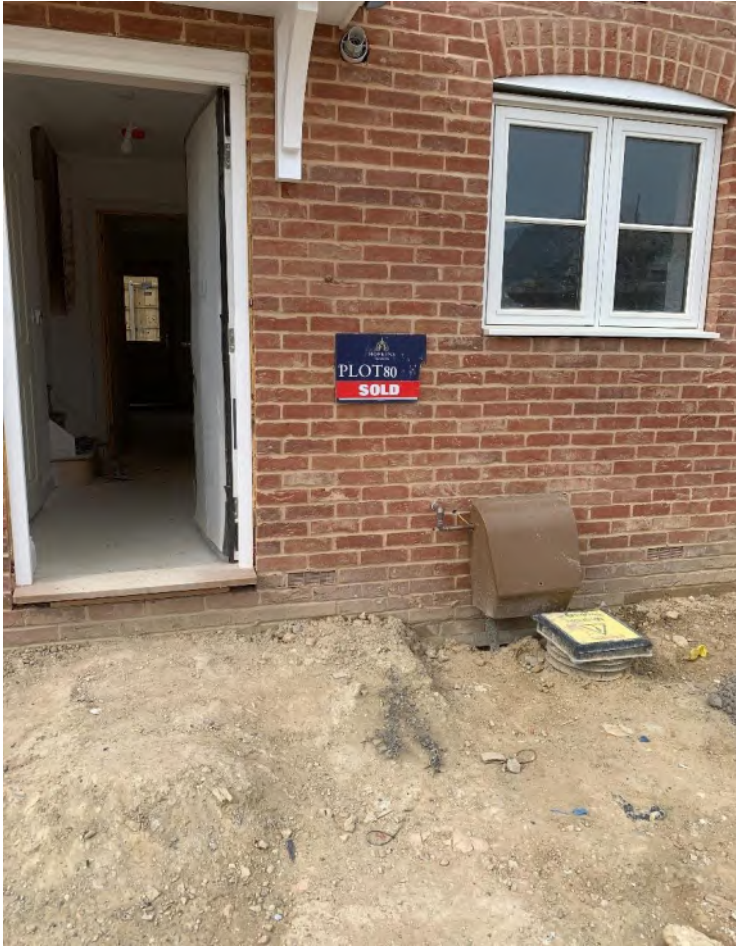
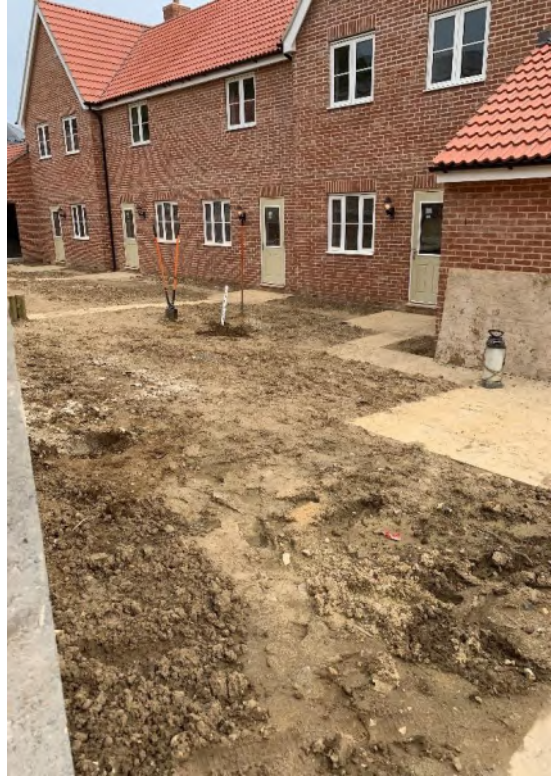
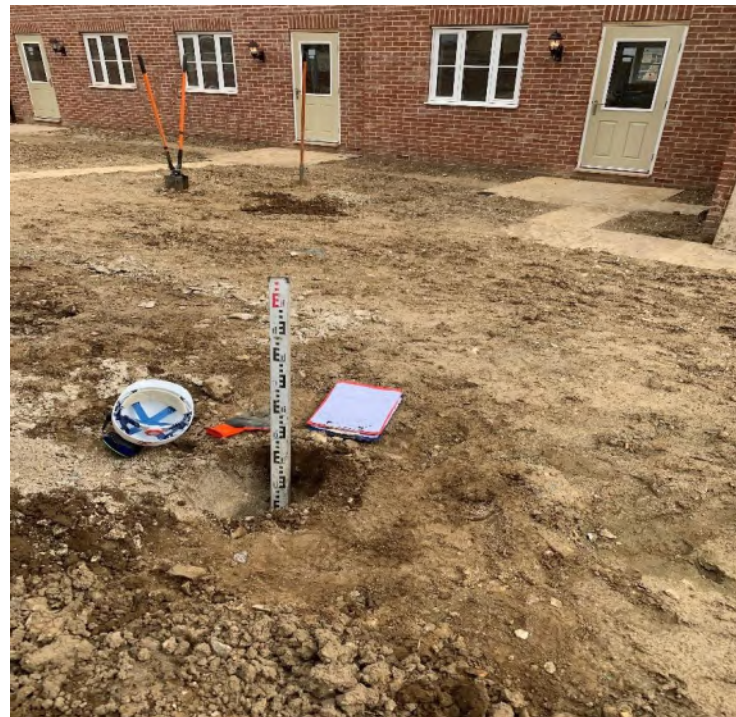
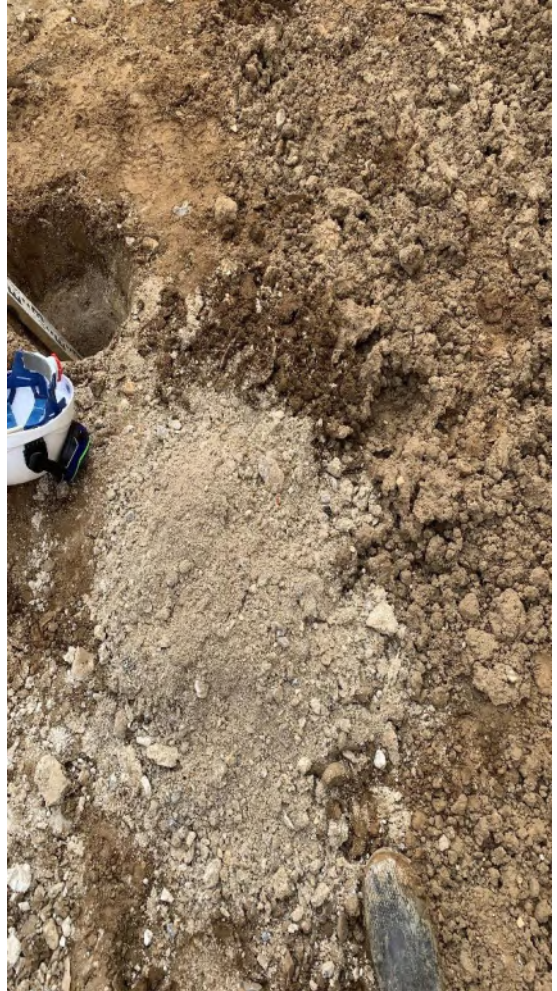
The potentially unsuitable subsoil material was identified within the back garden of plot 80 only. A sample of the subsoil material noted within the back garden of plot 80 (ES1, 0.15-0.5m) was taken to submit for chemical testing at an accredited laboratory. The results of this testing are discussed further in section 3.2 of this report.

The table shows that the detected concentrations of each contaminant were below the generic assessment criteria (C4SL and S4UL) and were therefore considered suitable for use. the subsoil material encountered within plot 80 was therefore considered suitable for use.

**Photographs 9-12**, taken on the 19<sup>th</sup> May 2023 showing examples of hand dug trial pits and the nature of the subsoil and topsoil within the soft landscaping of plot 80 (back garden).

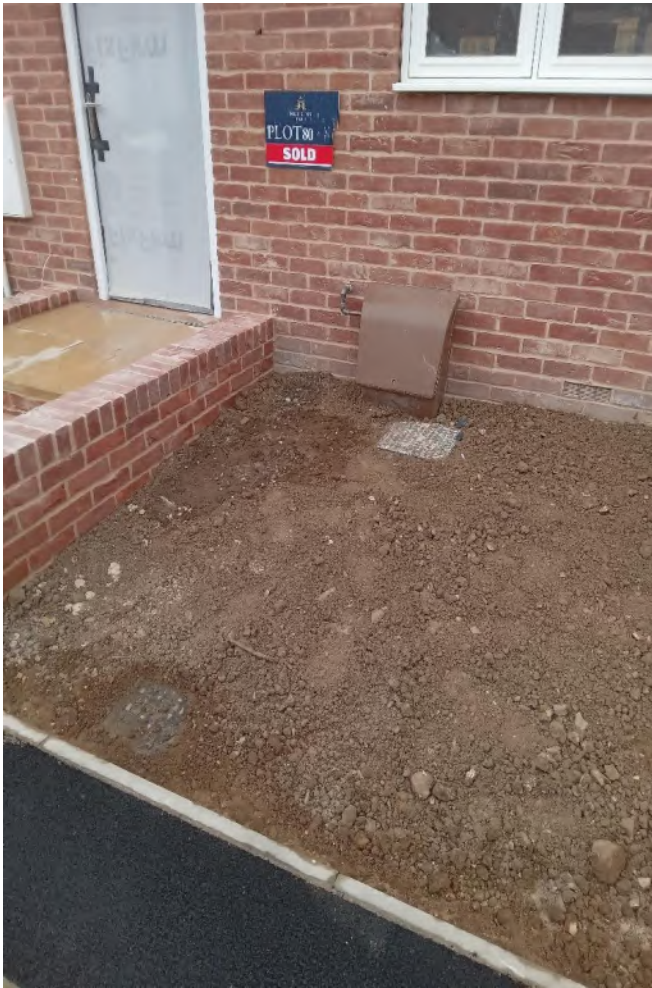
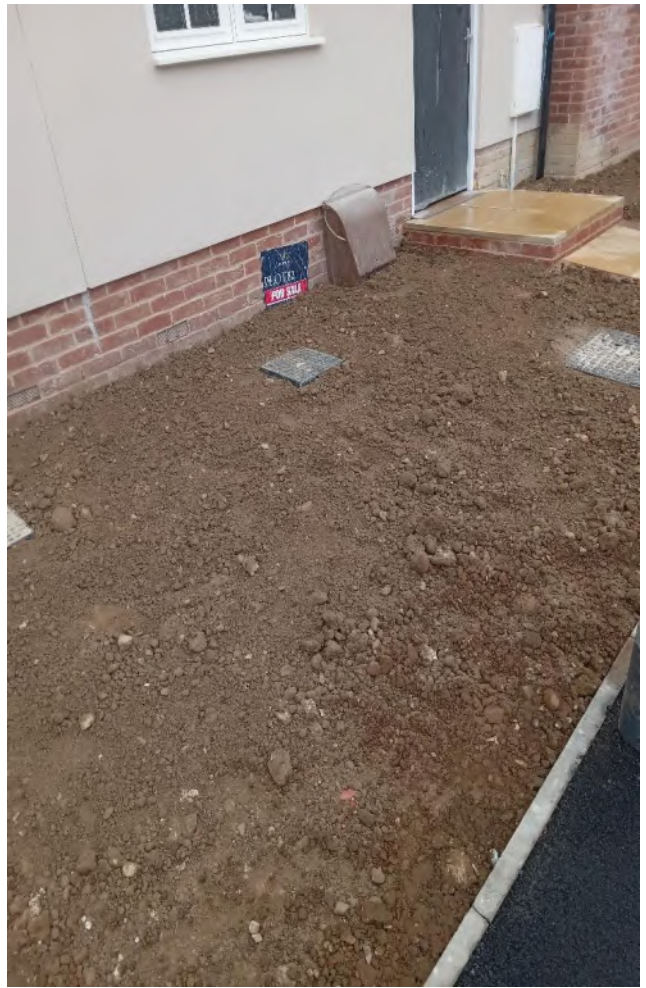
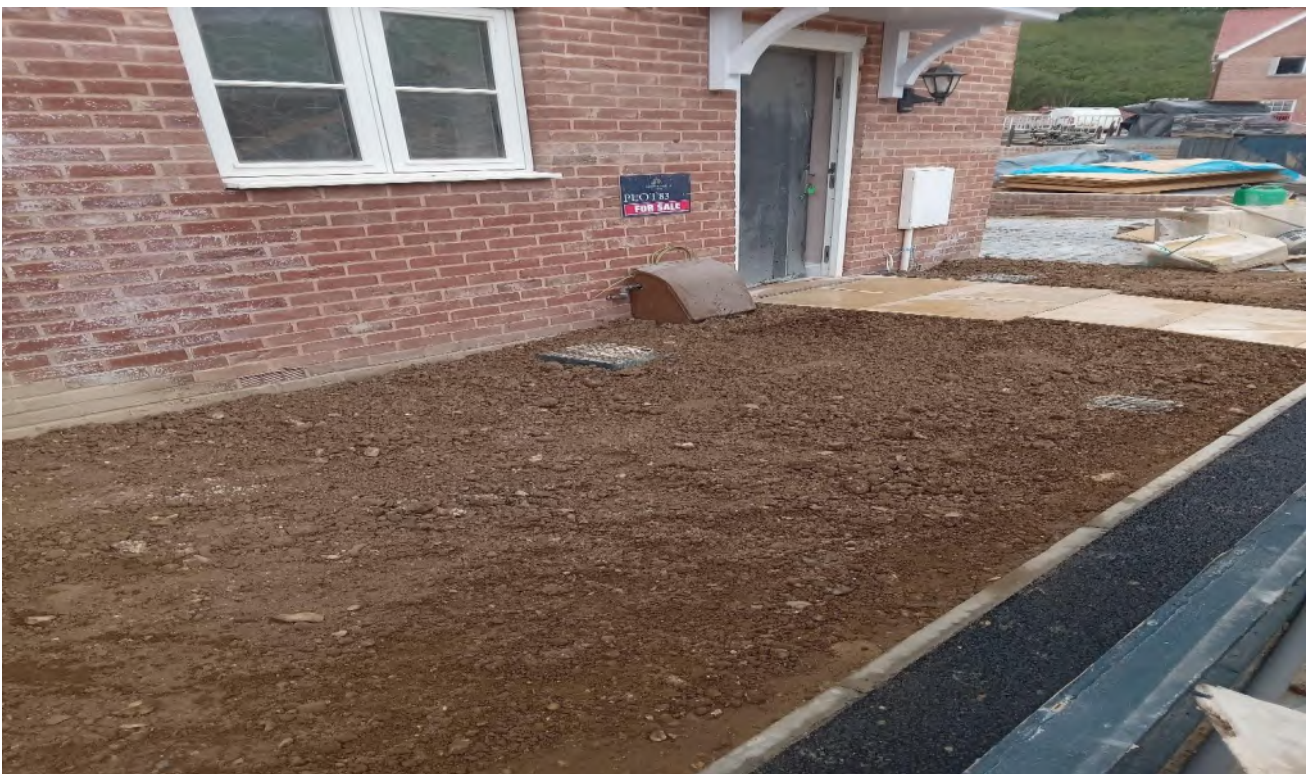
- Concrete edging was observed adjacent to footpaths and curb sides at approximately 45° angle.
- A maximum depth of excavation of 500mm was completed within HDTP77-01, HDTP80-01 and HDTP80-02 due to encountering very hard ground, however the cover system was deemed suitable upon reaching this depth, from the point of view of the lack of dark, potentially contaminated material, which has been the focus of the need for a cover in other plots on the site.
- At the time of the site visit topsoil had not been placed within the front gardens of plots 80-83. However, since our site visit HH have provided photographs of the topsoil being placed within the front gardens of these plots, which have been reviewed and are deemed suitable.

**Client Supplied Photographs 13-15**, taken on the 31<sup>st</sup> May 2023 showing topsoil placement within the front gardens of plots 80-83.
