Document: Remediation Verification Report

Project: Needham Market Quarry

Reference No.: GN17820_RV33

VERIFICATION REPORT FOR REMEDIAL ACTIVITY

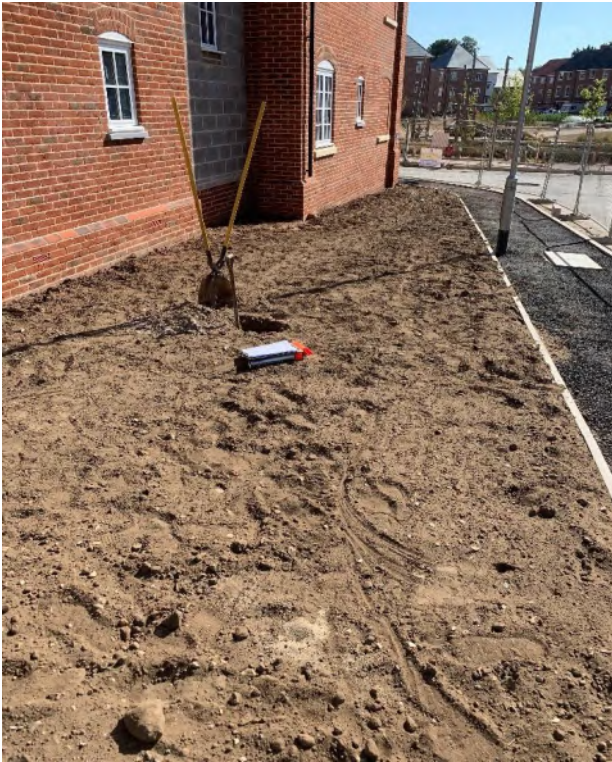
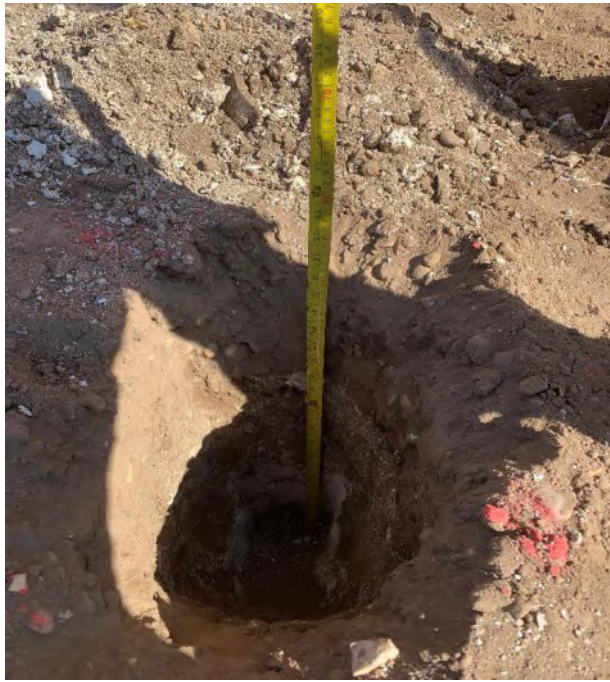
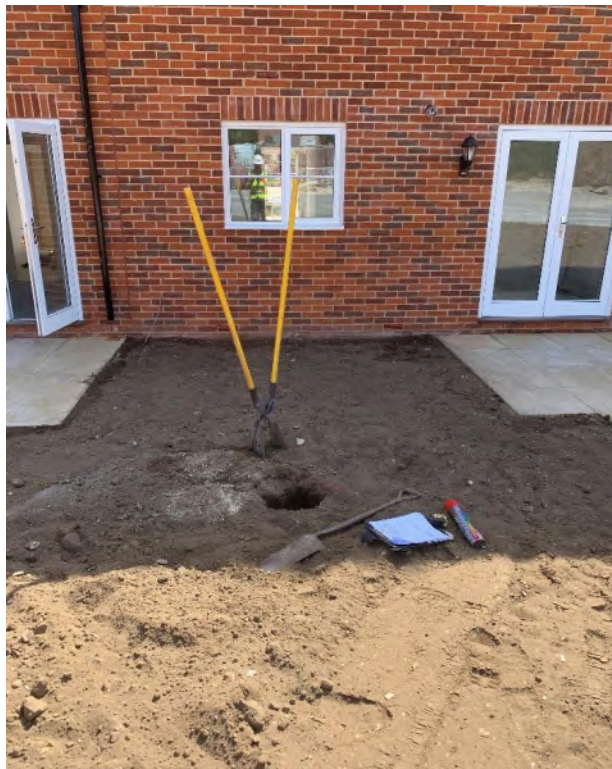
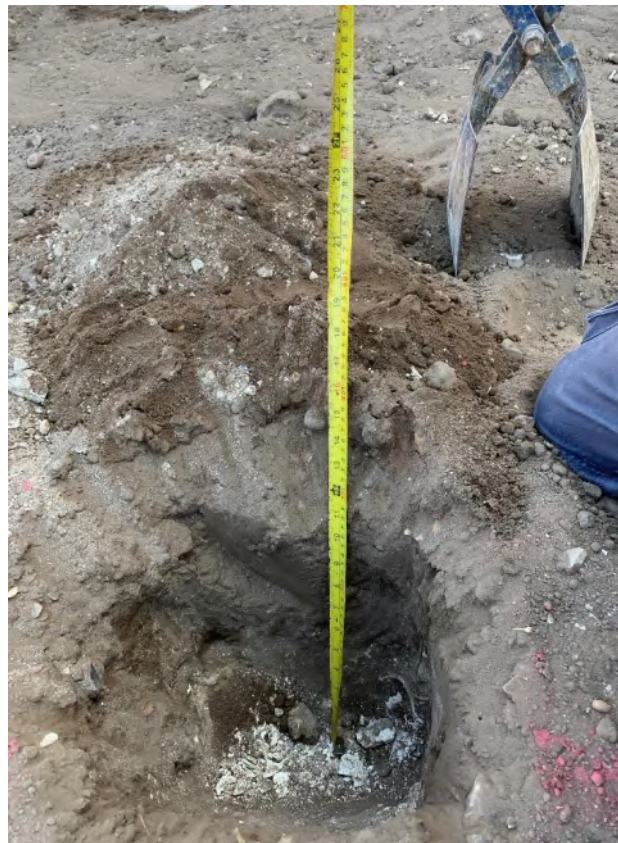
Photographs 1-4, taken on the 09th August 2022 showing examples of hand dug trial pits and the nature of the subsoil and topsoil within the soft landscaping of plots 198 and 200-203 (representative of plots 197-199 & 200-203).

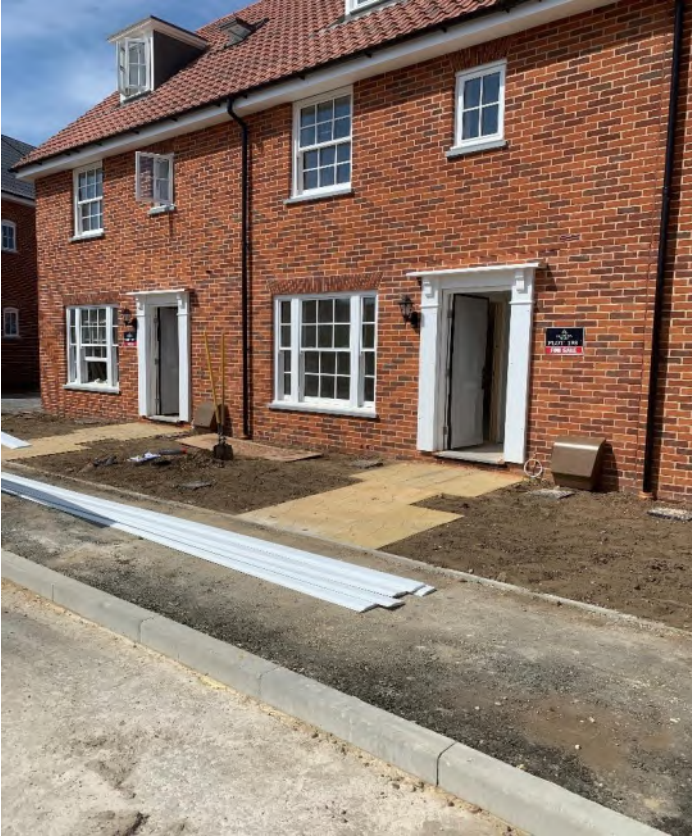
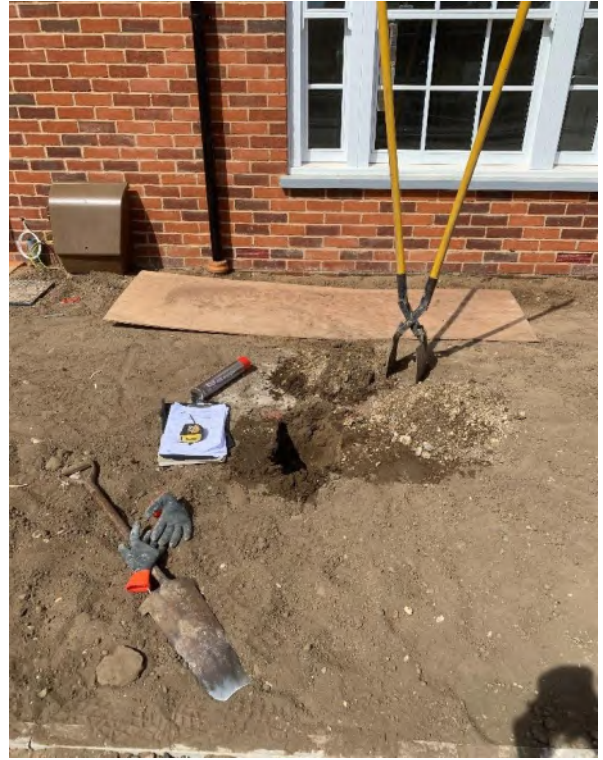
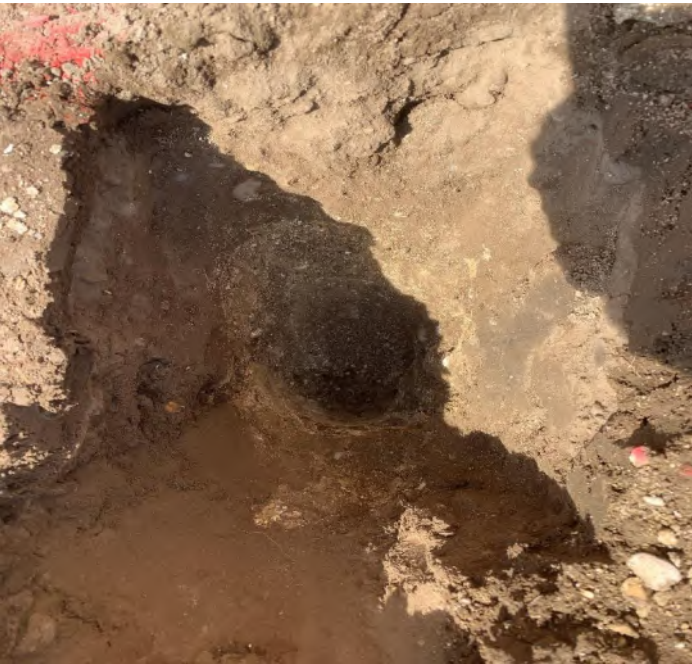
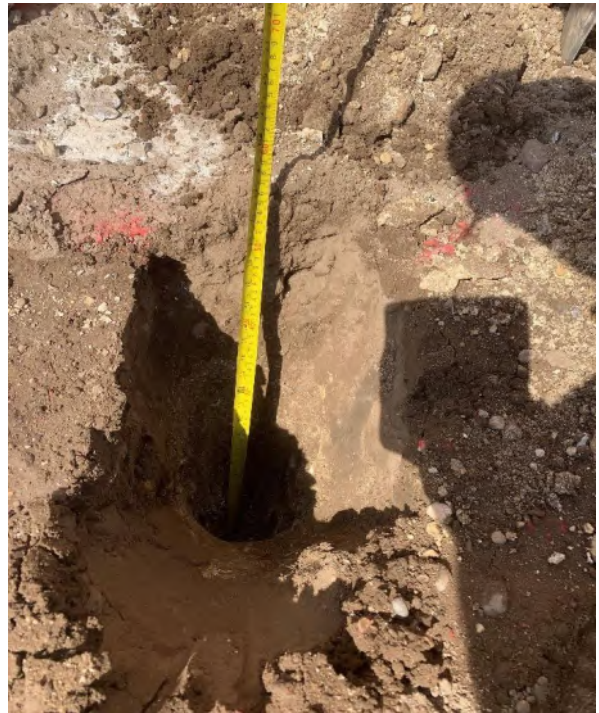
- Concrete edging was observed adjacent to footpaths and curb sides at approximately 45° angle.
- An insufficient topsoil thickness of 120mm was identified within trial pit HDTP198-01 (minimum thickness required is 150mm) and was noted to constitute a small area of the back garden of this plot and is representative of the same areas within plots 197 and 199. Since our site visit, HH have confirmed that additional remedial works including stripping the topsoil back of the affected areas, subsequent additional excavation of subsoil to allow for a minimum thickness of topsoil has been undertaken within plots 197-199. HH have provided a photograph, which is included on the photosheet in the appendix to show the thickness of the topsoil following the further remedial works (200mm).

Photographs 5-8, taken on the 09th August 2022 showing examples of hand dug trial pits and the nature of the subsoil and topsoil within the soft landscaping of plot 198 (representative of plots 197-199 & 200-203).

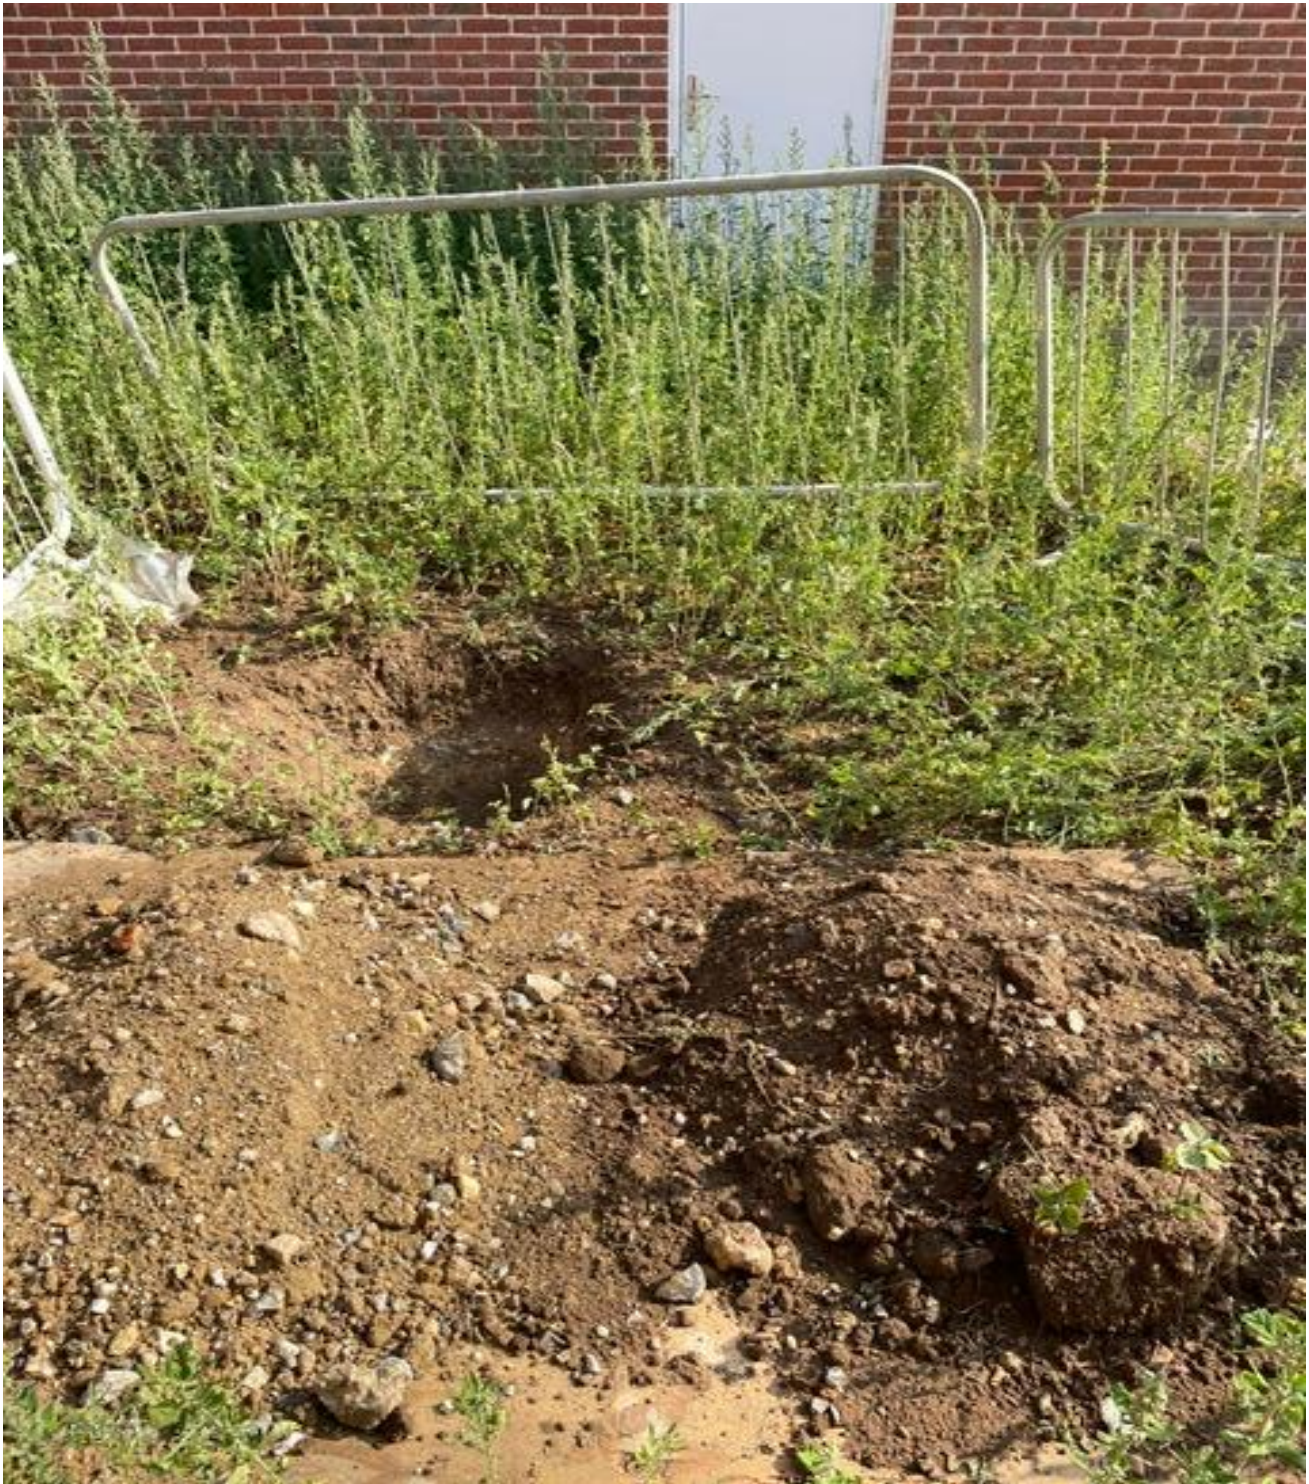
Photograph 8, taken by HH on the 18th August 2022 showing the hand dug trial pit and the nature of the subsoil and topsoil within the soft landscaping of plot 96 (very small back garden).

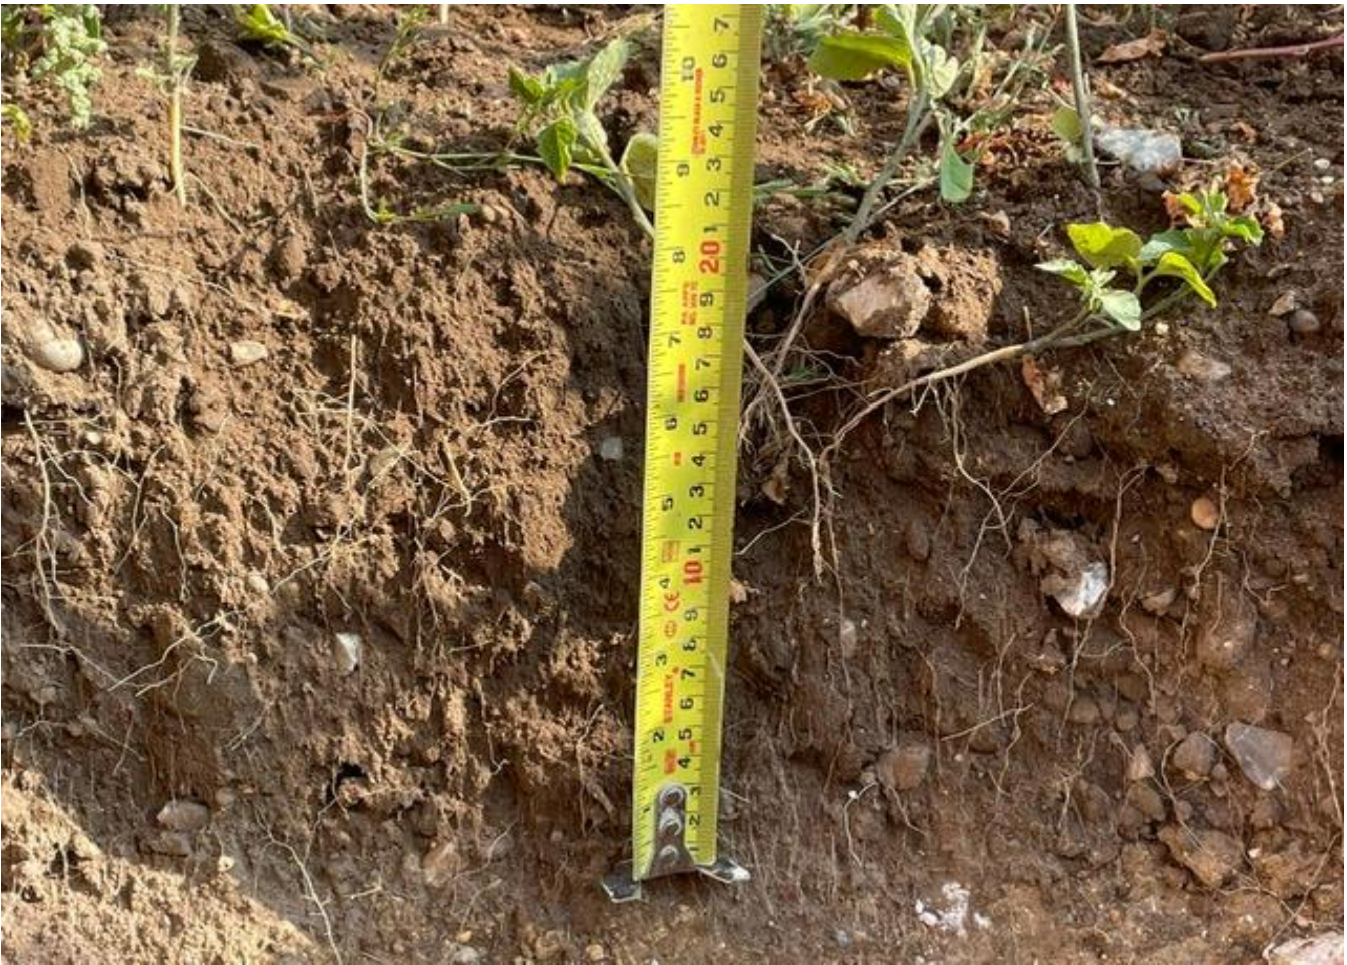
The thickness of suitable soil was recorded to be at least 500mm within trial pits completed in plot 198 and 600mm within trial pits completed in plot 200. Following the site visit, HH have confirmed that further remedial works have been undertaken within plots 197-199, including excavation of subsoil to provide a thicker layer of topsoil, which is at least the minimum 150mm required.

Photograph 9, taken by HH on the 18th August 2022 showing thickness of topsoil within plot 198 (representative of plots 197-199) following remedial works.
