**Document:** Remediation Verification Report

**Project:** Needham Market Quarry

**Reference No.:** GN17820\_RV37

**REMEDATION VERIFICATION REPORT**  
**FOR REMEDIAL ACTIVITY**  
**AT**  
**NEEDHAM MARKET QUARRY (Plots 70-75)**

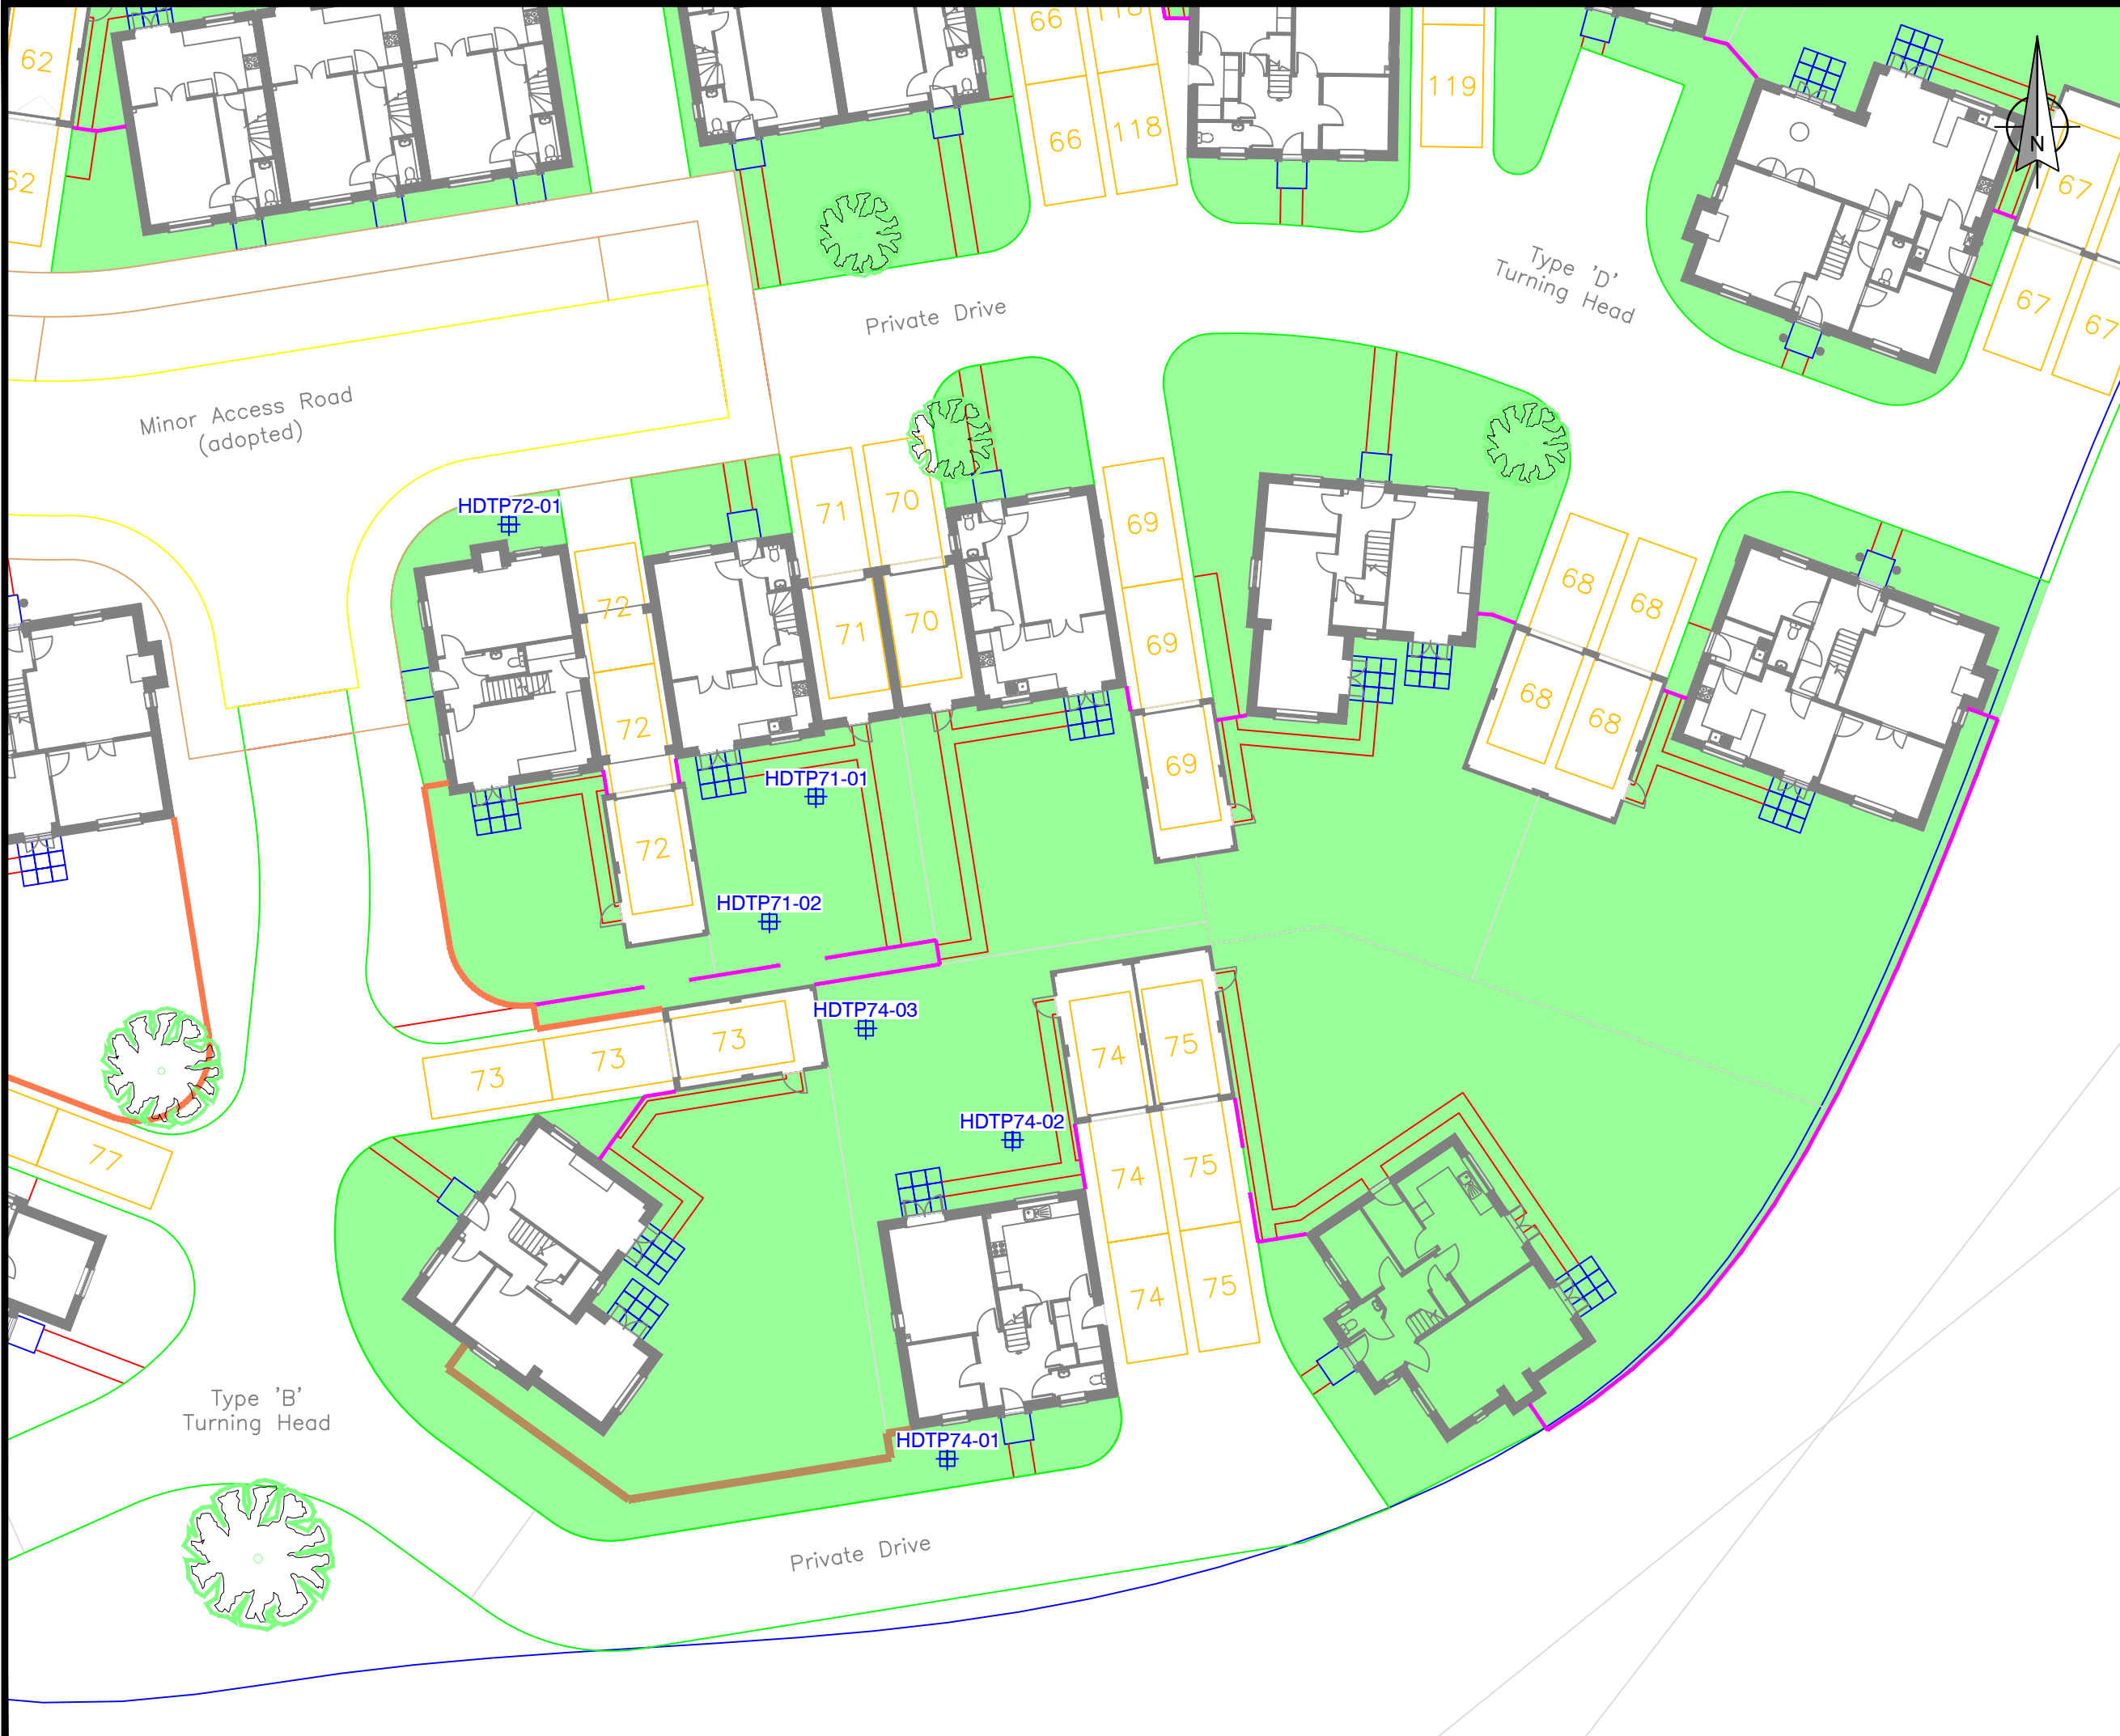
Client : Hopkins Homes Ltd  
 Project : Needham Market Quarry  
 Job No : GN17820 Date : March 2023  
 Drawing Title : Fieldwork Location Plan - Plot 69-75  
 Drawing No : GN17820 - DR502an  
 Scale : 1:250 @ A3  
 Drawn by : RW Checked by : CD  
 Eastings : 609480 Northings : 253940

The fieldwork locations are shown on drawings GN17820-DR502an included within the appendix. Hand excavated trial pits were undertaken to record the thickness and physical descriptions of the materials present and to confirm material suitability.

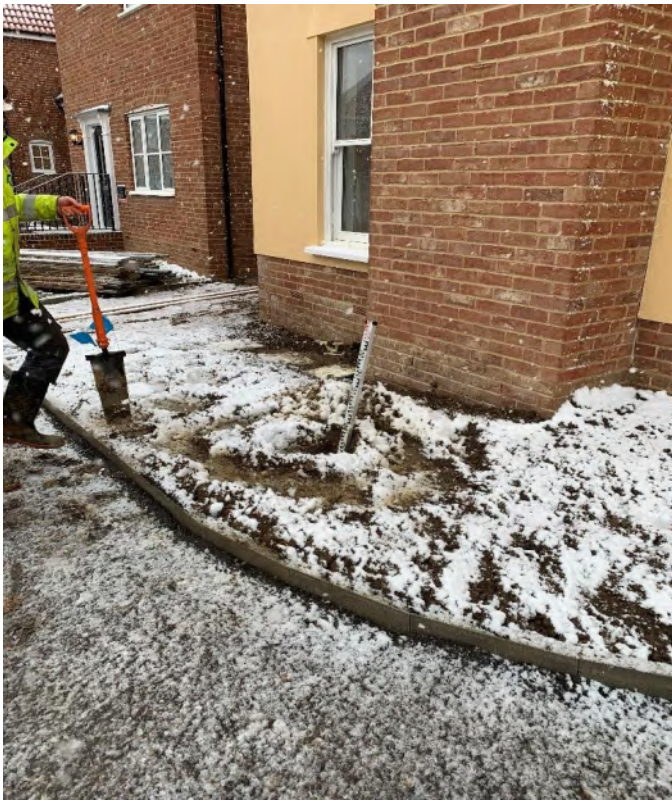
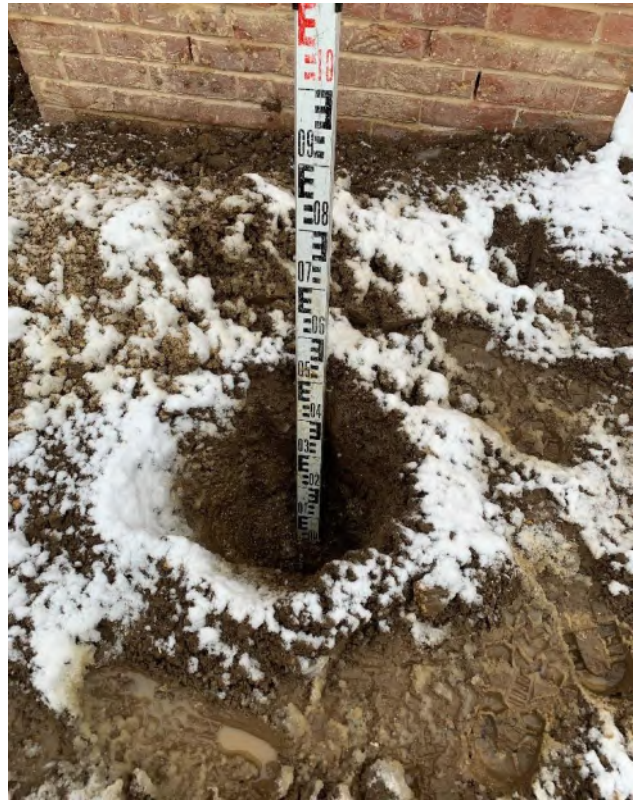
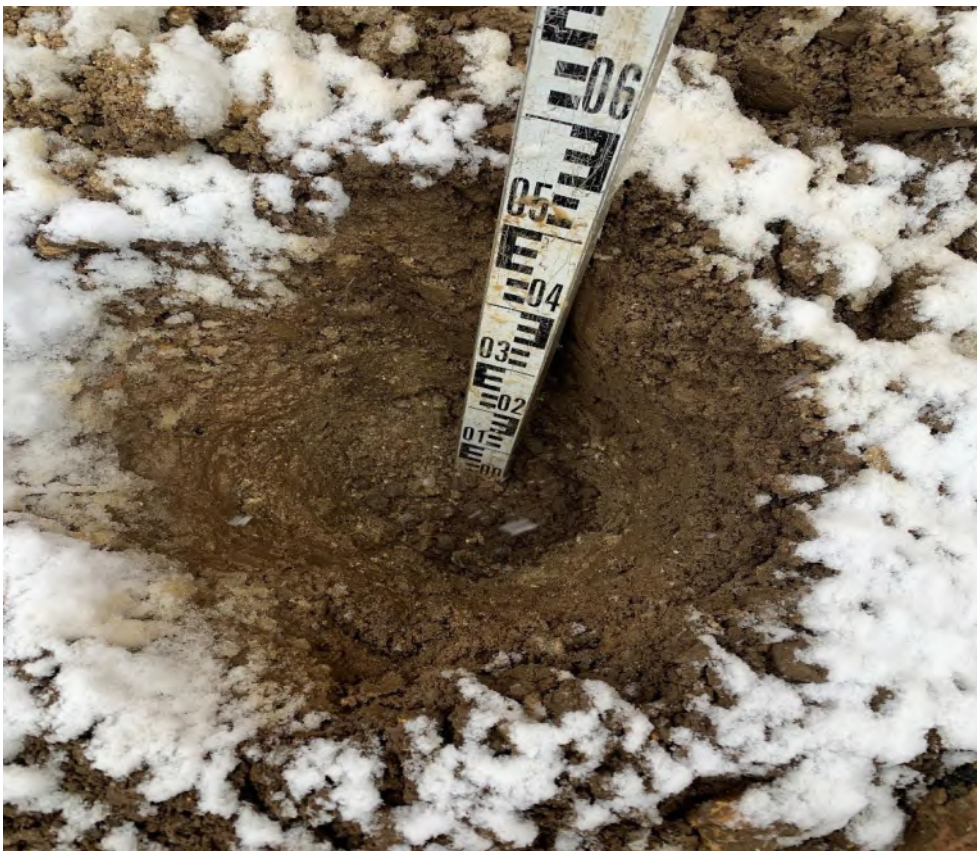
**Photographs 1-3**, taken on the 10<sup>th</sup> March 2023 showing examples of hand dug trial pits and the nature of the subsoil and topsoil within the soft landscaping of plot 72 (front garden).

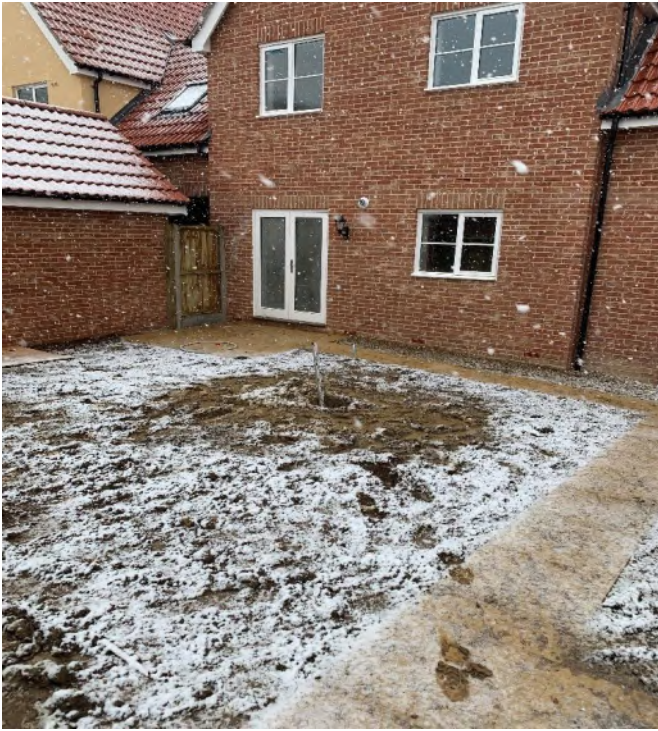
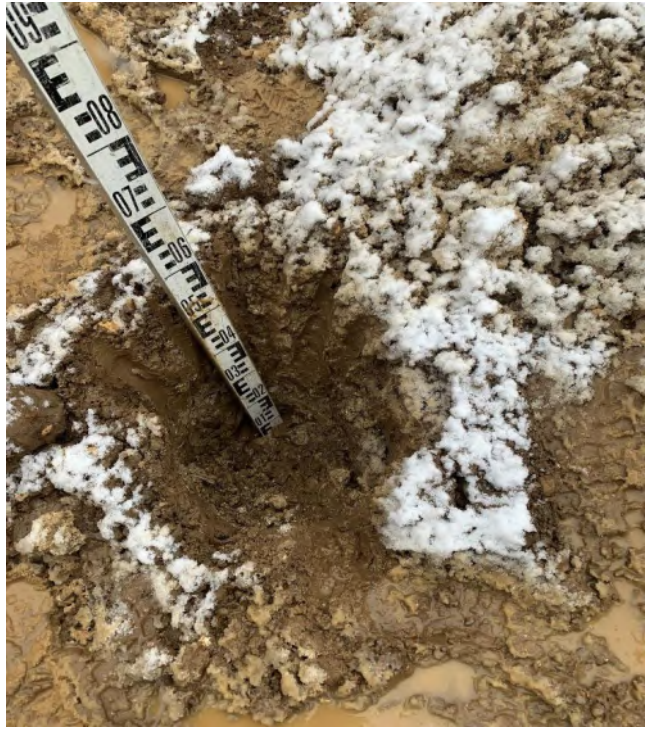
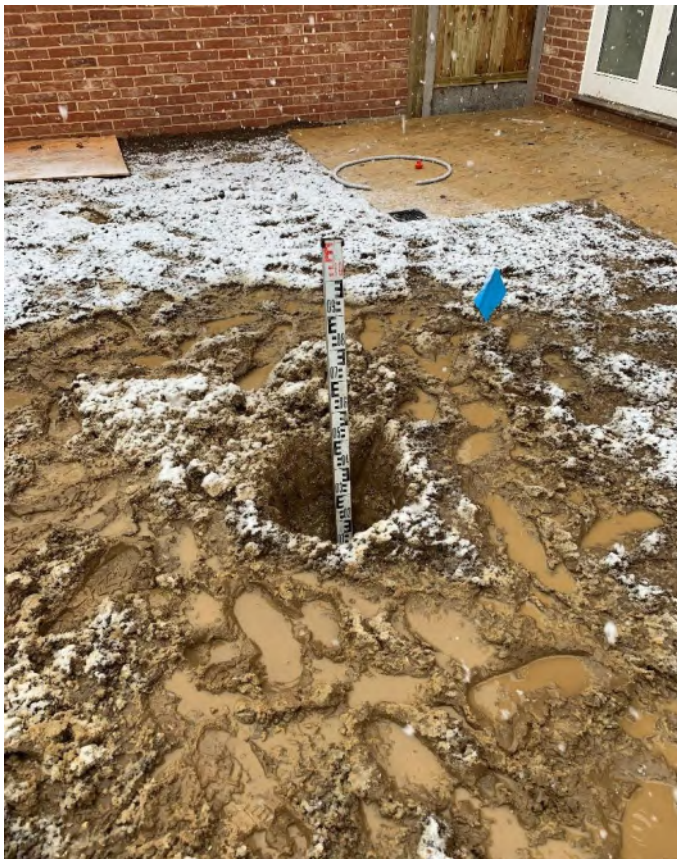
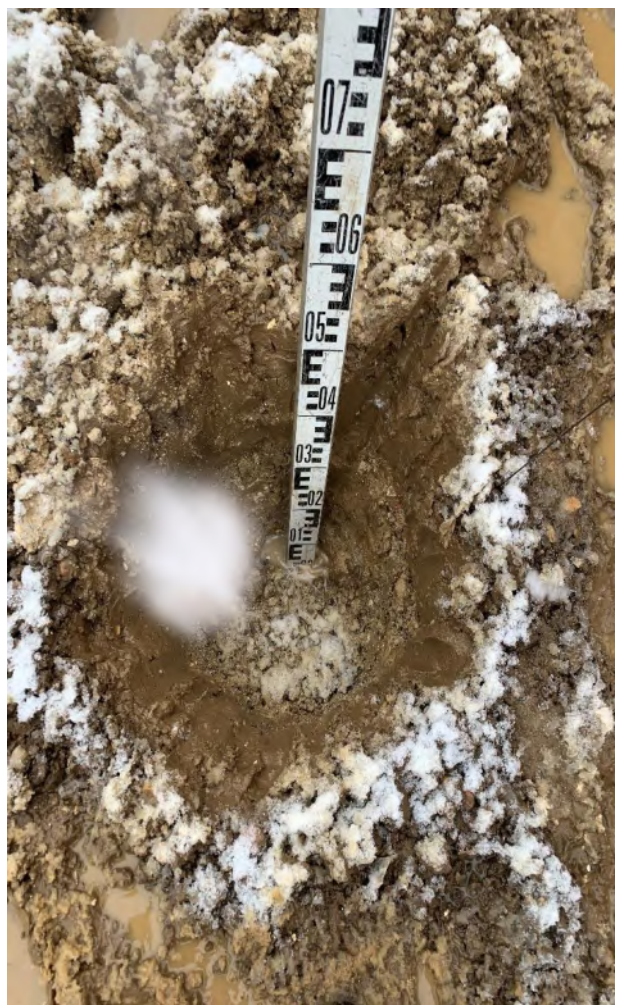
**Photographs 4-7**, taken on the 10<sup>th</sup> March 2023 showing examples of hand dug trial pits and the nature of the subsoil and topsoil within the soft landscaping of plot 71 (back garden).

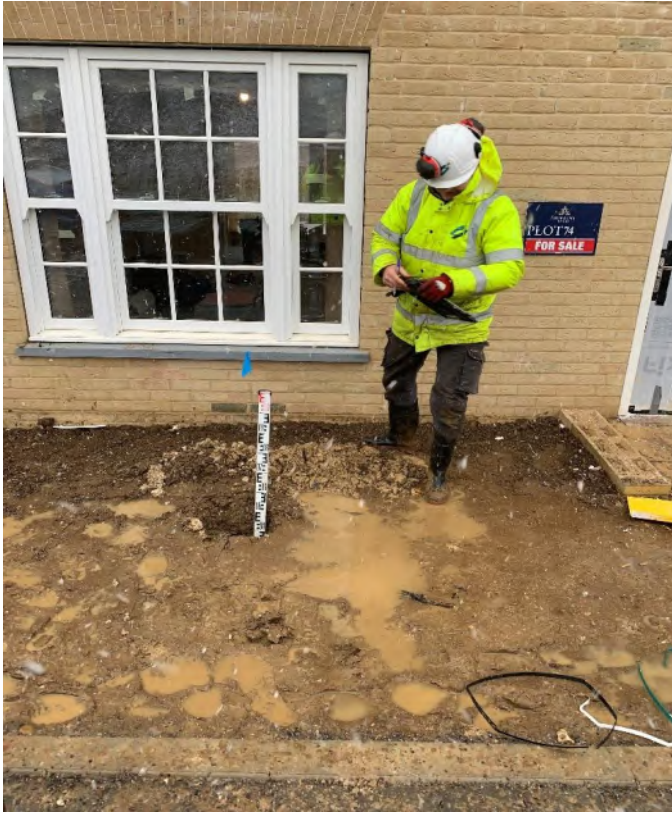
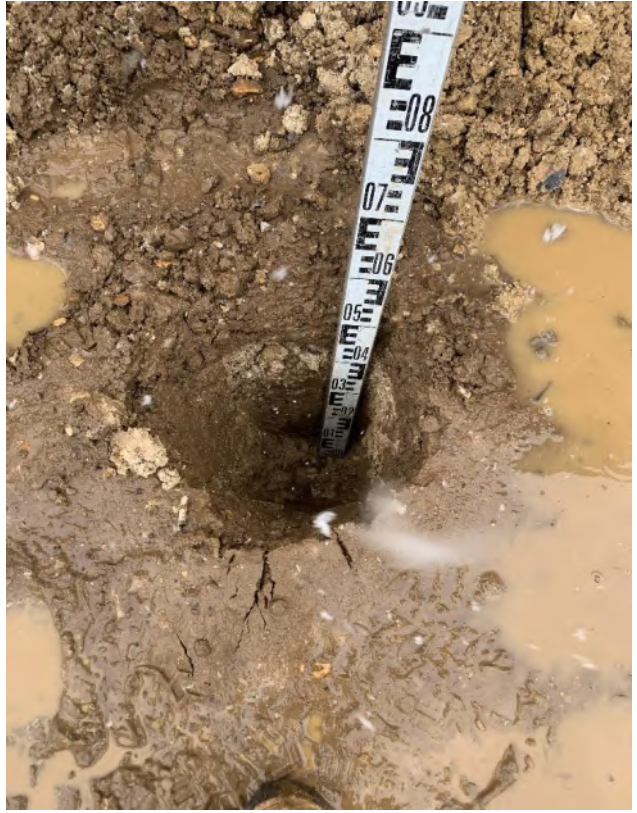
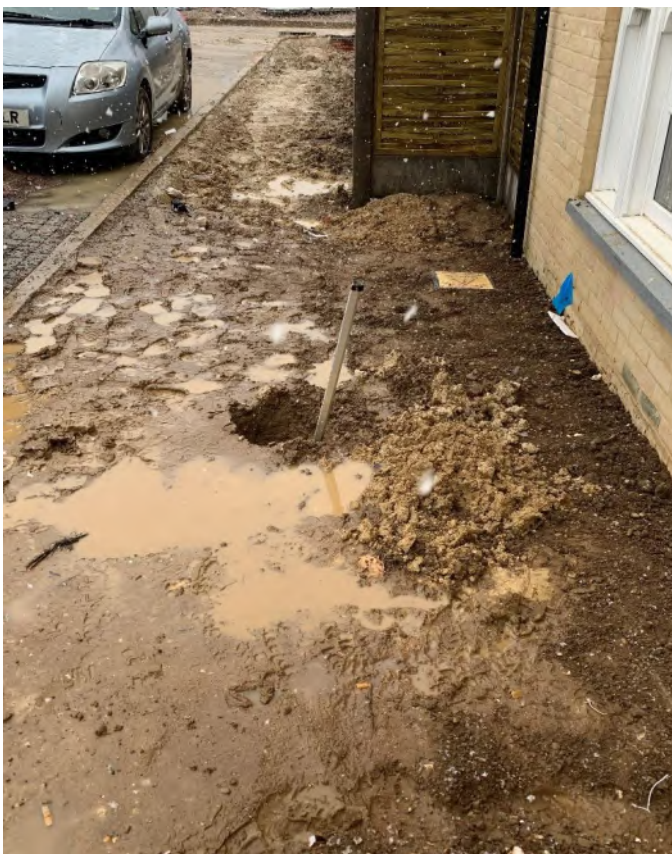
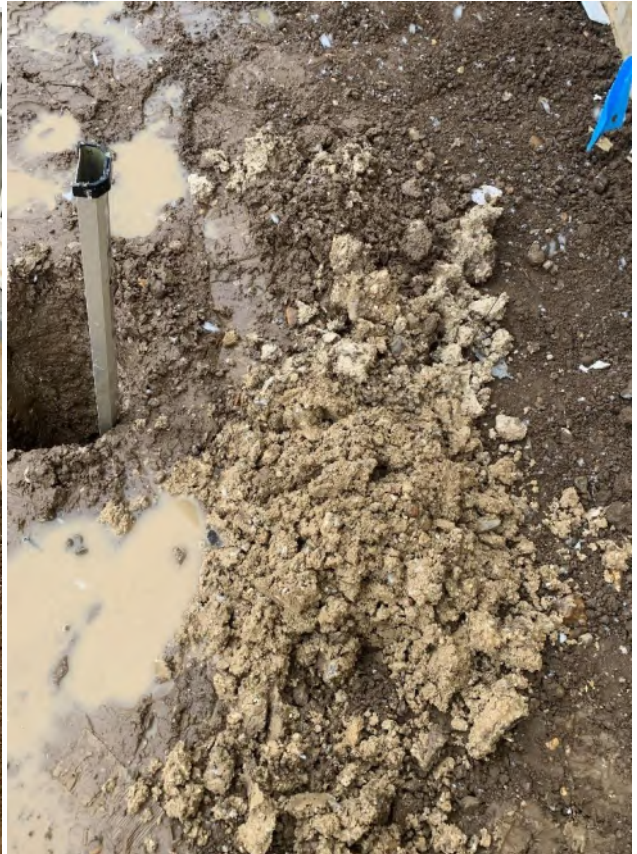
**Photographs 8-11**, taken on the 10<sup>th</sup> March 2023 showing examples of hand dug trial pits and the nature of the subsoil and topsoil within the soft landscaping of plot 74 (front garden).

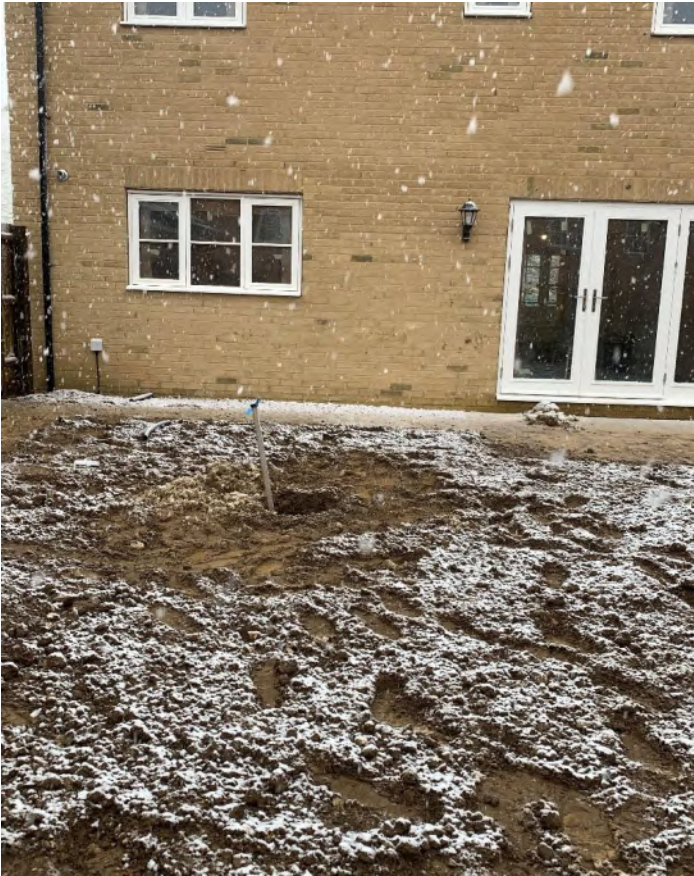
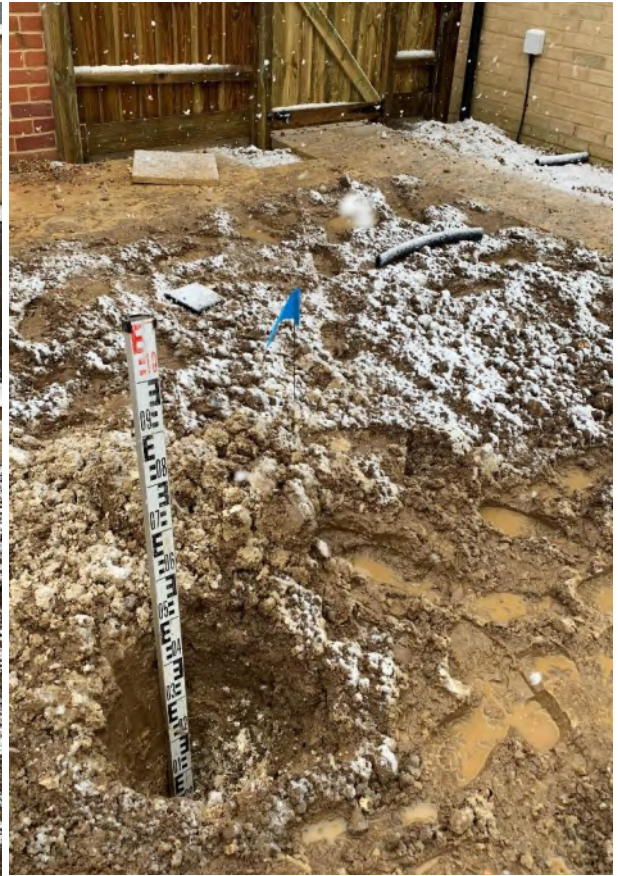
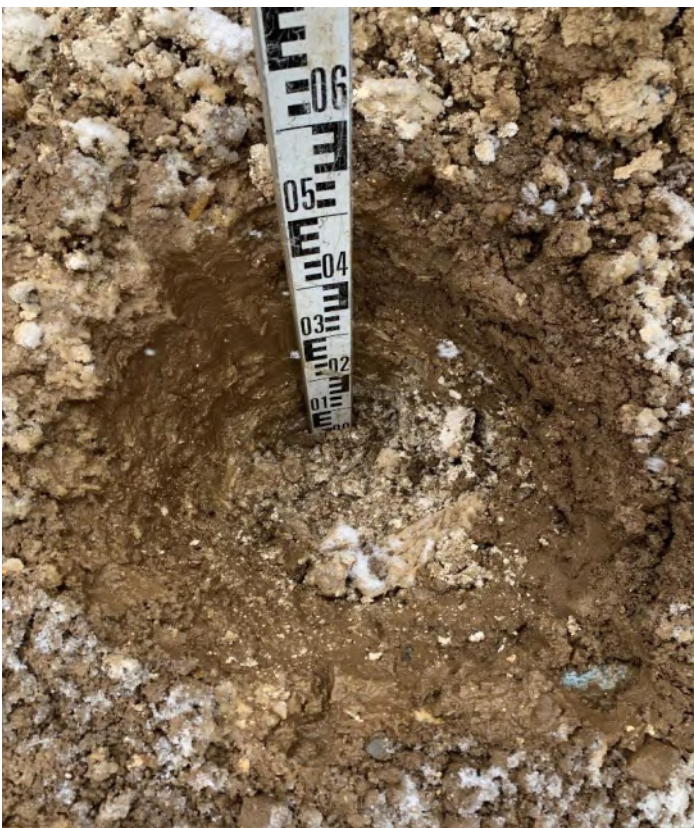
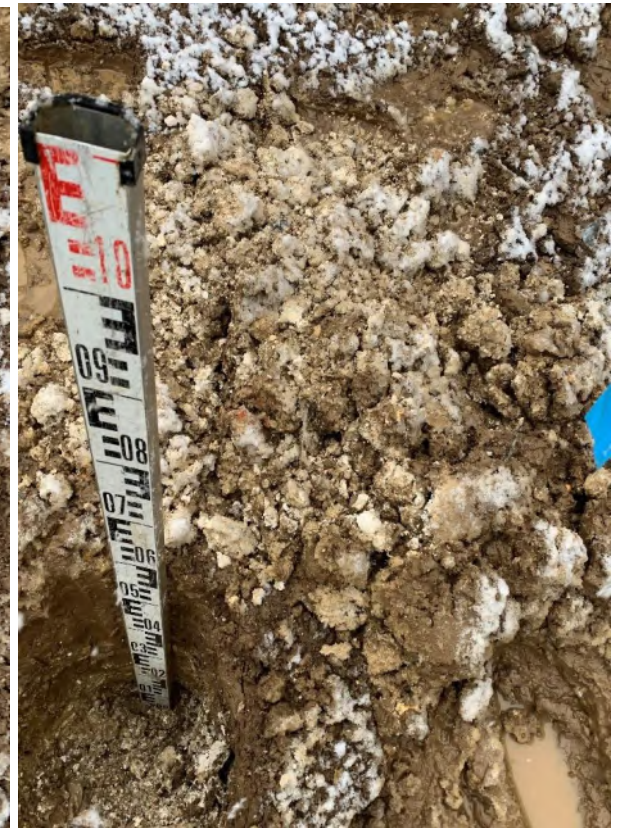
**Photographs 12-15**, taken on the 10<sup>th</sup> March 2023 showing examples of hand dug trial pits and the nature of the subsoil and topsoil within the soft landscaping of plot 74 (back garden).
