St Martine Church, Beley, Ringwood

St Martine Church	Existing Roof
Oct 23	
Ref - 22.CHURCH.roof.01

St Martine Church	Proposed Roof Repair
Oct 23	
Ref - 22.CHURCH.roof.05

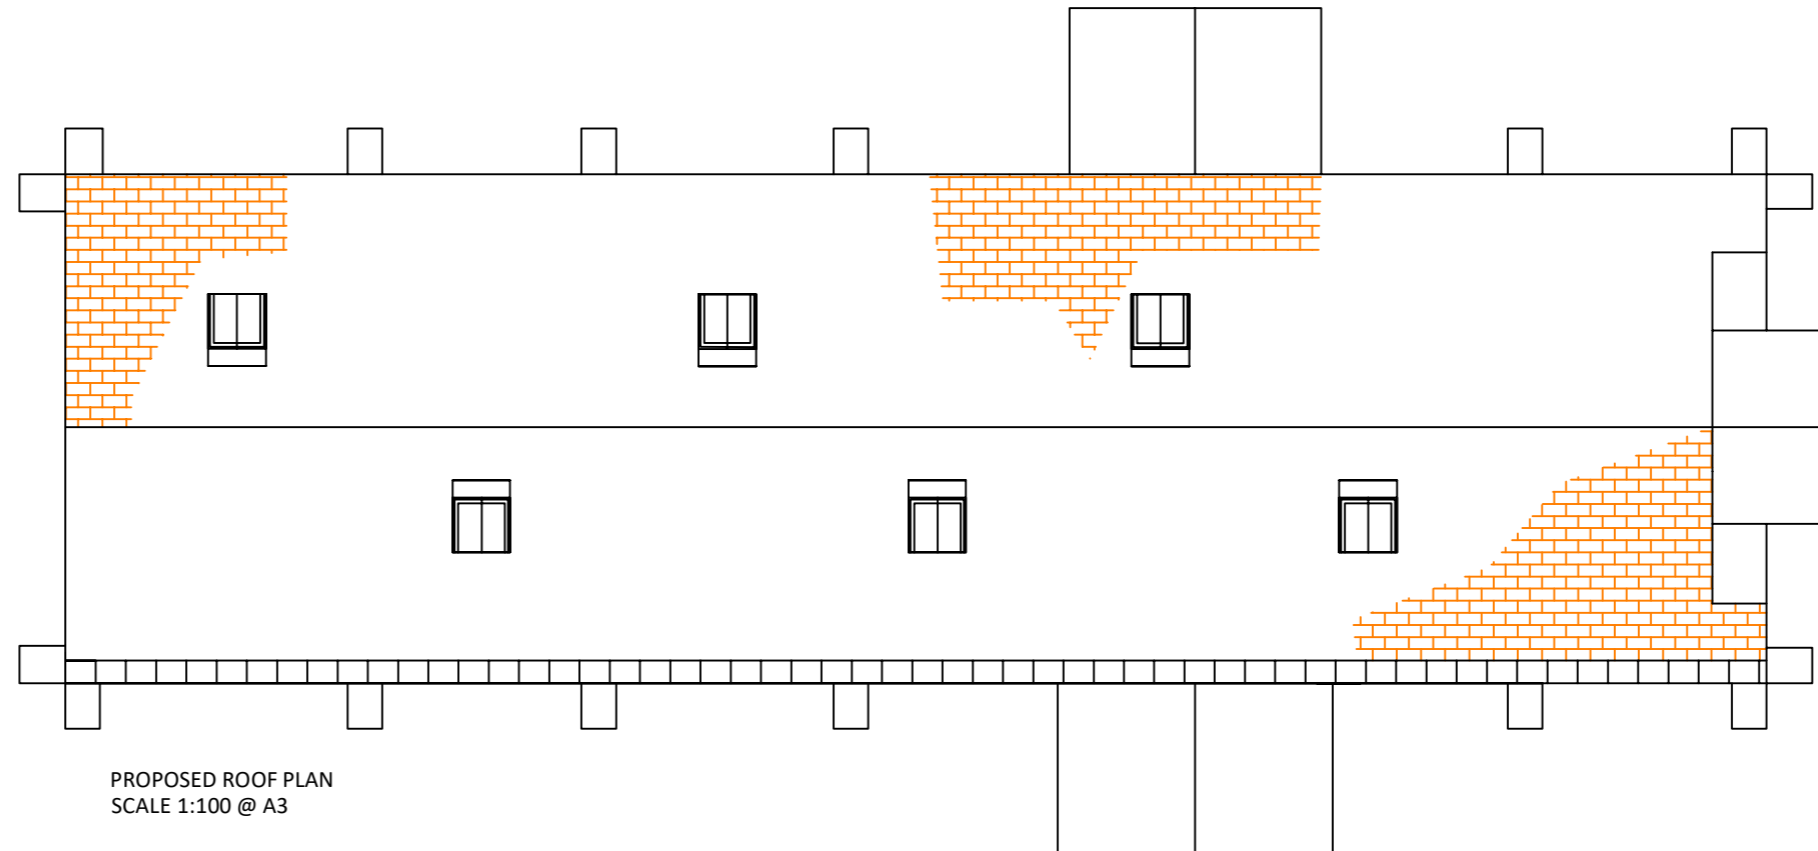
PROPOSED ROOF PLAN
SCALE 1:100 @ A3

New roof tile - as per conservation officer approval of samples

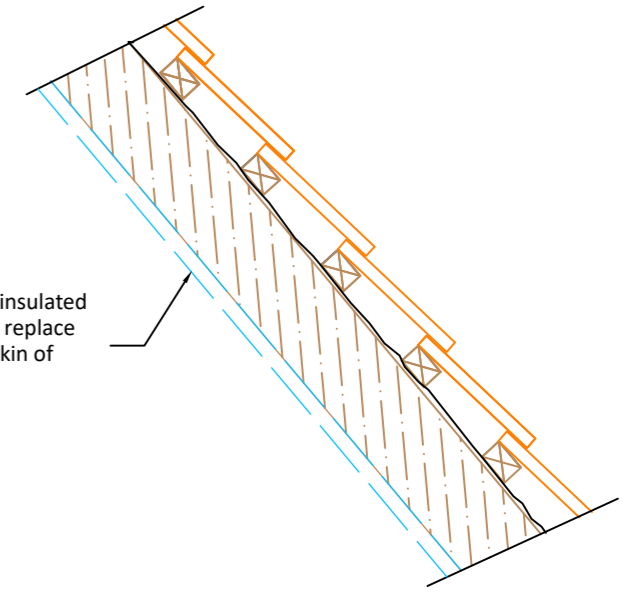
DETAIL 3
not to scale

internal skin of insulated plasterboard to replace existing single skin of plasterboard

replace existing insulation (combination of mineral wool, polystyrene and rigid PIR) with new insulation between rafters

Existing roof has a combination of mineral wool, rigid PIR insulation and polystyrene insulation with single skin of plasterboard. Intention to replace with new insulation between the rafters, then internal layer of insulated plasterboard.
