Preliminary Ecological Appraisal and
Bat Roost Assessment

Meeting Hall, Otford Lane, Sevenoaks,
TN14 7EG

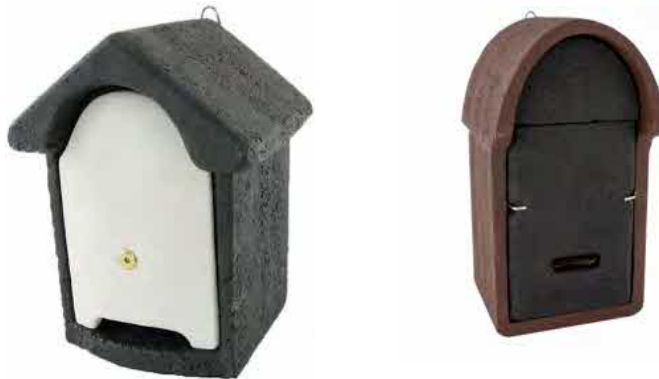
Vivara Pro WoodStone Bat Box – A general purpose bat box that supports a range of species (Figure 6). These can be hung on trees in a variety of heights and aspects in order to provide a variety of micro-climates.

Large Multi Chamber WoodStone Bat Box – This is a multipurpose box designed for larger colonies and a range of bat species including pipistrelles, noctules and brown long-eared bats. These should be hung on mature trees around the site (Figure 6).

Figure 6: Vivara Pro WoodStone Bat Box (left) and Large Multi Chamber WoodStone Bat Box (right)

- 4.32 The siting of bat boxes is important and have the best rate of occupancy when they are situated within or adjacent to bat-friendly features, such as treelines. The bat boxes should be situated where they are sheltered from strong winds and should be exposed to the sun for most of the day, therefore southern aspects are favourable. Multiple boxes may be hung on one large tree, facing different aspects. Bat boxes should be

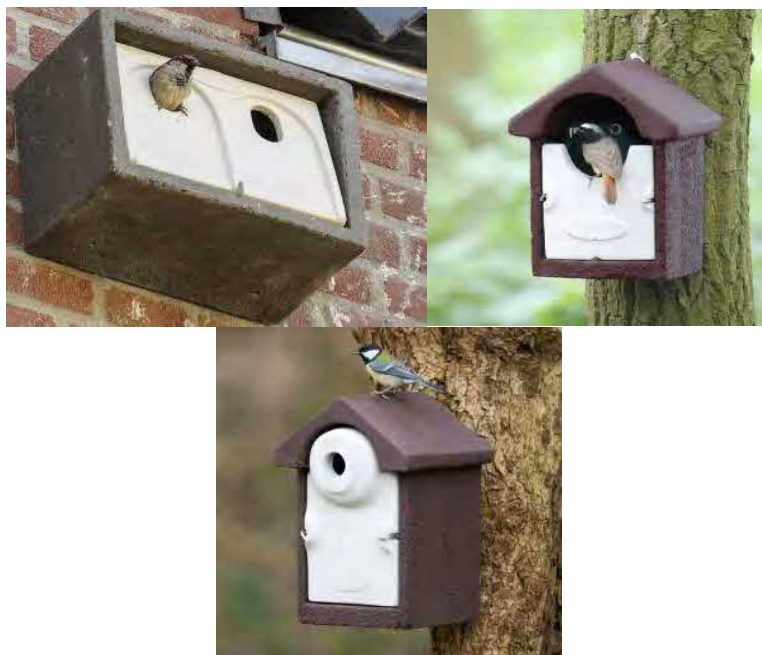
Figure 7: Examples of suitable bird boxes which could be installed on site – Vivara Pro WoodStone House Sparrow Nest Box (left), Vivara Pro Barcelona WoodStone Open Nest Box (centre) and Vivara Pro Seville 32mm WoodStone Nest Box (right)

- 4.34 Bird nesting opportunity can be installed within existing trees on site. Again, hardwearing woodcrete boxes, or similar, are recommended. Figure 7 gives examples of suitable bird boxes, of which these or similar, could be installed onto the brickwork of the auction house or on existing retained trees. The boxes should be positioned on a north or east facing aspect and at least 2m above the ground if possible. These would cater for species such as house sparrows and wagtails.

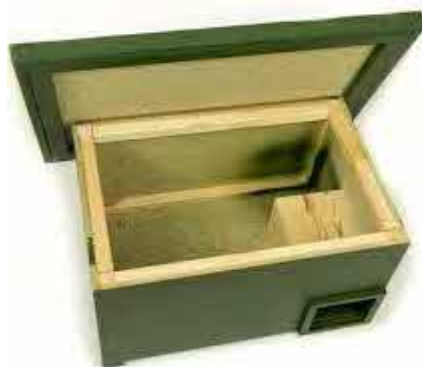
Figure 8: Example of a hedgehog house that can be utilised on site

- 4.35 There is also suitable habitat on site for hedgehogs within the site boundaries. As such, ecological enhancements for hedgehogs are recommended. Hedgehog homes could also be placed across the site (Figure 8). These provide areas of shelter for hedgehogs within the site, helping support the local population.

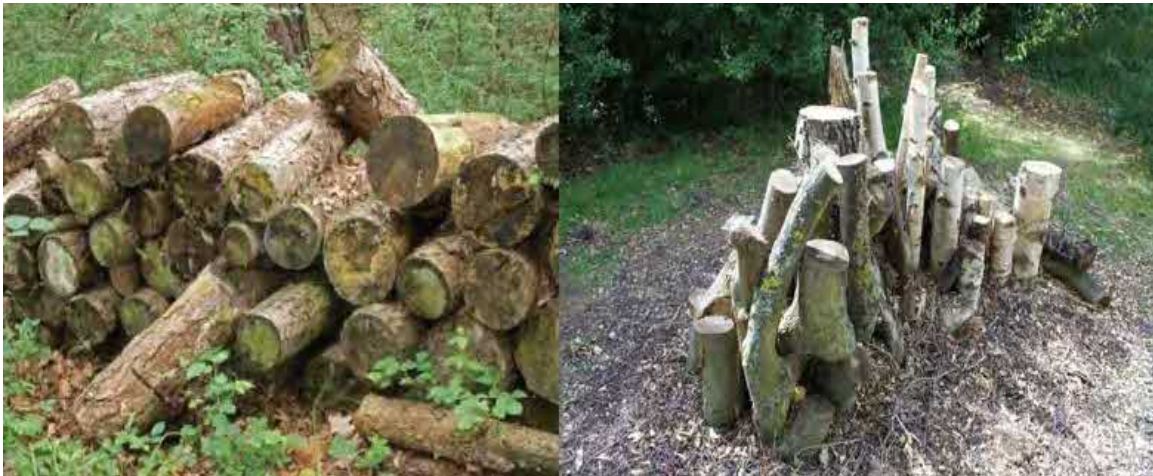
Figure 9: Examples of log piles which should be created on site

- 4.36 It is recommended that log piles are created for use as refugia by amphibians as well as reptiles, small mammals and invertebrates (Figure 9). These can be located in a variety of locations, such as damp places with some situated in sunnier locations. They can be placed within the middle of the new herbaceous or wildflower planting. These

should be stacked and perhaps some leaf litter added. Planting around log piles with species such as honeysuckle or clematis can also add value.

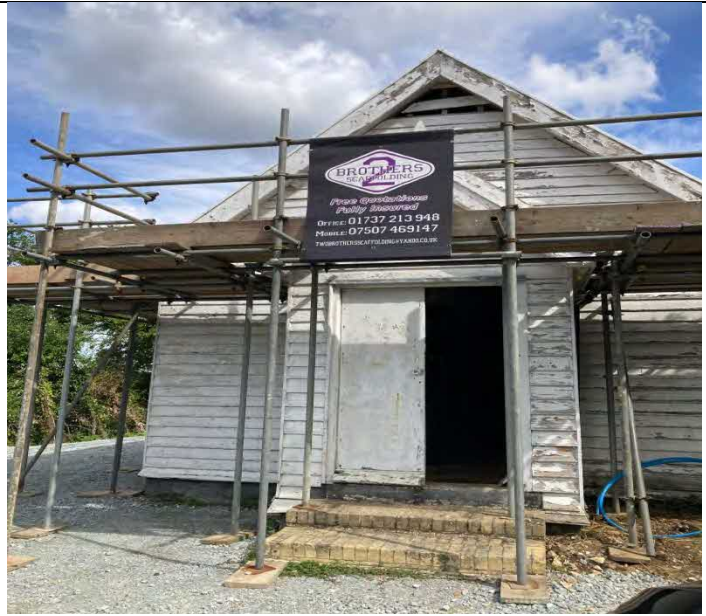
Photograph 1: The hall view from the road

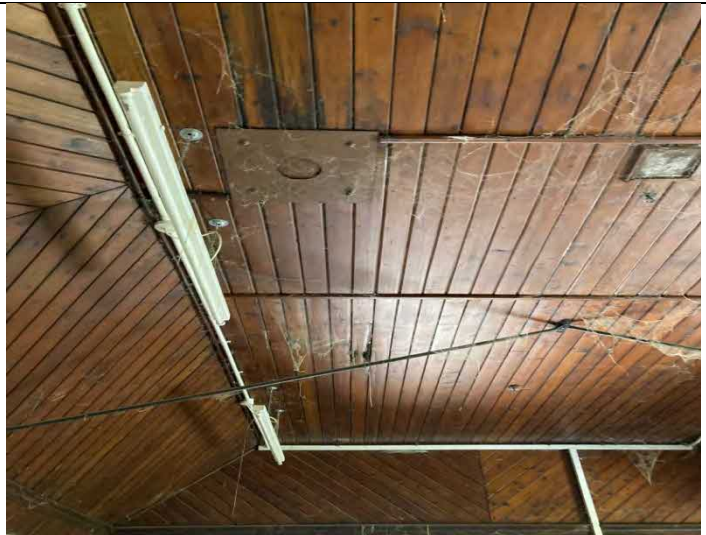
Photograph 2: Inside the building, well sealed

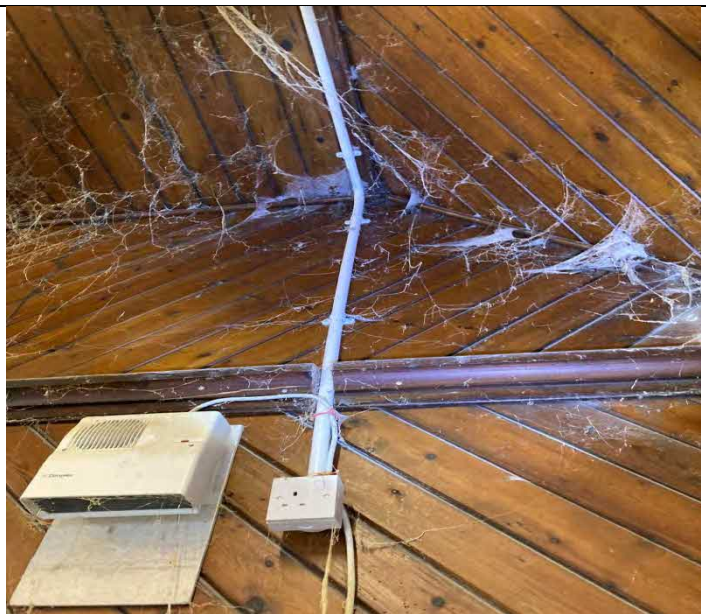
Photograph 3: Another view of the roof structure

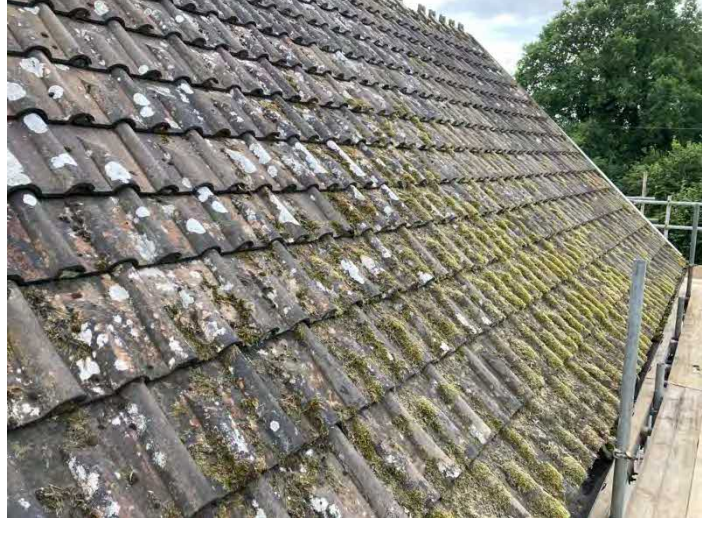
- 3.17 The majority of the building had a clay tile interlocking roof that is in mainly good condition. On the eastern aspect much of the roof was covered in moss, essentially sealing the tiles. No obvious gaps were present. On the western aspect, again, most of the tiles were well sealed. There were several tiles which were lifted on the southern aspect, but the gaps were limited and the extent of the gaps appeared minimal.

<p>Photograph 4: Largely well sealed tiles across the roof</p>

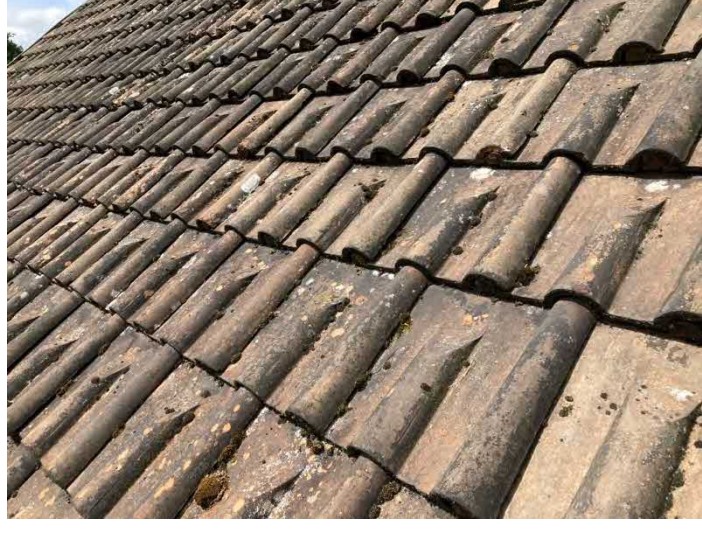
<p>Photograph 5: The other face of the roof. Again, largely well sealed across the roof</p>

- 4.13 However, as the building is to be retiled, it is recommended if any evidence of bats is found, or indeed a live bat, then all works must cease and a suitably qualified ecologists contacted.

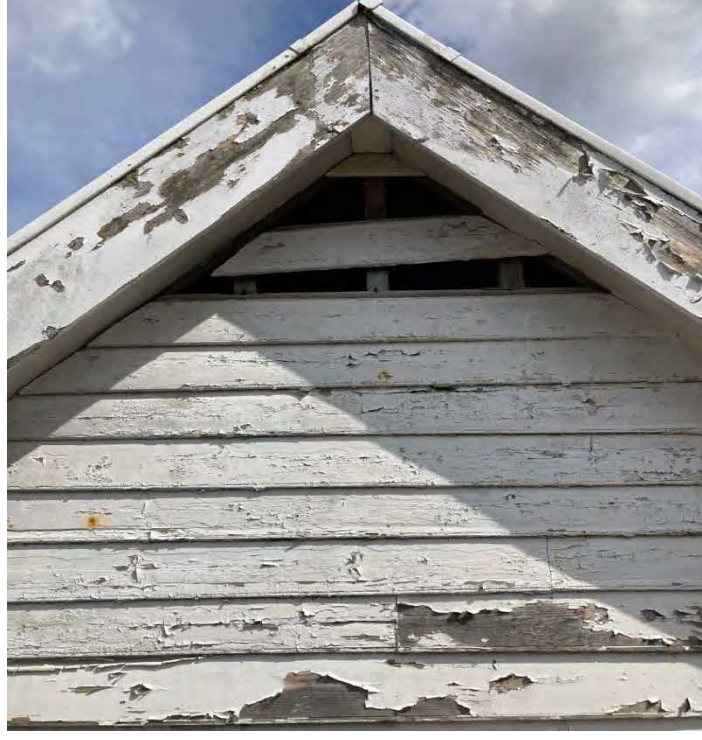
- 3.18 A small void was present above the hall. This could not be accessed internally, but as scaffolding was present, this void could be viewed from a small gap in the weatherboard on the southern aspect. However, when viewing, a section of the weatherboarding moved as was rotten allowing the internal void to be better viewed. Otherwise the void appeared to be well sealed from the external environment. No evidence of bats was recorded within the void, where viewing was possible. The void was cramped and narrow, no more than 0.5m in height and was considered to have limited suitability for void dwelling bats.

<p>Photograph 6: One of the boards moved during investigation of the void</p>

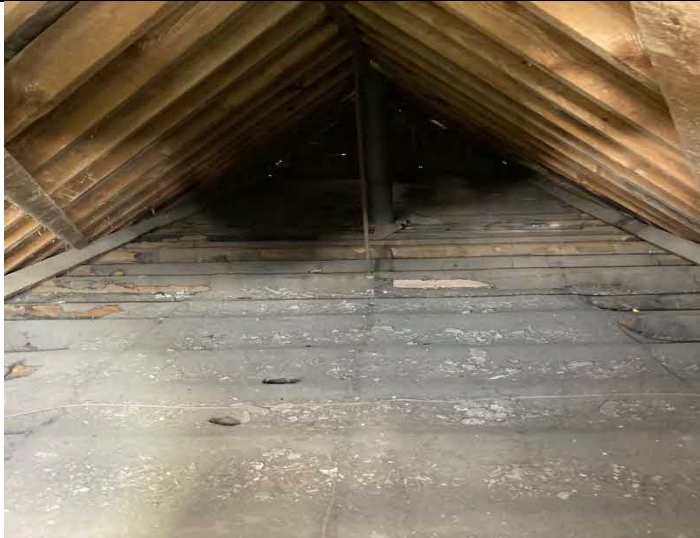
Photograph 7: View inside the void. Full entry into void was not possible. It was narrow and cramped. No evidence of bats where viewing was possible

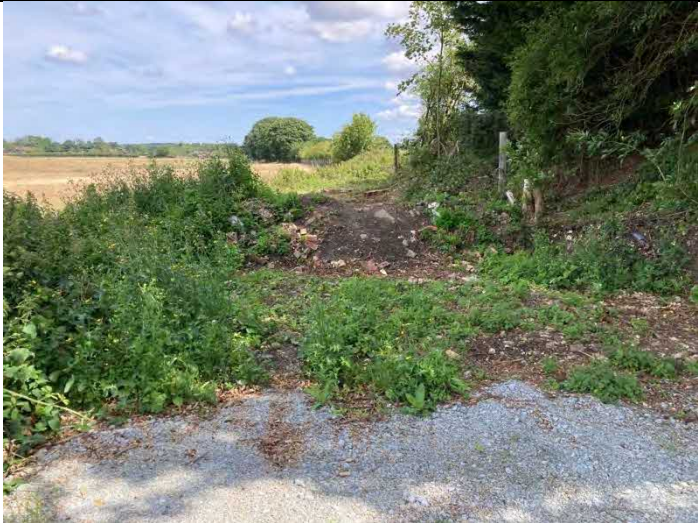
3.14 A section on the northern edge of the site supported a mixture of ruderal and scrub species, and showed signs of disturbance and tree removal. Species included bramble and common nettle, with scentless mayweed (*Tripleurospermum inodorum*), garlic mustard (*Alliaria petiolata*), cleavers (*Galium aparine*), hogweed (*Heracleum sphondylium*), sycamore saplings and creeping thistle.

Photograph 10: Northern ruderal area

4.22 Overall, the site is not considered to support a significant reptile population, however the ruderal and scrub edges, if cleared, must be cleared sensitively to allow any reptiles present to move to safer areas such as the site boundaries. As the boundaries are to be left untouched by the development they are considered to be a safe refuge for any reptiles present.

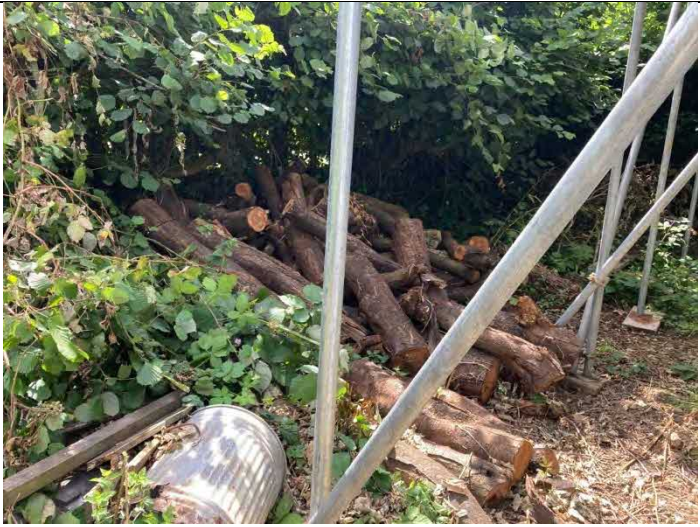
- 3.22 No bats were recorded emerging from the roof structure or hole in the weatherboarding.
- 3.23 The trees along the eastern tree line have some areas of ivy cover. However, the trees do not have the complex growth features which would be suitable for supporting roosting bats and therefore were considered to have 'negligible' potential to support roosting bats owing to their small stature and/or lack of suitable roosting features. The blackthorn along the western edge was not considered suitable for roosting bats and as such was considered to have 'negligible' potential to support roosting bats

Photograph 11: Northern tree line / hedgerow
