cornwall
environmental
consultants **LTD**

**Bat and Barn Owl Assessment
1 Coastguard Cottages
Treen
St. Levan
Penzance
TR19 6LQ**

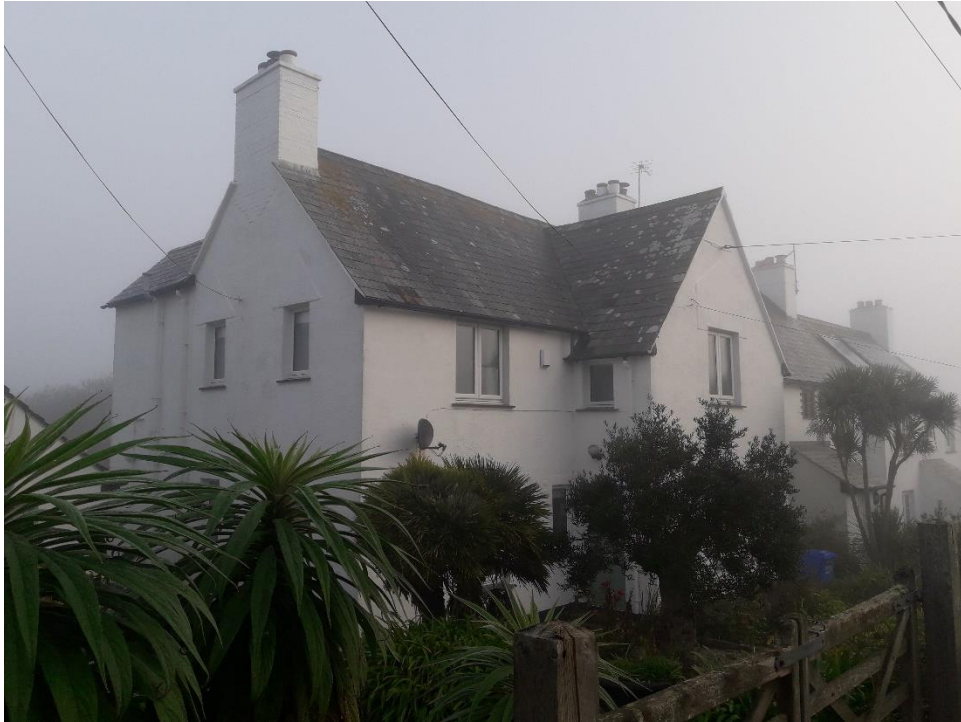
Figure 1. Property assessed.

The property assessed is an end terrace building and detached garage. The buildings are located in a rural location which are surrounded by cattle and sheep grazed pasture with a good network of hedgerows overlooking a well treed valley. These conditions will provide good foraging and roosting opportunities for bats and barn owls.

The main property is a two storied 'L' shaped end terrace building with a single storied extension and a detached garage. Both buildings are built from rendered stone, and concrete block with unlined slate roofs. The roof void of the main building was accessed by means of a roof ladder and searched for evidence of use by bats. The floor, walls and ridge of the building were inspected, and it was noted that there were small collections of droppings from use by long-eared bats on the floor of the void. A search around the outside of the building was then undertaken and it was noted that there are gaps within the ridge and fascia boards which would allow bats to gain access and exit the building. The garage building was then searched, and all areas inspected for evidence of use by bats.

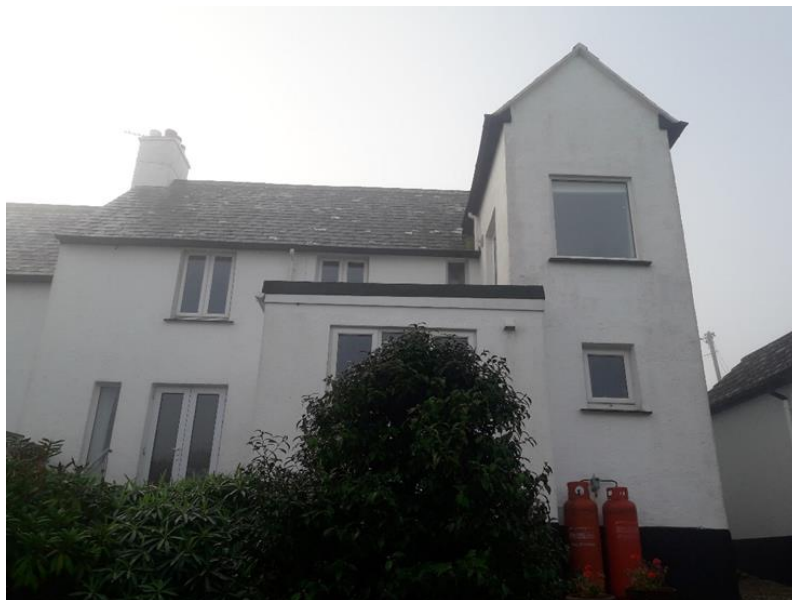
Figure 2. Northern elevation of property and garage.

The proposal includes the demolition of the garage and construction of a single storied building to 'wrap' around the northern and western elevation. The plans for the proposal have been consulted and the proposal will not impact on the roof or block access to the roof void being used by bats.

Although no current evidence of roosting bats was found within the garage building it cannot be assumed that bats are not present when works commence. Care should therefore be taken during the work as bats could roost unseen deep within crevices in the structure, particularly under ridge tiles, beneath wall plates, or between or above lintels. If any bats are discovered during the work, they must not be handled: works must stop immediately, and advice sought from CEC (tel 01872 245510).

If you wish to promote wildlife, it is possible to provide roosting opportunities for bats within the completed building. Access for bats can be provided into the roof space (or into the space beneath the roofing slates if the development is to have vaulted ceilings) by leaving small gaps 15-20mm wide by at least 50mm long in suitable places. Suitable places would include behind soffits, fascia and barge boards or at the gable apex. The access points would need to be next

Alternatively bat bricks can be built into the walls of the building. These should be located as high as possible and away from any external lighting. These are widely available from a number of sources. Bat bricks are available from websites such as Wildcare (<https://www.wildcare.co.uk/wildlife-nest-boxes/bat-boxes/wall-mounted.html>) or NHBS (<https://www.nhbs.com/equipment>).
