cornwall  
environmental  
consultants LTD

Bat and Nesting Bird Assessment  
31 Fernhill Road  
Newquay  
TR7 1LE

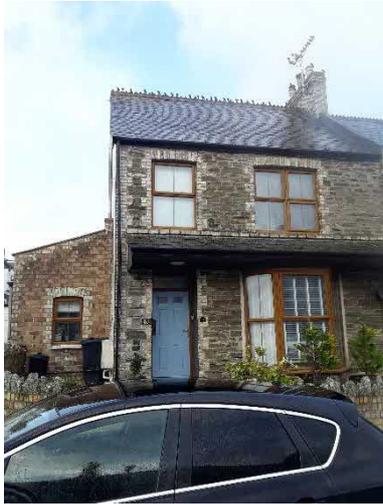
The building is a two-storey end-terrace dwelling house with stone walls and a pitched roof of slates which are not underlined. It has false ceilings with an enclosed roof void c. 3m high (Figures 1 & 2).

The roof void was accessed and the floor, roof and stored items were searched. Externally there were no gaps behind the fascia boards along the east and west sides where bats would be able to gain access into the roof, nor behind the bargeboard on the south gable. The ridge and roof slates were in good condition with no gaps suitable for access by bats. No bats or evidence of bats was found at the time of the survey.

Figure 1 East side of the building

Although no current evidence of roosting bats was found it cannot be assumed that bats are not present when works commence. Care should therefore be taken during the work as bats could roost unseen deep within crevices in the structure, particularly under ridge tiles or beneath wall plates. If any bats are discovered during the work they must not be handled: works must stop immediately and advice sought from CEC (tel 01872 245510).

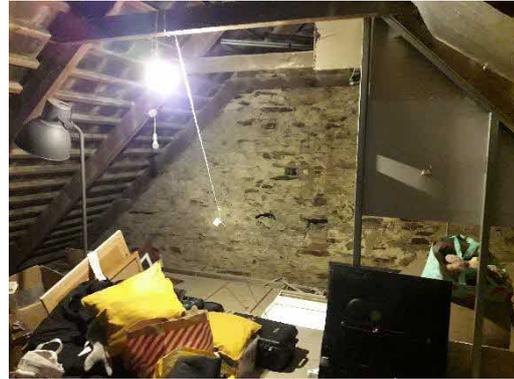
Figure 2 Roof void
