Existing Living/Kitchen Architrave Detail (1:1)

Proposed Living/Kitchen Architrave Detail (1:1)

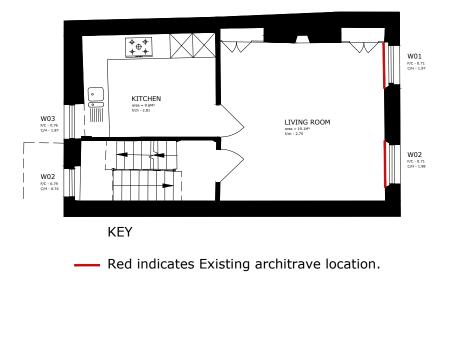
Note: Profile taken from First Floor Living room Window Architrave. No Architrave currently present to the Kitchen window.

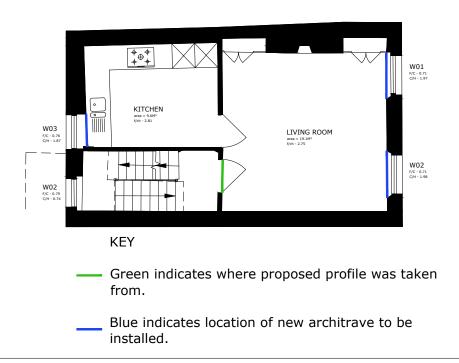
Note: Detail is a profile match of the original architrave within the Living Room/Kitchen which is to be retained. New architrave to be installed to Living room and Kitchen windows only.
