Report prepared for: [Redacted]

For the Site of: Cheynes Farm, Warren Lane, Cottered, Herts, SG9 9QD

Emergence and Activity Bat Survey (EBS)

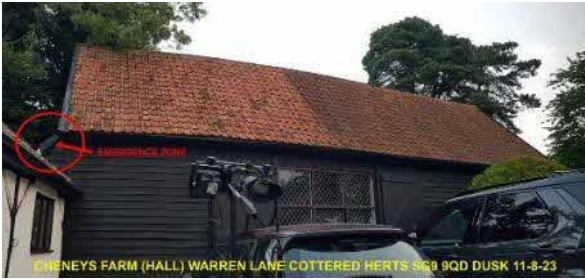
SS: 20:34 Dusk	Distant passes from 20:50 to 21:56.
EV	B3	10/08/2023 20:19 to 22:05 SS: 20:34 Dusk	Common pipistrelle: Distant passes from 21:10 to 21:52.
DR	B2	10/08/2023 20:19 to 22:05 SS: 20:34 Dusk	Common pipistrelle: Distant passes from 21:11 to 21:38.
PH	B4	11/08/2023 20:19 to 22:00 SR: 20:33 Dusk	Common pipistrelle: Three emergences from the eastern corner of B4 from the shiplap at 20:46 and 20:51. One emergence from the guttering on the eastern corner at 20:54 on B4.

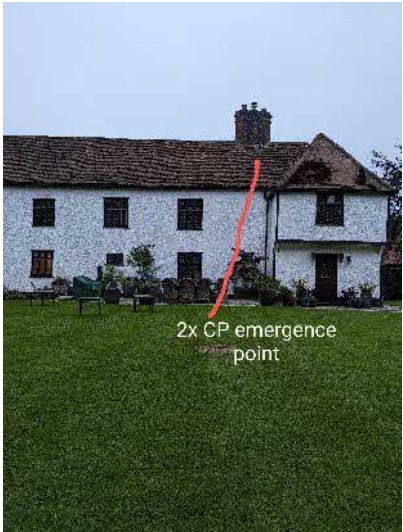
Figure 3: emergences at 20:30.

Dusk	
JW	B1	<p>18/08/2023 20:03 to 21:50 SR: 20:20 dusk</p>	<p>Common pipistrelle:</p> <p>Two emergences from the tiles near the chimney stack on the southern elevation to the rear of the building at 20:30.</p> <p>Two additional emergences from the tiles near the chimney stack on the north-western elevation at 20:53.</p>

<p>2x CP emergence point</p>

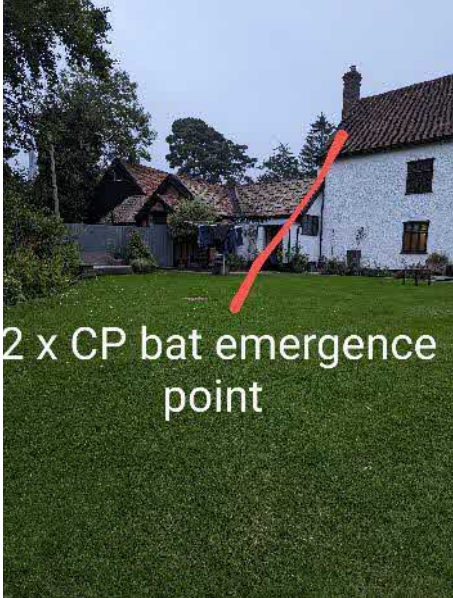
<p>2 x CP bat emergence point</p>
			<p>Figure 4: emergence at 20:53</p> <p>Passes along the rear garden from 20:23 to 20:47.</p>
ZH	B6	<p>18/08/2023</p> <p>20:03 to 21:50</p> <p>SR: 20:20</p> <p>dusk</p>	<p>Common pipistrelle:</p> <p>Distant passes from 20:33 to 21:19.</p>
PH	B6	<p>18/08/2023</p> <p>20:03 to 21:50</p> <p>SR: 20:20</p> <p>dusk</p>	<p>Common pipistrelle:</p> <p>Feeding activity along the ridge of the barns from 20:29 to 21:12.</p>
ES	B1	<p>18/08/2023</p> <p>20:03 to 21:50</p> <p>SR: 20:20</p> <p>dusk</p>	<p>Common pipistrelle:</p> <p>Passes along the ridge of B1 from 20:52 to 21:24.</p>
CS	B1	<p>19:20 to 21:10</p> <p>SR: 19:46</p>	<p>Common pipistrelle:</p> <p>Passes within the front drive from 20:09 to 20:41.</p>
EM	B1	<p>19:20 to 21:10</p> <p>SR: 19:46</p>	<p>Common pipistrelle:</p> <p>Passes within the rear garden from 20:09 to 20:45.</p>

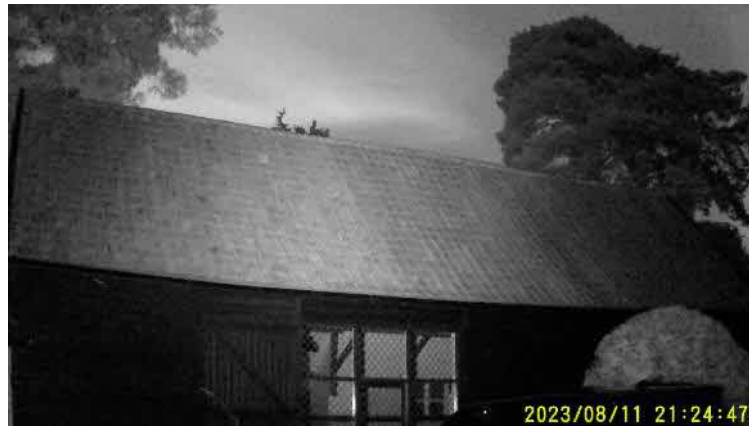
Figure 5: IR still 11/08/2023 (B4)

11/08/2023 - three emergences out of B4. General activity recorded.

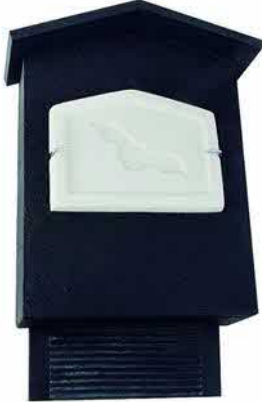
</div> <p>Figure 8: Chillon Woodstone Bat Box (British-made)</p> <p>A minimum of two Chillon Woodstone bat boxes will be hung on the trees or the building at a minimum of 3m from ground level and face south/southwesterly. These boxes are known to be used by Brown Long-Eared bats (BLEB) and crevice-dwelling species.</p> <p>No further mitigation or compensation is required under this licence. Commuting bats were using the grounds and surrounds; therefore, any tree, hedges or linear feature should be retained if possible.</p>
