Cheynes Farm, Cottered, Herts

Ecology Report

Prepared for: [REDACTED]
Title: Cheynes Farm, Cottered, Herts – Ecology Report
Project number: AEL2111
Document version: 3.0
Document status: Final
Document date: 21 September 2023

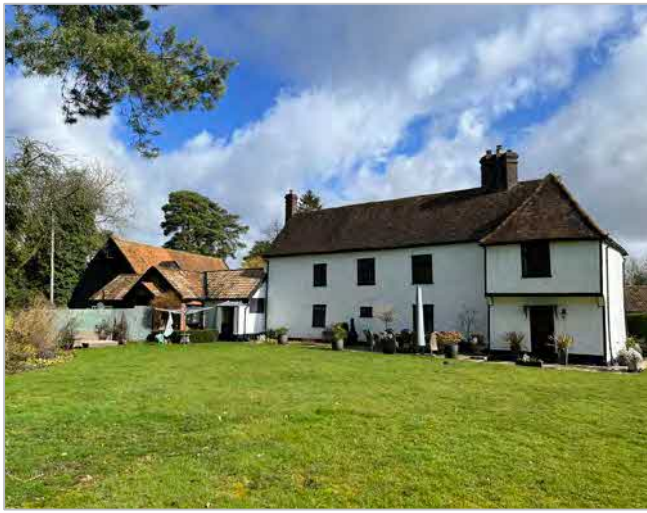
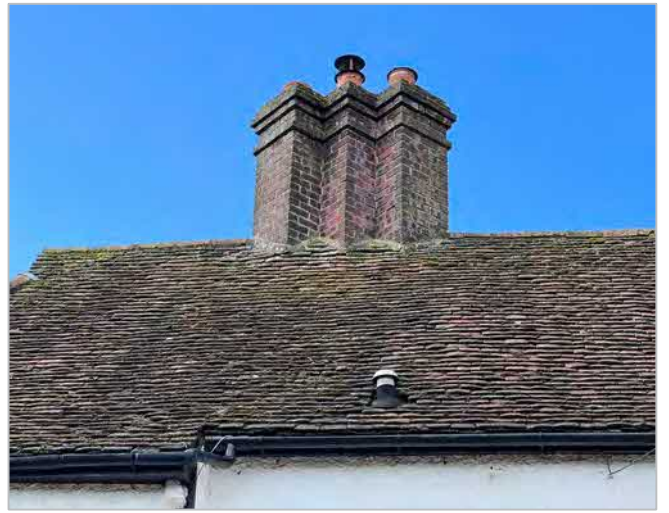
- 3.1 The farmhouse was an historic brick building with rendered painted external walls and a pitched clay peg-tiled roof with a north facing gable end with a central brick chimney. The southern end of the building had a hipped roof section. The building was oriented along an approximate north-south long-axis with the main roof with east and west facing roof pitches and the southern hipped roof section supporting north, south east and west facing pitches. A large enclosed and dark roof void ran the entire length of the building with a floor to ridge height in excess of 2.5 m.

- 3.2 No evidence of bats was obviously present on the exterior of the building, but a number of potential bat roost features were noted around the exterior of the building as follows:

- soffit gaps;
 - verge gaps;
 - gaps below ridge tiles;
 - gaps below lifted lead flashing; and
 - numerous gaps below bowed or lifted roof tiles
- 3.3 Several thousand bat droppings of a size and form consistent with those produced by brown long-eared bats were present on the floor of the loft below the ridge line. The droppings were widely along the entire length of the floor with three separate large accumulations.

- 3.4 The farmhouse is a building of high bat roost suitability i.e. it is a building with a number of potential bat roost sites that appears to support a significant bat roost.

Photo 1 - Farmhouse

Photo 2 - Farmhouse

- 4.4 In this instance, the minimum number of recommended surveys to prove bat absence for each building are as follows:
- Farmhouse – three surveys;
 - Farmhouse kitchen – one survey;

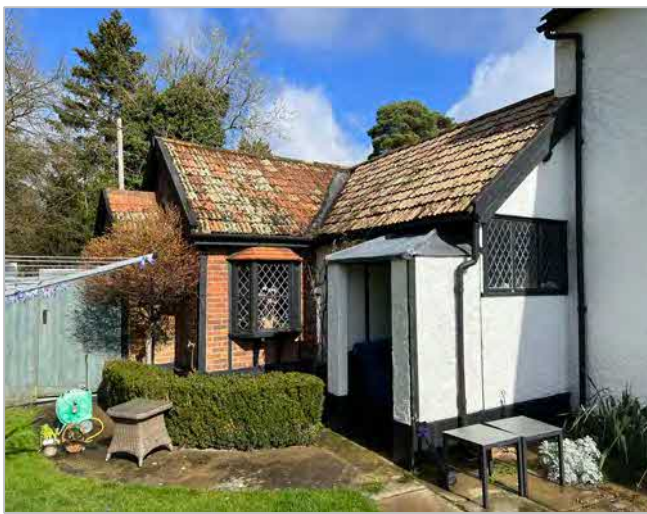
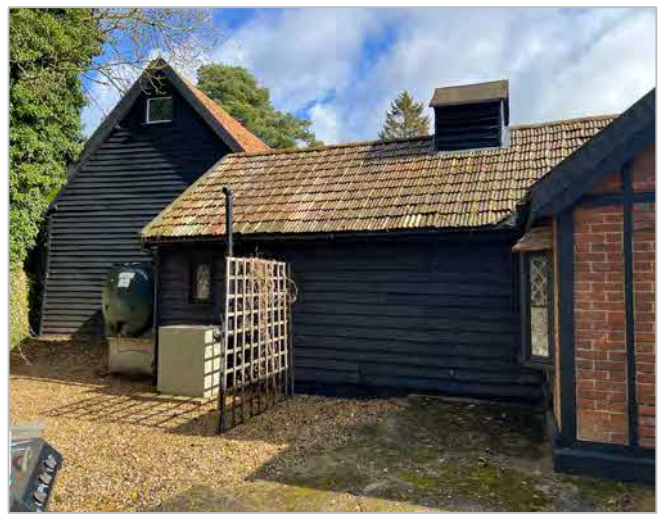
- 3.5 The farmhouse kitchen was a single storey building that adjoined the northern end of the farmhouse. It was of brick construction with mainly painted rendered walls. It had a pitched gable ended roof covered in clay pantiles with a central west projecting gable ended wing.
- 3.6 The building did a vaulted ceiling with no roof void.
- 3.7 No evidence of bats was present on the exterior of the building, but it did possess a small number of potential bat roost feature as follows:
- Gaps between uneven and lifted pantiles;
 - Eave gaps.
- 3.8 The farmhouse kitchen is a building of low bat roost suitability i.e. it is a building with a small number of potential bat roost sites that is unlikely to support a significant bat roost.

Photo 3 - Farmhouse Kitchen

Photo 4 - Farmhouse Kitchen

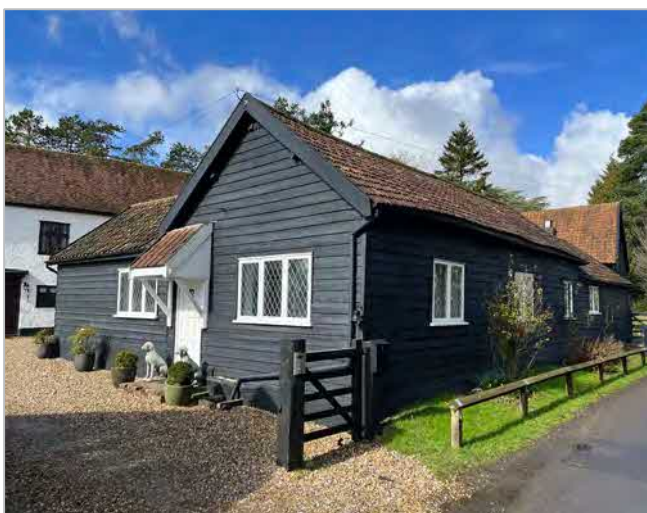
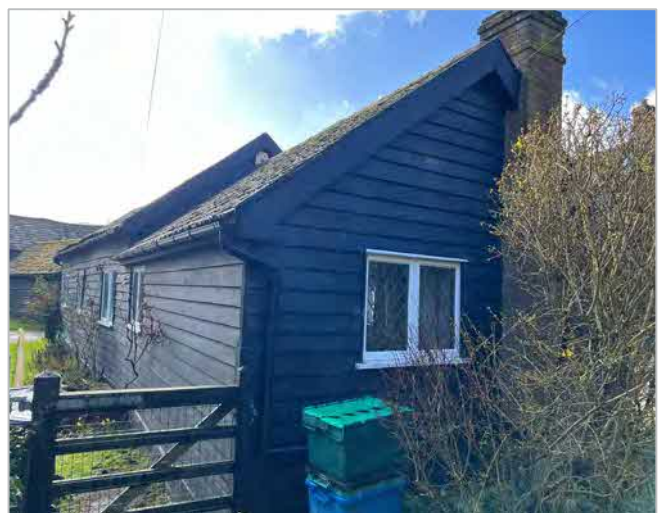
- 3.9 The cottage appeared to a former timber framed barn that had been converted into a single storey dwelling with three adjoining pitched clay pantile covered roofs and black painted timber weather boarded external walls.

- 3.10 The building had three gable ends facing north, south and west.
- 3.11 The weatherboards on the external walls were all well-fitted with no obvious bows or gaps between them.

- 3.12 There was no obvious evidence of bats on the outside of the building.
- 3.13 A small number of potential bat roost features were noted as follows:

- Eave gaps;
 - Gap below a lifted lead flashing around the chimney base; and
 - Gaps between individual clay pantiles.
- 3.14 A precautionary bat roost suitability assessment is that the farmhouse is a building of low bat roost suitability i.e. it is a building with a small number of potential bat roost sites that is unlikely to support a significant bat roost.

Photo 5 - Cottage

Photo 6 - Cottage

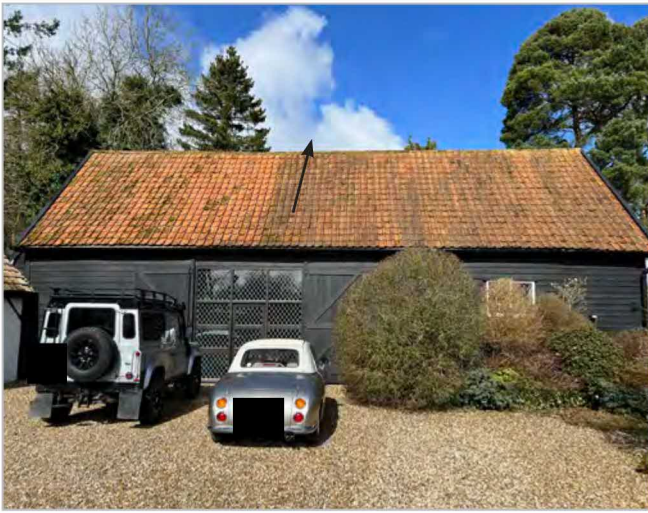
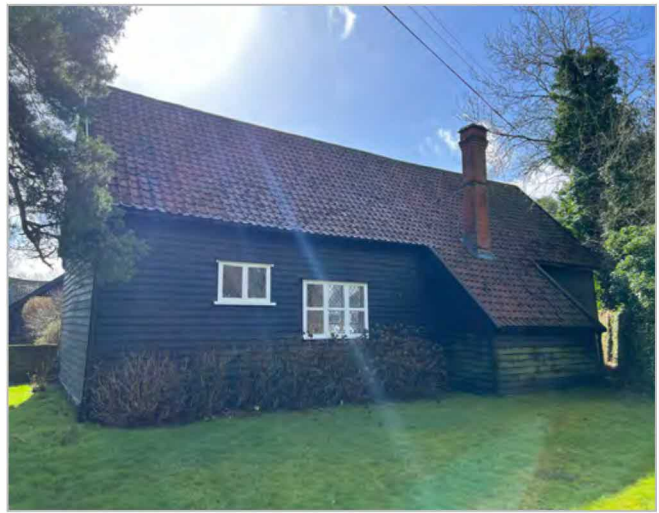
- 3.15 The Hall was an historic timber framed barn that had been converted to habitable space. It was two storey building with a pitched gable ended roof covered in clay pantiles oriented along an east-west long axis with north and south facing roof faces.
- 3.16 The external walls were clad in black painted timber well-fitted weatherboards. Internally the building had a vaulted ceiling.
- 3.17 There was no evidence of bats on the exterior of the building.
- 3.18 A small number of potential bat roost features were noted on the exterior of the building as follows:
- Soffit gaps;
 - Gaps between individual clay pantiles.
- 3.19 A precautionary bat roost suitability assessment is that the farmhouse is a building of low bat roost suitability i.e. it is a building with a small number of potential bat roost sites that is unlikely to support a significant bat roost.

Photo 7 - Hall

Photo 8 - Hall

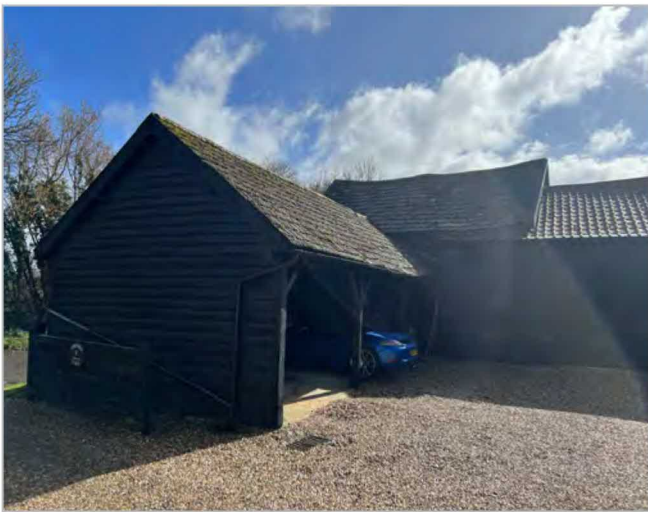
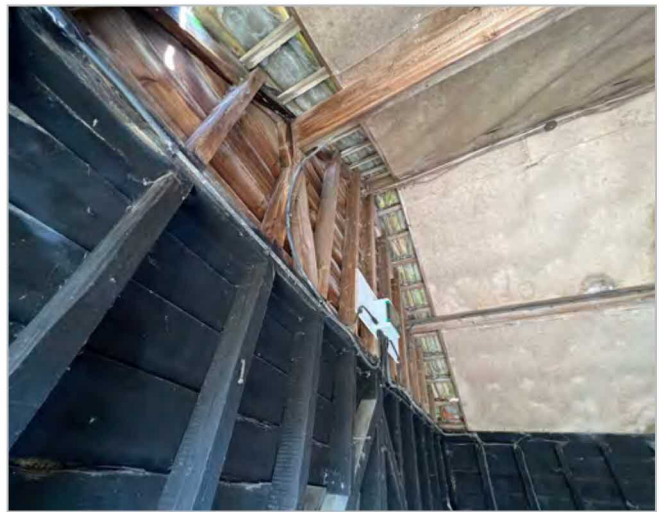
- 3.20 The cart lodge was a three bay building oriented along a north-south long axis with its southern end attached to the adjoining storage barn, and its northern gable end and east facing external wall clad in black painted timber weatherboards. The pitched roof was clad in clay pantiles and was partly lined with ply board. The roof was in a poor state of repair and leaked rainwater.

- 3.21 No evidence of bats was present on the outside of the building or on internal building surfaces or the concrete floor.
- 3.22 Gaps were present under pantiles.
- 3.23 The building was considered to be of low bat roost suitability.

Photo 9 - Cart Lodge

Photo 10 - Cart Lodge

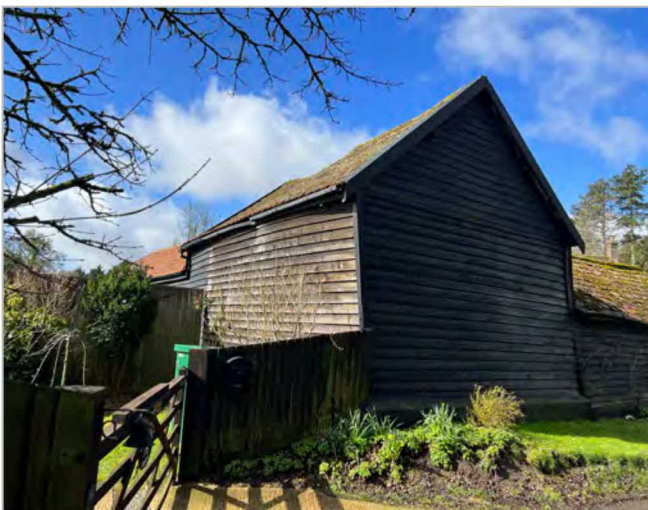
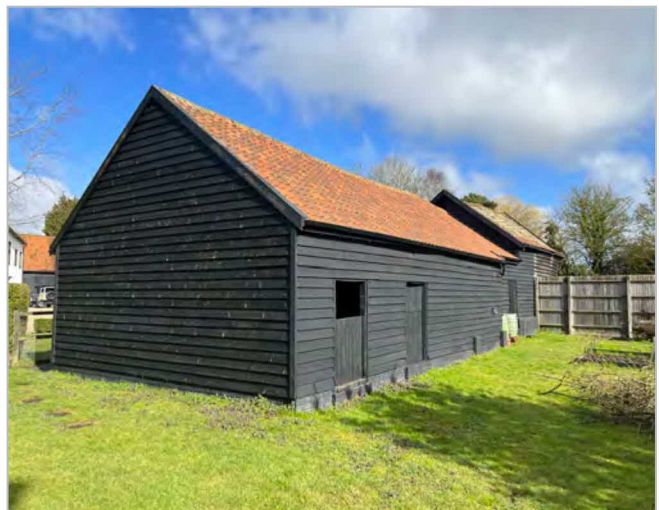
- 3.24 The storage barns comprised three adjoining timber framed barns oriented along an east-west long-axis. It was built on brick plinths and possessed concrete floors, pitched pantile covered roofs and black painted weatherboard covered walls. The two western barns appeared to have been subject to relatively recent renovation and repair with modern wall and roof timbers evident inside the barn, and a pantile roof covering over a modern breather membrane and open eaves.

- 3.25 A total of 15 small tortoiseshell butterfly wings were present in scattered locations across the floors of the three barns along with five brown long-eared bat *Plecotus auritus* type droppings on the floor of the western most barn, indicating night roosting and possible day roosting inside the barns by an individual bat.

- 3.26 A small number of potential bat roost features were noted on the exterior of the building as follows:
 - Eave gaps about the eastern gable end;
 - Gaps between individual clay pantiles.

- 3.27 In overall terms the barns were assessed as a group of buildings with moderate bat roost suitability.

Photo 11 - Storage Barns

Photo 12 - Storage Barns

- Cottage – one survey;
 - Hall - one survey;
 - Cart Lodge – one survey
 - Storage Barns – two surveys.
- 4.5 If, after completing the above minimum surveys, bats are confirmed to be roosting, an additional verification survey of that building may be deemed necessary to confirm the nature, type and number of bats using each building. In the case of the storage barns, it is considered unlikely that more than two surveys will be required.
