CARTLODGE, WORKSHOP AND STABLES OVERVIEW

PROJECT TITLE
**Cheynes Farm, Warren Lane,
 Coterred, Herts, SG9 9QD**

DRAWING TITLE
Proposed Barns Roof Plan (A3)

DRAWING No.
2222/PD/344

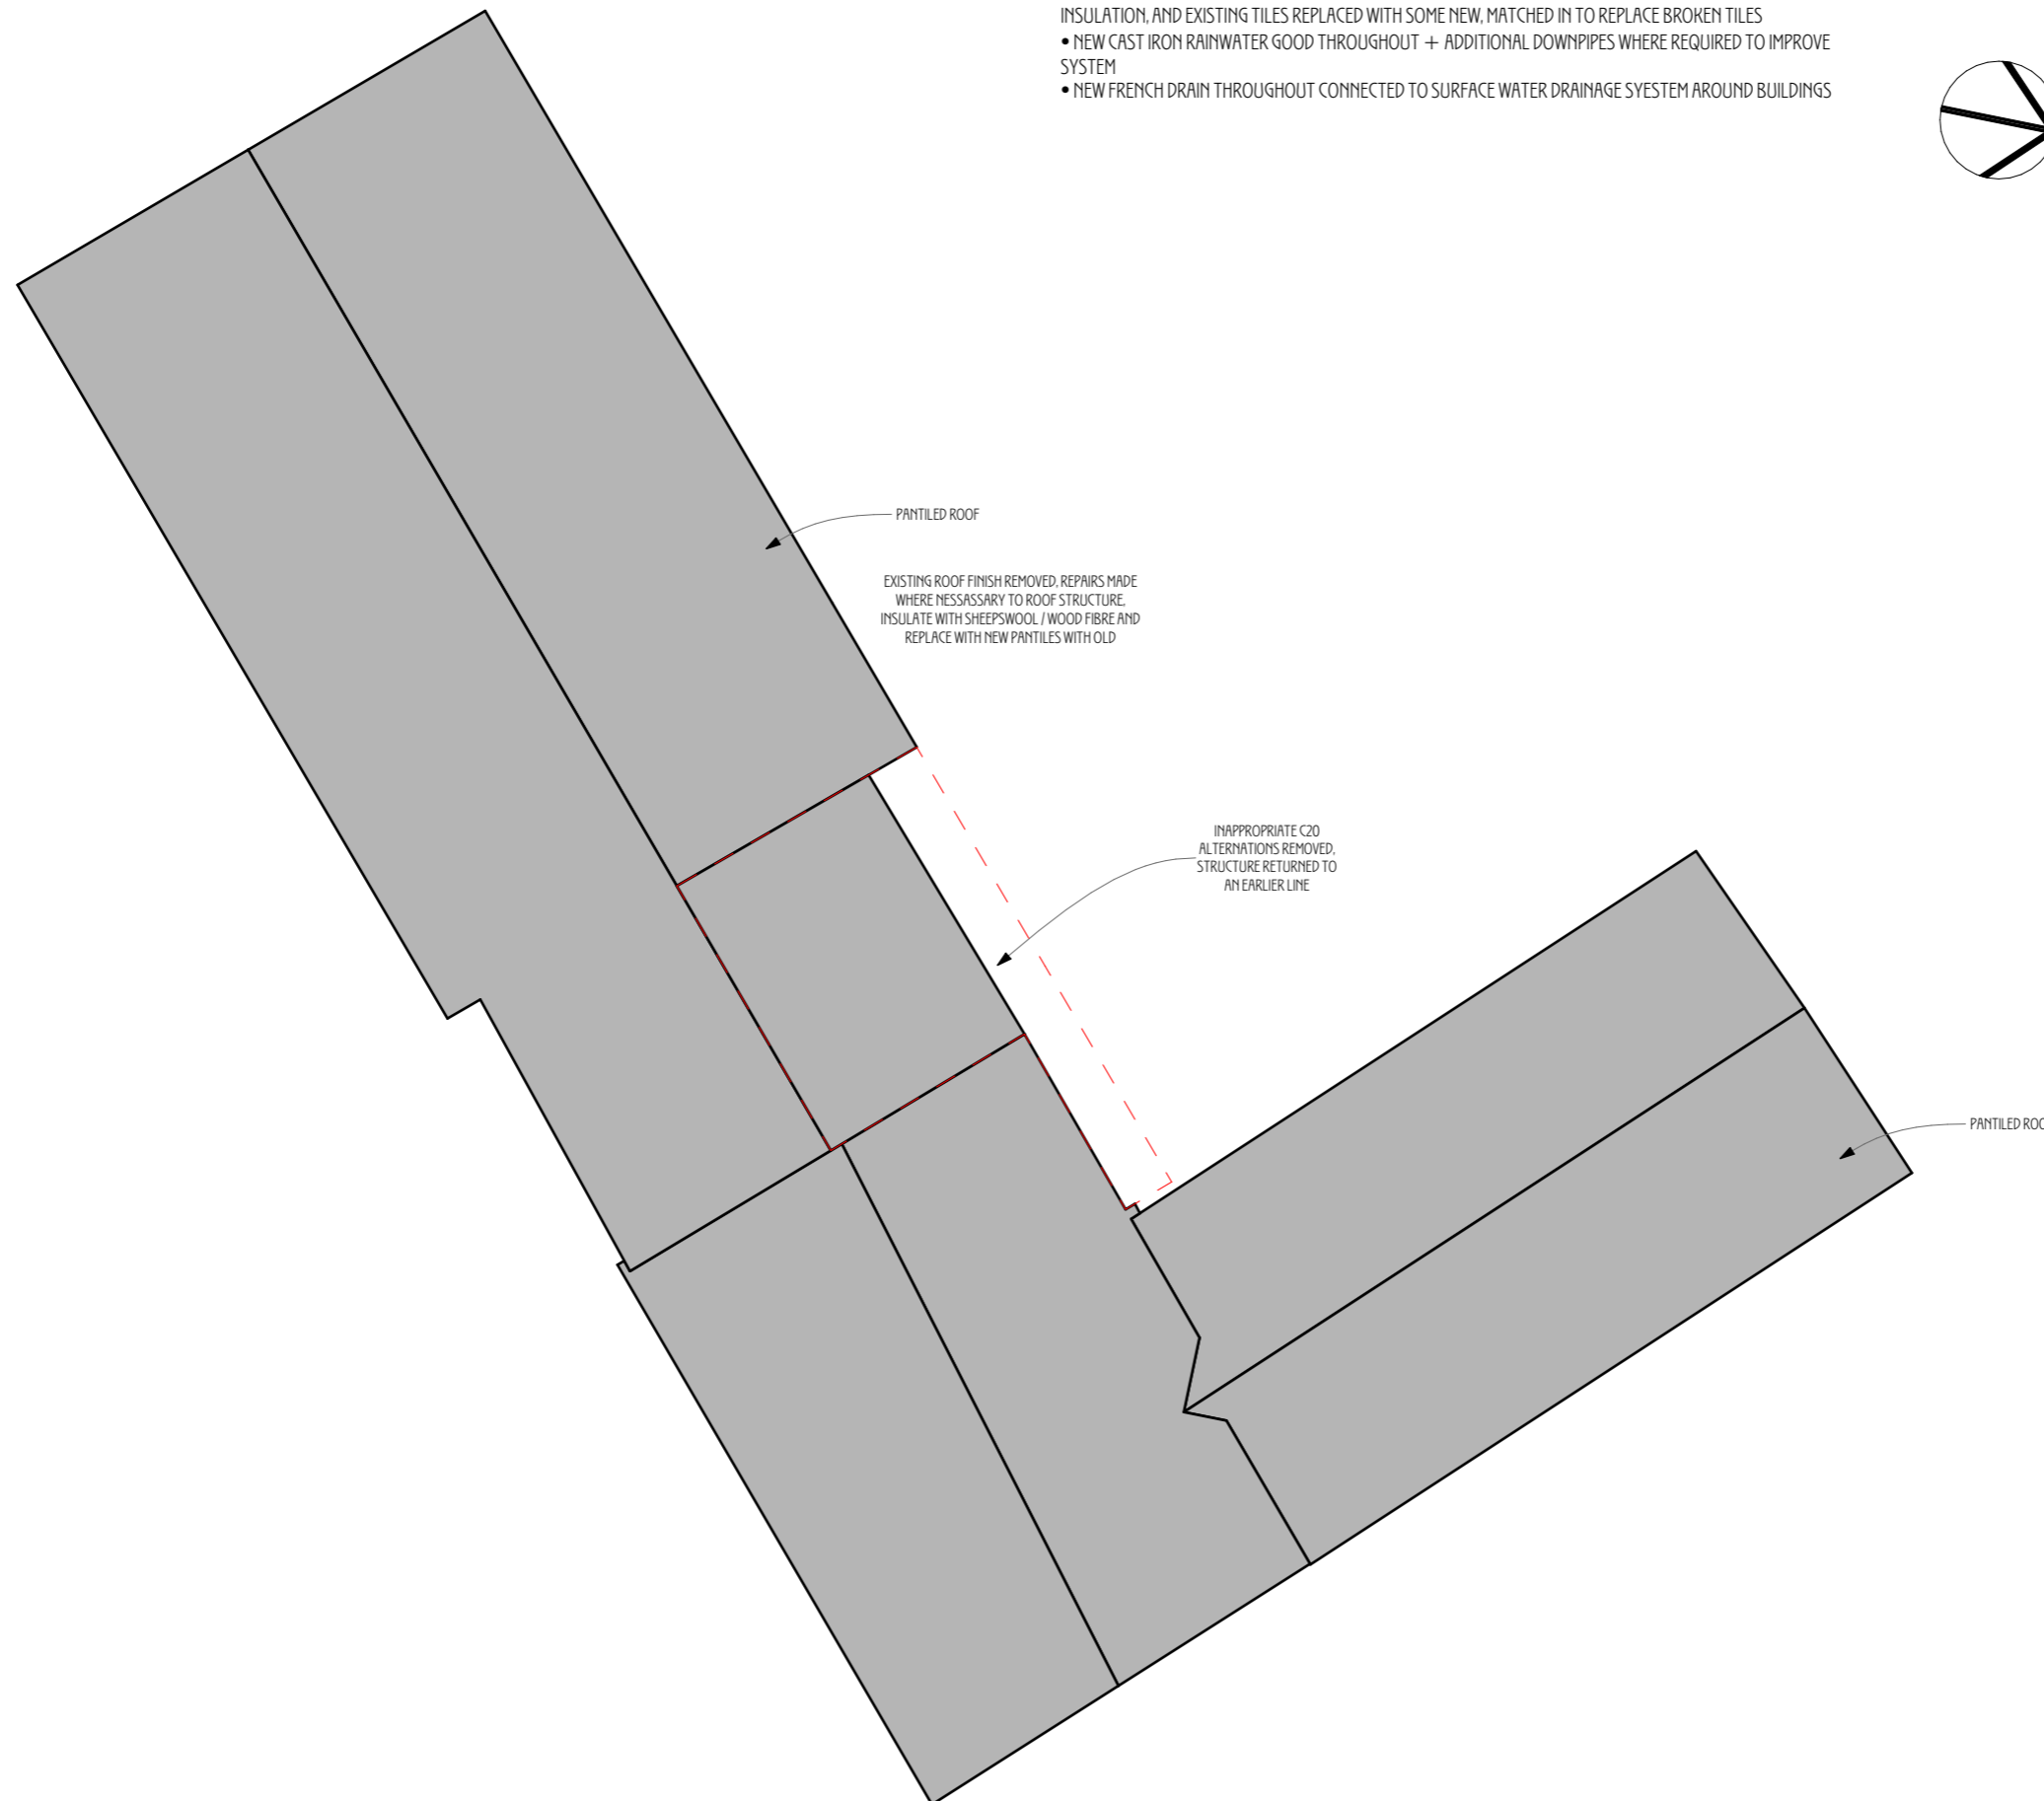
- STABLE BARN 3, 4 AND 5 REBUILT INTO GYM, SHOWER ROOM AND MEZZANINE ABOVE
- EXISTING BARN 1 & 2 FRAME STRUCTURALLY ASSESSED AND MAKE STRUCTURAL INTERVENTIONS TO REINSTATE LOST / INAPPROPRIATE PAST ALTERATIONS. TRADITIONAL SPLICE / SCARF JOINTS AND SENSITIVE REPAIR METHODS.
- EXISTING ROOF PEG & ROOF TILES TO TBE REMOVED. ROOFS INSULATED WITH SHEEPSWOOL OR WOOD FIBRE INSULATION, AND EXISTING TILES REPLACED WITH SOME NEW, MATCHED IN TO REPLACE BROKEN TILES
- NEW CAST IRON RAINWATER GOOD THROUGHOUT + ADDITIONAL DOWNPIPES WHERE REQUIRED TO IMPROVE SYSTEM
- NEW FRENCH DRAIN THROUGHOUT CONNECTED TO SURFACE WATER DRAINAGE SYSTEM AROUND BUILDINGS
