Caroline Suite, Stonehouse Court Hotel, Stonehouse

Bat Preliminary Roost Assessment Report

On behalf of Crocker House Ltd

Project Code: JM2023027Av1

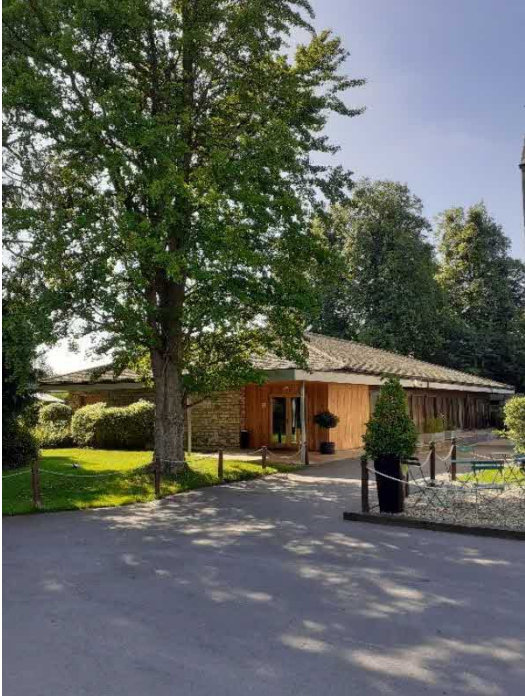
| No | Photo | Description |
|---|---|---|
| 1 | | North and west elevation of the Caroline Suite, viewed from the driveway of Stonehouse Court Hotel. |

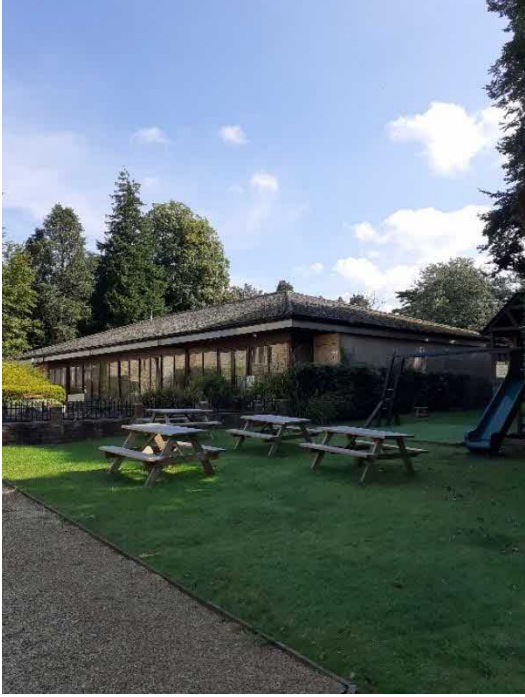
| No | Photo | Description |
|---|---|---|
| 2 | | South and east elevations of the Caroline Suite, with surrounding garden visible to the fore. |

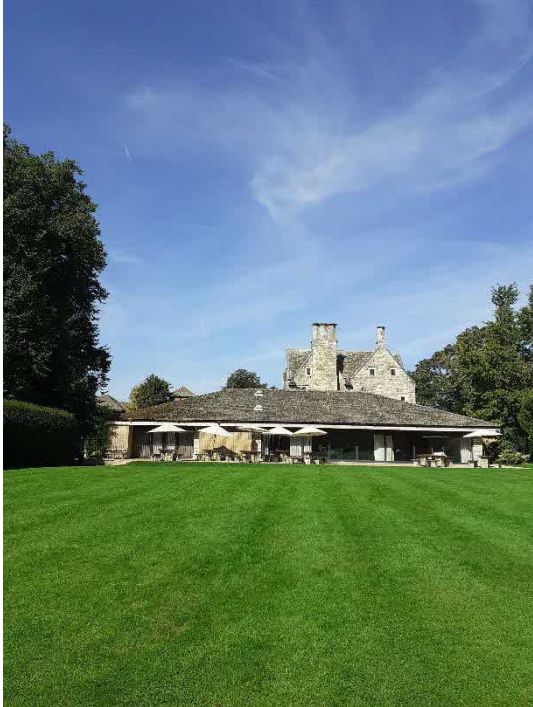
| No | Photo | Description |
|---|---|---|
| 3 | A wide-angle photograph showing the east elevation of the Caroline Suite, a large stone building with a gabled roof and two chimneys. The building is situated behind a vast, well-maintained green lawn. The sky is clear blue with a few wispy clouds. Trees are visible in the background. | East elevation of the Caroline Suite and amenity grassland. |

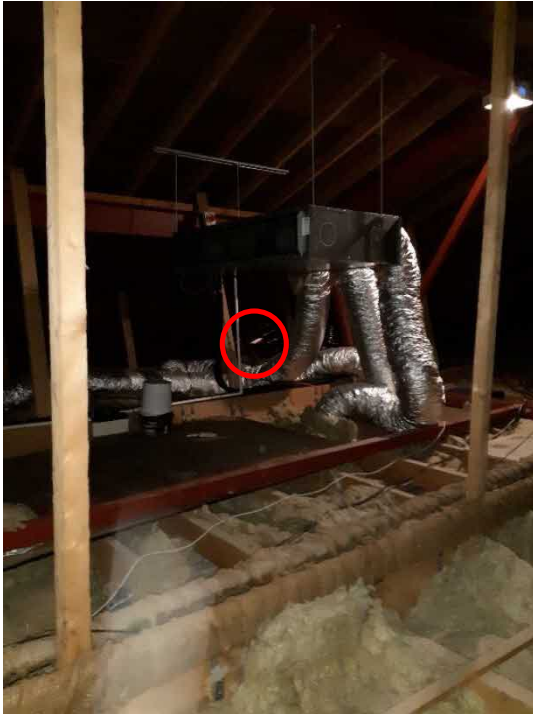
| No | Photo | Description |
|---|---|---|
| 4 | An interior photograph of the loft space. The room is dimly lit, with a bright light source on the right. The ceiling consists of wooden rafters. Large, flexible ducts wrapped in silver insulation are visible, running across the floor. A red circle highlights a small opening or hole in the insulation or ductwork. The floor is covered with wooden joists and some debris. | Internal loft of Caroline Suite, with daylight visible on the east elevation of the roof, near the location of vents. |

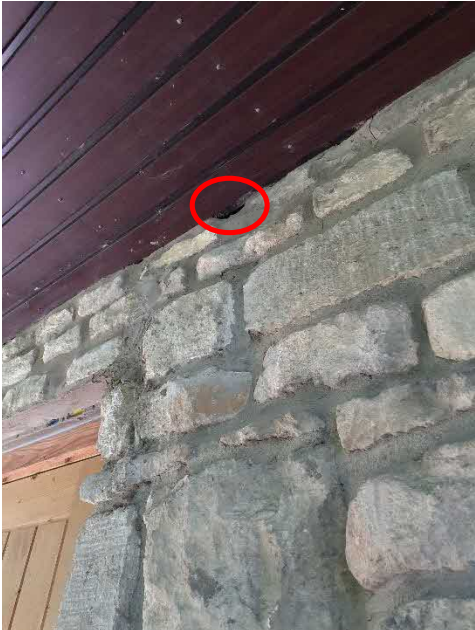
| No | Photo | Description |
|---|--|---|
| 6 | A close-up photograph of a stone wall. The wall is made of large, irregular grey stones. Above the wall, there are dark brown wooden eaves. A red circle highlights a small gap between the top of the stone wall and the bottom of the wooden eaves. | Gap between north elevation wall and wooden eaves (potentially leading to internal loft space). |

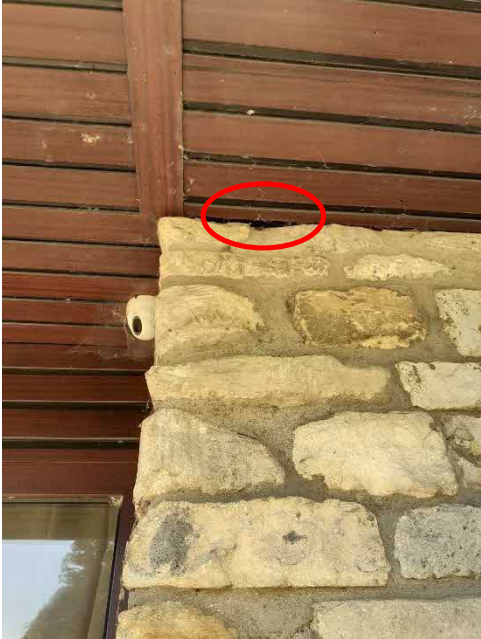
| No | Photo | Description |
|---|--|--|
| 7 | | One of several gaps between east elevation wall and wooden eaves (potentially leading to internal loft space). |

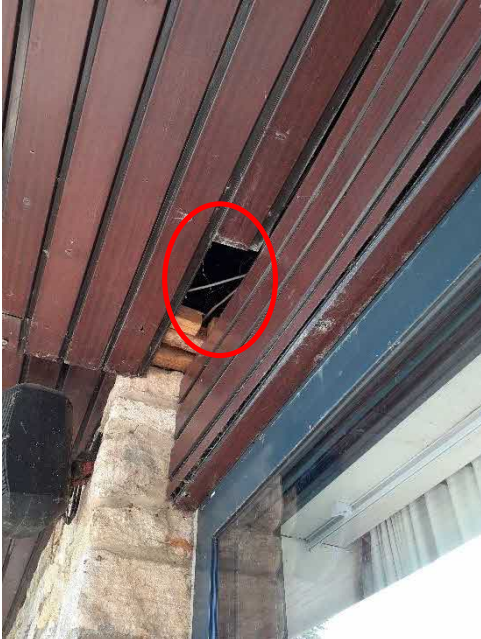
| No | Photo | Description |
|---|--|--|
| 8 | | Broken wooden panel on east elevation roof. |

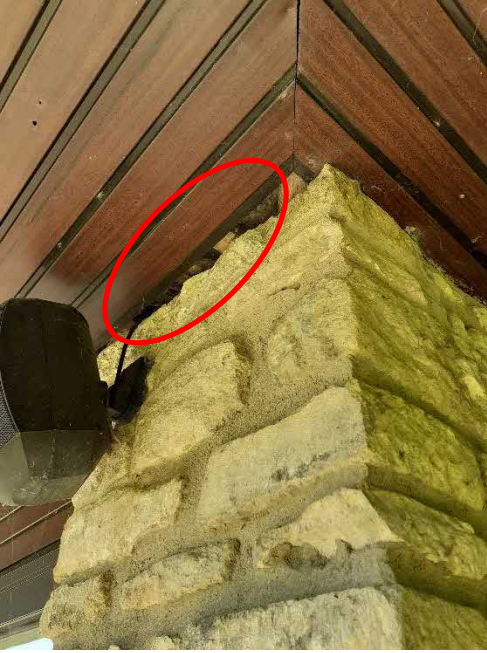
| No | Photo | Description |
|---|--|---|
| 9 | A close-up photograph of the corner of a stone wall. The wall is constructed from large, light-colored stone blocks. Above the wall, there are wooden eaves. A red circle highlights a gap between the top of the stone wall and the wooden eaves. | <p>Gaps between east elevation wall and wooden eaves (potentially leading to internal loft space) located near north-east corner of roof.</p> |

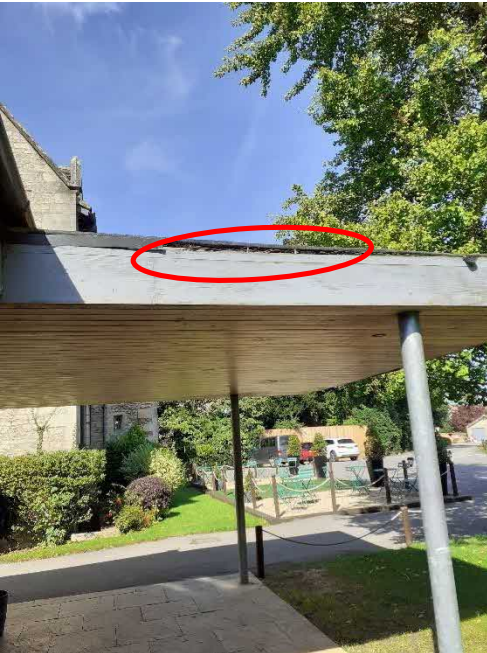
| No | Photo | Description |
|---|--|---|
| 10 | A photograph of a flat roof area. The roof is covered in grey felt. A red circle highlights a section of the roof where the felt appears to be torn or missing. The roof is supported by a wooden overhang and a metal pole. In the background, there are trees and a building. | <p>Torn roof felt above flat roof on north elevation of building. Unlikely to be a potential roost feature for bats.</p> |

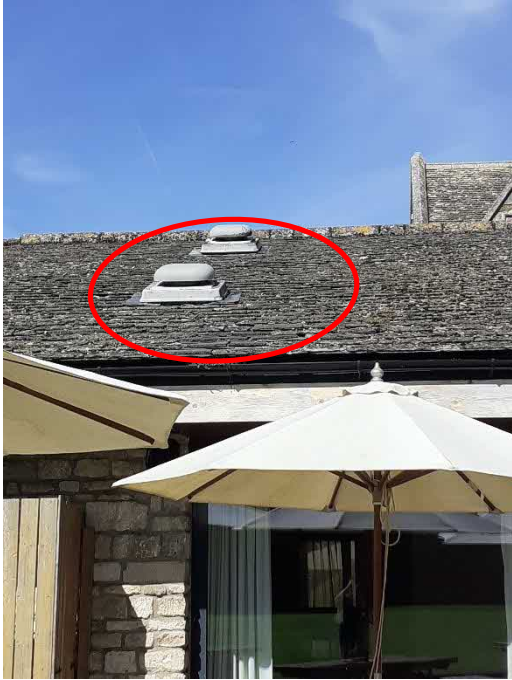
| No | Photo | Description |
|---|---|--|
| 11 | | <p>Gaps under roof tiles and lead flashing were visible near the roof vents on the east elevation roof (daylight was visible in the internal loft space in this approximate location).</p> |

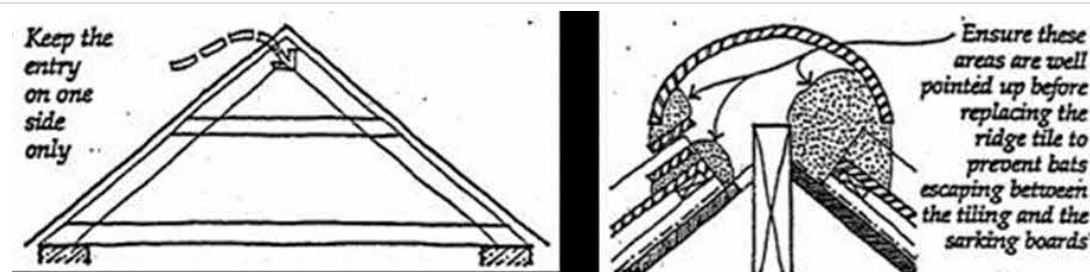
Diagrammatic view of ridge tile and cross section through ridge tile showing access point (taken from Scottish Natural Heritage 1996). Bitumastic lining must be used near/on the ridge beam to ensure bats can only have contact with this type of membrane to avoid any possible entanglement with a breathable membrane.
