Our ref: SW23/0016/AML1

### **Gables Cottage, Churchill –Bat Survey**

### Gables Cottage, Churchill – Addendum Information

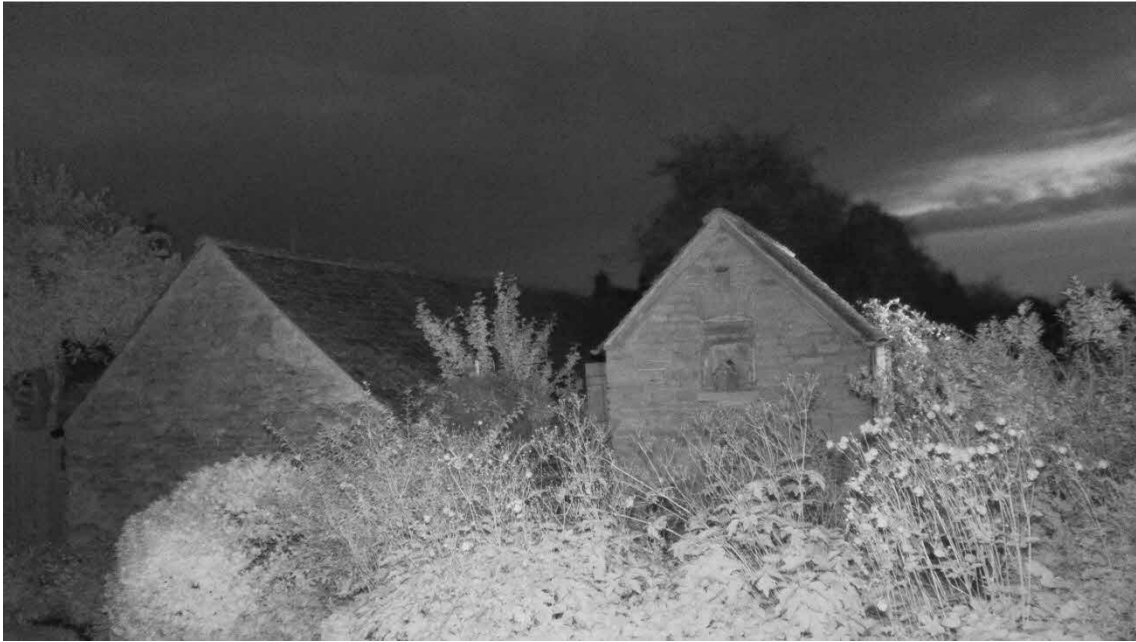
Photo 1

mode was also used. This was paired with an Anabat scout detector and two IR floodlights directed at the buildings. The field of view for the camera is shown on Photo 1. The buildings could not be monitored from the south and west due to them abutting the boundary of the property.

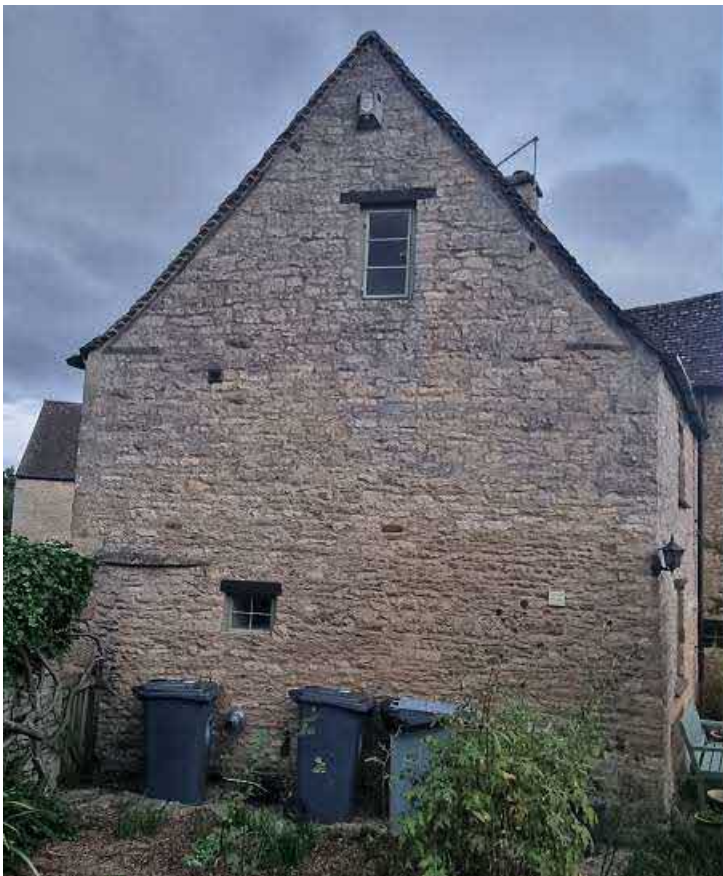
Photo 2

The proposed location for the extension to Gables Cottage is shown on Photo 2. It has no potential to support roosting bats and no evidence of bats was found.

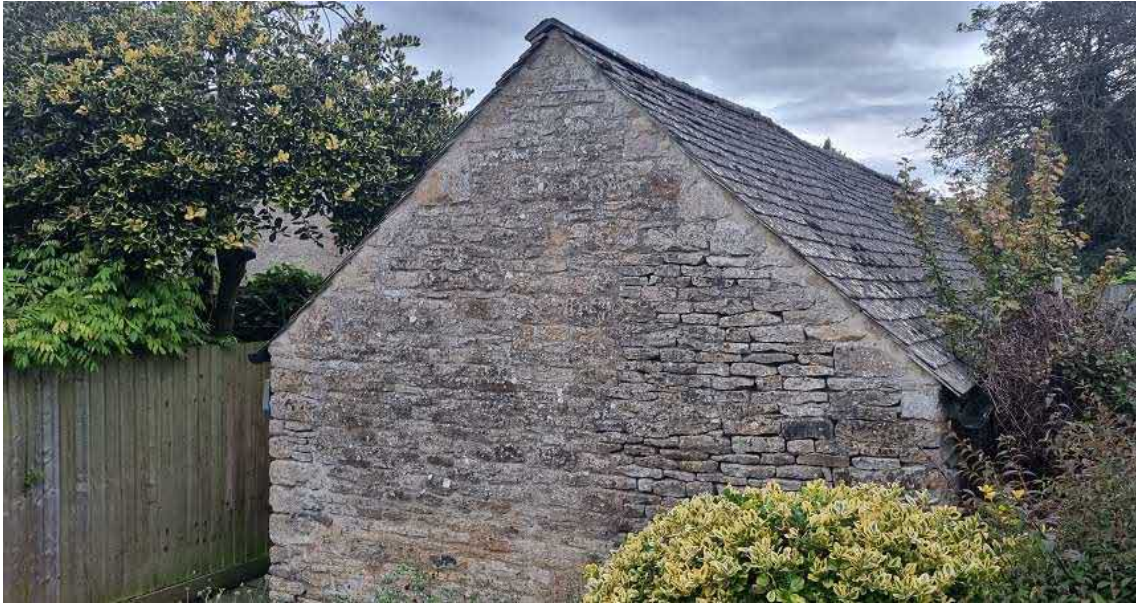
Photo 3

The two outbuildings both have brick exterior walls and old, possibly natural, slate tiles on the roof. They were both assessed to have medium roosting potential. The larger building (Building 1, Figure 1. See also Photo 3) is part of a longer structure that extends out of the site and into the adjacent property. That part surveyed is internally divided into two rooms. Both rooms were noted to be open to the roof and therefore lacked a contained roof void. The roof tiles were noted to be lined with traditional F1 type bitumen roofing felt. Within the smaller room there was a heavy buildup of cobwebs along the internal ridge beam indicating there a lack of recent activity in this area and no evidence of bats was found in this part of the building. By contrast, the interior of the larger room was noted to be largely free of cobwebs and a single long-eared bat was seen located between a rafter and the ridge beam (see Photo 4). A search of the floor below the bat found 3-4 droppings and a sample of these was collected for DNA analysis to confirm which long-eared species was seen.

**Confirmation of the presence of a long-eared bat roosting in Building 1 means that the above provisions apply and a derogation licence issued by Natural England must be obtained before any work can be carried out to this building that could infringe the above protection. The presence of a single bat and relatively small number of droppings in Building 1 would indicate that it is a non-maternity day roost. In accordance with Table 3.2 of the**

In order to reduce the regulatory burden for developments that affect a low value roost of this type, Natural England operate a specific licence known as the Low Impact Class Licence for bats. This operates to allow development affecting a low value roost, to be licenced using a more streamlined and faster process. This in turn reduces delays and costs for the development. Sam Watson Ecology is registered with Natural England to operate under the Low Impact Class Licence for bats, registration ref: RC102. Under this licence there is flexibility over the provision of compensatory roosting provision and the installation of a bat box on a tree or building would meet the requirements of the low impact class licence. The Schwegler 1FF bat box is known to be used by long-eared bats and would therefore be suitable in this instance.

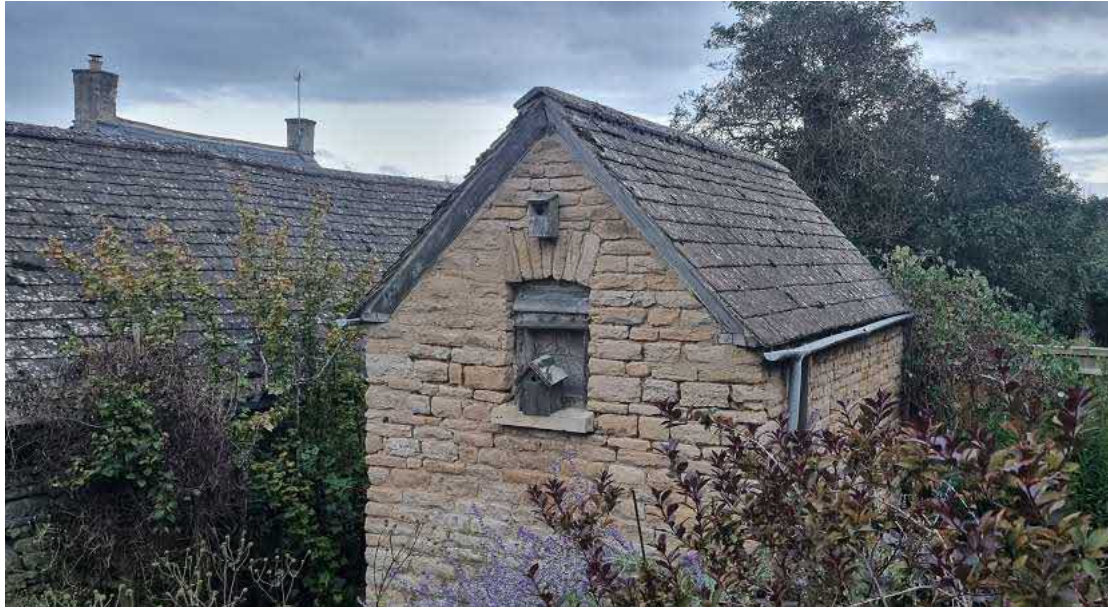
Photo 5

The other outbuilding (Building 2, Figure 1. See also Photo 5) is of a similar construction internally, although the internal walls do not go above the eaves, meaning the roof is open along the length of building. A small number of small mammal droppings were found at the western end of this building, together with 3-4 yellow underwing moth wings. This would suggest the presence of a night feeding perch, but the droppings were not clearly identifiable as being produced by a bat, so a sample of these was also collected for DNA analysis. The results of analysis of both dropping samples will be provided once available.

The other dropping sample, obtained from Building 2, has been identified as lesser horseshoe *Rhinolophus hipposideros*. The small accumulation of droppings found in this building together with a few moth wings would suggest it is most likely used as a night feeding roost or possibly infrequently as a day roost. No bats of this species were detected during the dusk survey or seen in Building 2. Table 3.1 of the updated UK Bat Mitigation Guidelines<sup>1</sup> indicates that this species is rare or has a restricted distribution in south-west England. Based on Table 3.2 a feeding perch or non-breeding day roost of such a species is of value at the 'site' level, falling short of 'local' value on the basis that the evidence would indicate that it is used infrequently and by no more than an individual bat.

As the roost in Building 2 cannot be retained as part of the proposal, compensation in the form of an alternative roost is to be provided. The design is shown on the attached drawing provided by Woodfield Brady Architects. In order to meet the roosting requirements of lesser horseshoe bats, an enclosed void will be created in the garage (location shown on Figure 1) by 'boxing in' the western half of the roof above eave height. The building has a clear span truss design (see Photo 1) and so would provide an open and uncluttered roost location. An access 250x500mm in size will be created in the gable to allow free flight access into the void for lesser horseshoe bats. The roof lining in the garage is plastic and so there is no entanglement risk, but a location for a lesser horseshoe bat to hang will in any event be provided in the form of a piece of roughened board (e.g. ply) attached at the underside of the rafters.
