**Heritage Assessment for 1-4 The Barracks,
Bransbury, Hampshire, SO21 3QJ**

October 2021

NON-TECHNICAL SUMMARY

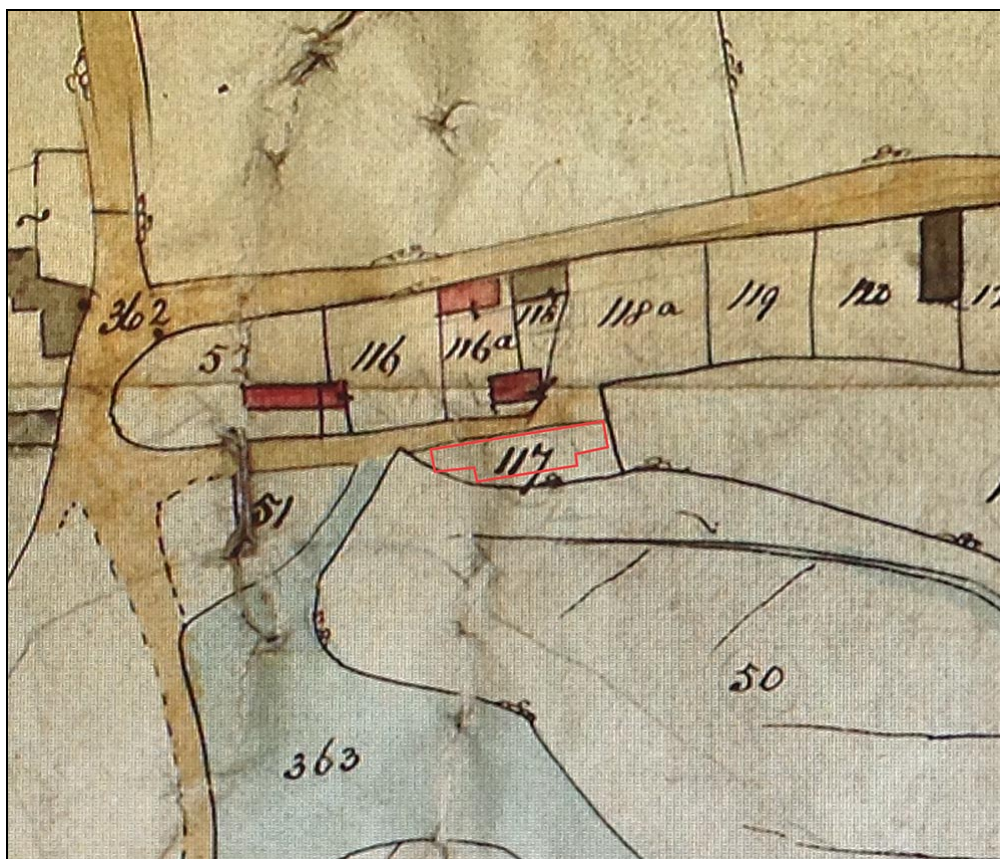
Figure 3 Extract from the Barton Stacey Tithe map of 1840 (HRO No.CD/340), the site of the Barracks is outlined in red

2. The Barton Stacey tithe map of 1840 does not show the Barracks, but the empty plot within which it will later sit is owned, according to the Apportionment, by the Dean & Chapter of the Cathedral of Winchester and the executors of William Courtney (the tenant farmer of Bransbury manor), and is described as a "garden" (HRO No.CD/340). A plan of the manor of Bransbury dated 5th December 1845 (HRO No.DC/J14/9/1) still does not show the Barracks, with the land remaining in the hands of the Dean and Chapter of Winchester. Again a map of Bransbury Manor Farm, Barton Stacey, in the ownership of the Dean and Chapter, dated 1857, marks no building within the plot (HRO No.11M59/WDC/E2/6275). The last account book of the Dean & Chapter held by the Hampshire Record Office to mention Bransbury is one dated to 1861 (HRO No. DC/C5/160), which indicates that the manor was still owned by them at this date.

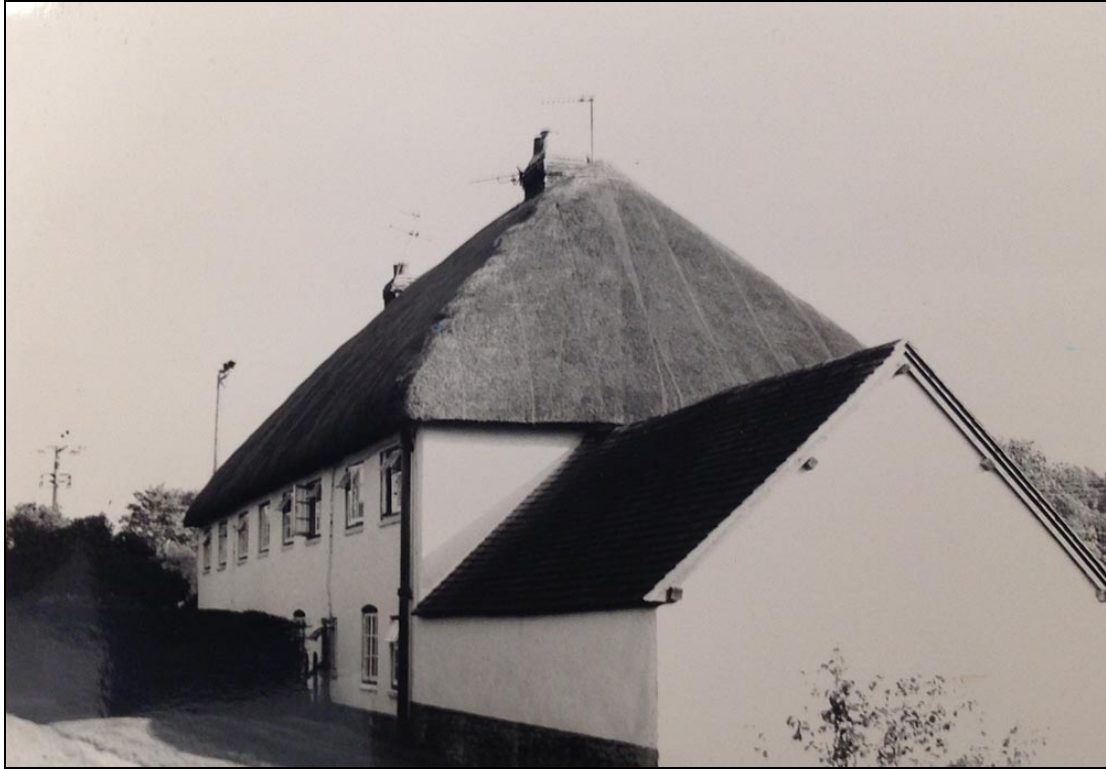
3. A photograph of 1983 shows the north elevation of the cottages as they were then, described on the rear as a “part thatched, part tiled building” (HRO No.126M90/23/4).

Figure 8 Photograph of the north elevation of the Barracks taken in 1983 (HRO No.126M90/23/4)

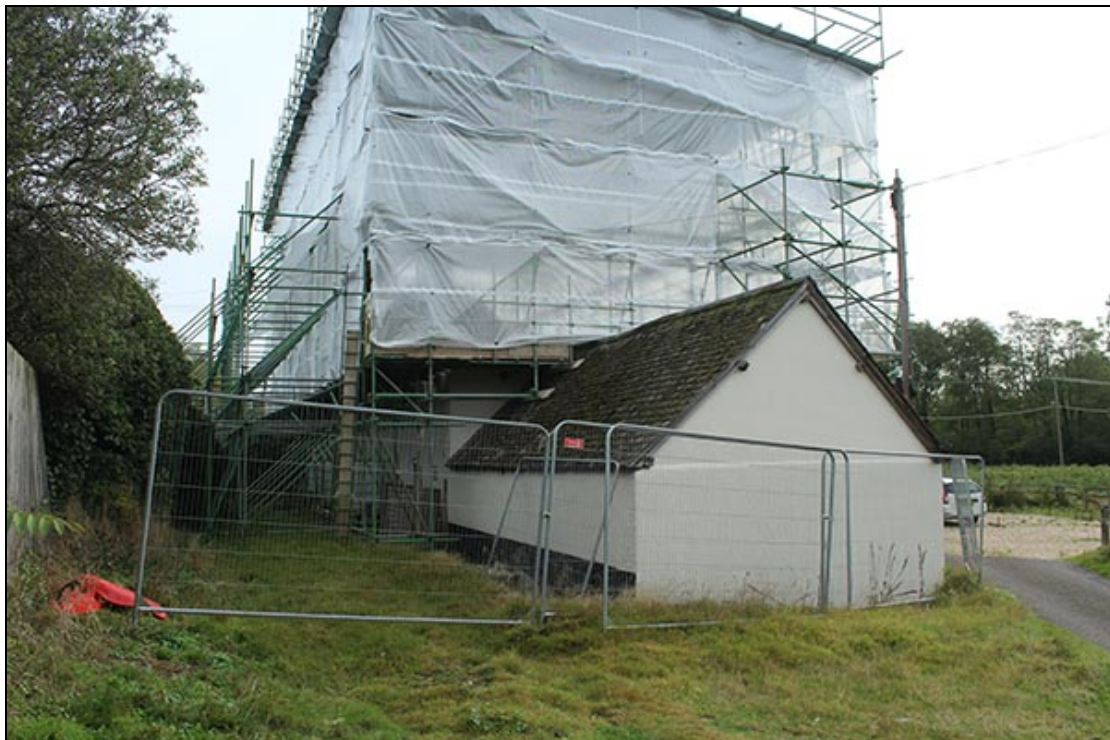
Figure 9 The same view taken during the site visit on 11th October 2021

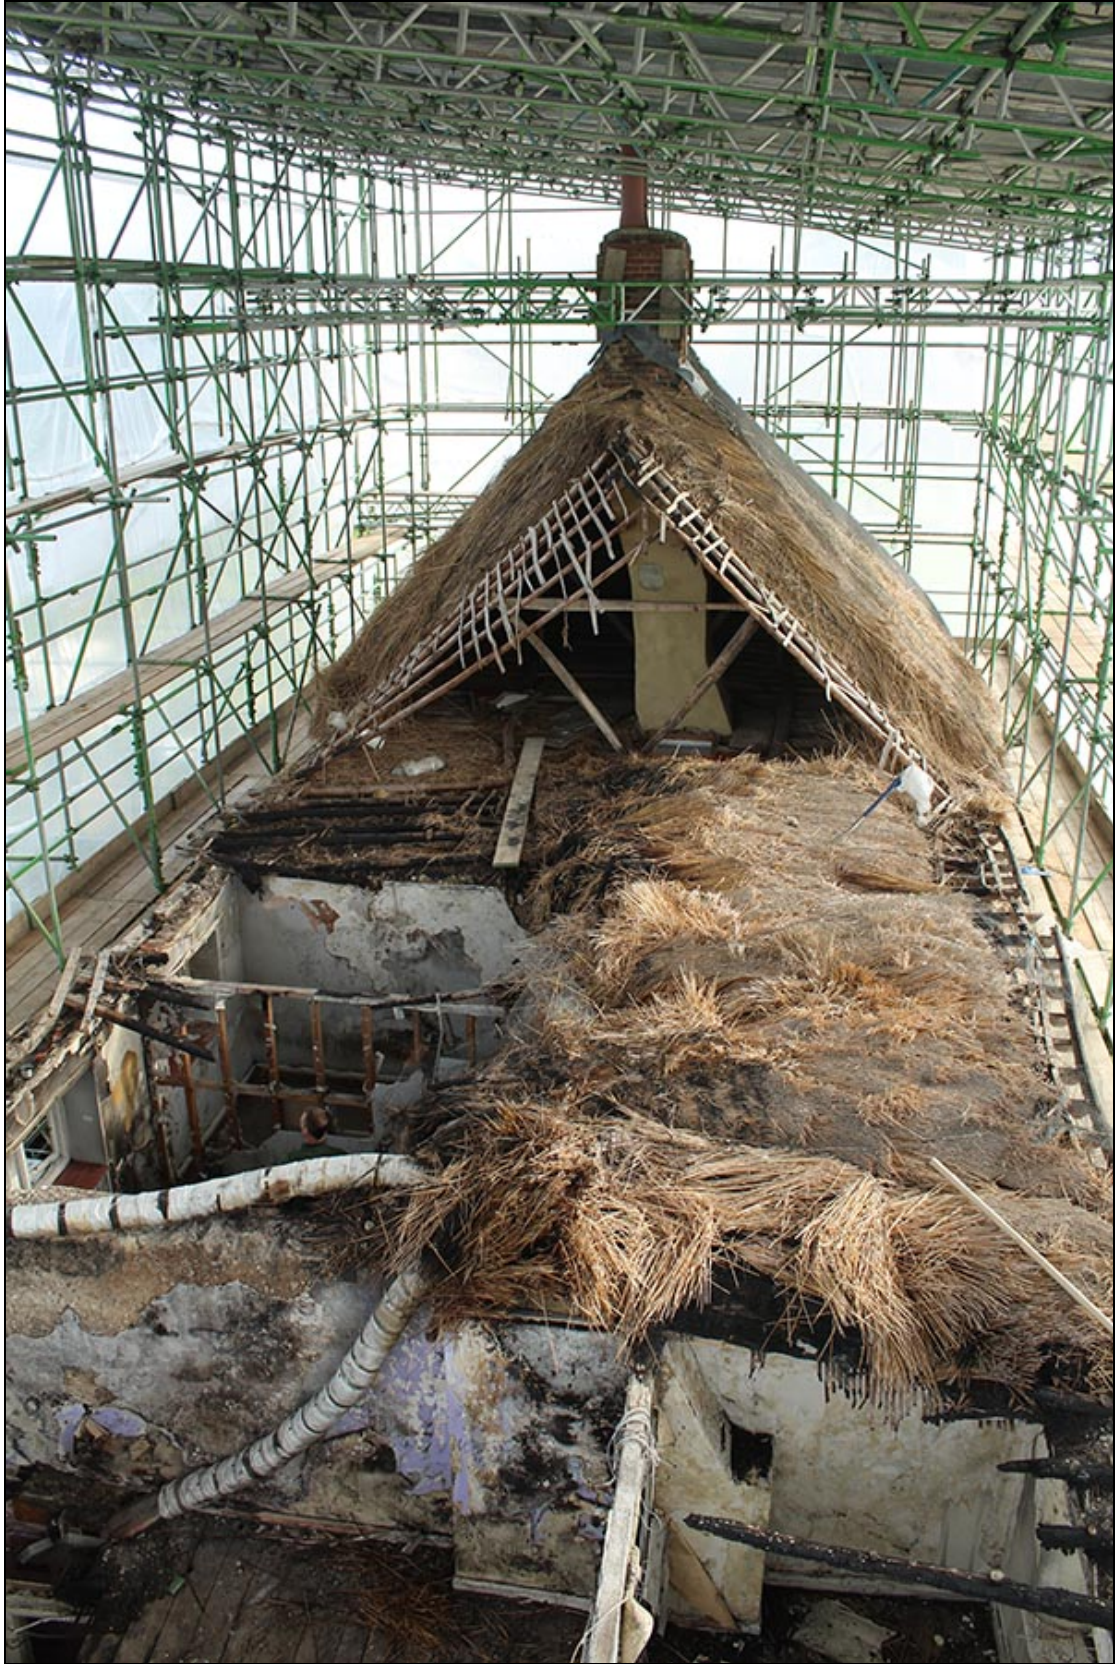
Figure 10 The remains of the roof of the Barracks, looking east. The fire damage progressively gets worse from No.1, in the foreground, through No.2, which still retains the frame of its studwork in its upper rear rooms, to No.3, where the internal rooms are largely intact, to No.4, where there is little visible damage.

5. In terms of completeness, the outer walls are largely intact, albeit with the loss of all the original window openings and parts of the rear first storey fabric. The roof survives only over No.4 at the eastern end of the terrace. Internally the only original features to survive are the four staircases, with the original first floor layout no longer visible, and the ground partition replaced and multiplied in brick. Therefore should restoration of these cottages be considered, it must be remembered that in terms of fabric, it will be solely the cob walls and the eastern end of the roof that will represent the original building.

6. It is not the function of this report to comment upon the condition of the surviving cob walling, save to state that it was historically considered important to prevent water ingress for the sake of its stability, hence the use of dwarf walls in flint and brick, the projecting of the eaves, and the use of render. The extinguishing of the fire in March 2021 has inevitably led to the ingress of much water into the upper part of the cob walling in Nos.1-3.

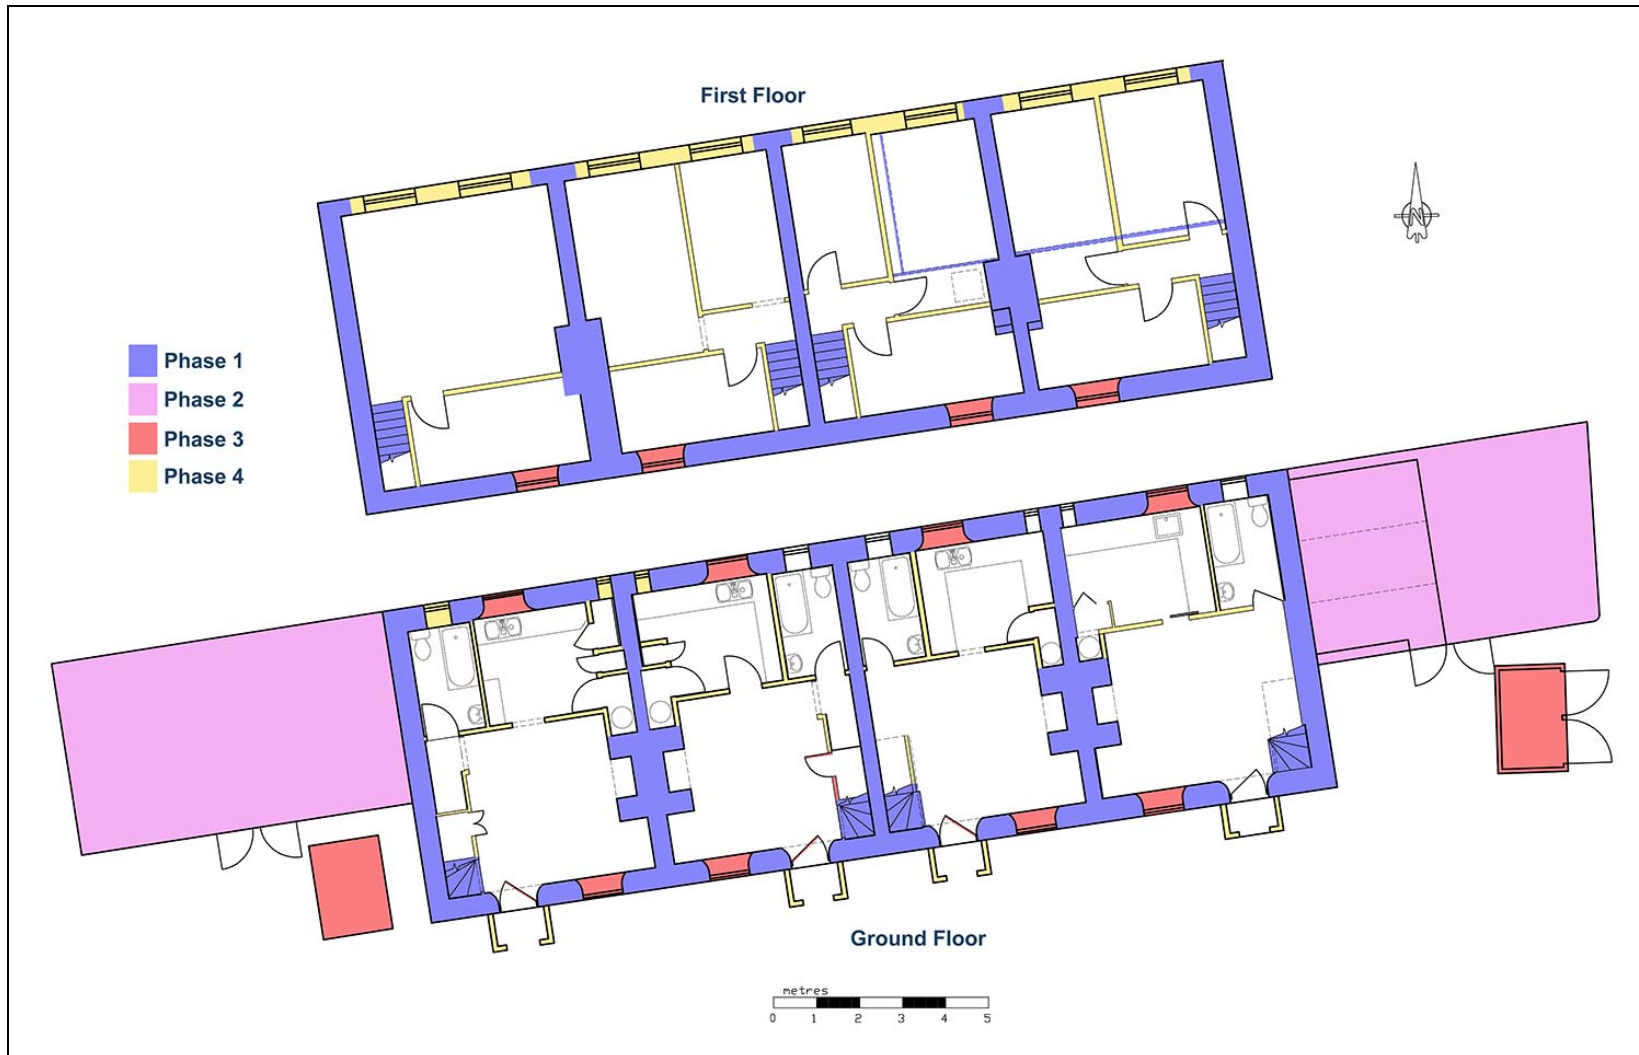
Figure 11 Phased plan of The Barracks

1. A site visit was undertaken by George Anelay (West Sussex Archaeology Ltd) and Joe Thompson (Sussex Oak & Iron) on 11th October 2021, which resulted in the identification of five phases to the building.

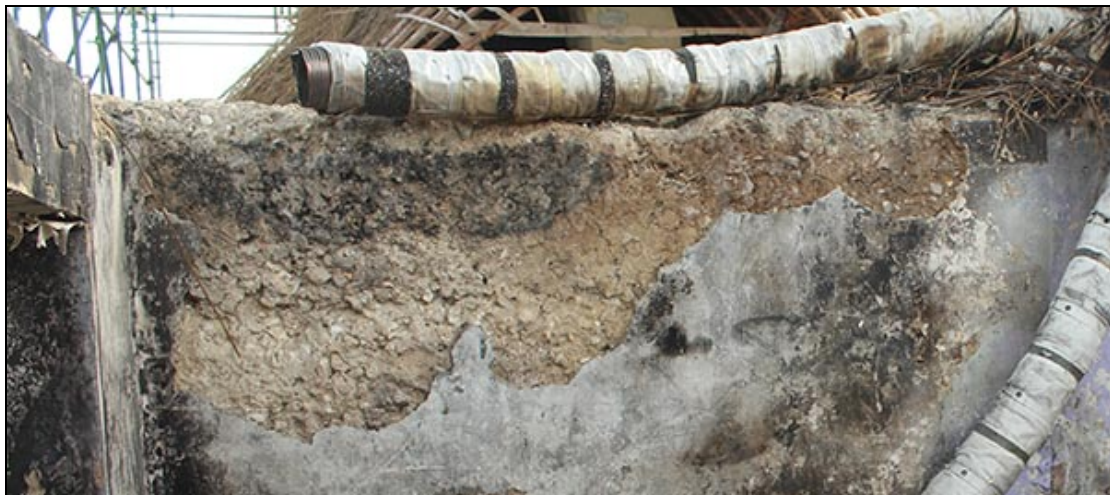
2. **Phase 1**, dated to between 1857 and 1871 on the map evidence, involved the construction of a row of four two-storeyed cottages. The walls are constructed of chalk cob, a not uncommon building material in this part of Hampshire, sitting upon a dwarf wall laid in flint. The dwarf wall has brick quoins at the four corners and is tarred, although the latter may not be original. The chalk cob wall extends from above the flint dwarf wall to the eaves and appears to be between 500mm to 600mm in thickness. Each cottage has a two-flue brick stack, with Nos.1 & 2 built back-to-back as are Nos. 3 & 4. The bricks are well made, of even size and consistency with an orangey/red colour, and were laid in an earth-based mortar. There were originally two fireplaces to each cottage, one on the ground and one on the first floors. The upper ones have since been covered over (see Phase 4 below).

Figure 12 Exposed section of cob walling in first floor rear room of No.1, looking east

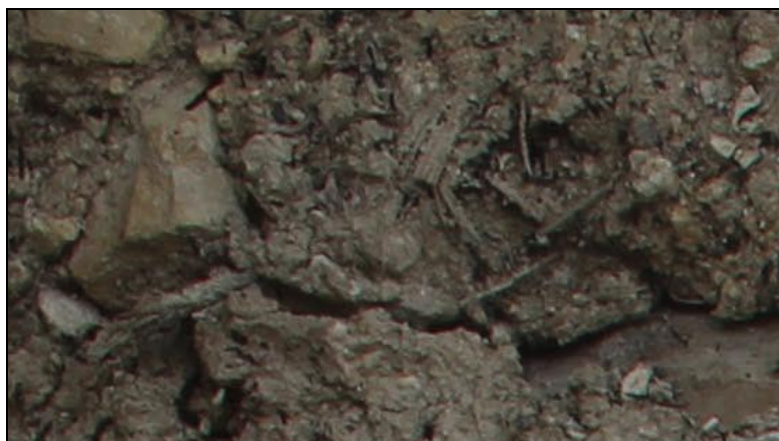
Figure 13 Detail of the chalk cob walling

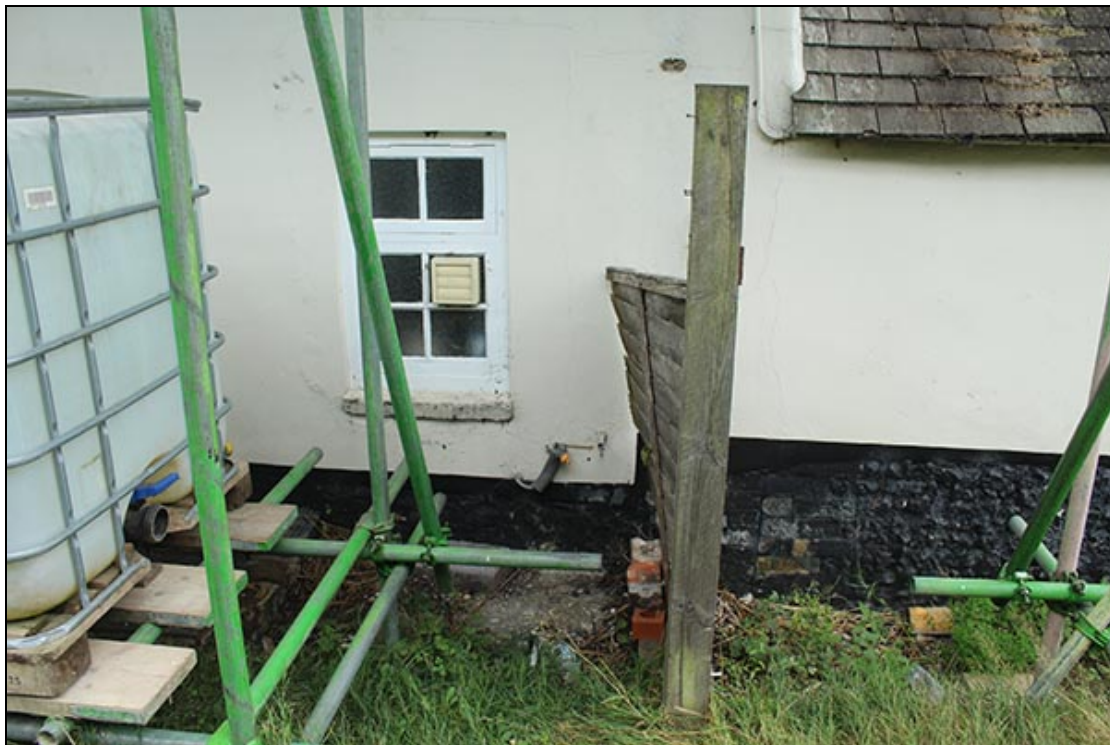
Figure 14 The dwarf wall supporting the cob of the cottages (to the left of the wooden fence) and the higher level one supporting the walls of the western outshot (to the right)

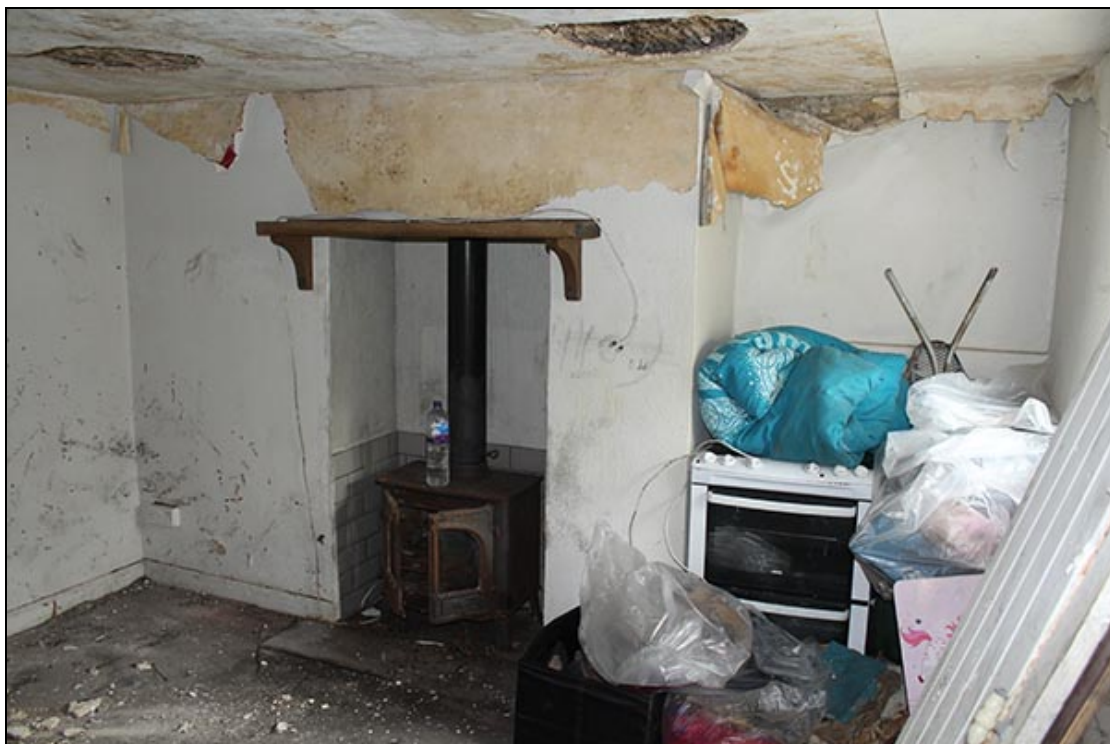
Figure 15 Ground floor fireplace in the front room of No.1, looking east

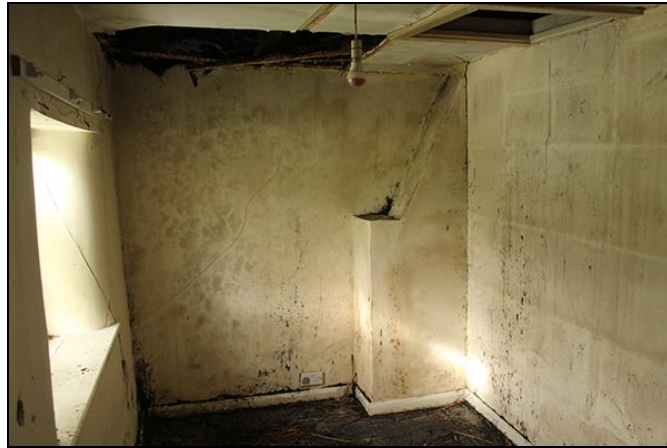
Figure 16 The first floor fireplaces now lie blocked up just to the left of the right hand Phase 4 wall, here seen in No.2, looking west

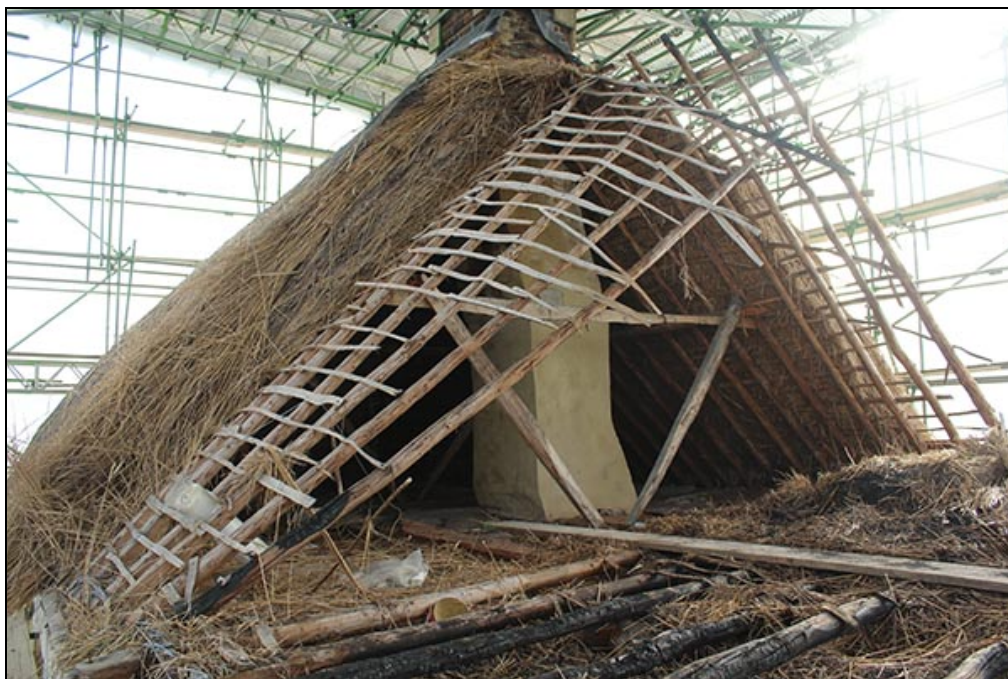
3. The roof is constructed of softwood pole rafters resting on a softwood pole ridge above softwood side purlins. These are supported by softwood collars, but with poplar raking struts and poplar wall-plates. Poplar tends to grow well on wet but not waterlogged sites and the surrounding area may well be a suitable habitat. The use of Poplar, in England, as a structural timber is scarce but not rare in the 18th and 19th centuries. The roof covering was, and still is, thatch, tied to cleft oak laths with tarred twine. The ceiling joists and first floor joists within the cottages are hewn and sawn poplar, with the ceilings composed of lath and plaster covered with two coats of plasterwork comprising a pricking up coat and a finish coat using lime based plaster and finished in a limewash or distemper. The first floor joists are arranged in two lengths running from the front to back of the cottages, supported by an internal partitioning wall between its two original rooms, although this has since been replaced (see Phase 4).

Figure 17 The surviving section of roof over No.4, showing its construction, looking east

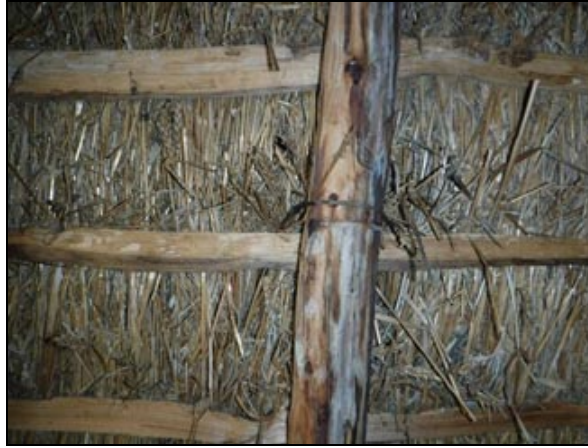
Figure 18 Detail of the inside of the roof, showing the cleft oak laths and tarred twine, used to fix the base coat of the straw

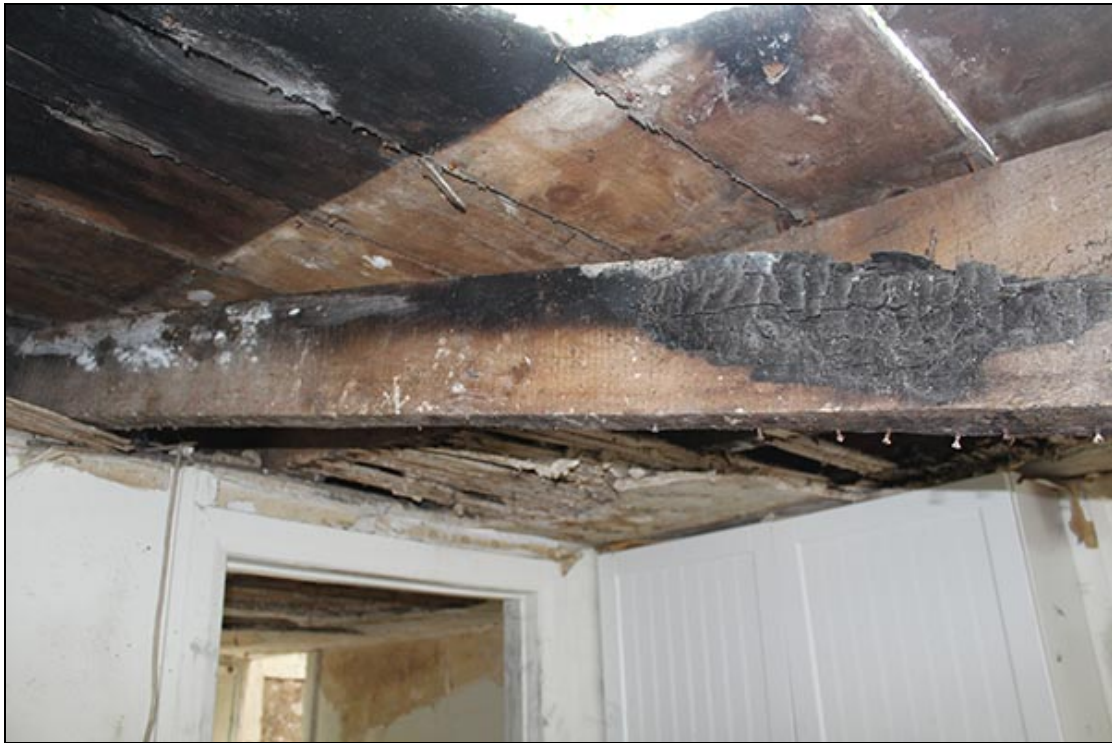
Figure 19 The northern first floor poplar joists, here still partly supported on the dividing wall between the two ground floor rooms in No.1, with the elm floor boards above, and a remnant of the lath and plaster in the corner, looking south-west

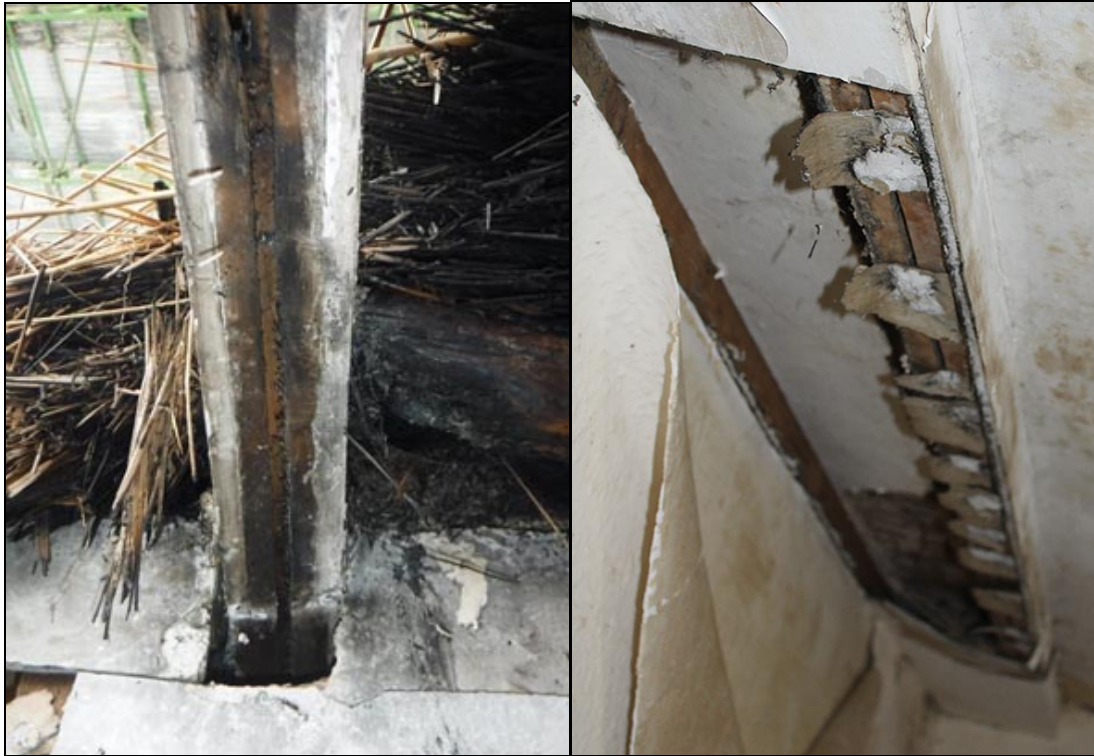
4. On the first floor, across each of the four cottages, a grooved timber of poplar runs east-west at ceiling level below the ridge. The groove would have accommodated thin boarding, acting as a partition between the heated front bedroom and the two unheated bedrooms/lodging rooms behind. Further grooved timbers ran perpendicularly northwards off these to hold the thin boarding partition that separated the two rear rooms. The floorboards throughout at first floor level appear to be sawn from elm. A single staircase rises from ground to first floor in each cottage in the southern corner opposite the fireplace. The carriage pieces, treads and risers are all of imported softwood.

Figure 20 The grooved timbers in the first floor ceilings that once accommodated thin boarded partitions. To the left is the east-west running one in No.2 (looking east), and to the right is the north-south running example in No.3 (looking north)

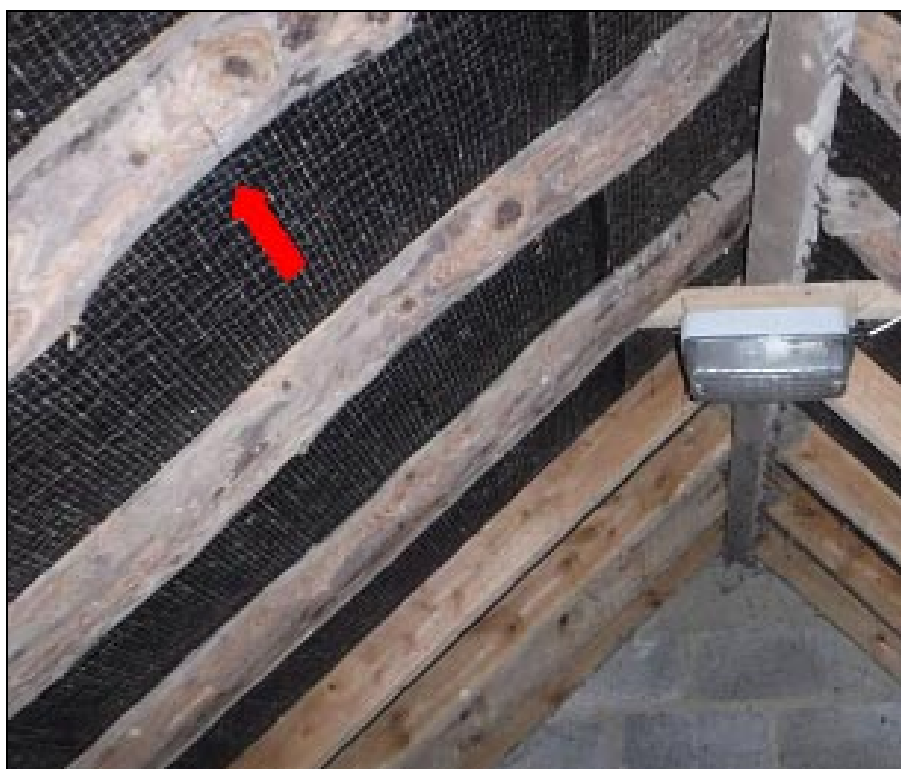
- Phase 2**, dated to before 1871, involved the addition of single storey outshots to the east and west ends of the terrace of four cottages, presumably for the storage of fuel and other items. Each outshot was partitioned into two, presumably so that each cottage had its own store. These outshots were clearly not built as a piece with the neighbouring cottages, since the brick quoins are separate, do not align, and the former's dwarf wall incorporates a central brick pier, a detail not present in that of the latter. Their original walls were of chalk cob and their roofs of thatch, as evidenced by tarred twine marks surviving on the rafters, to match the cottages. The roof rafters, where not replaced by later alterations, are of softwood poles.

Figure 22 Tarred twine mark on one of the rafters of the eastern outshot, indicating that it was once thatched like the neighbouring cottages, looking east

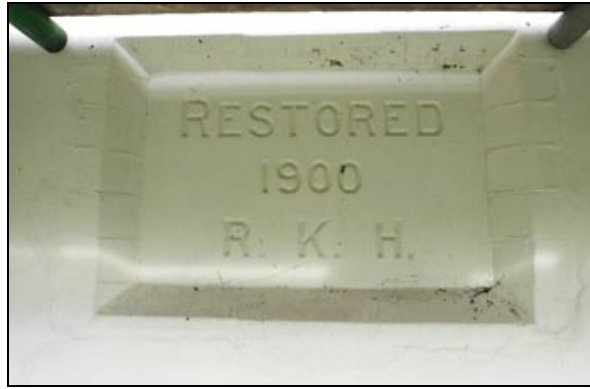
Figure 23 The restoration stone centrally set into the south face of the cottages

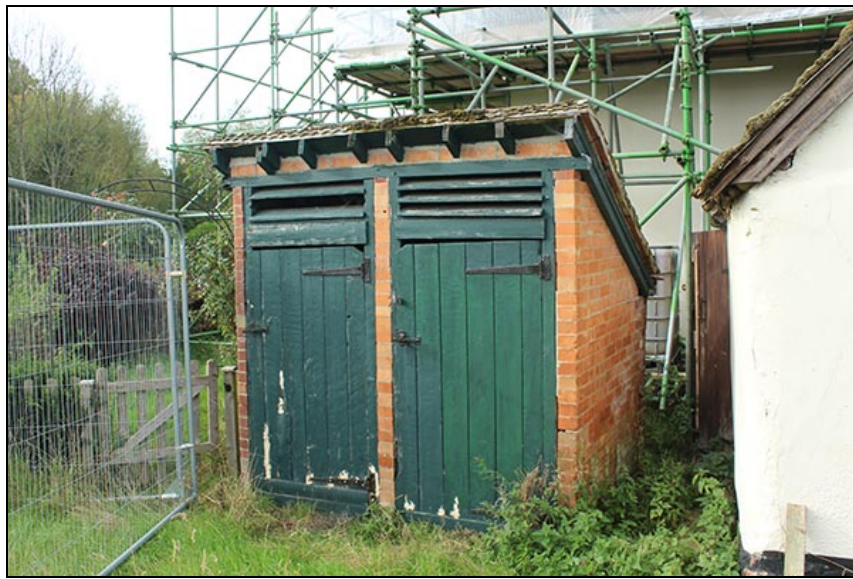
Figure 24 The eastern pair of new brick privies of Phase 3, looking west

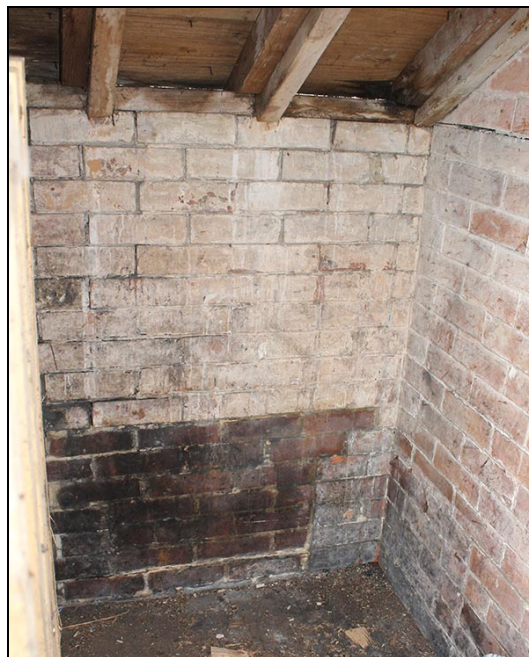
Figure 25 The infilled brickwork in the rear wall of the northern of the two eastern privies, indicating the location of a hole that once may have been linked to a pig-sty behind

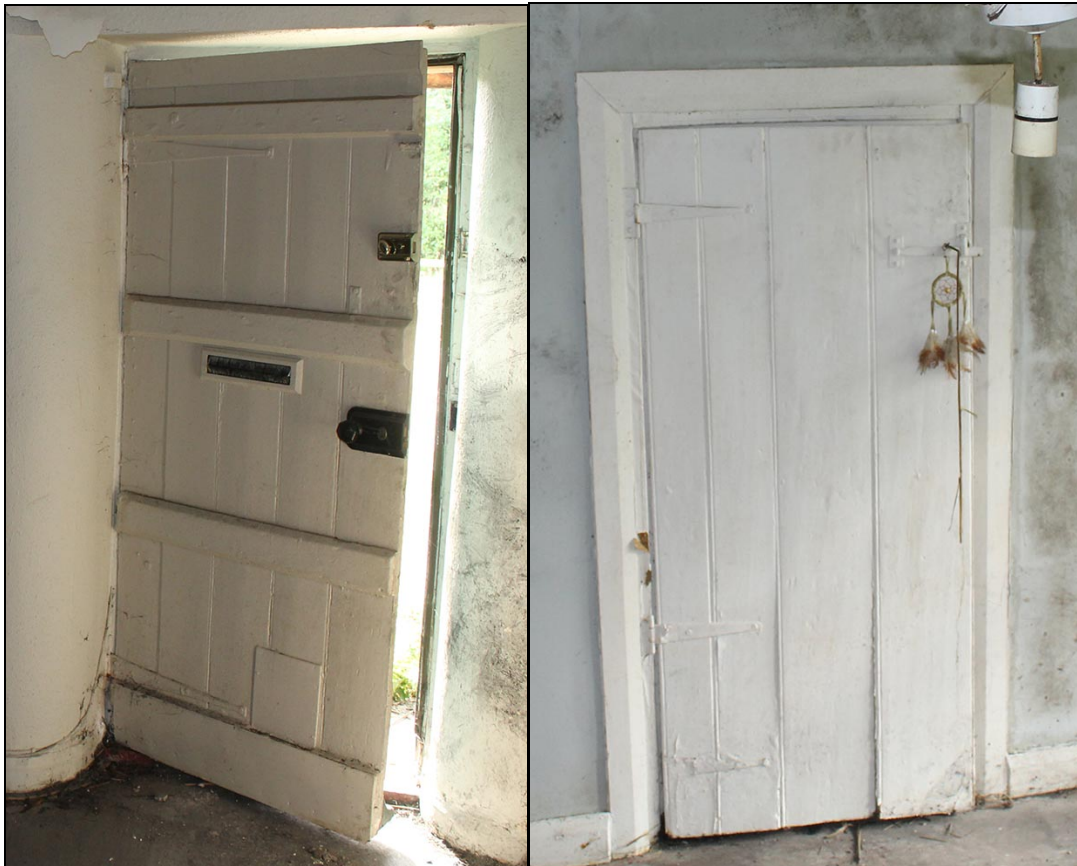
7. The existing front doors to Nos.1-3 are probably of Phase 3, judging by their form of construction, and a single surviving understairs cupboard (in No.2) would appear to match. The casement windows inserted in this phase all have six-lights and bevelled brick sills. It is probable that all the Phase 1 windows were removed and replaced, although later Phase 4 changes to the rear windows on the first floor mean that we cannot be certain that they too were included with the others. Certainly no trace of any of the original Phase 1 windows exists. Window catches from this phase survive only on the ground floor south window in No.1 and ground floor rear window in No.2.

Figure 26 The front door of No.1, probably of Phase 3, and the understairs cupboard in No.2

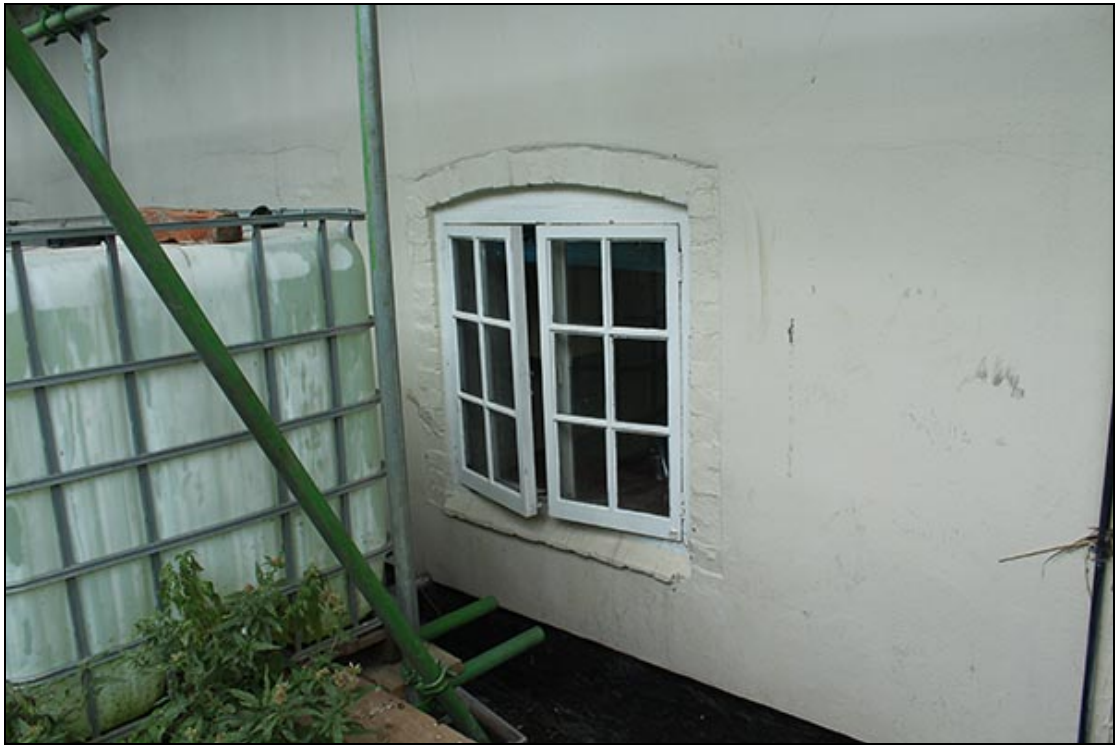
Figure 27 A typical Phase 3 window, with bevelled sill

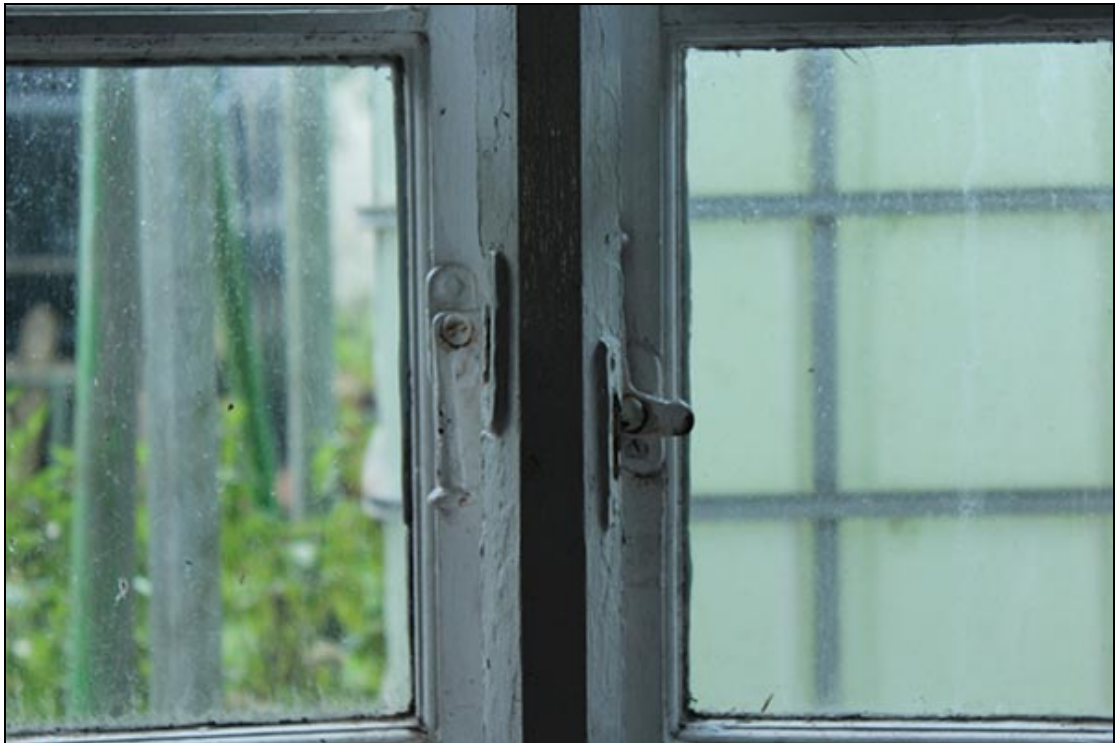
Figure 28 Two of the three surviving Phase 3 window catches, here in the rear room of No.2

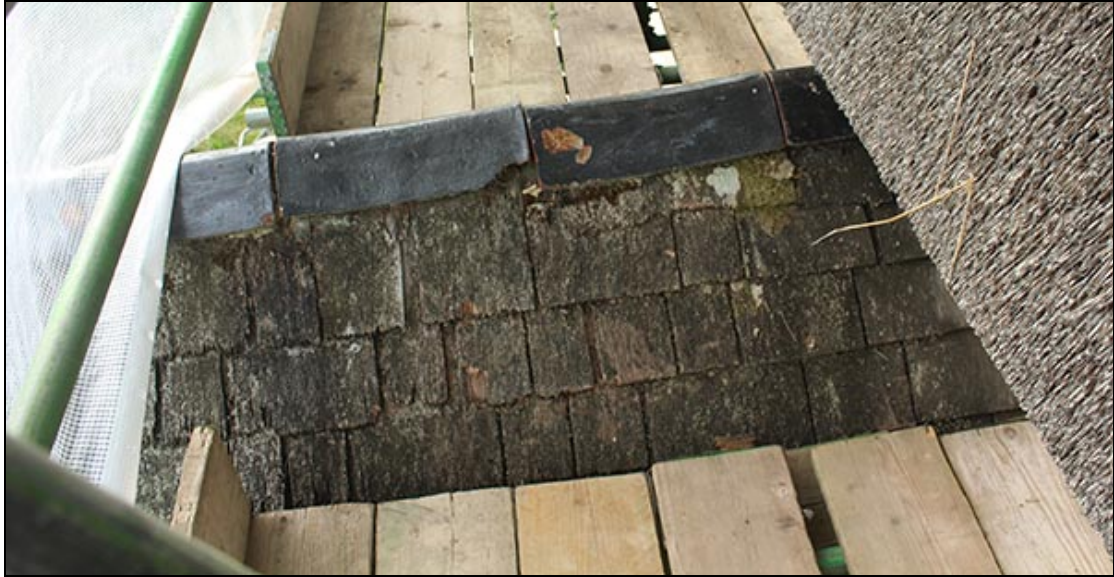
1. The thatch on the outshots was probably removed during this phase and replaced with a plain clay tiled roof, certainly the 1983 photograph describes the building as “part thatched and part tiled”. Later, in Phase 4, the tiles were replaced with shingles, but the ridge tiles retained. The latter have a manufacturer’s stamp with the words “Major Late Sealy Bridgwater”. The Sealy brick and tile works in Bridgwater, Somerset, were taken over by H C Major in 1872, therefore these tiles must date after the original construction of the outshots shown on the 1871 Ordnance Survey map.

Figure 29 The Phase 3 ridge tiles over the eastern outshot, looking south

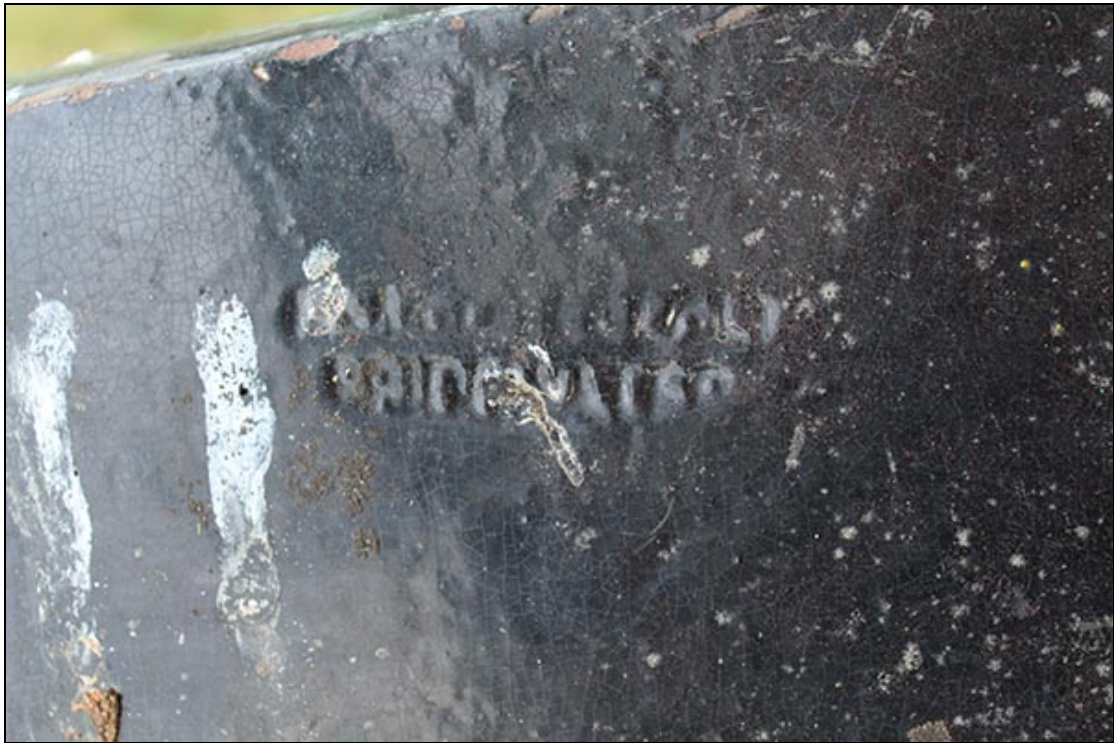
Figure 30 Detail of one of the Phase 3 ridge tiles, showing the maker's stamp

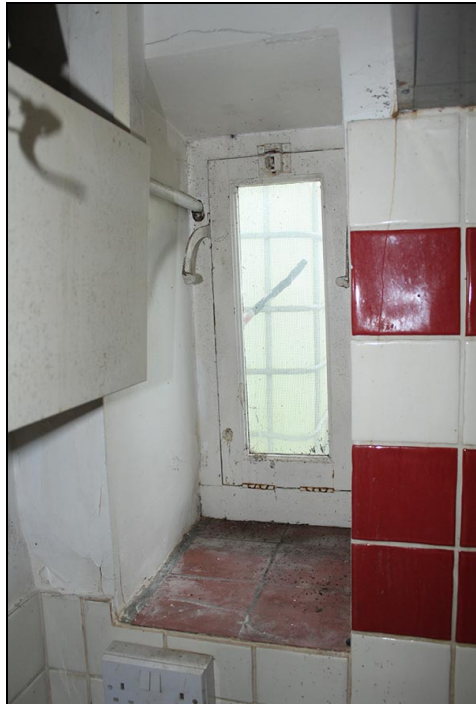
Figure 31 New Phase 4 window in the pantry of No.2, looking north

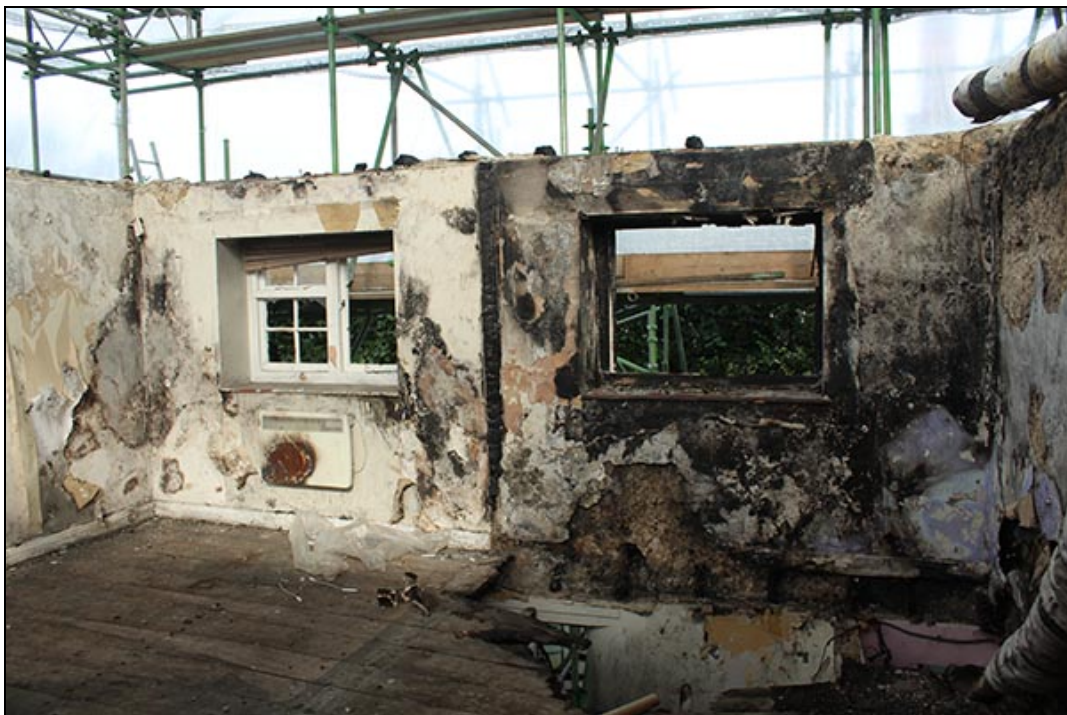
Figure 32 New Phase 4 windows, with quarry tiles laid in the sills, in the first floor rear wall of No.1, looking north

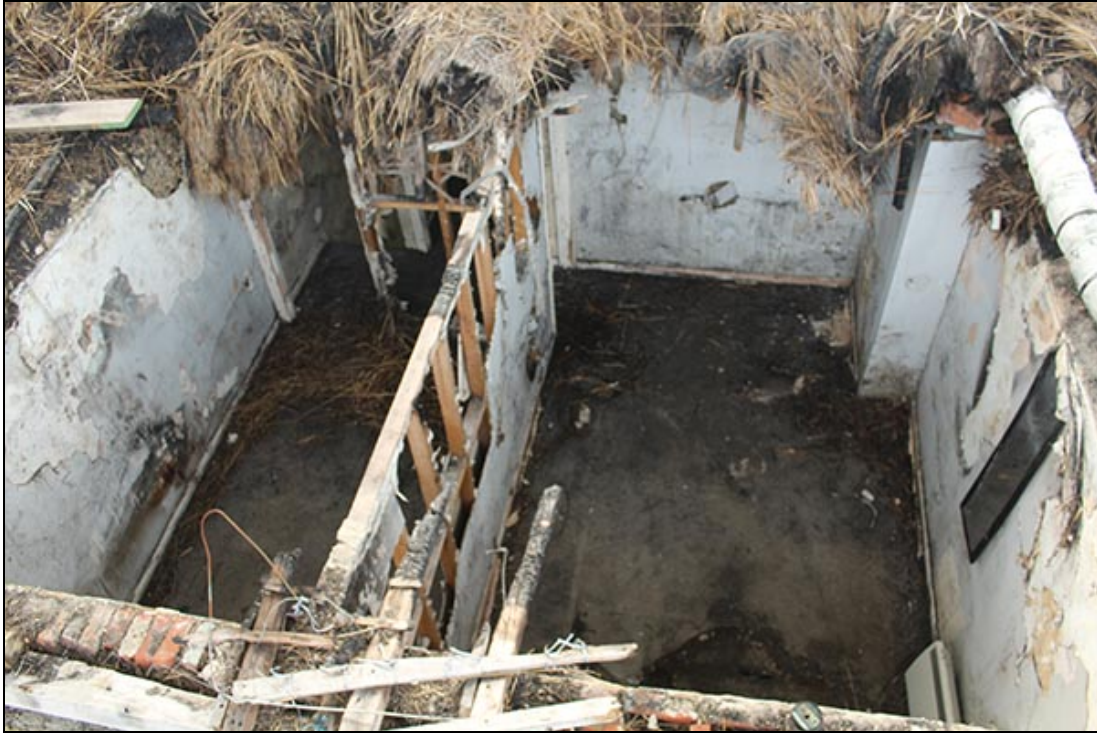
3. Internally these Phase 4 changes were linked to the re-ordering of both the ground and first floor layouts. On the first floor the earlier partitions were swept away and stud walling, using imported softwood, plasterboard and new doors, was inserted to form an upstairs landing that obviated the need to pass through one of the rear bedrooms to access the other. The original first floor fireplaces in the front rooms were also infilled, since they did not fit with the new subdivisions.

Figure 33 The new first floor layout of Phase 4, here in No.2, looking south
