**Heritage Assessment for 1-4 The Barracks,
Bransbury, Hampshire, SO21 3QJ**

October 2021

NON-TECHNICAL SUMMARY

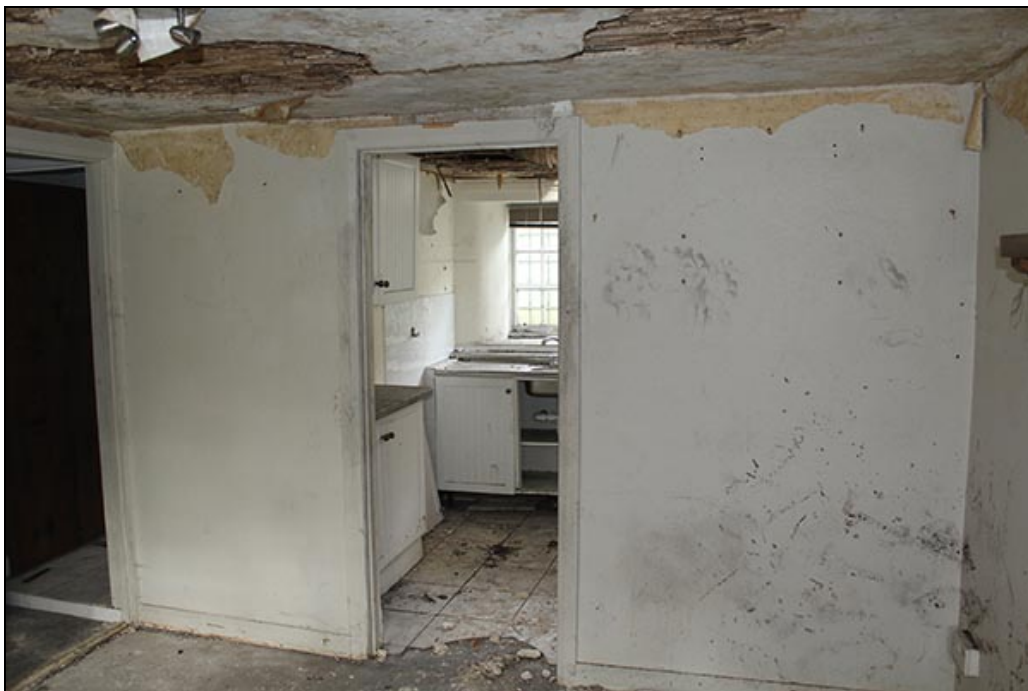
4. On the ground floor in Phase 4, the original timber partition that had separated the front and rear rooms was replaced in brick, with the rear space subdivided by additional brick walls into three to form a bathroom, kitchen and pantry/cupboards. Coal-fired ranges with back boilers were introduced into the old fireplaces, tied to hot water cylinders located in the adjacent cupboard.

Figure 34 The Phase 4 ground floor internal partitions dividing the rear space into bathroom (to the left), kitchen (centre) and pantry/cupboards, here in No.1.

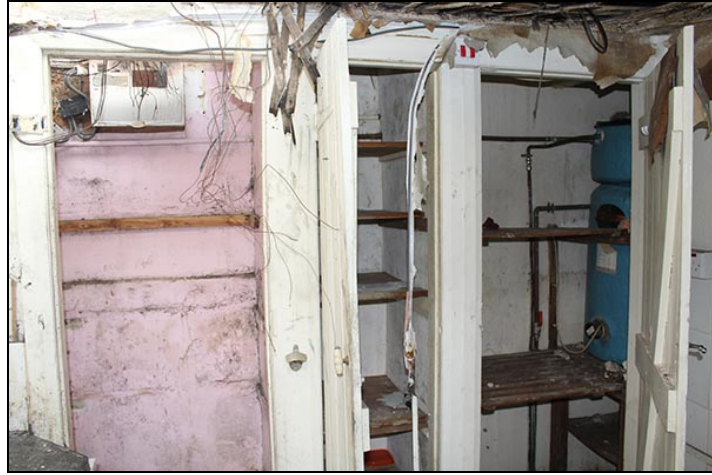
Figure 35 The Phase 4 pantry (to the left) and cupboards (to the right) in No.1, the only cottage in which they were not later altered or removed, looking east.
