# Preliminary Bat Survey Report for Garage at 3, Ruby Grove, Rainworth, Nottinghamshire

20<sup>th</sup> October 2023

Report Number: 2310/04-MLE-01

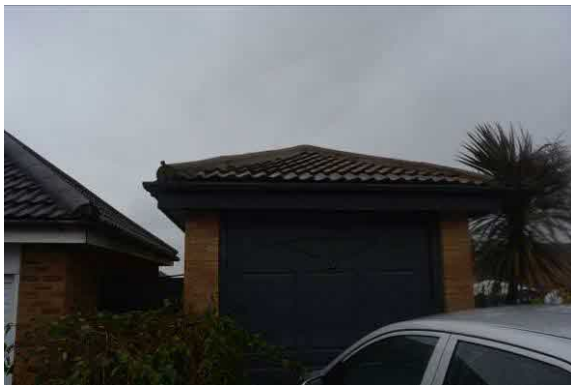
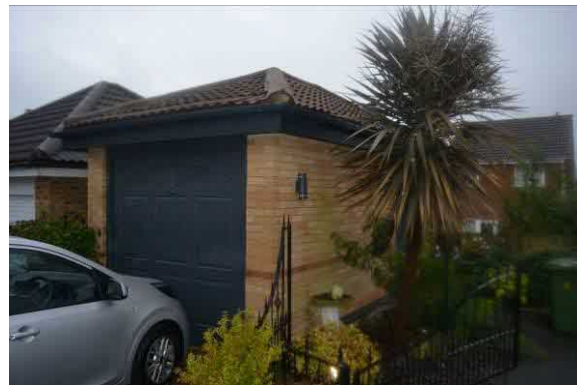
Figs. 1 & 2 64 Pastures Hill

The site comprised a detached, single garage, with pitched tiled roof (Figs. 1 and 2).

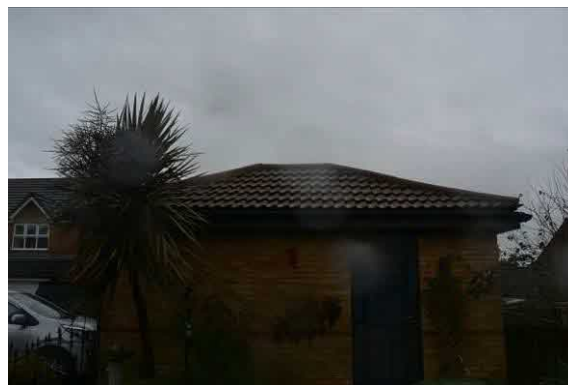
Externally, the inspection revealed an absence of any suitable gaps or crevices; the roof was in good condition throughout, with all of the pitched tiles and ridges tightly fitting (Figs. 3 and 4).

Fig. 3 External detail – roof with no gaps

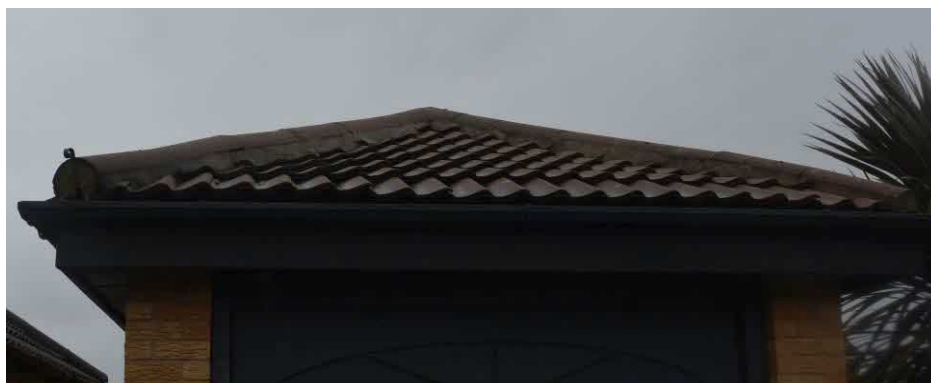
Fig. 4 External roof detail – no gaps/crevices present

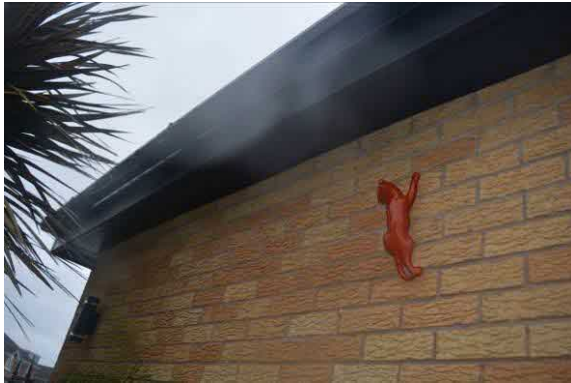
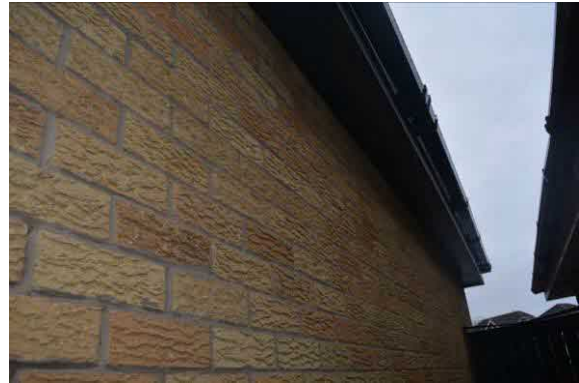
The roof overhang/eaves detail were all fully sealed, with the soffits tightly fitting to brickwork and render (Figs. 5 and 6 - overleaf).

Figs. 5 & 6 UPVC soffits fully sealed with no gaps/crevices present

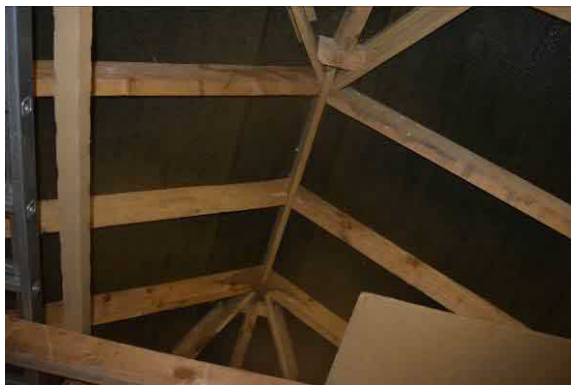
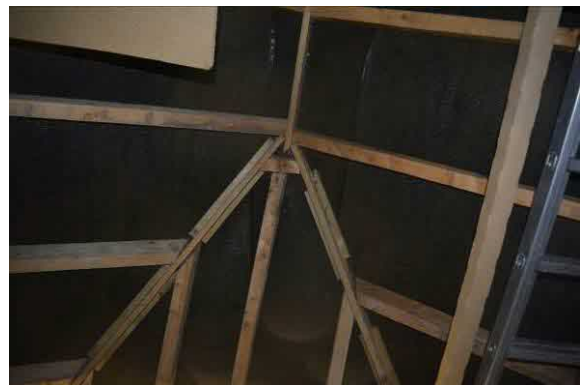
Internally, the inspection revealed no roof void was present, with the timber roof structure and bitumen felt roof lining evident (Figs. 7 and 8).

Figs. 7 & 8 Roof structure with felt lining

No light penetration was observed anywhere within the garage roof, which was evidently fully sealed internally.

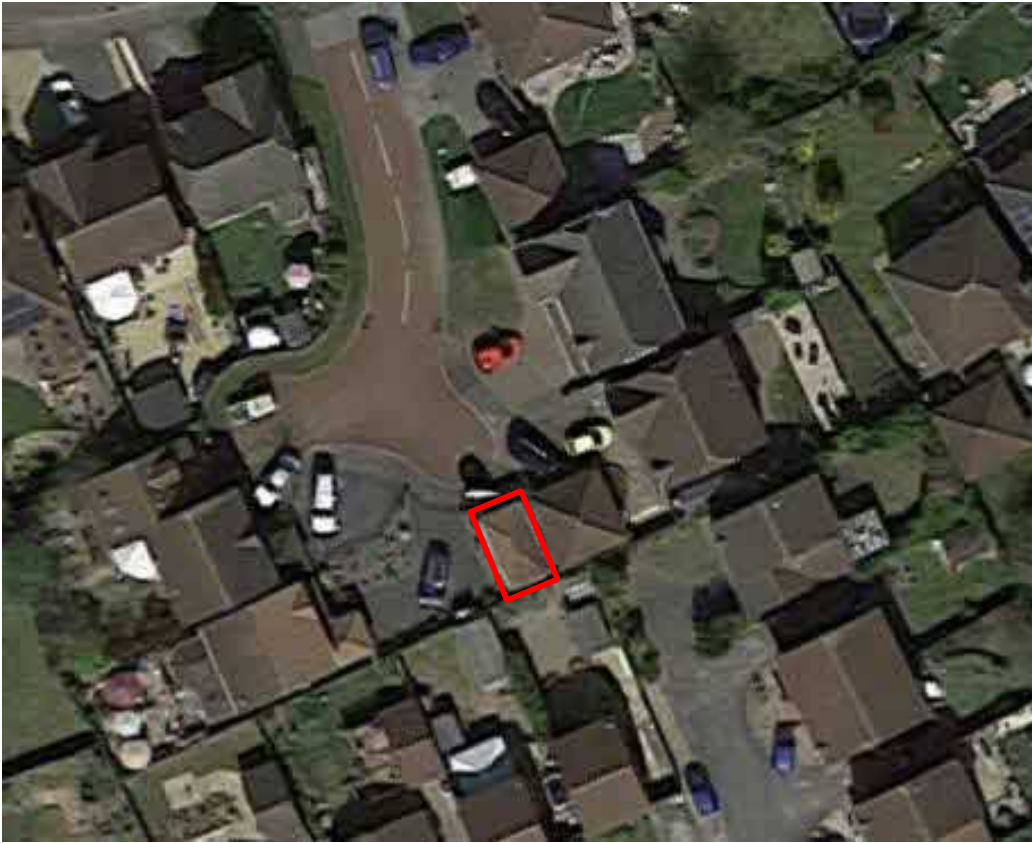
Appendix 2: Site layout

Application building
