**BAT SURVEYS REPORT**  
**OF**  
**THE OLD CHAPEL, REGIL**

<b>Site Address</b>	The Old Chapel, The Street, Regil, BS40 8BD
<b>Report type</b>	Bat Emergence Survey Report
<b>Client</b>	Dr Kate Button
<b>Project number</b>	001BUTT100

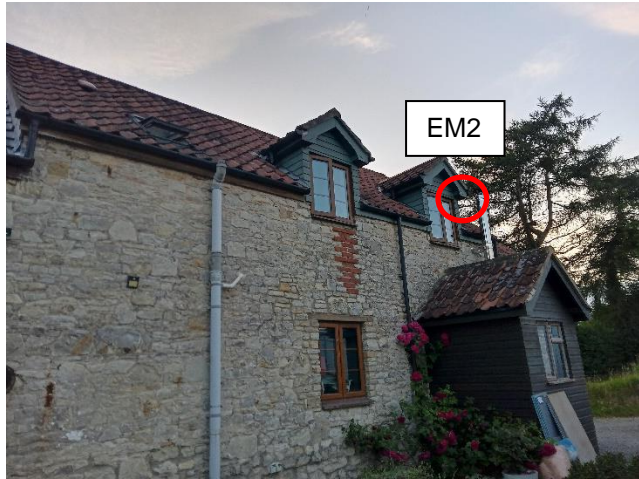
Image 01: Eastern Elevation in which there was a confirmed common pipistrelle emergence on the 06<sup>th</sup> July 2023.

- 3.2.9 At 21:42, a common pipistrelle was observed commuting from the north of the site heading south.
- 3.2.10 At 21:54, a common pipistrelle was observed heading toward The Old Chapel building but did not enter.
- 3.2.11 **At 21:57, two common pipistrelles were observed to emerge from the northernmost dormer window on the eastern aspect of the Old Chapel (EM2, Appendix F, Image 01).**
- 3.2.12 At 22:03, a common pipistrelle was observed to forage in the garden east of the property.
- 3.2.13 At 22:12, a *myotis sp.* bat was observed circling over the site.
- 3.2.14 At 22:19, a Leisler's bat was observed to be foraging behind the view of the surveyor.
- 3.2.15 At 22:28, two soprano pipistrelle bats were observed foraging to the eastern aspect of the Old Chapel before commuting south-east.

- 4.1.3 There were confirmed bat emergences on the 20<sup>th</sup> of July 2023 from the northern gable end of The Old Chapel, on the 06<sup>th</sup> of July from the northern dormer window on the eastern aspect of The Old Chapel, and on the 21<sup>st</sup> of June from under a gap in wooden boarding, to the central, western aspect of The Old Chapel. A peak count of 2 common pipistrelle bats were seen emerging from the building during each survey.

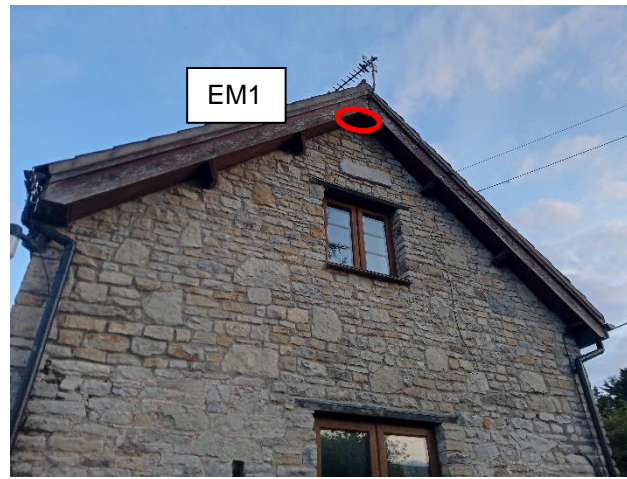
Image 02: Northern Elevation from which there were two confirmed common pipistrelle emergences on the 20<sup>th</sup> July 2023.

- 3.2.3 **At 21:39, two common pipistrelle bats were seen to emerge from the northern gable end of The Old Chapel (EM1, Appendix F, Image 02) from underneath soffit box.**
- 3.2.4 At 21:45, a *myotis sp.* bat and several common pipistrelles were observed to forage between the driveway and the road.
- 3.2.5 At 21:48, a noctule bat was seen to commute over the site.
- 3.2.6 At 22:33 a lesser horseshoe bat was heard to commute along The Street.
- 3.2.7 At 22:39, the first Leisler's bat of the survey was observed commuting over the site.
- 3.2.8 The site was host to regular *myotis sp.*, noctule, Leisler's and *pipistrellus sp.* call activity throughout the course of the survey.

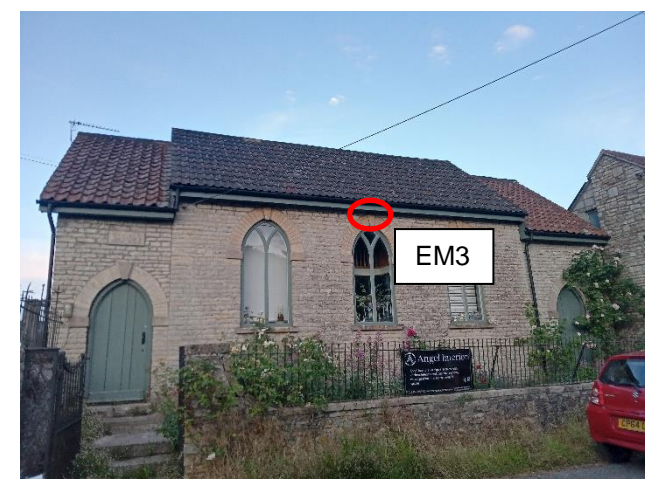
Image 03: Western Elevation from which there was a confirmed common pipistrelle emergence on the 21<sup>st</sup> June 2023.

- 3.2.16 At 21:51, a common pipistrelle was observed commuting east over the site.
- 3.2.17 **At 22:20, a common pipistrelle was observed to re-enter a gap in the wooden boarding under the guttering to the centremost, western aspect of The Old Chapel (EM3, Appendix F, Image 03).**
- 3.2.18 **At 22:22, a common pipistrelle was observed to emerge from the same location.**
- 3.2.19 **At 22:27, a common pipistrelle was observed to emerge from the same location.**
- 3.2.20 At 22:30, common pipistrelle and *myotis sp.* were observed foraging in the site's garden.
