ECOLOGY UPDATE SURVEY REPORT

Meredith Barn

Meredith Lane
Tibberton
Gloucestershire
GL2 8DZ

September 2023

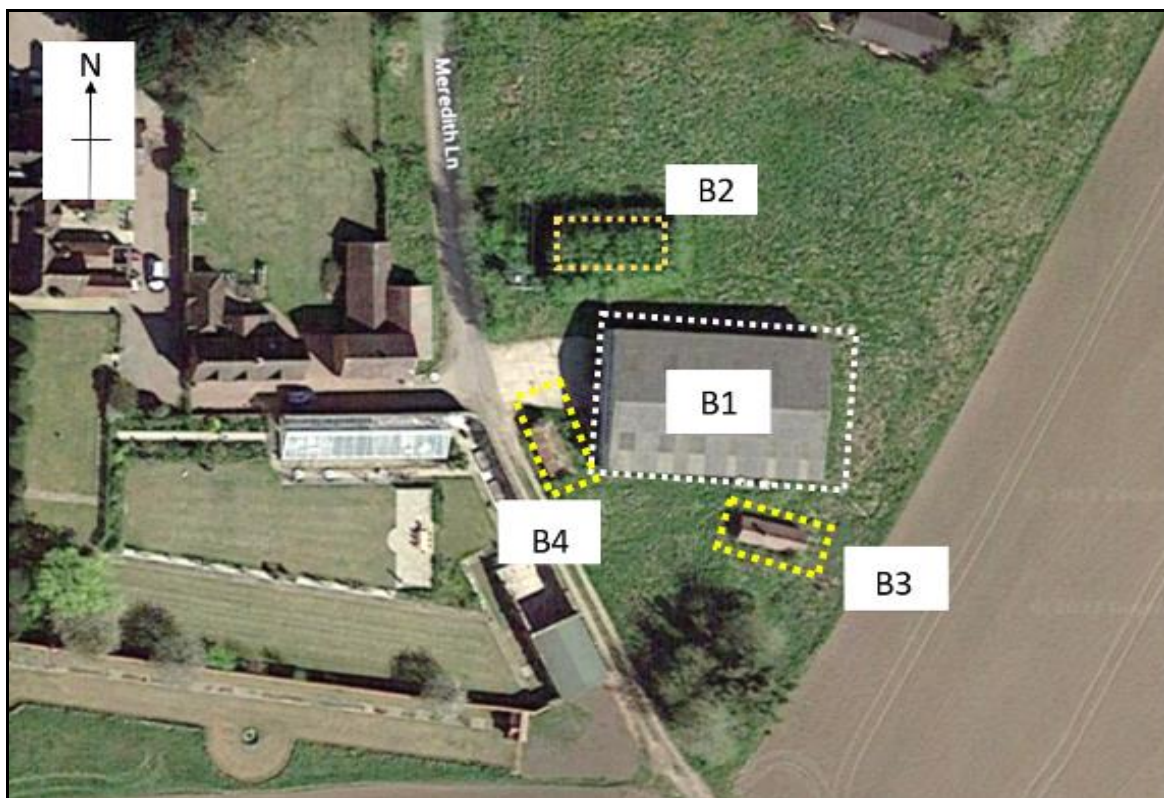
Figure 1 – Location of Meredith Barn, showing the three buildings, including B1 which comprises the prior approval outlined in white the buildings subject to bat activity suveys outlined in yellow (Source - Google Earth, 2023).

The site was subject to a **Preliminary Ecological Appraisal** undertaken by Elite Ecology in March 2020 which recommended bat activity surveys be undertaken on two (B3 and B4, Figure 1) of the four buildings which were classified as having low or moderate suitability to support bat roosts. The other two buildings (B1 and B2, figure 1) were classified as having negligible suitability to support roosting bats.

A bat flight dusk emergence survey was carried out on the evening of the 28th July 2023 on B3 (figure 1) and a dawn re-entry survey was carried out on the 16th August 2023. A single survey was carried out on B4 (figure 1) on the 2nd September 2023, in accordance with current survey guidance for buildings of low and moderate bat roost suitability.

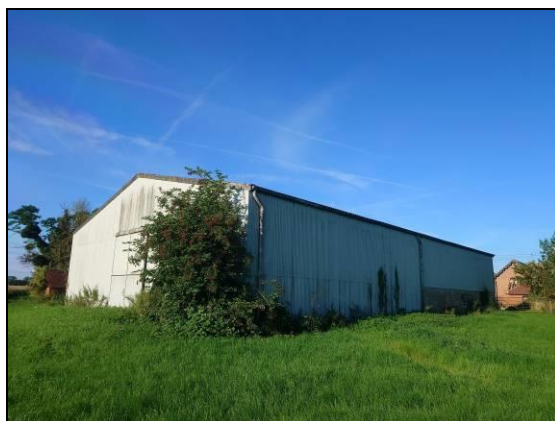
Photo 1 – Tall grasses surrounding B1.

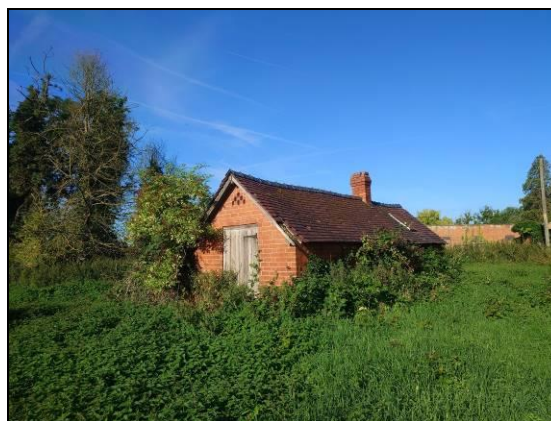
Photo 2 – Common nettle and bramble at B4.

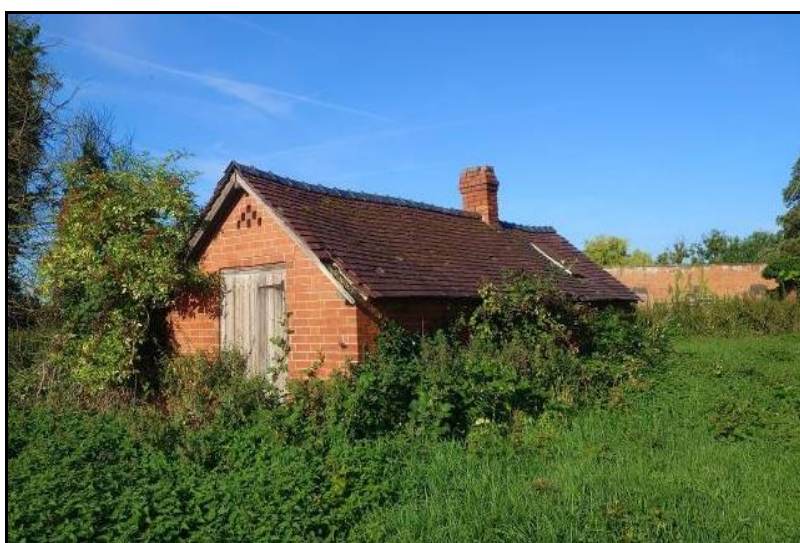
Photo 3 – B3

This is a small derelict brick-built building (3m x 9m) with traditional clay tile pitched roof and a small chimney. There are two entrances to this building, on the east and west gable. The wooden door on the west gable is in poor repair with many access gaps for bats. The wooden door on the east gable is in better condition but still has gaps in where bats could gain entry.

The walls are generally in good condition with air vent brick work to the east gable end. There is no missing mortar in the brickwork where bats could roost. The roof is constructed with traditional clay tiles which are predominantly well sealed except for two missing tiles. There are numerous gaps at the tile verge where bats could gain entry.

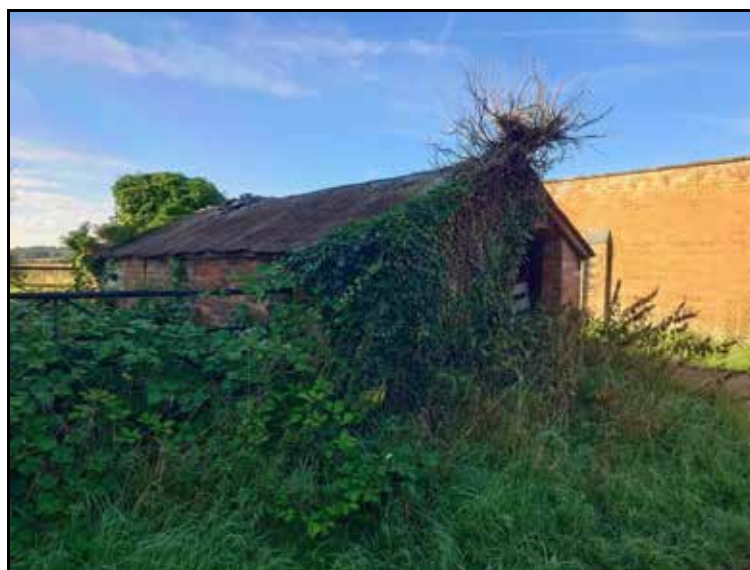
Photo 4 – B4

Building 4 is a small derelict brick built agricultural building (3m x 8m) with pitched corrugated tin sheet roof in poor condition. The brickwork is generally sound with only minor missing mortar in places. Access is provided through an open doorway with rotting timber framework.

There are many gaps for potential bat entry especially at eaves height, wall to roof plate. Vegetation has encroached significantly up the gable end which is covered in dense ivy growth.

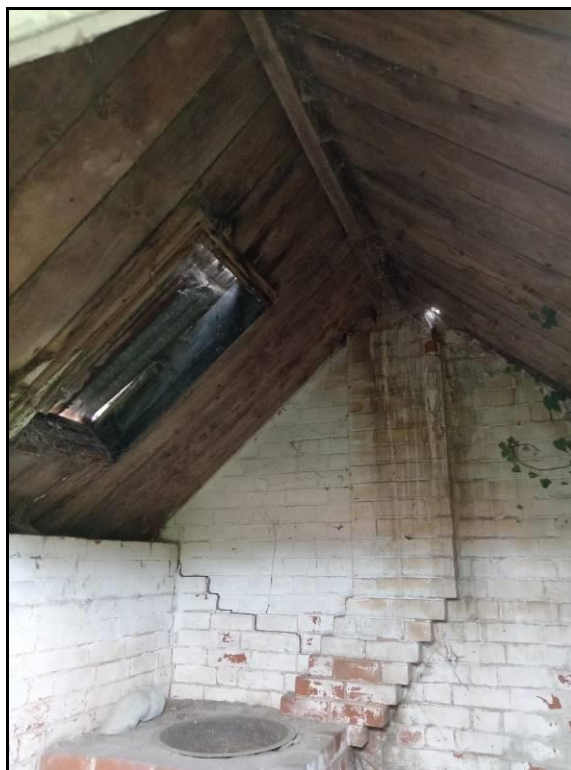
Photo 5 – Internal view of B3

B3 has been split into two sections by a single partitioning internal brick-built wall, this is bricked to the roof height, with only access possible at the time of survey to the western room. The western room has an open doorway and allows easy access for flying bats.

The building has rotting timber sarking on the underside of the roof with minor spaces between offering potential opportunities for crevice dwelling bat species. The room was heavily cobwebbed, suggestive of no recent bat use.

B3 was assessed as having ‘moderate’ potential for roosting bats and B4 as ‘low’ potential for roosting bats, and thus it is considered that conditions have not changed since the previous two assessments made by Elite Ecology 2020 and Swift Ecology 2021.

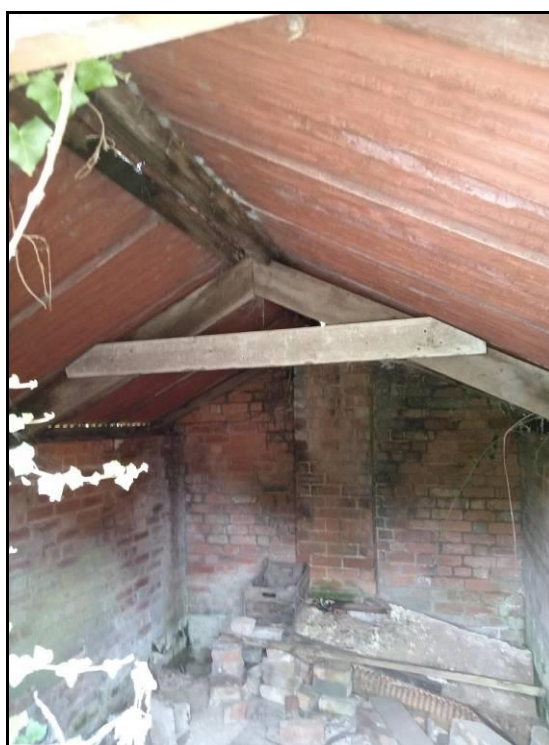
Photo 6 – Internal view of B4

B4 has a corrugated pitched tin roof, the eaves are open with many gaps allowing plenty of daylight visible between the roof and timber wall plate. There are rough sawn supporting roof timbers with heavy cobwebbing suggesting no recent bat use. Internally there are no enclosed cavities or crevices that would provide suitable features for crevice dwelling bat species.

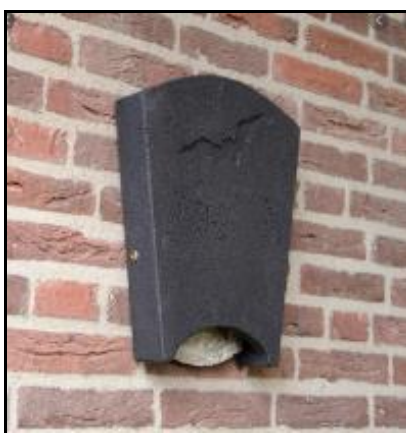
Figure 4 – Beaumaris Woodstone bat box

It is recommended that two of the following bat habitat enhancement boxes be permanently installed on the eastern and southern elevations of the converted building, installed at eaves height or above.

Two **Vivara Pro Built-in Woodstone Bat Boxes** (midi size) to be permanently installed. This will provide valuable roosting provision at the site for crevice-dwelling bats.

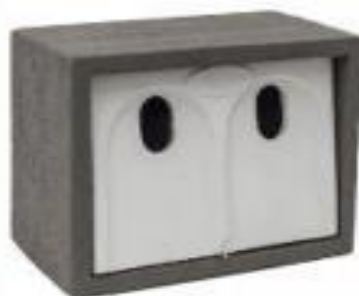
Figure 5 - Vivara Pro Woodstone House Sparrow Nest Box (double chamber)

One **Vivara Pro Woodstone House Sparrow Nest Box** (double chamber) will be permanently installed onto the eastern side elevation wall of the proposed building at eaves level. This will provide much needed nesting opportunity for house sparrows which have suffered a large decline in habitat and nesting areas, putting them on the conservation red list – Red list is the highest conservation priority, with the species needing urgent action.

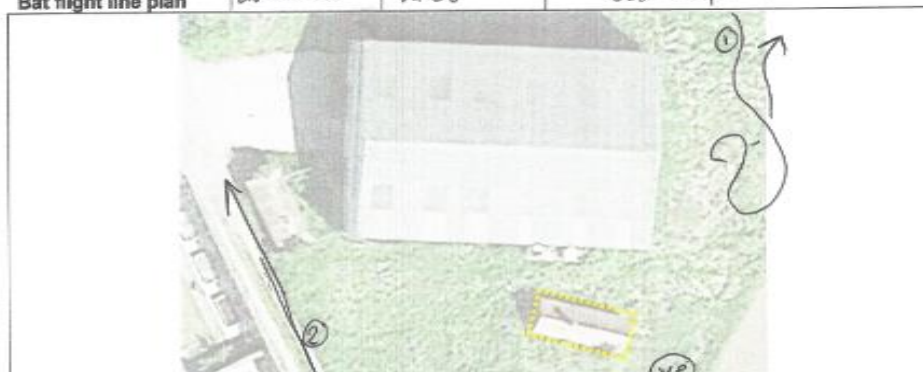
No. on plan	Species	Time	Count	Height	Observations
①	C.Pip	21:25	1	L	Foraging behaviour of single bat to rear of large frame building
	"	21:31	1	L	" "
		↓			" "
		21:48			
②	C.Pip	21:49	1	L	Commuting pass of C.pip just above hedge height

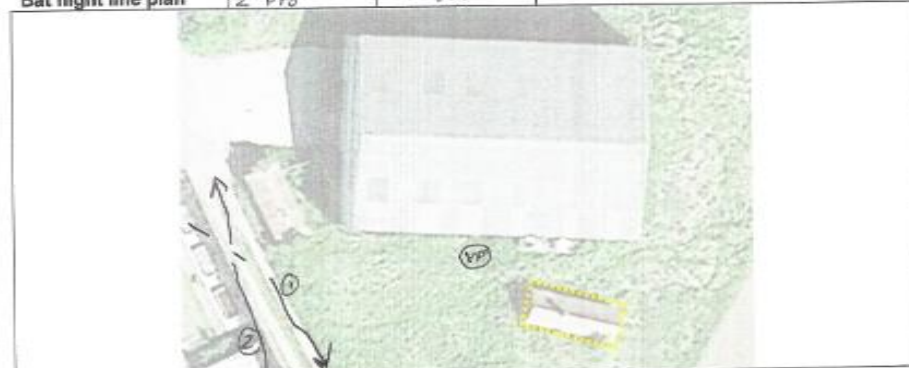
No. on plan	Species	Time	Count	Height	Observations
①	C.Pip	21:18	1	L/m	Commuting flight overhead of nearby outbuilding (south-north)
	"	21:29	1	m	Direct commuting flight of Common pip along track again south-north
②	"	21:48	1	L/m	Direct pass in other direction north-south

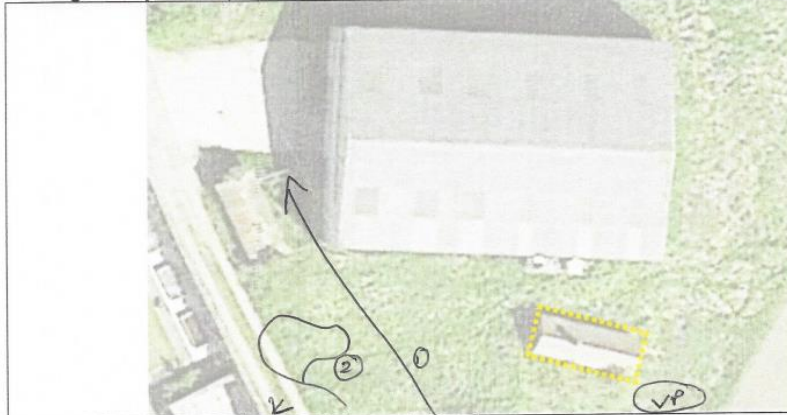
No. on plan	Species	Time	Count	Height	Observations
	Noctule	04:57	1	-	Detection but no observation
①	Noctule	05:02	1	H	Direct flight south to north
②	C. pip	05:22	1	L	Foraging bat along field edge margin

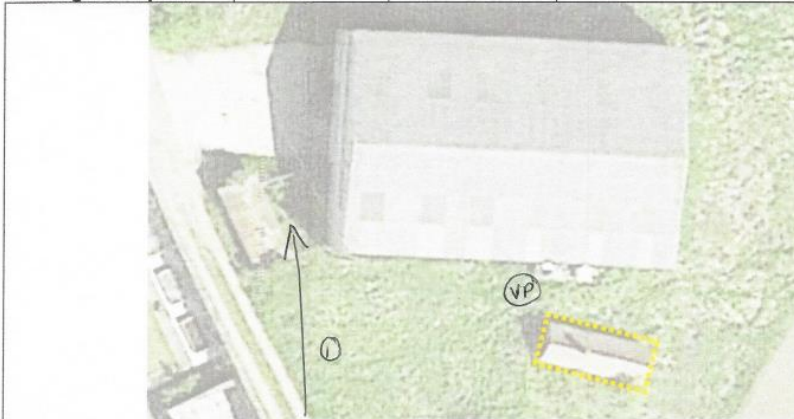
No. on plan	Species	Time	Count	Height	Observations
①	Noctule	05-02	1	H	A commuting flight overhead
	C. Pip	05-02	1	L/M	Foraging behaviour of Common Pip at front of property along lawn track
		↓			
		05-41

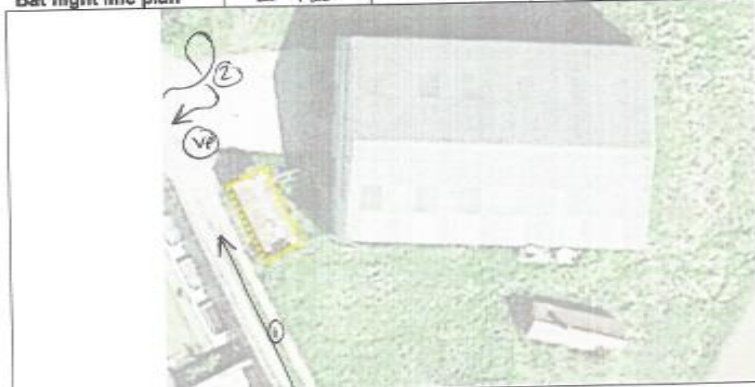
No. on plan	Species	Time	Count	Height	Observations
1.	Common Pip	21:48	1	L	DIRECT FLIGHT ALONG FARM FIELD ENTRANCE TRACK
	Common Pip	21:50	1	L	" "
					" "
2.	Common Pip	22:21	1	4/M	FORAGING FRONT OF LARGE PORTAL FRAME BUILDING
	Common Pip	22:32	1	L	FORAGING FLIGHT ALONG FARM FIELD ENTRANCE

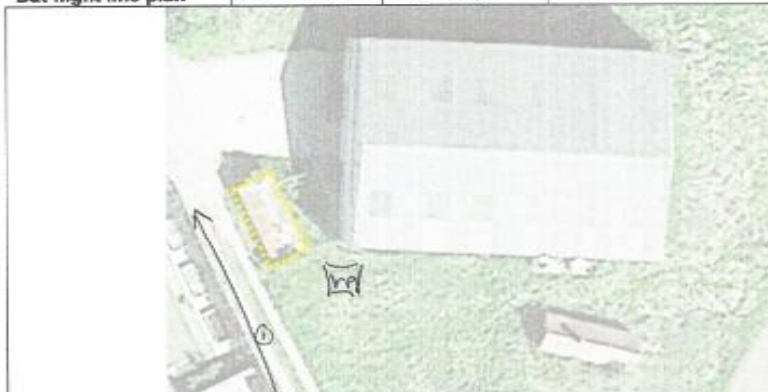
No. on plan	Species	Time	Count	Height	Observations
①	C-Pip	21:48	1	L	Committed flight of C-pip along farm track
	"	21:50	2-3	L	Continued committed flight with occasional propping
		22:48
