# Site Investigation Report

12045.1.TSI

## Overview

# Trial Hole Log No.1

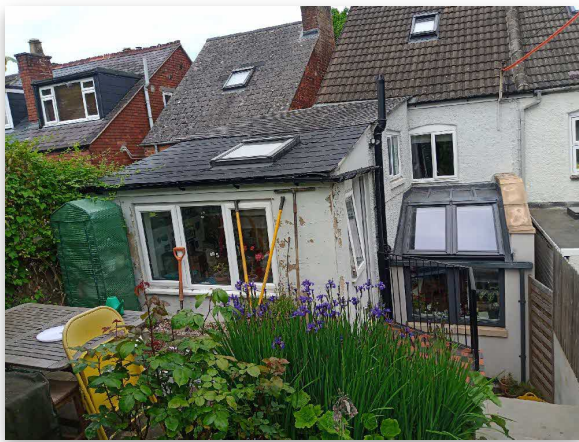
Fig 1.1: Trial Hole 1 Location

<b>Brief</b>	Auger were commissioned by Sedgwick to undertake a site investigation within the area of concern at the property.
<b>Trial Hole Findings</b>	Within TH1 we revealed the footing and augered to the required depth (3m) in the proposed location. We took root samples. These measurements are shown in Trial Hole Log 1 below. The base of the footing was determined by probing to a depth below 1m and therefore the exact profiles/depth cannot be guaranteed.

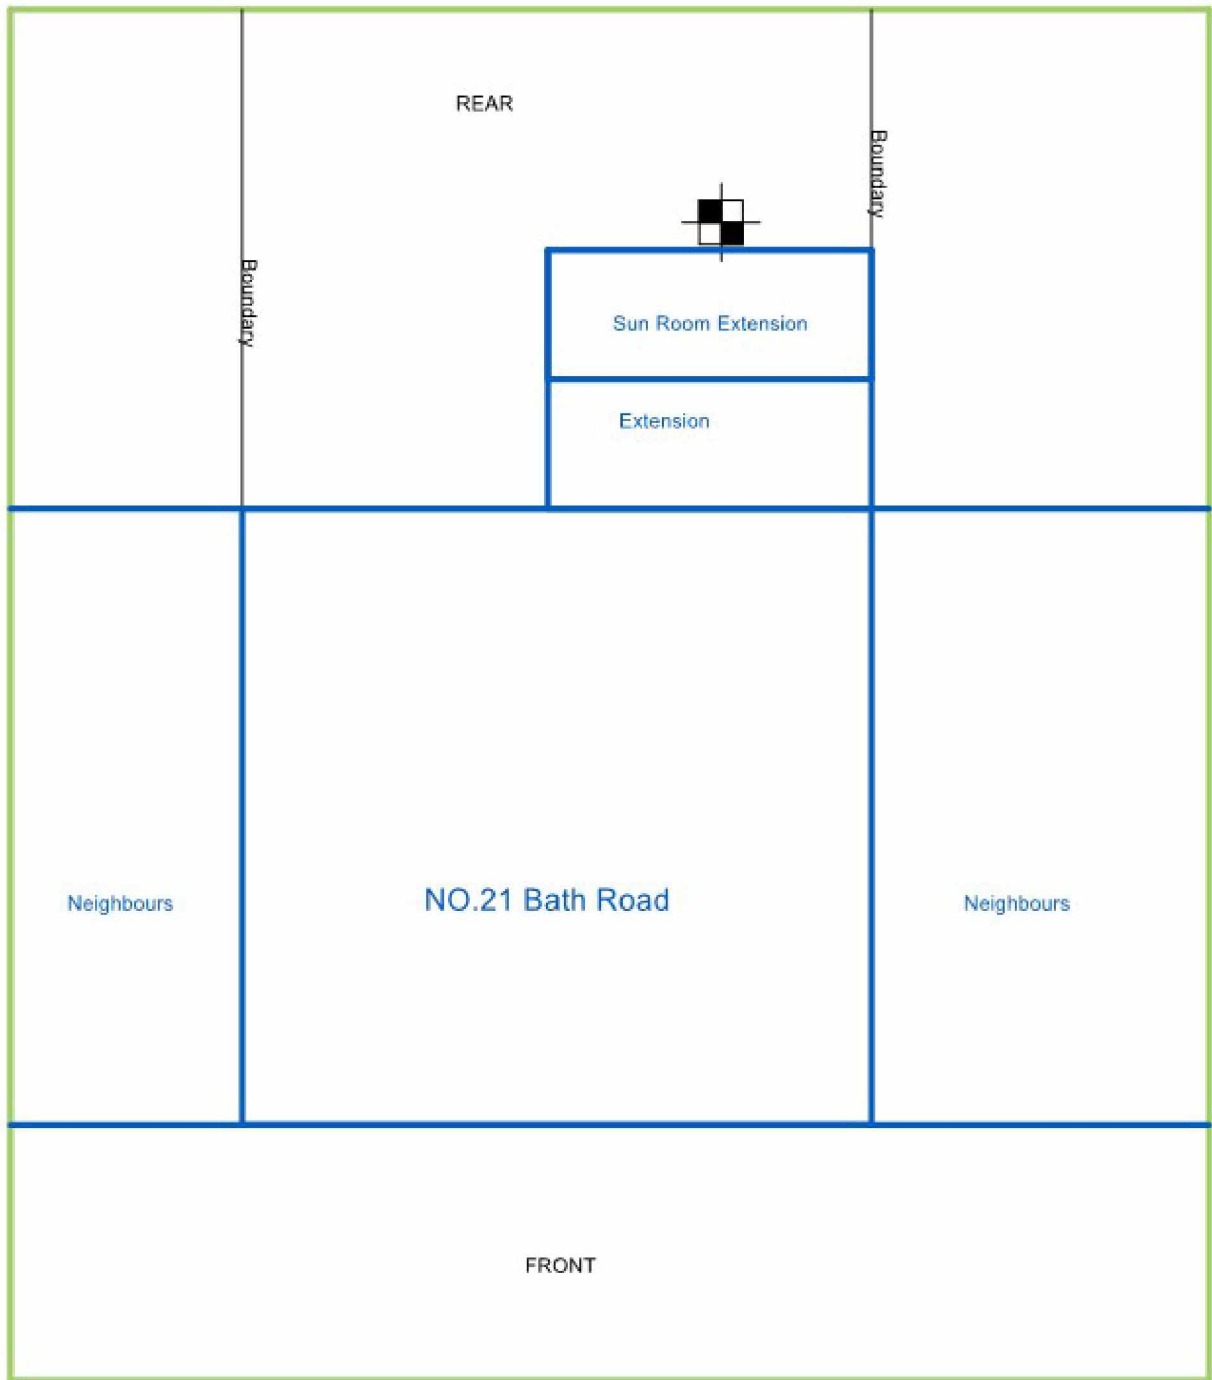
This drawing should be used for diagrammatic purposes only. Auger are not responsible or liable for any 3rd party works undertaken using the details outlined in this drawing. Confirmation of the drainage configuration can only be confirmed by excavation or detailed technical survey.

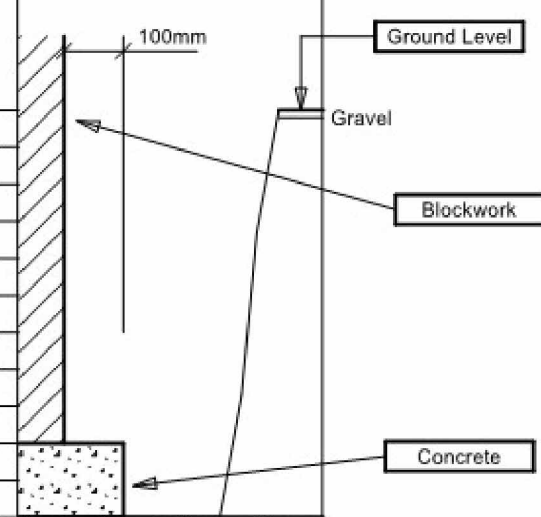
Location: Rear of sun room ext.

Depth (m)	Symbolic Log	Strata Description	Insitu Tests		Soil Sample	Root Sample
			SV(19)			
0.0

Ground Level Gravel Blockwork Concrete				
1.0			84kpa			Root @ 1.1m
1.5			86kpa			
2.0		Moist very stiff brown gravelly CLAY	92kpa			
2.5			94kpa			
3.0		TRIAL HOLE TERMINATED	96kpa

TH1, 1.1m		
3 no.	Examined root: a SHRUB, possibly a climbing or scrambling type. Similar in some ways to PASSIFLORA (Passion Flower). TENTATIVE.	Alive, recently*.
3 no.	Unfortunately all with insufficient cells for identification.
