**The Rookery  
Hurstbourne Tarrant  
The Hill  
Hampshire  
NGR: SU 38164 53083**

**A  
Heritage Impact Assessment  
On  
Proposed Development**

September 2023  
**Mercian Heritage Series 2169**

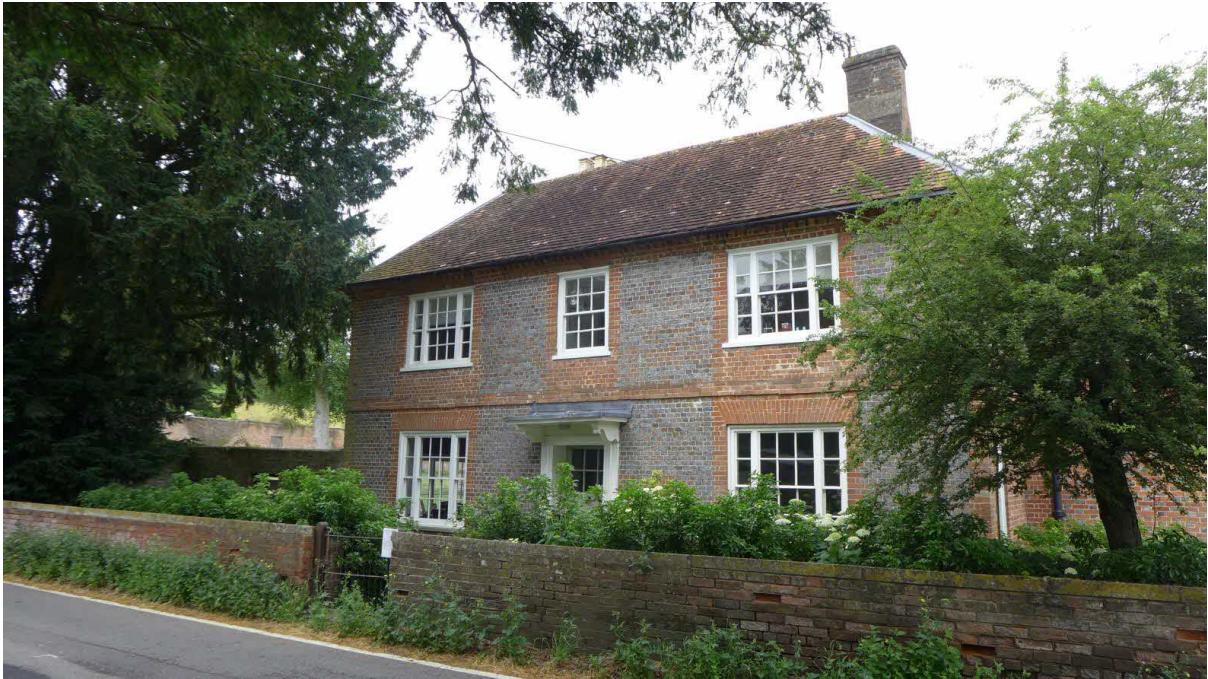
Pl.2: The front, or south, elevation of the Main House.

There are vertically aligned windows at ground and first-floor levels but no repeat of the red brick ‘columns’ in the brickwork. The ground-floor window has a flat arched head of rubbed brick, the head of the upper window is in the eaves. Both openings contain ‘6 over 6’ thin-barred sashes.

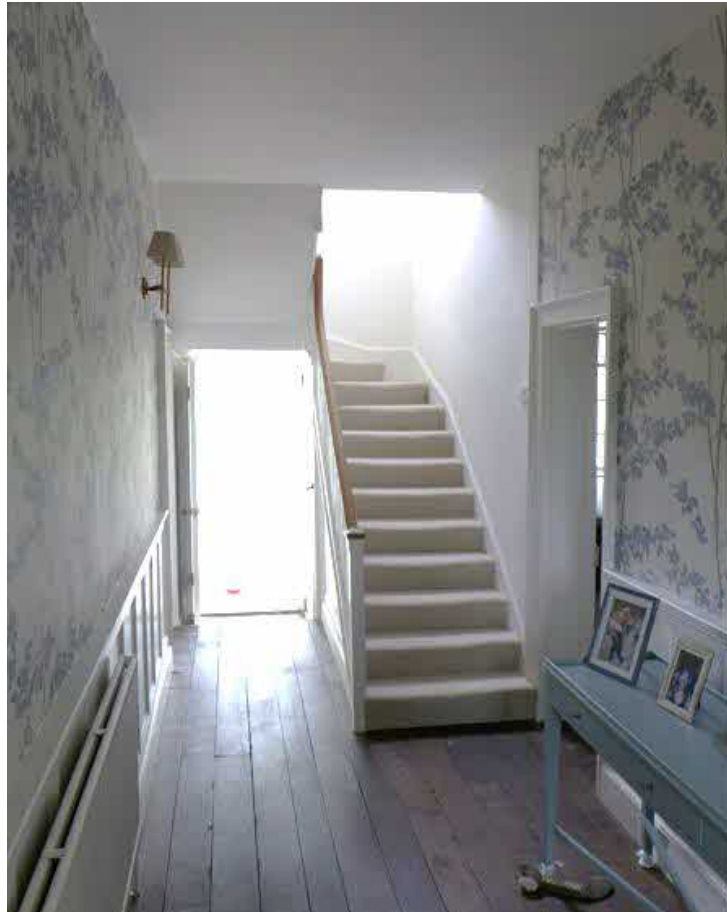
Pl.3: The entrance hall, looking north towards the stairs.

The stairs have a solid string with simple mouldings and stick balusters supporting the plain-moulded handrail; towards the top of the stairs is a section of ‘kites’ turning up to a quarter landing and as the hand-rail has a ‘swan’s neck’ or ‘ramp’ as it begins to turn. The newels are quite thin and square sectioned, with simple caps.

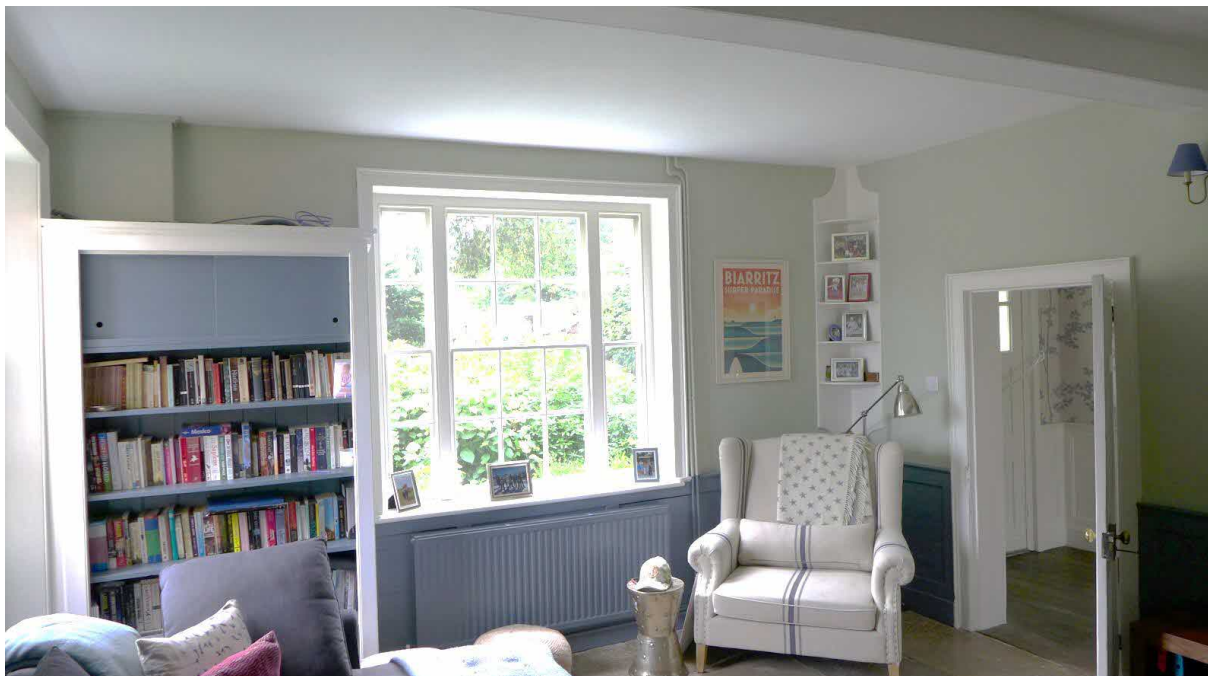
Pl.5: The former dining room, looking north-west.

The south-eastern front room – the former dining room - is lit by windows in the front and east walls – the front one with a sill above the room’s plain unpainted panelled dado and that in the side with a full height recess with low window seat. The room has no cornice and is spanned by a boxed west-east bridging beam. There is a solid stone floor of large and well-worn flags and a modernised brick-lined fireplace in the north wall. The room has evidently been modernised. A doorway through the eastern end of the spine wall leads into a baffle entry lobby leading not to the rear room but to the East Wing.

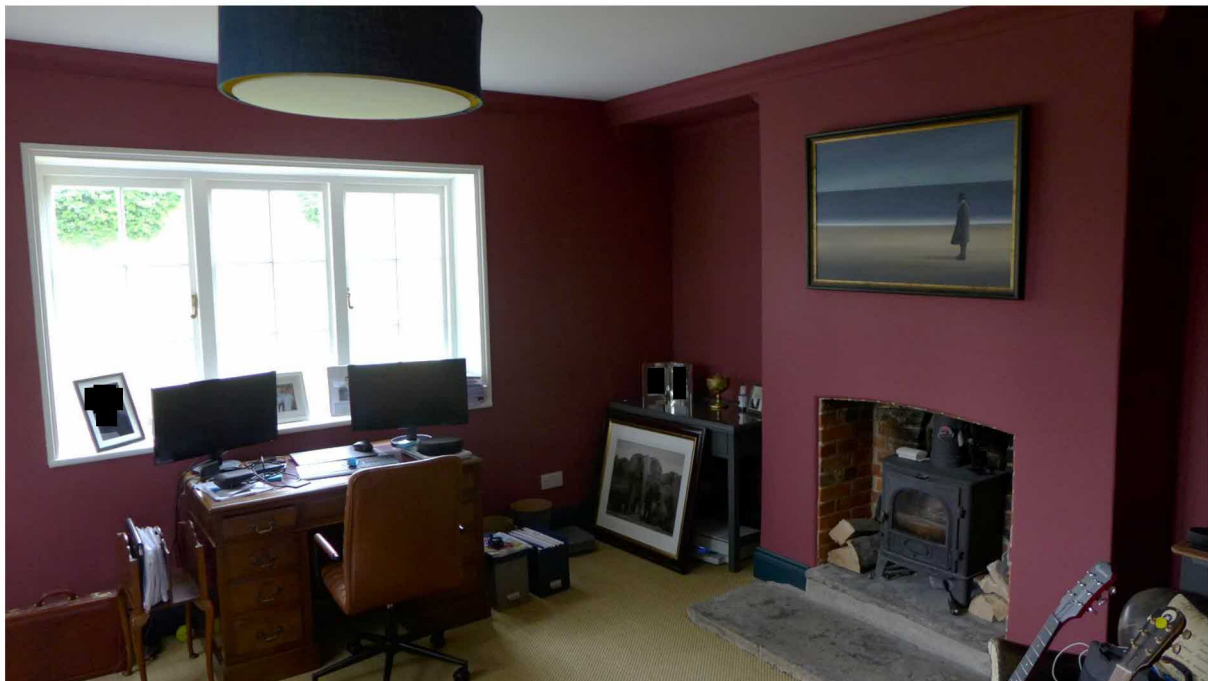
Pl.6: The drawing room, looking north-west.

The south-western front room, the present drawing room, is lit by windows in the front and side wall – though the character of the latter is unconvincing. Both windows are silled and the front one probably retains its original architrave.

The room has a skirtingboard – possibly modern – and no dado. It does have a very simple cyma moulded cornice – repeated at a slightly lower level in the recesses to either side of the stack in the rear, or spine, wall. That has a brick fire-place with segmental arched brick head with a modern woodburner within it and looks suspiciously modern. The ceiling in this room is lower than that in the south-eastern room – presumably in order to hide the structural bridging beam supporting the first-floor joists.

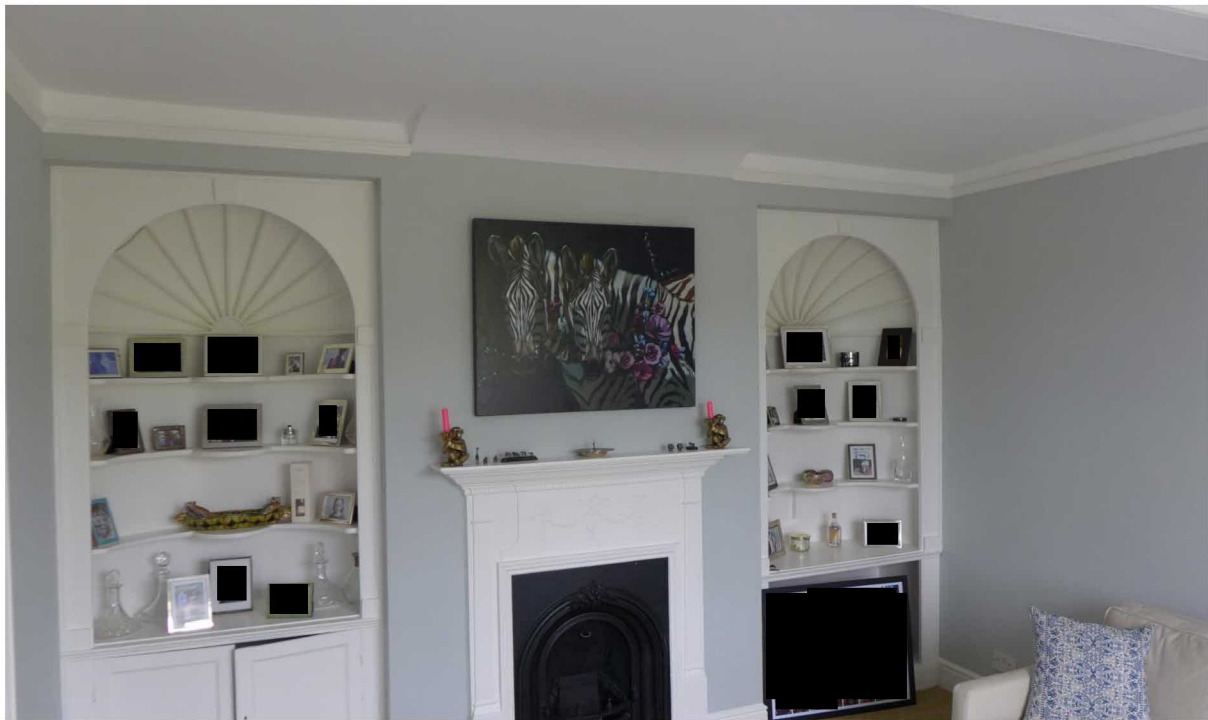
Pl.8: The sitting room, looking south.

A doorway with a six-panelled door of the back of the hall opposite the stairs leads into the rear north-western room, the present sitting room. The room is lit by the silled window in the north wall; it has a skirting board of uncertain date and an equally difficult to date plain cornice. The room is spanned by a west-east bridging beam.

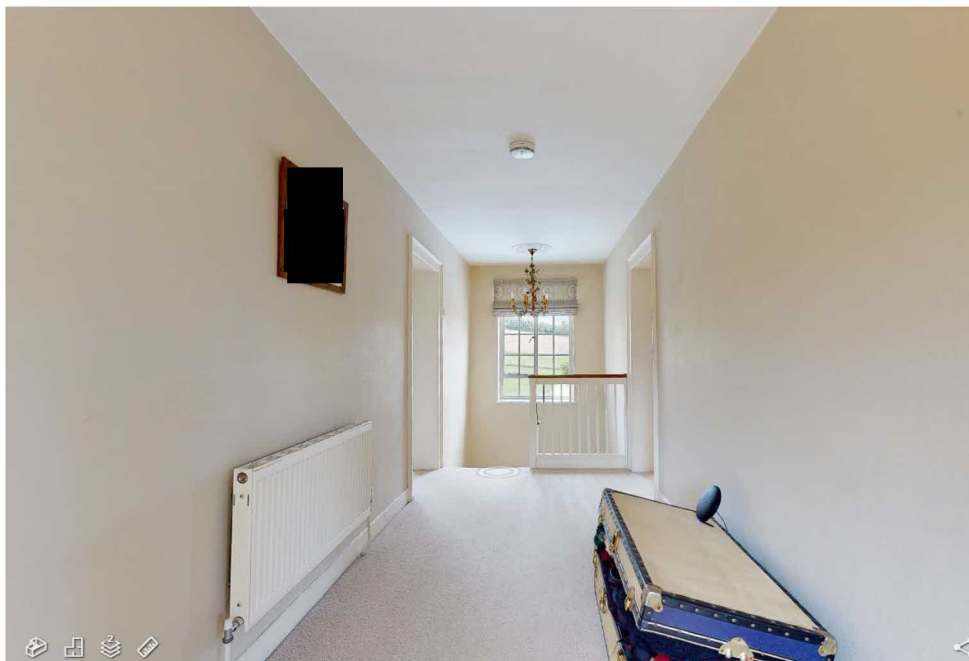
Pl.9: The first-floor landing, looking north to the stairs.

At first-floor level the window lighting the top of the stairs in the north wall is a two-light steel-framed ‘Crittall-type’ casement of the mid-20<sup>th</sup> century. The stair landing extends to the front, or south, elevation where the sashed window has splayed reveals that could suggest it once had shutters.

The landing is plainly decorated with just a low skirting board, though the simply moulded but well-proportioned doorcases of the doorways of it do seem to be original as are, presumably, the two panelled doors they contain. The landing has no cornice.

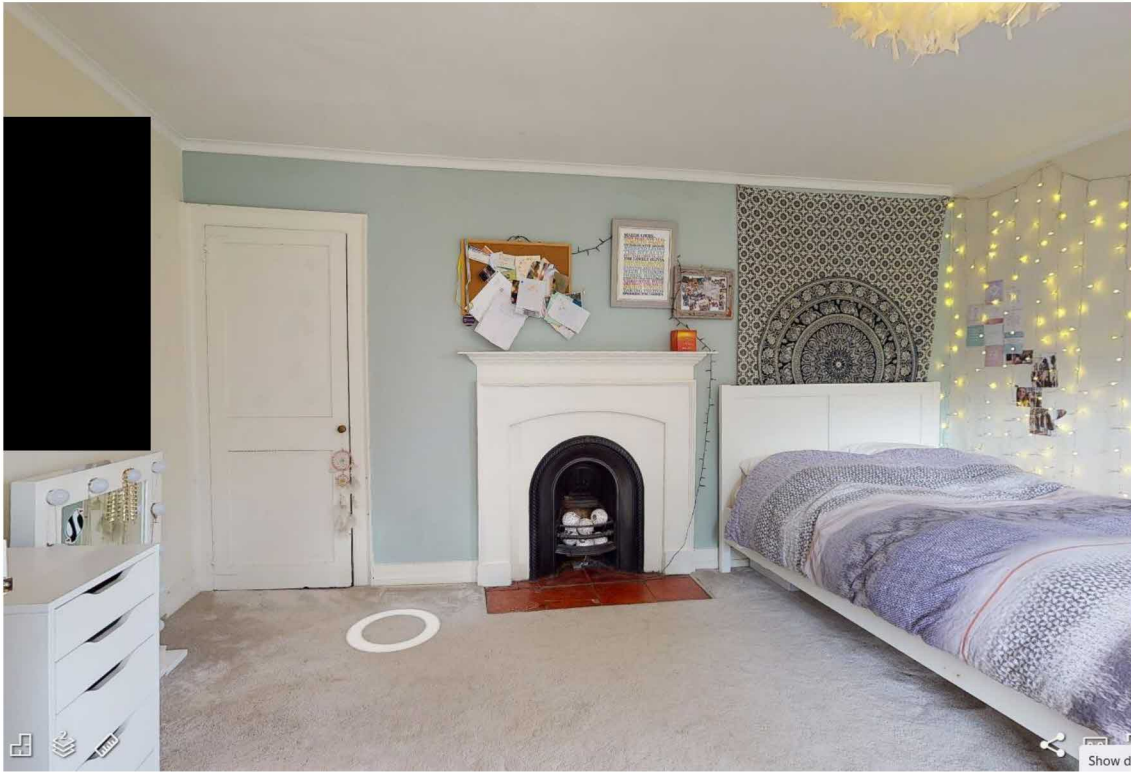
Pl.10: The south-eastern front bedroom, looking north.

The door to the south-eastern bedroom at this level has fielded panels on the room side and was probably originally hung on ‘L-hinges’; a small cupboard doorway to the west of the stack on the north side of the room still is.

The room is lit by silled windows in the south and east walls. It is plainly decorated with a low skirting board of uncertain date and what appears to be a modern thin coved cornice. The chimneypiece in the flush stack on the north, or spine, wall could be primary. It has a simple surround with full ebntablature and a segmental arched head to its original opening. That has been partially infilled to accommodate a mid-19<sup>th</sup> century cast-iron grate with semi-circular head. The plain tile hearth could be primary.

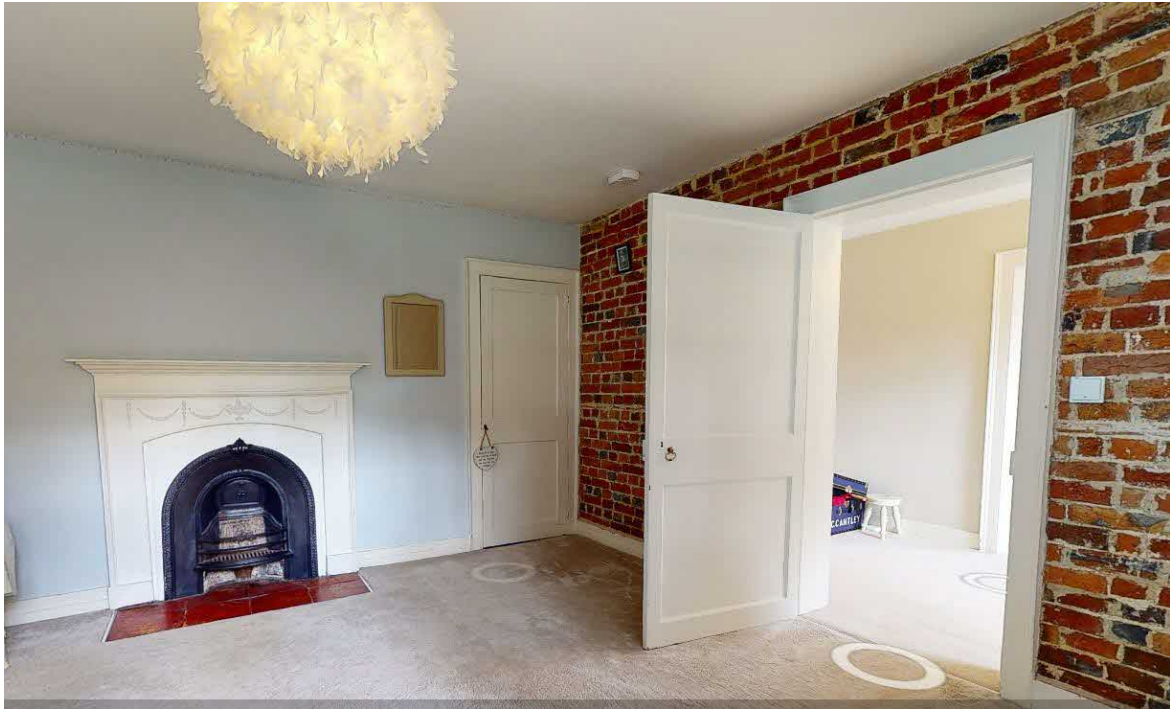
Pl.11: The south-western front bedroom, looking north.

The door of the doorway into the south-western front bedroom is still hung on ‘L-shaped’ hinges and has a fairly crude fielding on the inner face of the panels. For some reason the plaster has been stripped off the east wall of the room, exposing the brickwork. The room is lit by the silled tripartite window in the front wall. As with the other front bedroom it is plainly decorated – with a low skirting board that could be primary but no cornice.

On the north side is the same type of probably primary chimney piece as in the other front room – though this has decorative plaster swags above the original fireplace opening. The opening has also been infilled with a later cast-iron grate, presumably of the mid-19<sup>th</sup> century, and also retains a quarry tile hearth. To the right of the fireplace is a recess with a two-panelled door hung on ‘L-shaped’ hinges and assumed to be original.

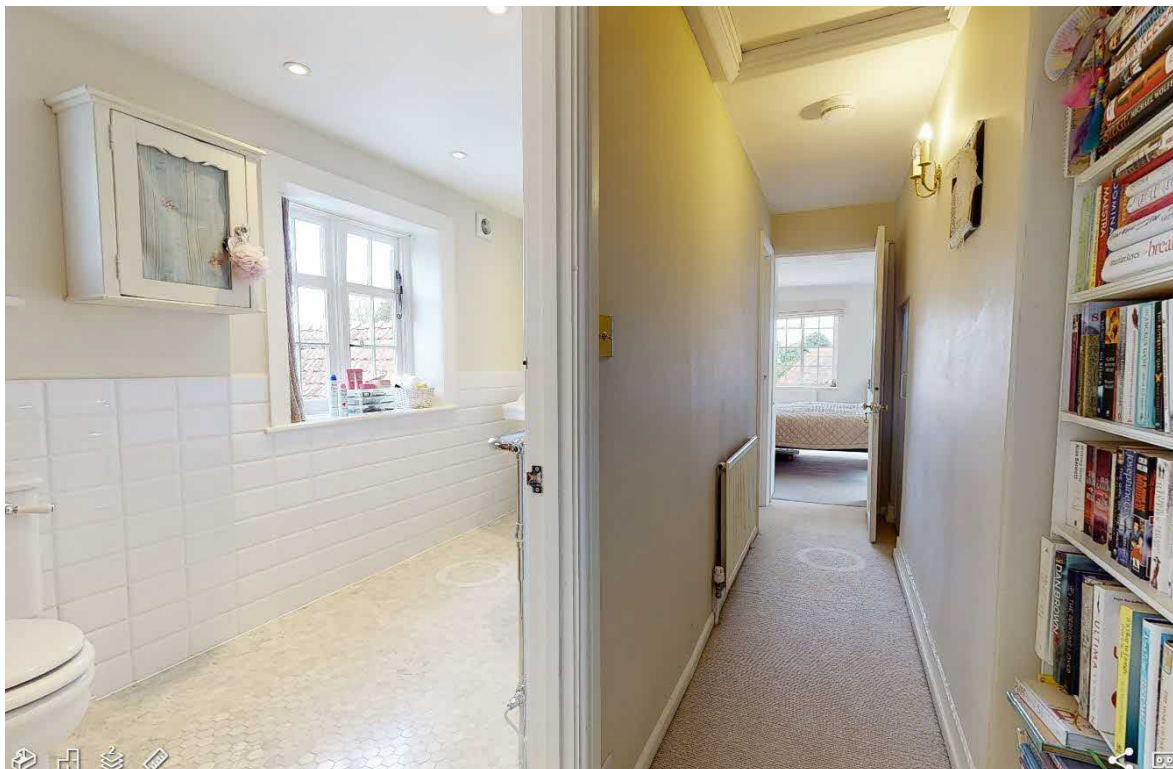
Pl.12: The former north-eastern rear bedroom looking east; the partition is inserted and the present arrangement quite modern.

The evidence indicates that there was originally a single room north of the spine wall and to the east of the stair landing, presumably lit by a single window in the north wall and lit by a fireplace opposite, in the stack projecting from the spine wall.

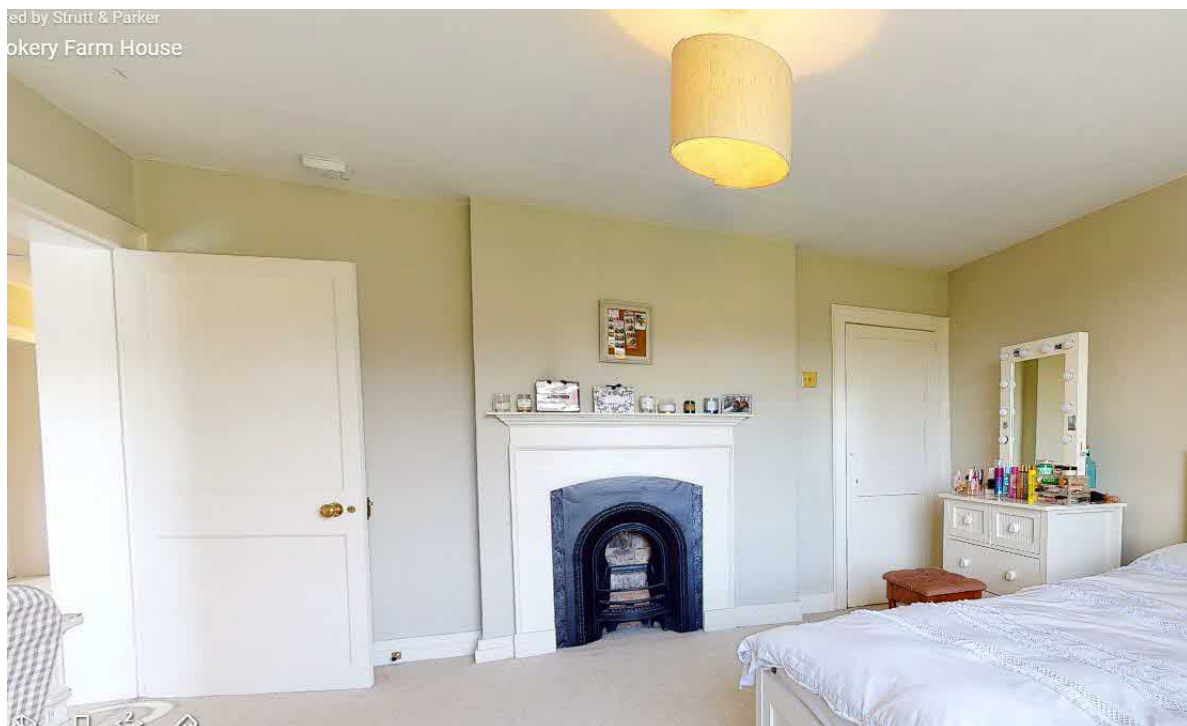
Pl.13: The south side of the north-eastern rear bedroom.

The north-eastern bedroom is also accessed from the stair landing and retains its original parameters. It is lit by the tripartite sash in the north, or rear, wall and opposite that is another possibly primary chimneypieces of the same type as those in the two front rooms. This lacks the swags of the one room but is otherwise very similar. Its original opening has also been infilled when a later cast-iron grate was fitted. The room is also quite plain, with simple skirting board and no cornice.

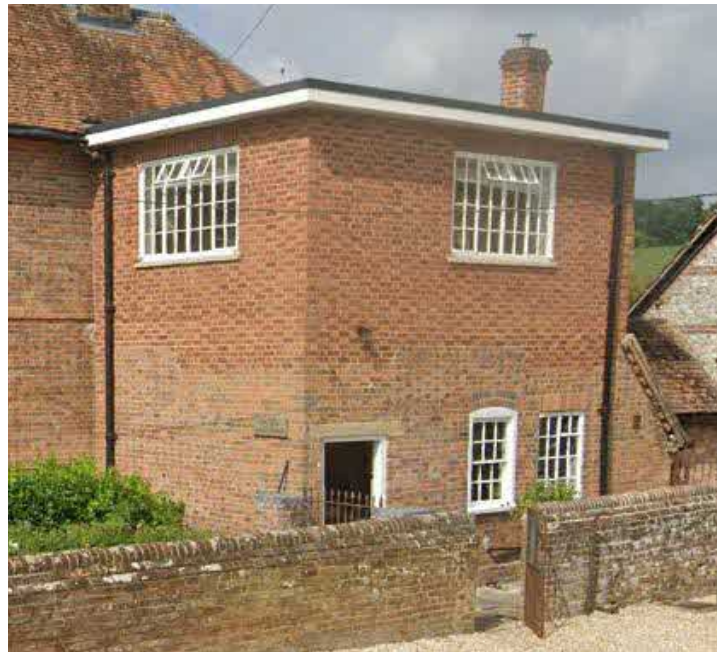
Pl.14: The eastern side of the house, with the East Wing (Building B).

The East Wing is a much altered range that appears to have been added against the eastern side of the Main House – originally as a single storey structure which was then raised up to two storeys.

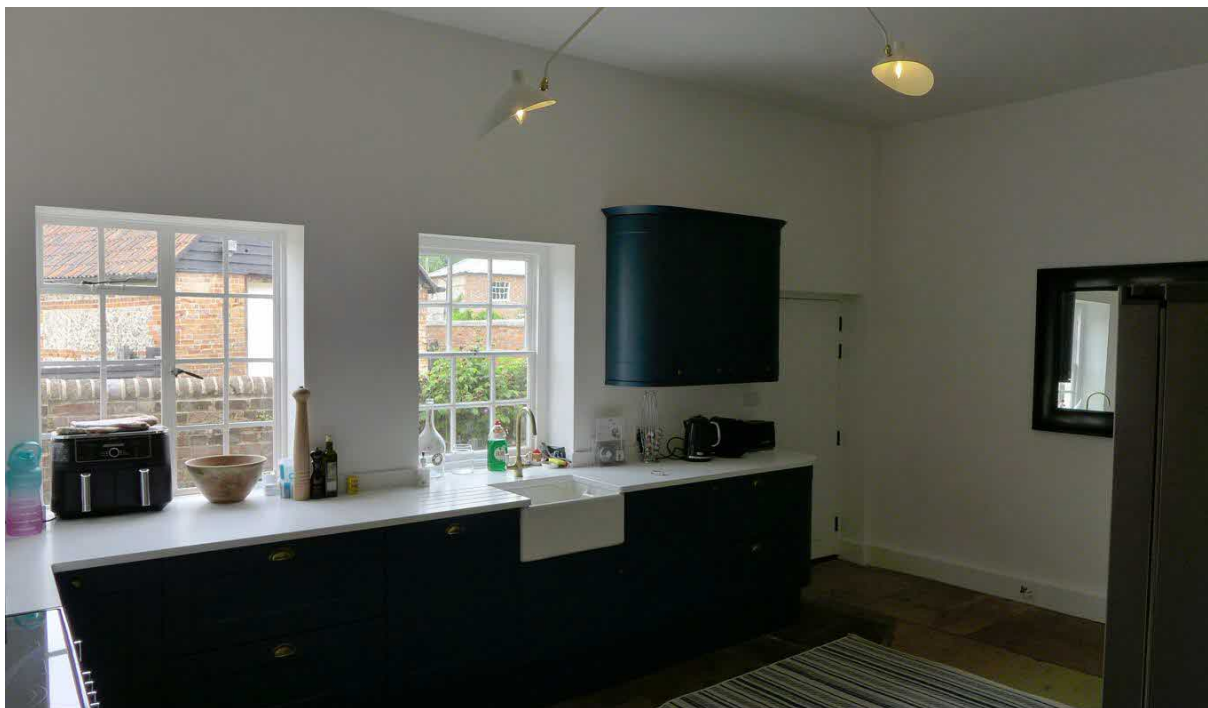
Pl.15: The ground-floor of the East Wing (Building D).

The interior of the ground floor was evidently gutted and modernised when the range was raised and remodelled. It is now mainly a modern kitchen with a utility room in the single-storey lean-to section. Interestingly the exposed internal brickwork indicates that the brick wall now dividing the kitchen from the lean-to is secondary to the eastern wall. The remodelled fireplace in the north wall of the kitchen containing the cooker is probably an early feature of the range but there are no surviving fixtures or fittings of note at this level. The added first floor contains a bedroom and *en suite* and contains nothing of architectural interest.

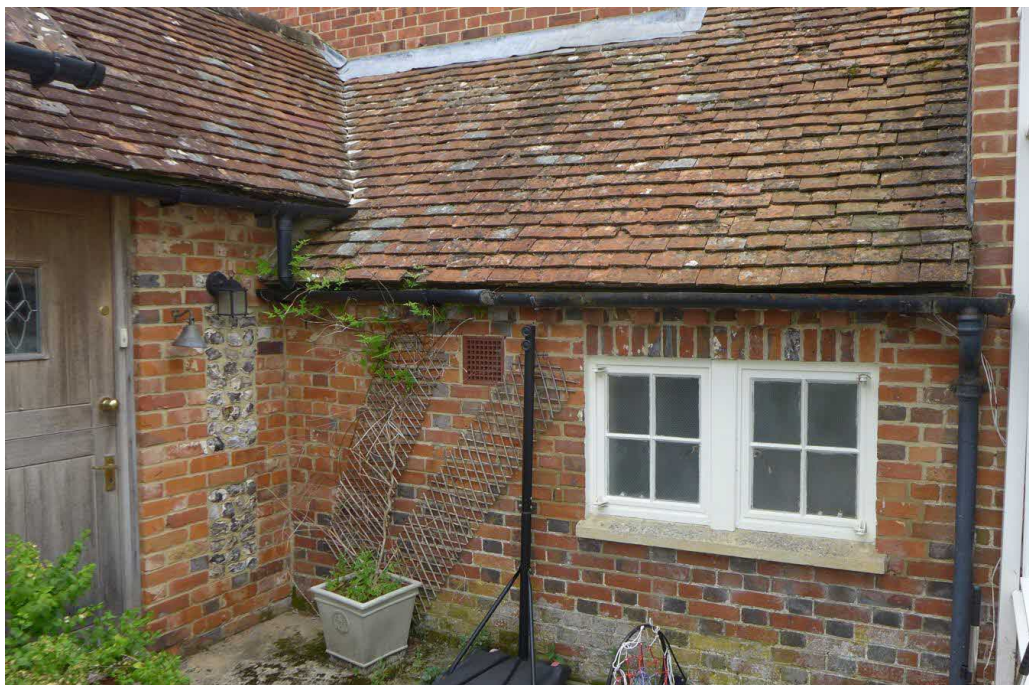
The lean-to section is more complex. As noted above its east wall appears to continue the line of the east wall of the East Wing (Building B), but there are inconsistencies in the brickwork and the decorative verged slope is odd. Its north wall, visible between the link section and the side of the Garden Room, is of old brick but most of that is set in cement mortar.

There are possible remnants of older brickwork *in situ* low down in the wall but the rest, above about 500mm, has evidently been rebuilt - presumably when the present casement window with its soldier arched brick head was added and, given the manner in which most of the brickwork is coursed through between the two, when the link was built. The lean-to roof is plain tiled and appears to be of recent date – as is the general character of the interior which is devoid of any fixtures or fittings of note.

Pl.16: The north side of the Linking Range; note modern window, the use of cement mortar and plainer brick above 500mm and bonding in of the two sections on the left-hand side.

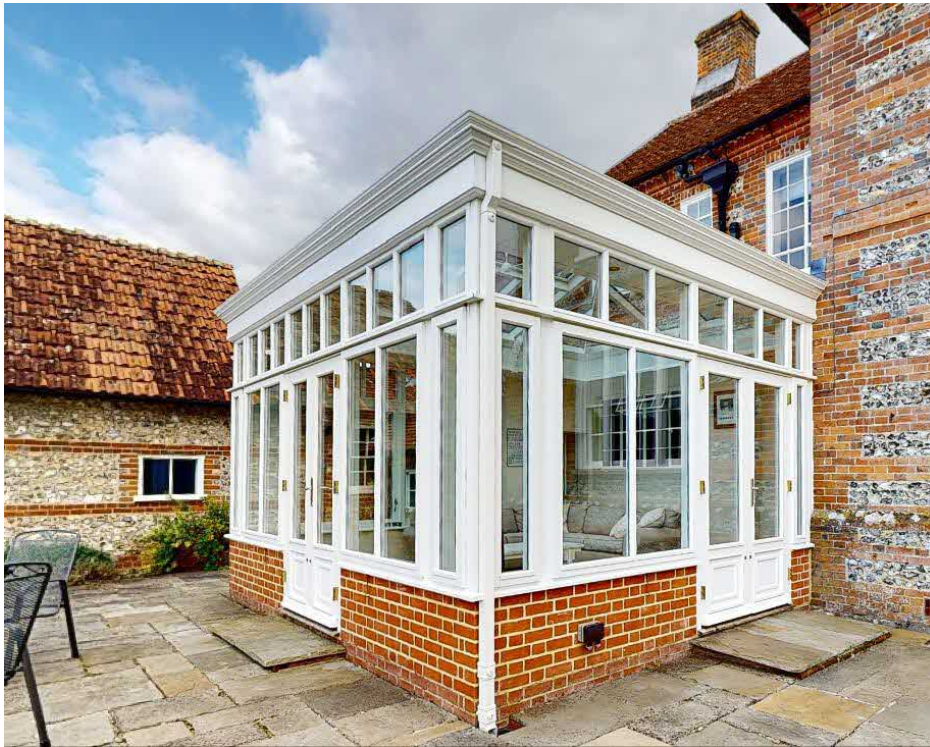
Pl.17: The modern garden room (Building D).

The Garden Room was built against the rear, or north, wall of the Main House, tucked into the angle between the main section of that wall and the side of the north-western projection. It replaced an earlier and smaller glazed conservatory or porch after being given planning consent in 2009. It is a large structure with vaguely neo-classical detailing on a brick plinth with fully glazed sides and a large top lantern.

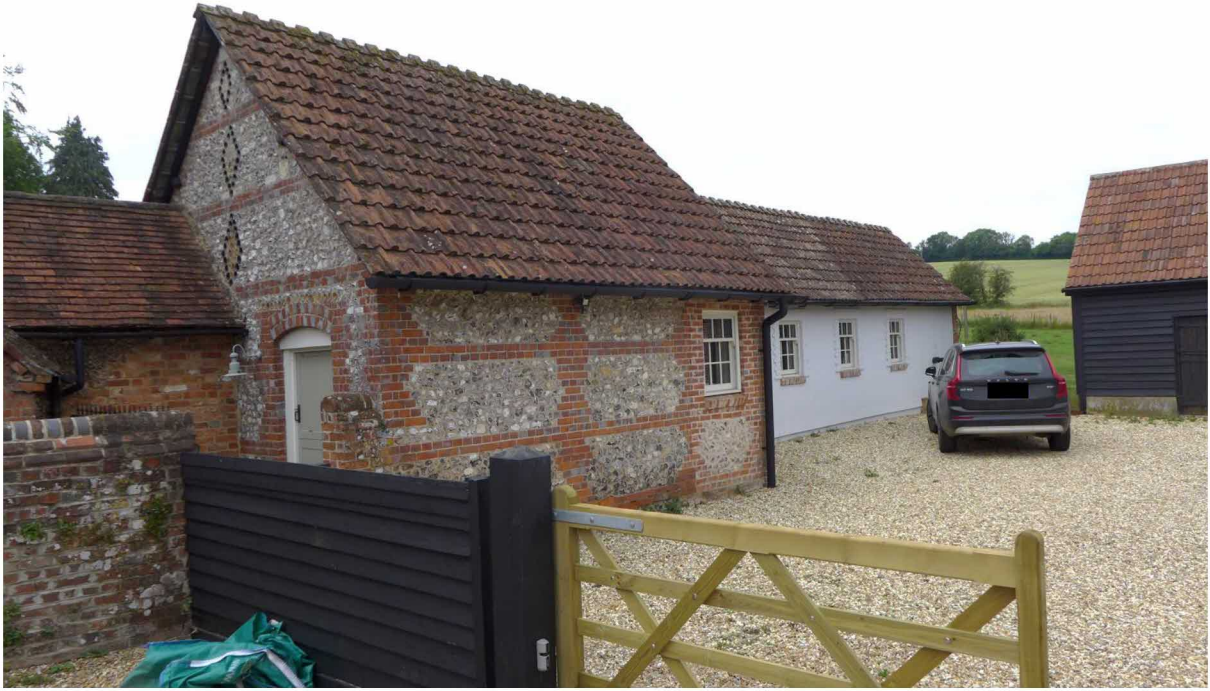
Pl.18: The Outbuilding from the south-east.

The main entrance at the east side of the south gable is a doorway with brick jambs and a segmental arched head of alternating red and burnt-grey brick headers – the surround enriched with a row of wine bottle bases above the brickwork.

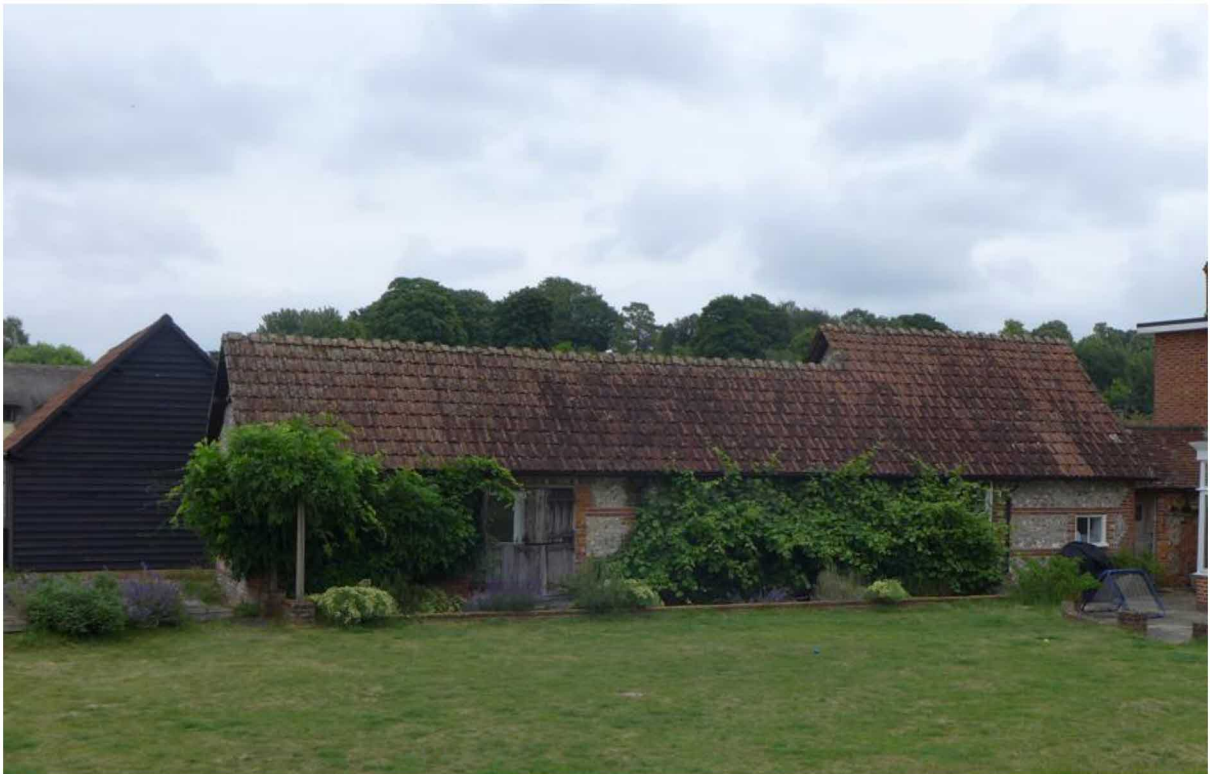
Pl.19: The west elevation of the Outbuilding.

The western side has a rounded brick corner at the south-western corner and a primary window opening in the shorter northern 'bay' of the design. A smaller window, set between the two intermediate rows of brick, appears to be inserted.

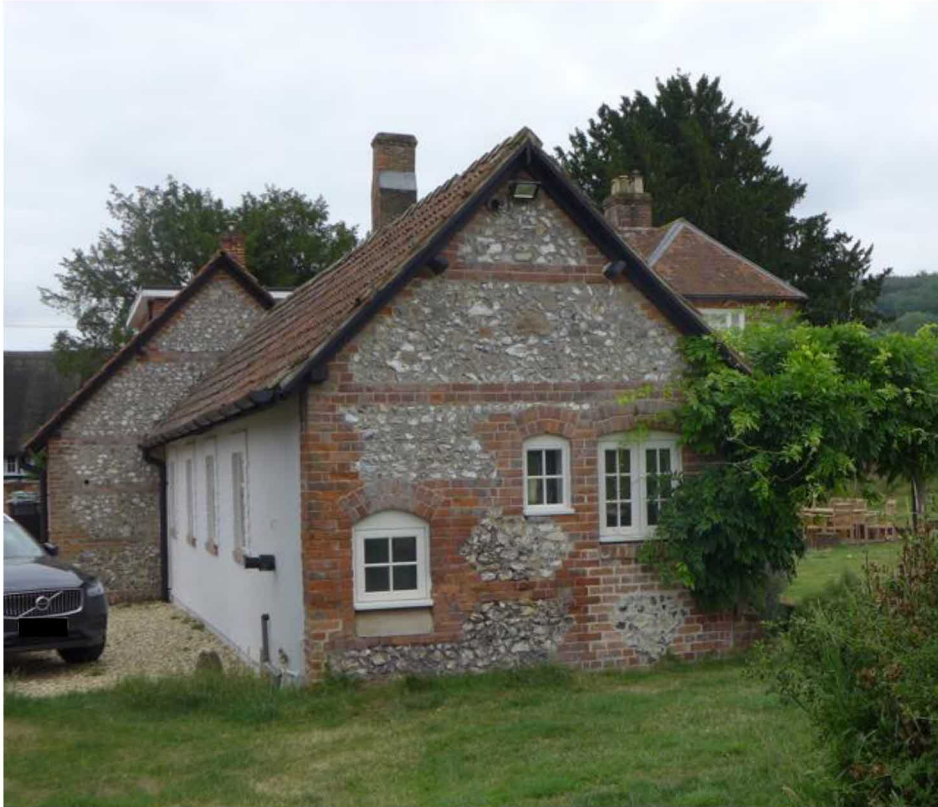
Pl.20: The Outbuilding from the north.

The north gable end is of crude flint-rich rubblestone with brick quoins and surrounds to original openings as well as horizontal bands echoing the traditional locations of a truss tie and collar – as well as further brickwork in the verges. There are now three window openings in the elevation, each occupied by modern casements.

These have almost pointed two-centred arched heads of two rings of brick and brick jambs. The small central window opening and the one on the extreme left-hand side are assumed to be original. The larger two-light casement at the right-hand end seems to have been set into the blocking of an original doorway – accounting for the inconsistency of cement mortar of the masonry and brickwork below its sill.

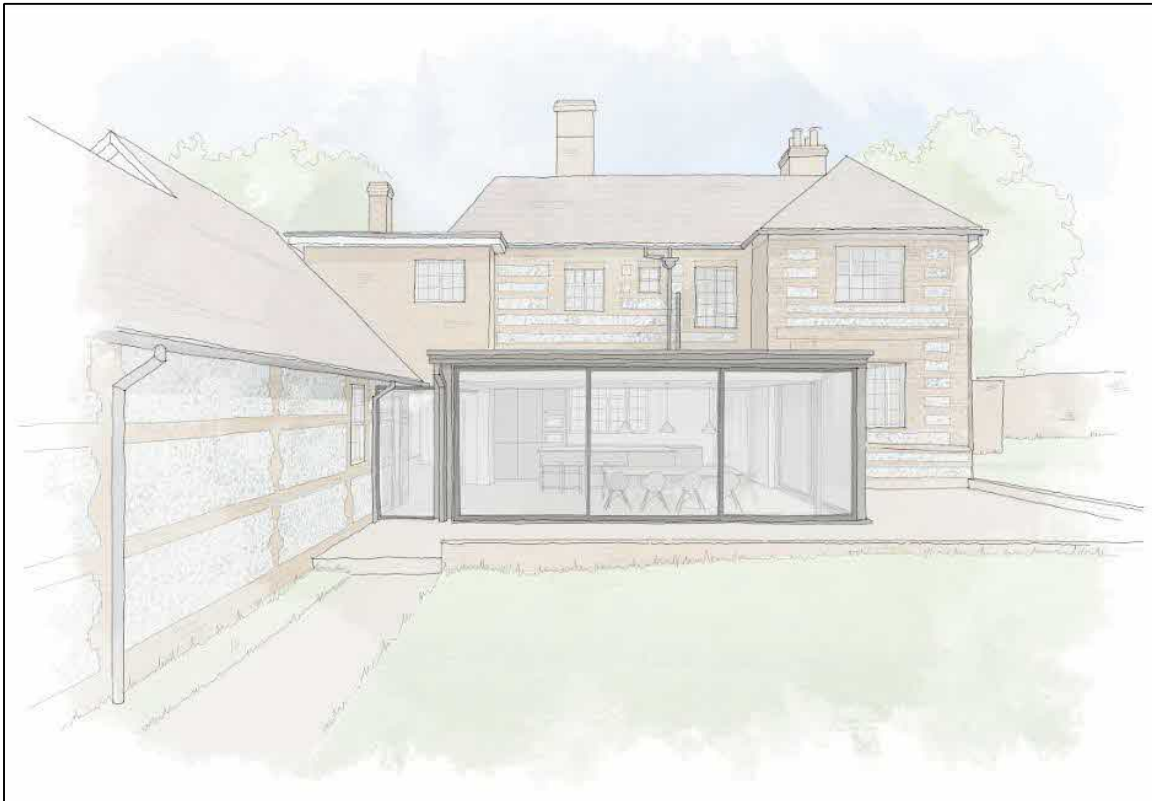
Fig.7: Artist's impression of the new kitchen range from the north.

Proposals are being developed for some alterations to the property and these can be broken down into two main elements – the removal and replacement of the present modern conservatory or garden room with a new structure of similar scale to accommodate a new kitchen, with associated changes to the existing one; and the conversion of the present Outbuilding or Annexe from *ad hoc* ancillary use into a guest suite. The proposals are shown in the plans and illustrations below.

Following the removal of the present modern conservatory or garden room, it will be replaced by a simple, high quality and well insulated single storey extension containing an enlarged kitchen. The existing kitchen will be re-purposed as a Utility/Boot Room.

It is considered that the proposed replacement structure is well-designed and proportionate and its scale and massing have been carefully considered. It is larger than the existing garden room but better infills the junction between the house and the annexe and is lower than the existing one so that more of the historic fabric of the rear of the house is visible.
