## Preliminary bat roost assessment

Site Location	Rookery Farm House, The Hill, Hurstbourne Tarrant, Andover, Test Valley, Hampshire, SP11 0AE
Document reference	CE4308-01
Date of Site visit	24 <sup>th</sup> August 2023
Report by	Garry Smith – Senior Ecologist Signature: [REDACTED] Tel: [REDACTED] Email: <a href="mailto:info@chaseecology.co.uk">info@chaseecology.co.uk</a>

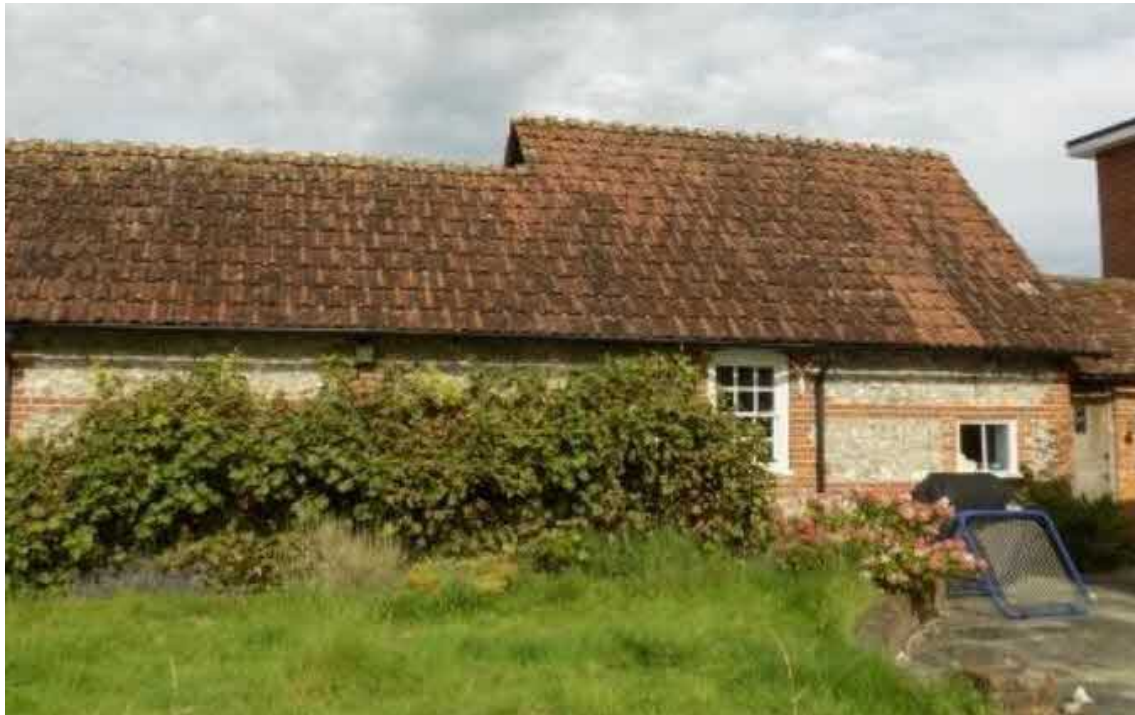
Image 1 – West facing elevation of the building

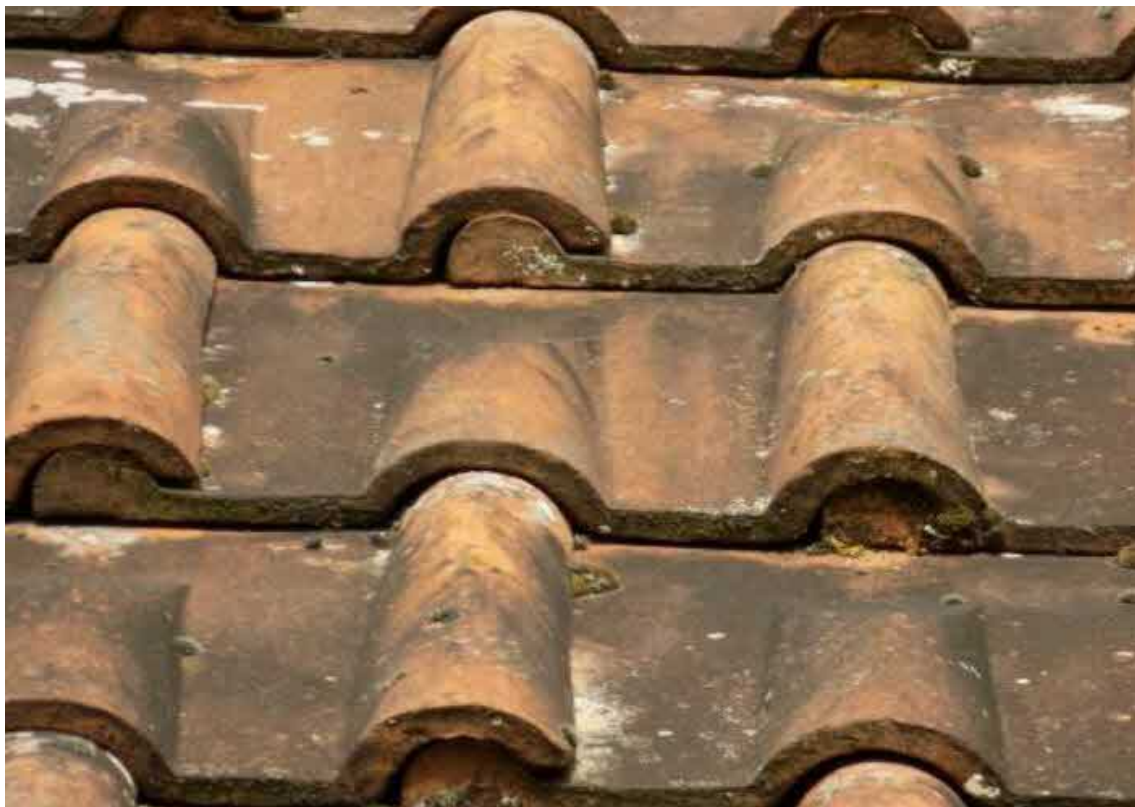
Image 2 – Close view of the West facing roof coverings which have demonstrated a fair level of condition

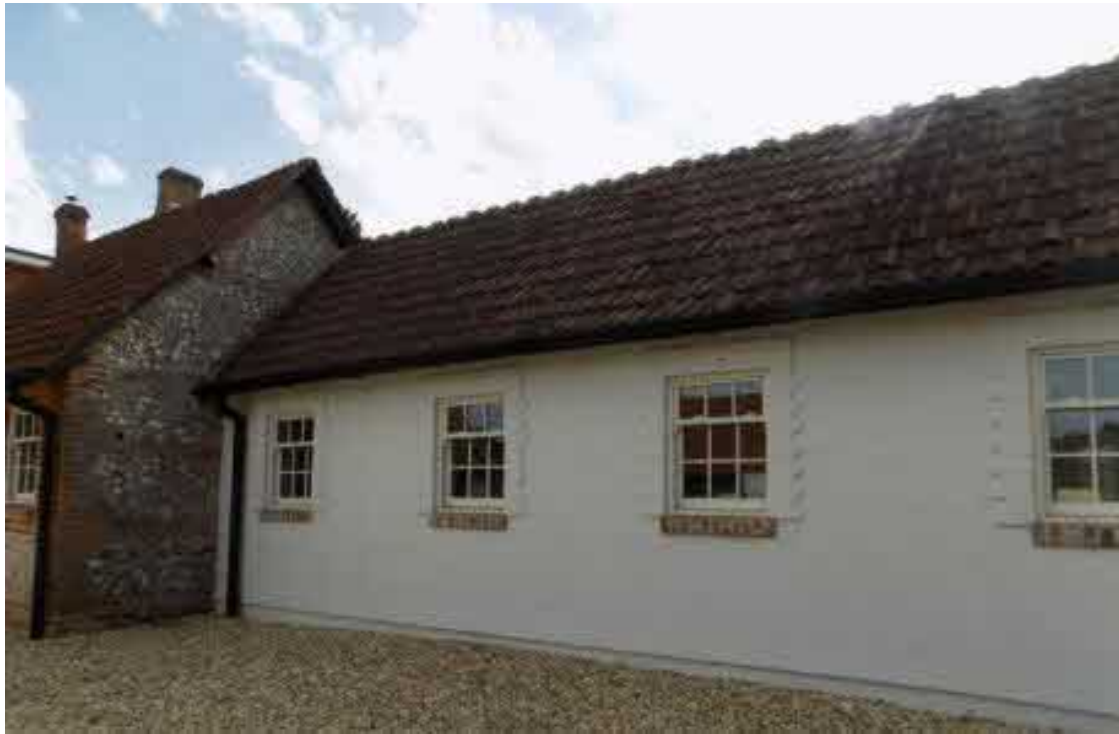
Image 3 – East facing elevation of the building

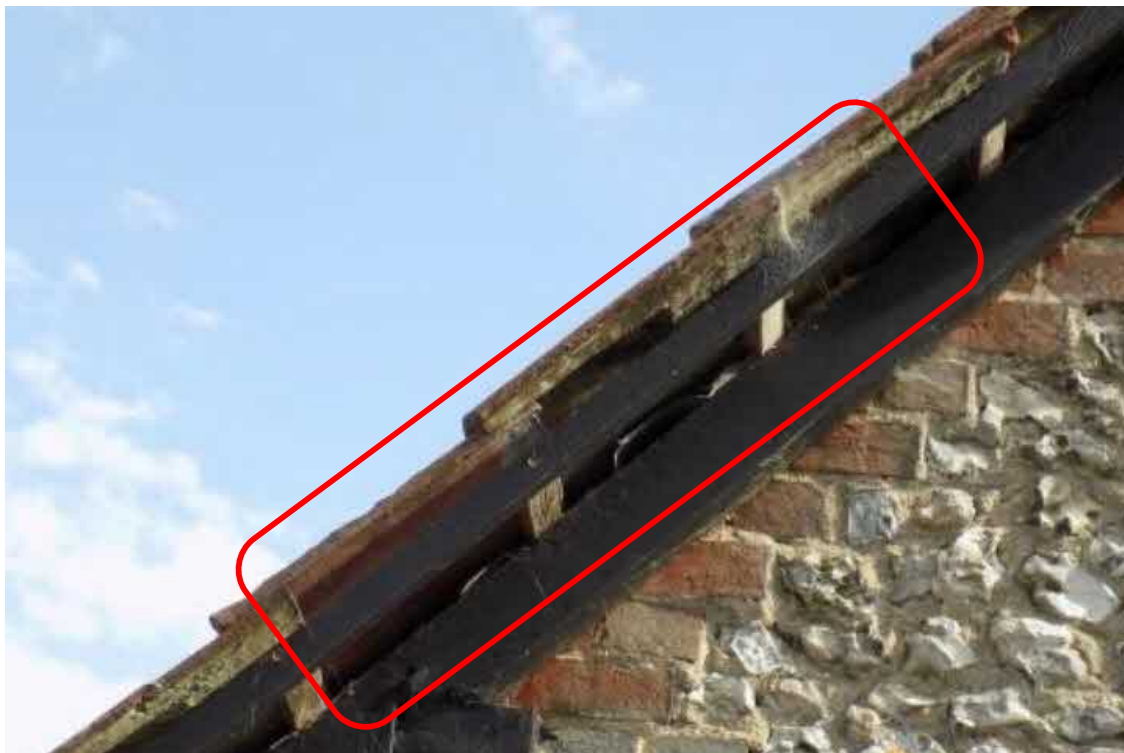
Image 4 – North facing gable offering gaps to the eaves areas which look to offer likely access opportunities for bats

- 6.4** The structure has demonstrated features of low value within the roof & eaves areas which offer access and availability to both void & crevice dwelling bats and could not be fully ruled out during the Preliminary Roost Assessment without causing disturbance to materials which in effect may cause disturbance to possible bat roosts within.

- 6.6** In line with current accepted guidelines, a structure that has demonstrated low value must have a further single emergence or re-entry surveys to rule out or confirm activity from bats. This survey should be carried out within the recommended survey season from May to September.

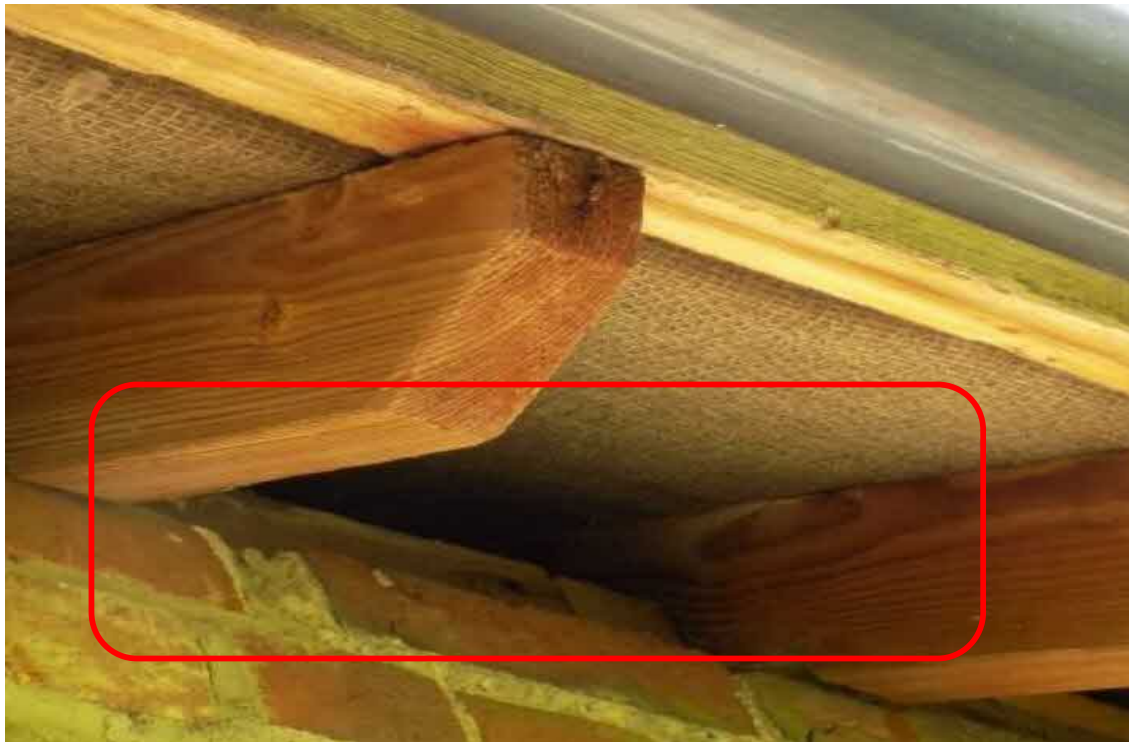
Image 5 – Further gasp of value to bats observed within the eaves areas

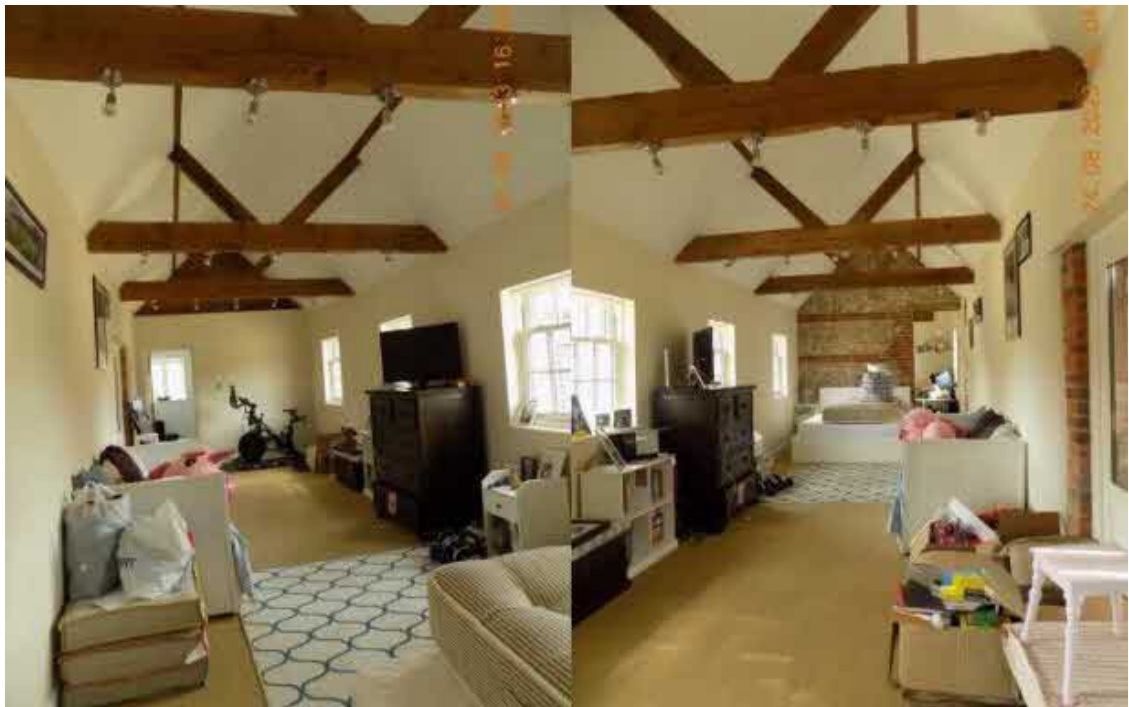
Internal	Features of value to bats	Notes
Membrane coverings	Yes	Felt membrane coverings observed around the eaves areas of the property.  No other assessment below the roof coverings available as the inner areas are a vaulted and boarded coverings.
Evidence from bats	No	No observed evidence from bats both internally or externally.

Image 6 – Internal view from within the building

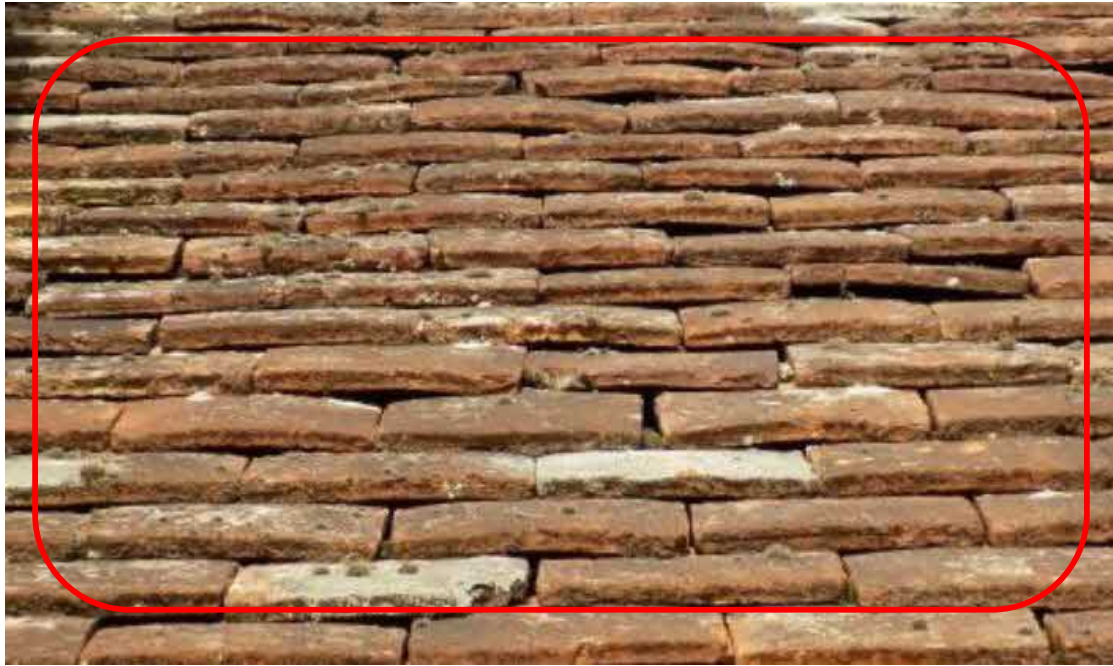
Image 7 – East facing connecting roof coverings between the building and main dwelling which has demonstrated gaps of value to bats

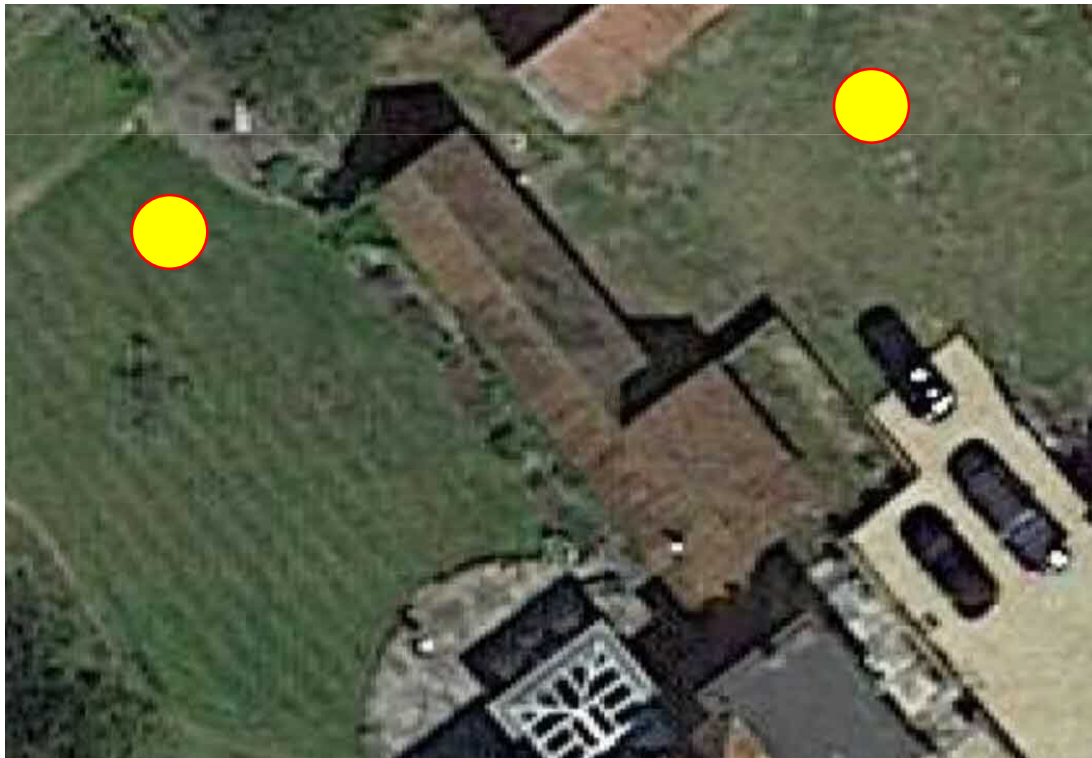
#### Appendix 4: Emergence Survey Location Points

Below site view to show suitable surveyor location points during each emergence survey to maintain visibility of the property.

In line with best practice survey guidelines, a total of two surveyors will be required to visually cover all elevations of the structure during each emergence survey.
