THE BARN, TOP O'TH' HILL, RIVINGTON LANE, RIVINGTON, LANCASHIRE

Historic Building Survey

Matrix Archaeology

Report No. 2021-10
(Project Code: MA810)

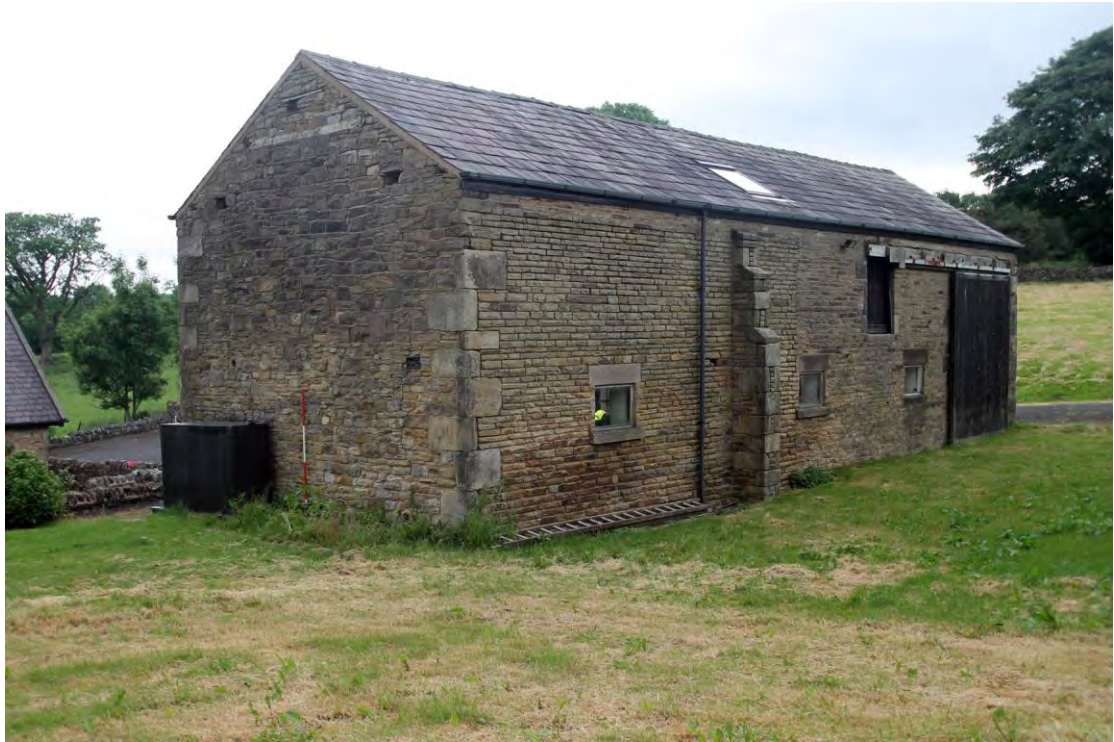
Plate 3. Barn south elevation, viewed from south-west.

The south-facing wall was neatly constructed of rectangular slabs of local fine-grained sandstone, in regular courses, with larger rectangular blocks defining the quoins at the wall corners. This was in contrast to the other three elevations, which comprised sandstone blocks set in fairly irregular courses. This may well reflect a desire to present a more impressive elevation to public scrutiny, given that this elevation is most obvious when the farm is viewed from the trackway located to the south-east.

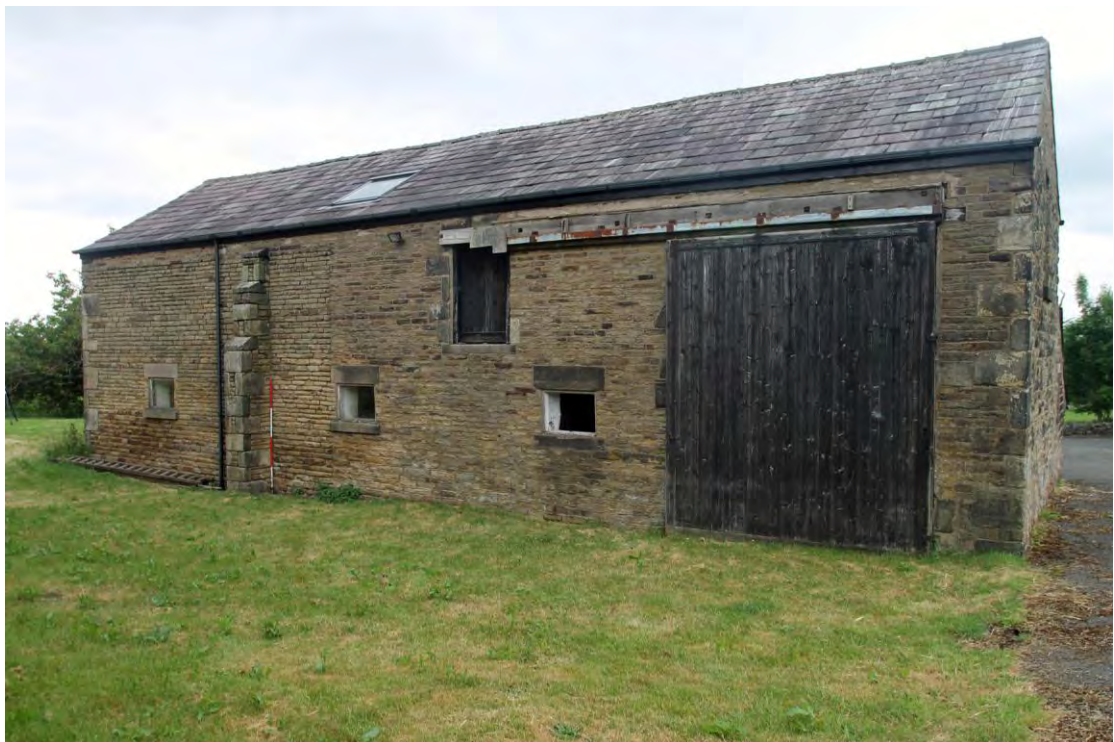
Plate 4. Barn south elevation, viewed from south-east.

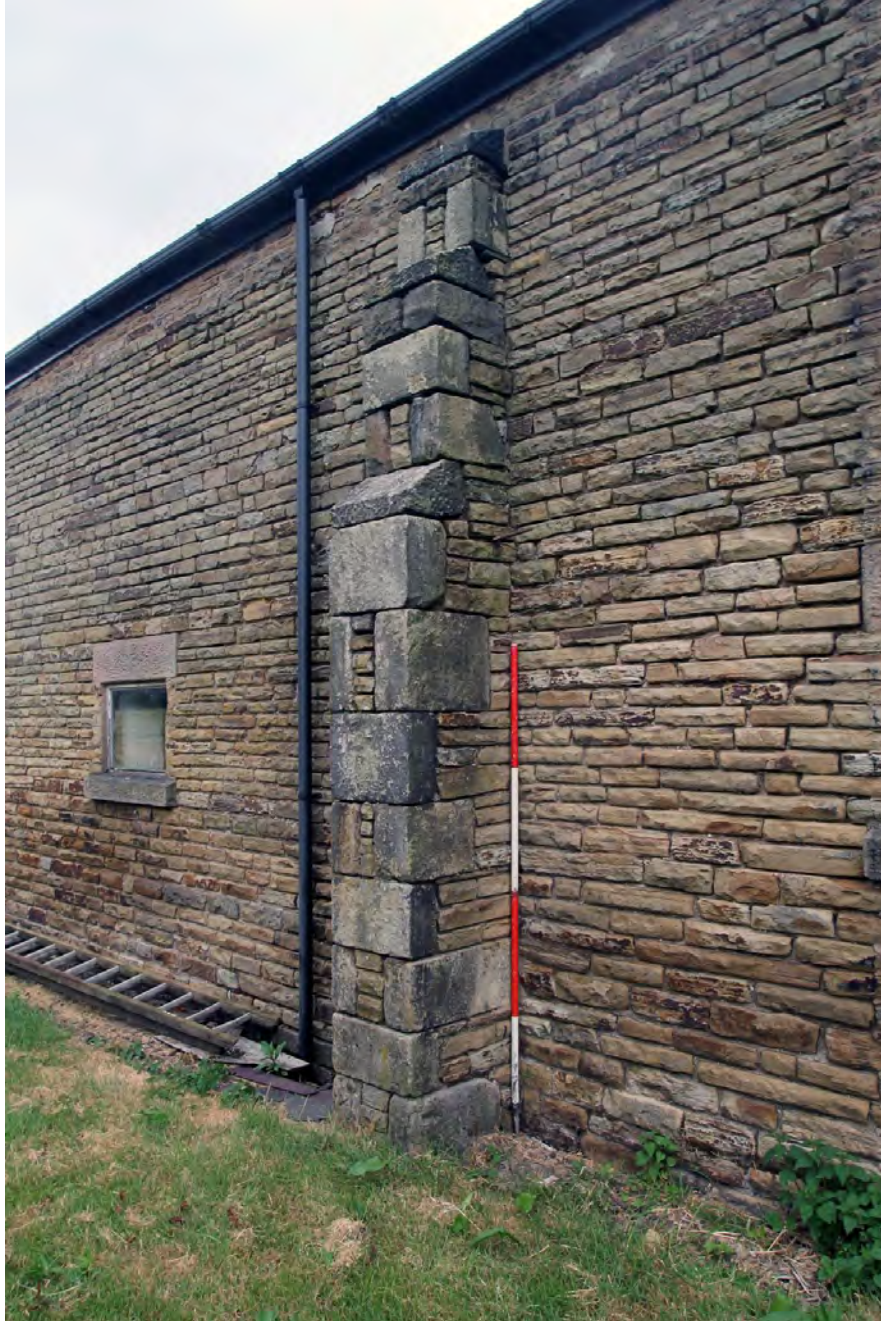
Plate 5. Buttress in barn south elevation, viewed from east.

At first floor level, giving access to the hayloft, was a small taking-in door, over bay 2. A tall chamfered buttress, probably original, defined the boundary between bays 3 and 4.

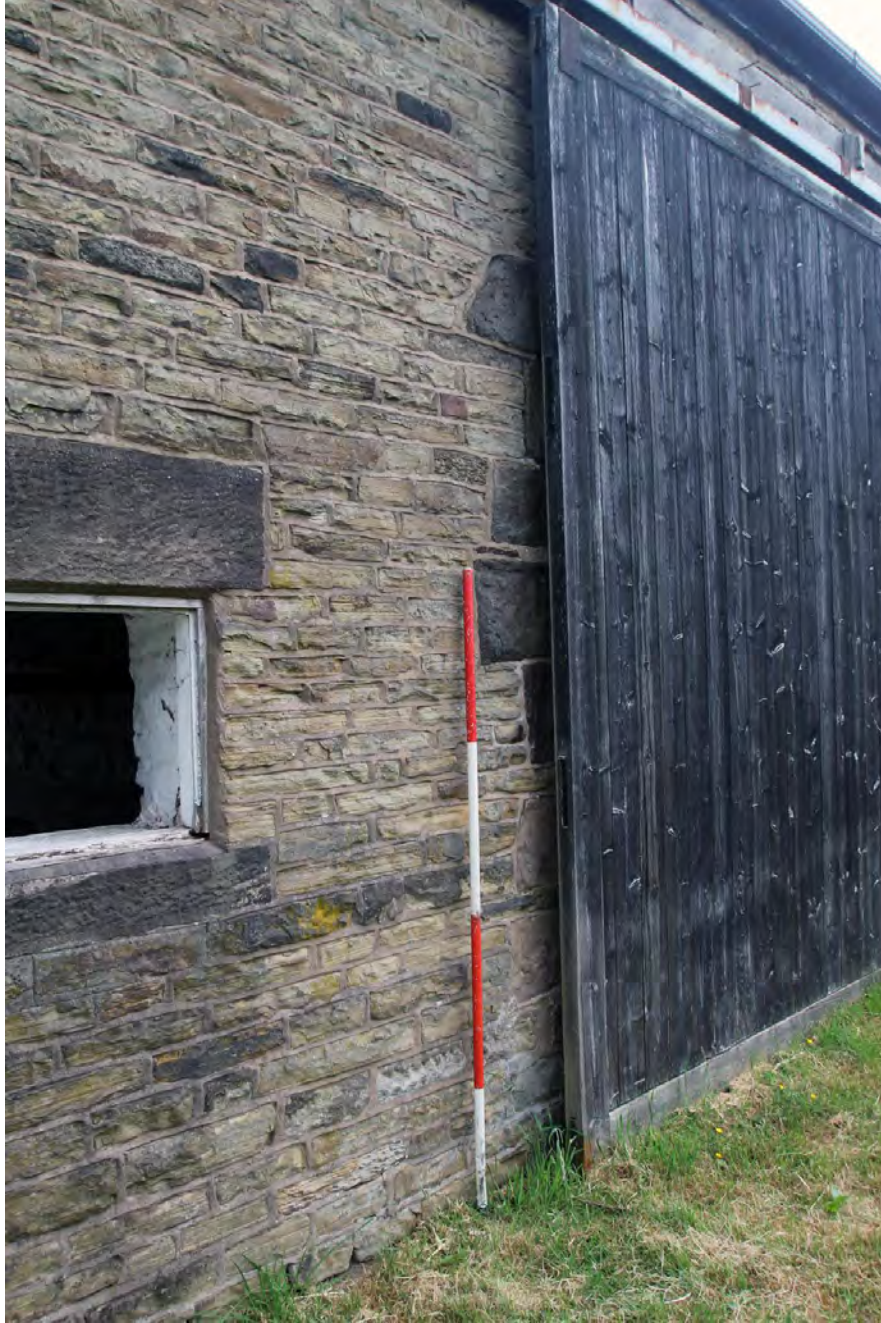
Plate 6. Doorway to drift house, in barn south elevation, viewed from south-west.

Bay 1 comprised the probable drift house, hence a large double doorway was located here. The sliding timber doorway could not be moved, although the door surround on the west side was formed of large sandstone blocks. At ground floor level, each of the remaining three bays were illuminated by small single light windows, with sandstone slabs for both cills and lintels.

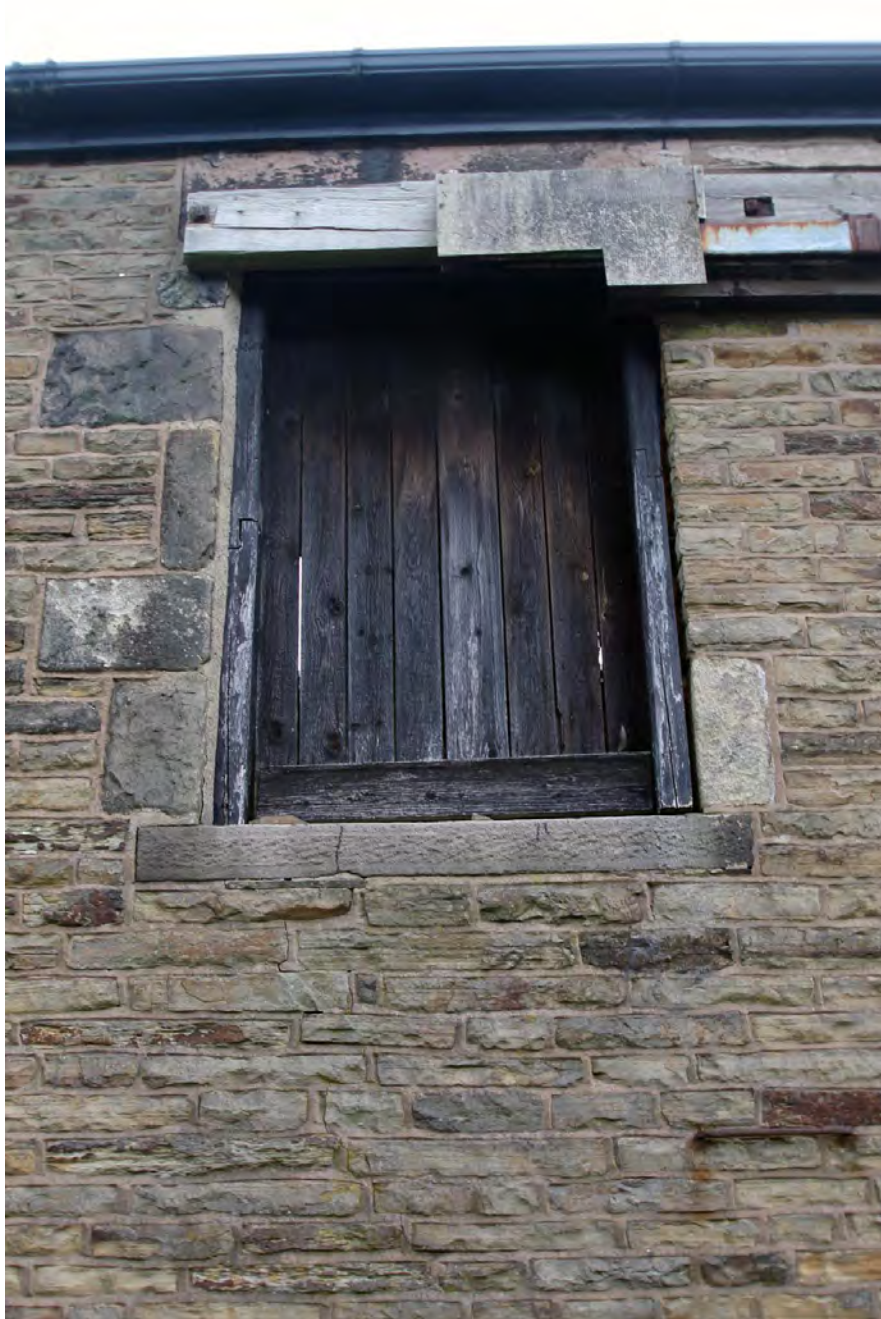
Plate 7. Taking in door in barn south elevation, viewed from south.

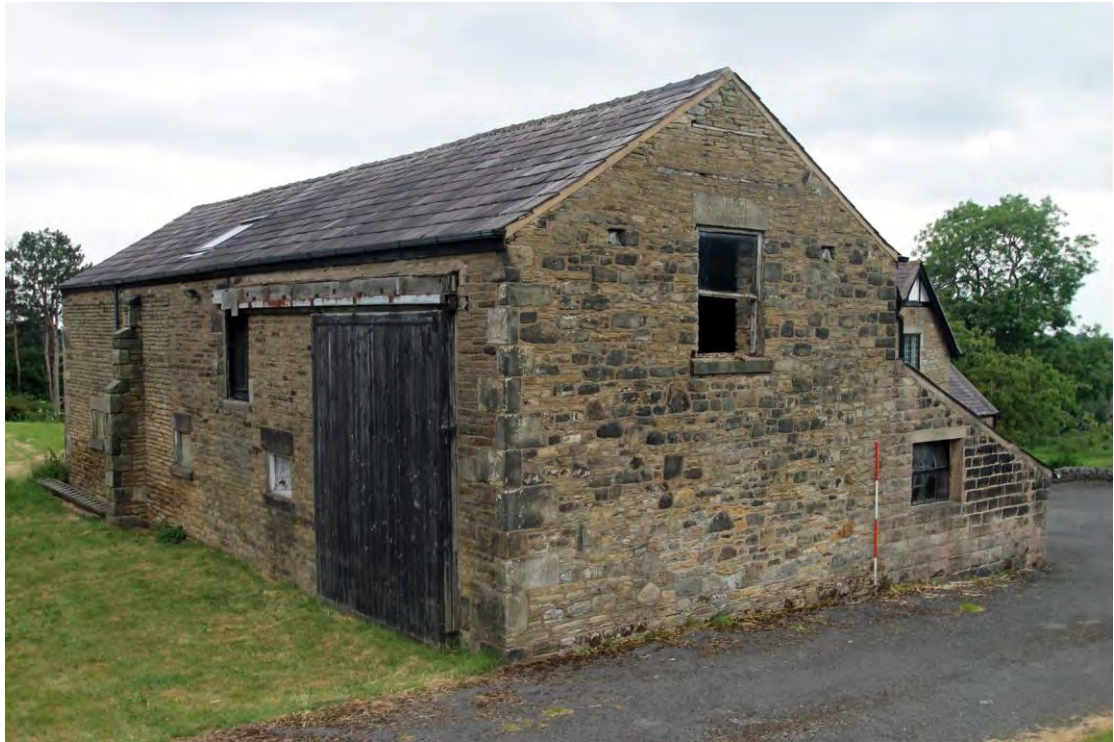
Plate 8. Barn, viewed from east.

This gable comprised irregular coursing of both sandstone blocks and slabs, in contrast to the neater 'public' face of the south elevation. At the upper level of the gable was a large two-light window, intended to illuminate the workings of

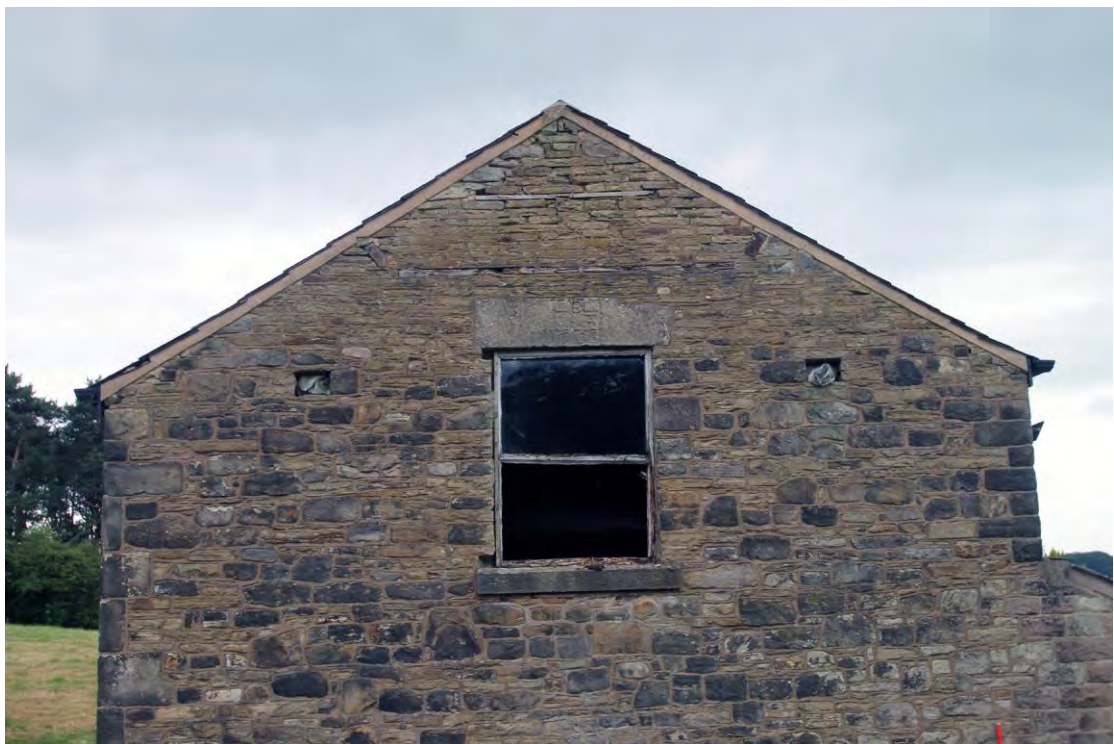
Plate 9. Pike of barn east elevation, viewed from east, showing ex situ datestone over window.

the probable drift house. The window lintel was of particular interest, as it comprised an ex-situ datestone of 1703, probably taken from the doorhead of the farmhouse which preceded the existing one. The window cill was a rectangular block of sandstone with a rusticated finish. To either flank of the window was a small rectangular hole, possibly a combination of both ventilation and owl hole, to reduce the rodent population.

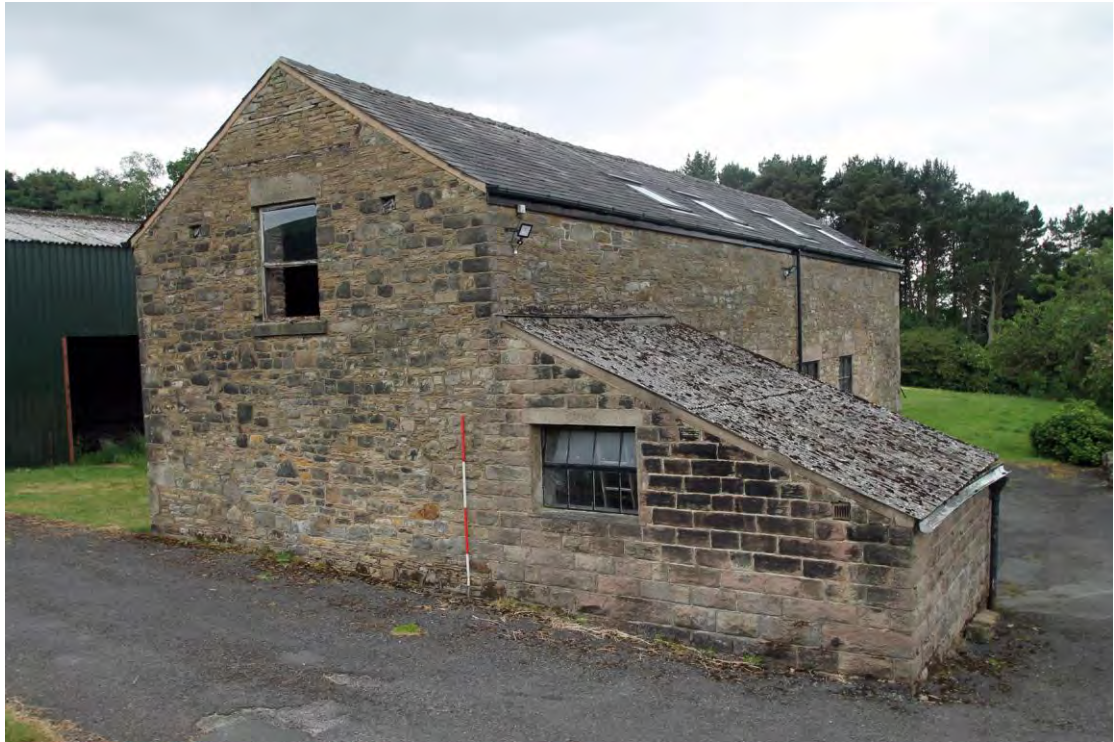
Plate 10. Barn, east elevation, viewed from north-east.

The appended outshut, on the north side, was bonded in by a vertical ragged joint, requiring the removal of the original quoins. The outshut comprised rectangular blocks of pink-buff coarse sandstone, laid in neat courses, which contrasted with the earlier gable. An eight-light window illuminated this single-storey structure.

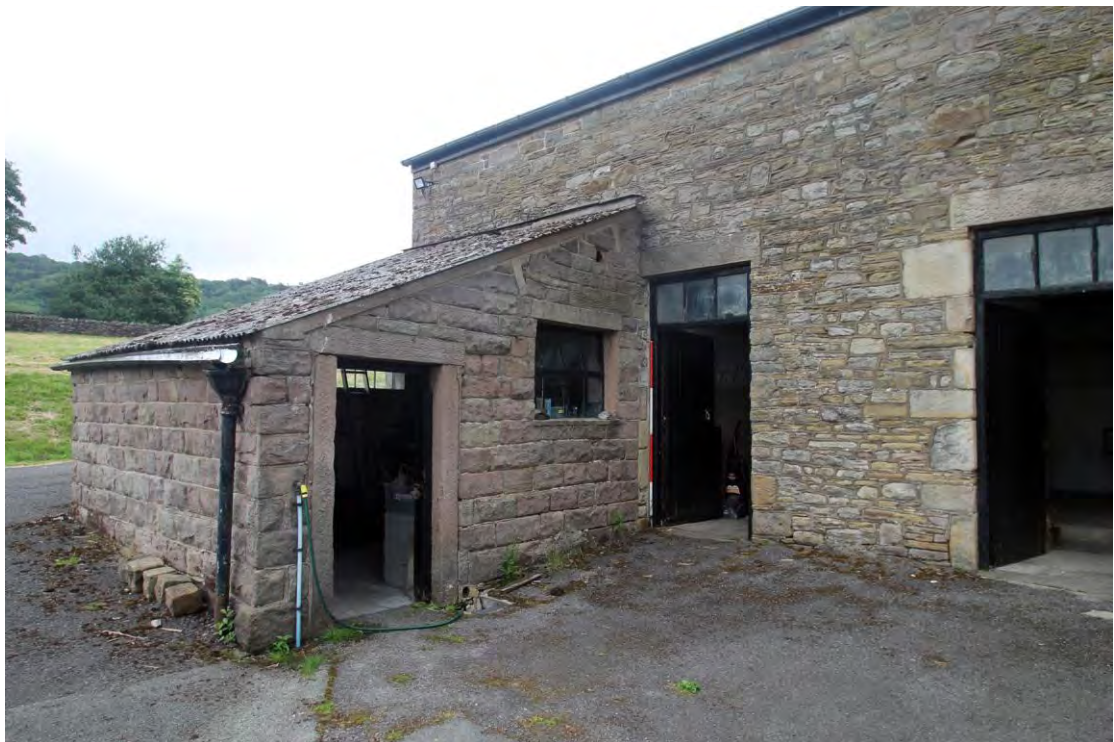
Plate 11. Barn, added lean-to, viewed from west.

This long elevation seems to have been most altered by later changes. Bay 1 was obscured by the addition of the later lean-to, although this may well have obscured an original double-doorway. A pair of doorways gave access into bays 2 and 3, these both had three-light windows over, and quoins to define the architraves, with rectangular sandstone lintels over.

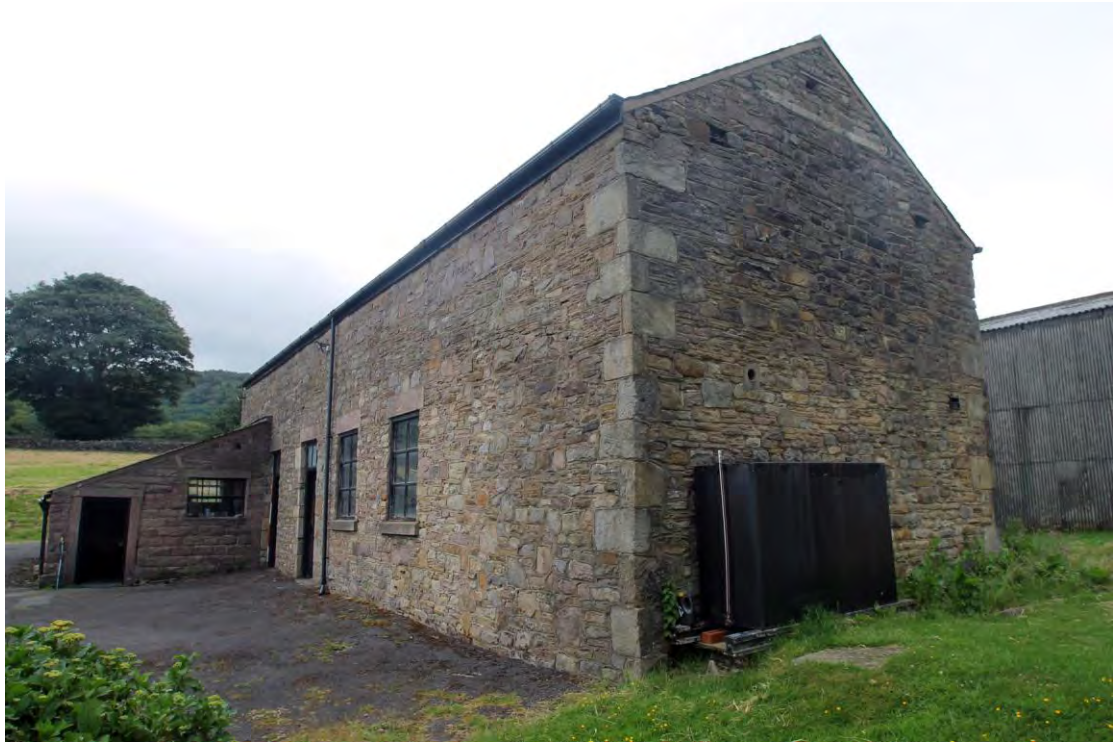
Plate 12. Barn, viewed from west.

This elevation contained no significant features other than three small rectangular holes in the pike of the gable, which may represent ventilation and/or owl holes. The west elevation of the outshut contained a doorway with monolithic gritstone lintel and architraves, as well as an eight-light window with a cast-iron frame. There was a straight joint which indicated the boundary with the barn, but this joint was offset, which suggested that this face of the barn may have had a vestigial porch.

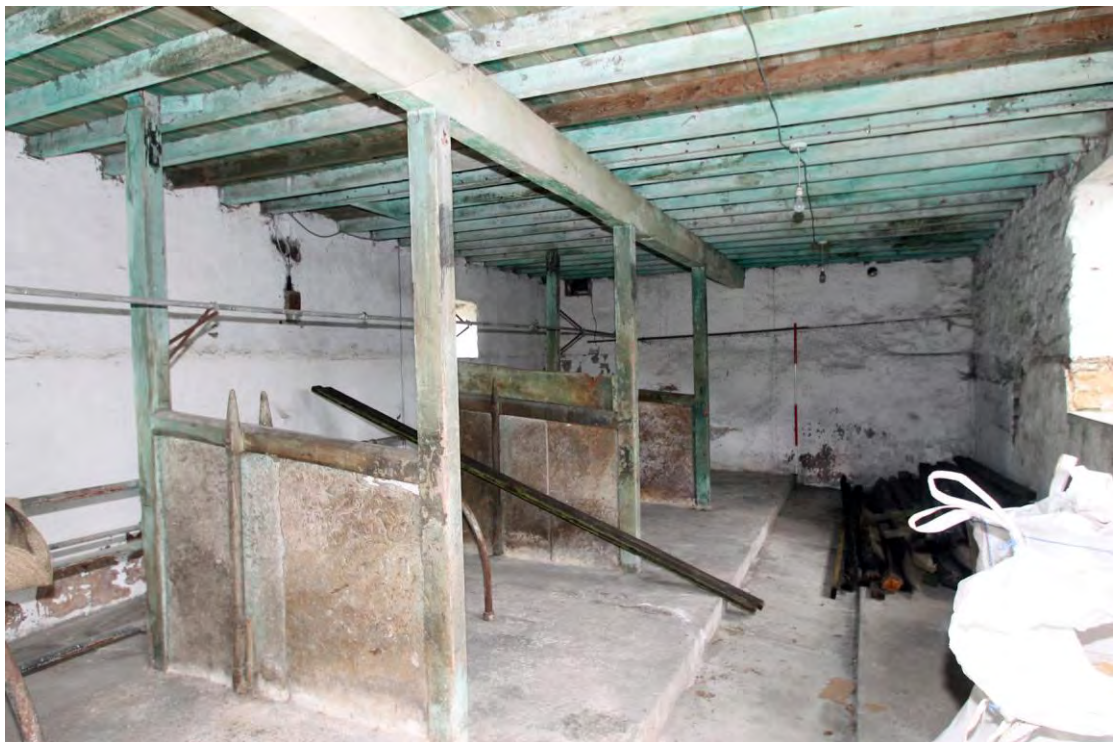
Plate 13. Barn, room G1, viewed from north-east, showing boskins.

Bays 3 and 4 were open as a single large space, containing four pairs of boskins, with a cross passage at the east end, which linked the doorway with the feed passage. The boskins were constructed by a series of four pairs of vertical posts linking between the floor and the timberwork of the ceiling. Thick, slightly angled side rails were then added between the pairs of posts, and these panels were infilled with flagstones, to define the boskin pairs.

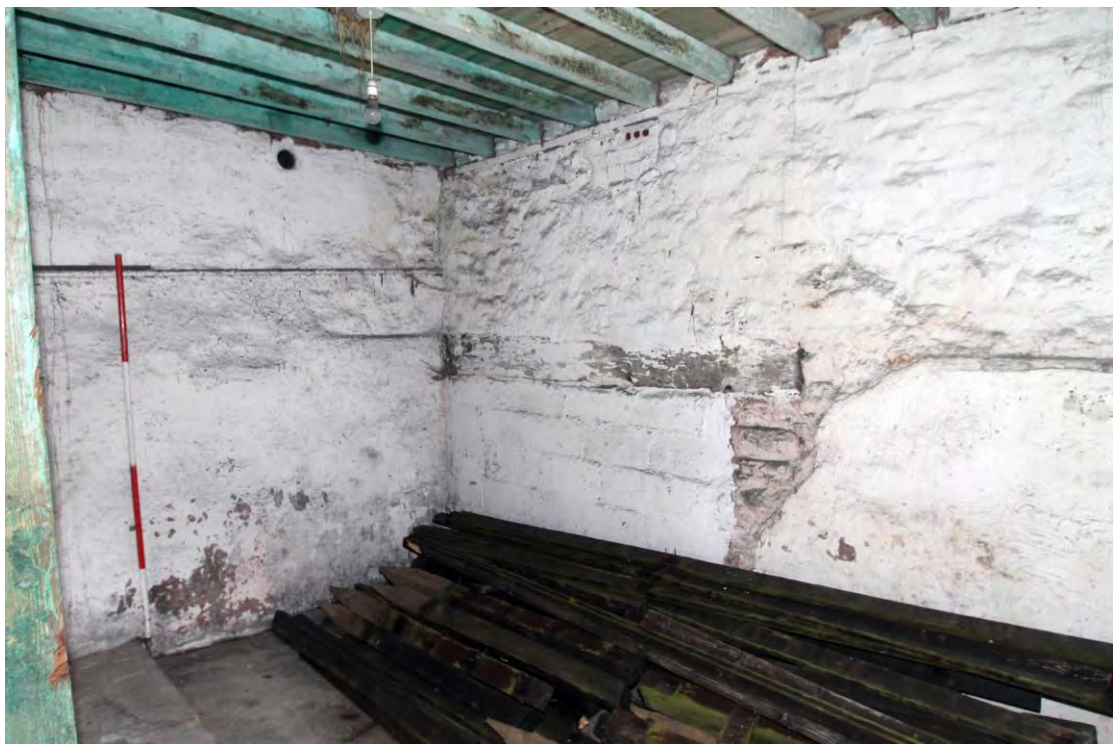
Plate 15. Barn, room G1, south west end, showing blocked doorway, viewed from east.

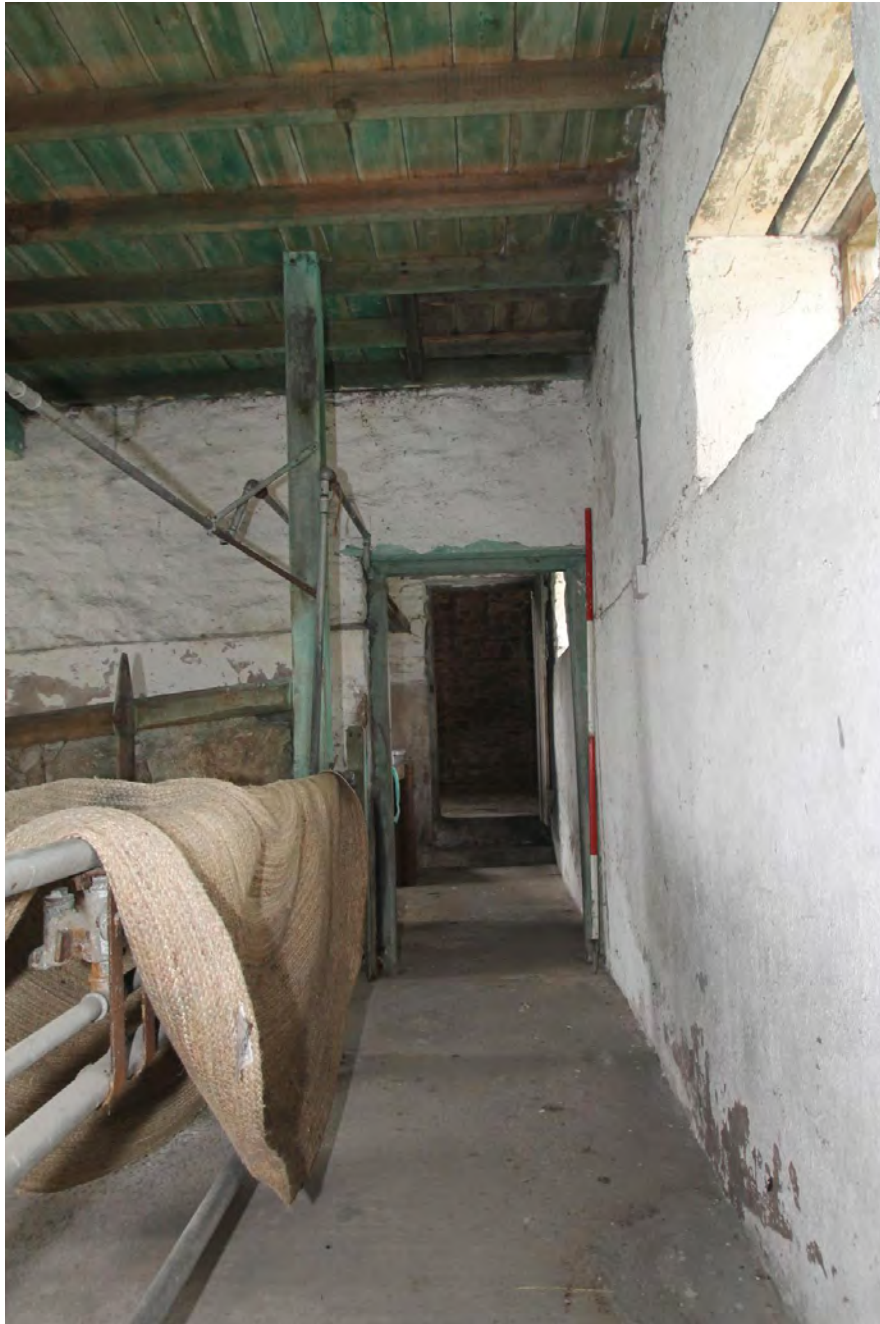
Plate 16. Barn, room G1, view along feed passage, from south-west.

On the feed passage side, the vertical posts were then linked by a continuous horizontal rail of steel pipe, which restricted the cattle within the boskin ends. Then each pair was subdivided by curved sections of steel piping, which linked to both the horizontal rail and to the floor. Finally, against the flagstone panels, vertical timber tie-posts, 50mm in diameter, were affixed, to tether the cattle. Within the concrete floor, a broad east-west drain extended between the walls, and presumably vented itself out through the base of the west gable.

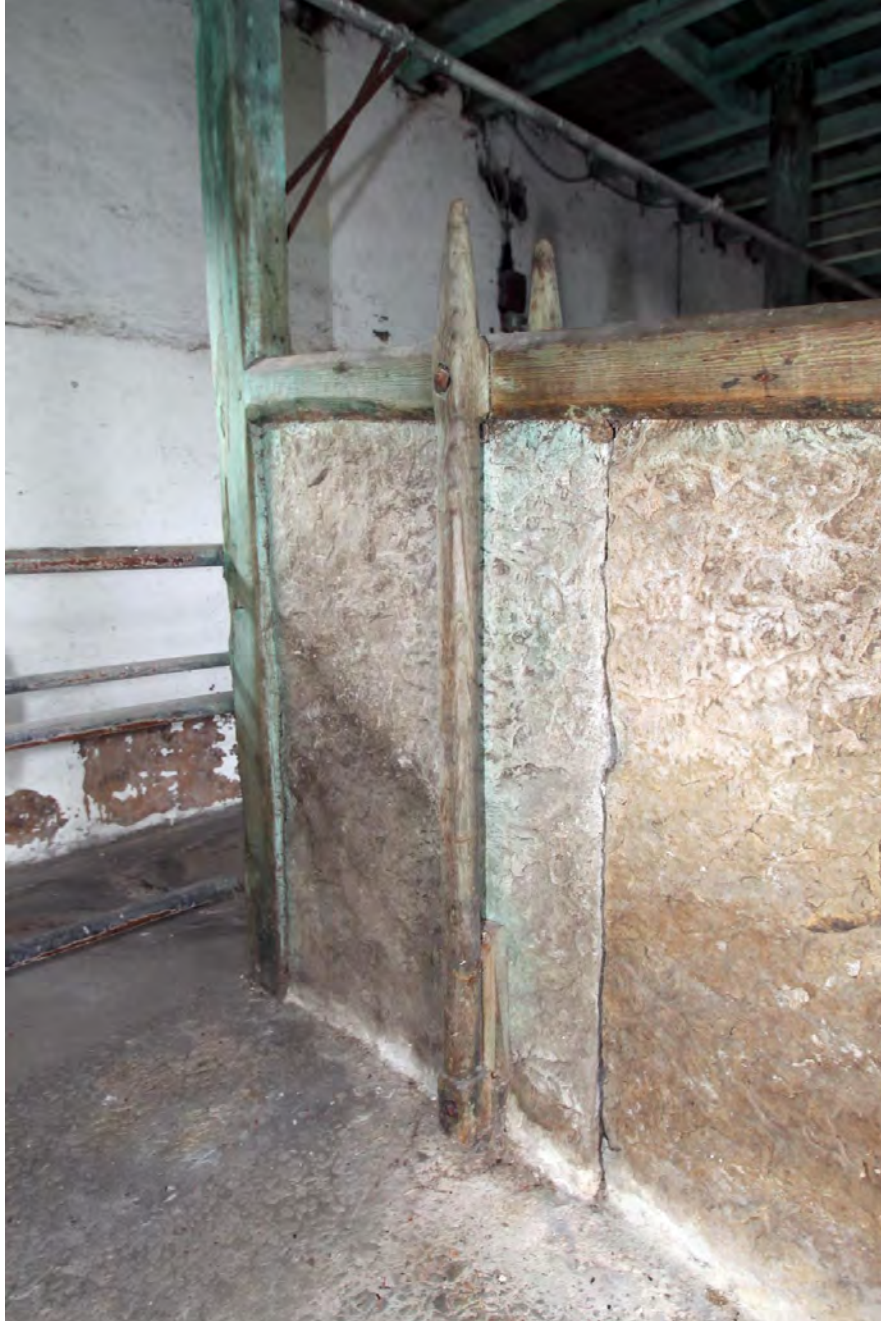
Plate 17. Barn, room G1, boskins, viewed from north.

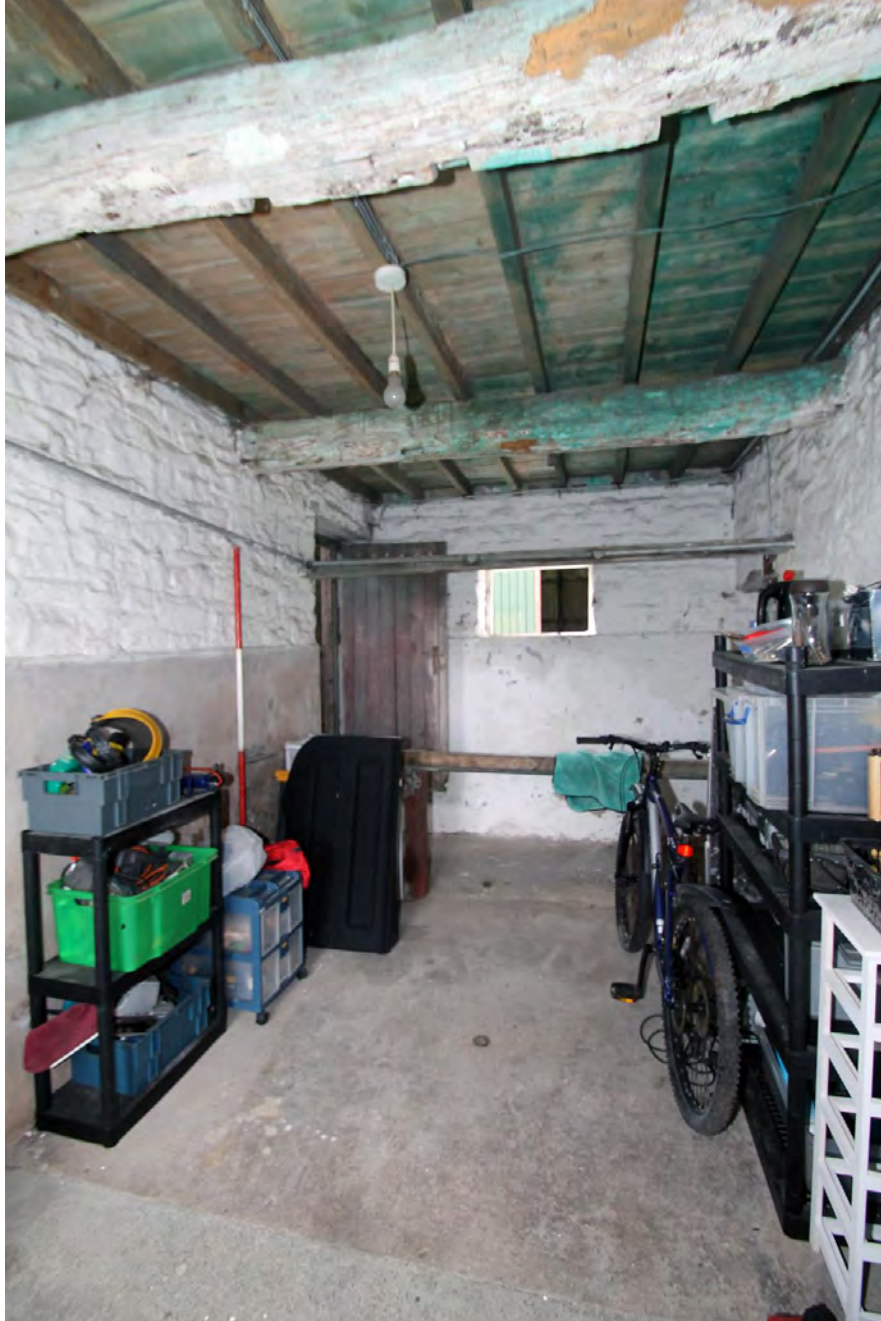
Plate 18. Barn, room G2, viewed from north-west.

Bay 2 comprised a self-contained shippon with a pair of boskins, which seem to be original features. A continuous feed passage extended along the south wall into the drift house, with a doorway into the bay 3/4 feed passage to the west. Within this bay, a thick timber rail defined the boskin end; although the steel rail which divided the boskin pair had been removed, leaving a socket on the rail, and another in the concrete floor. The tie-posts for tethering of the cattle were contained by metal brackets affixed to the east and west walls. The former drain at the 'tail' side of the boskins had been infilled by concrete.

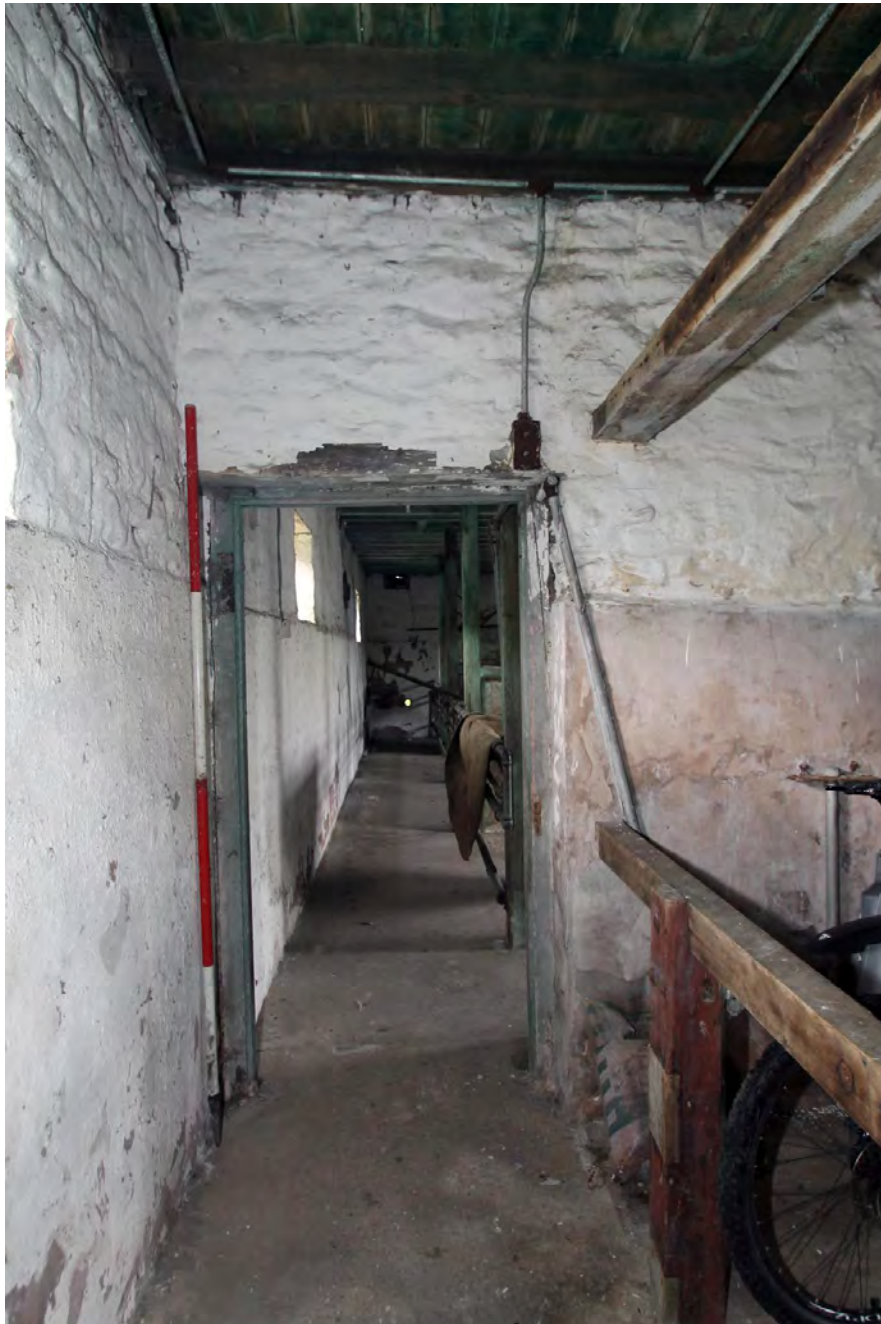
Plate 19. Barn, room G2, feed passage, viewed from north-east.

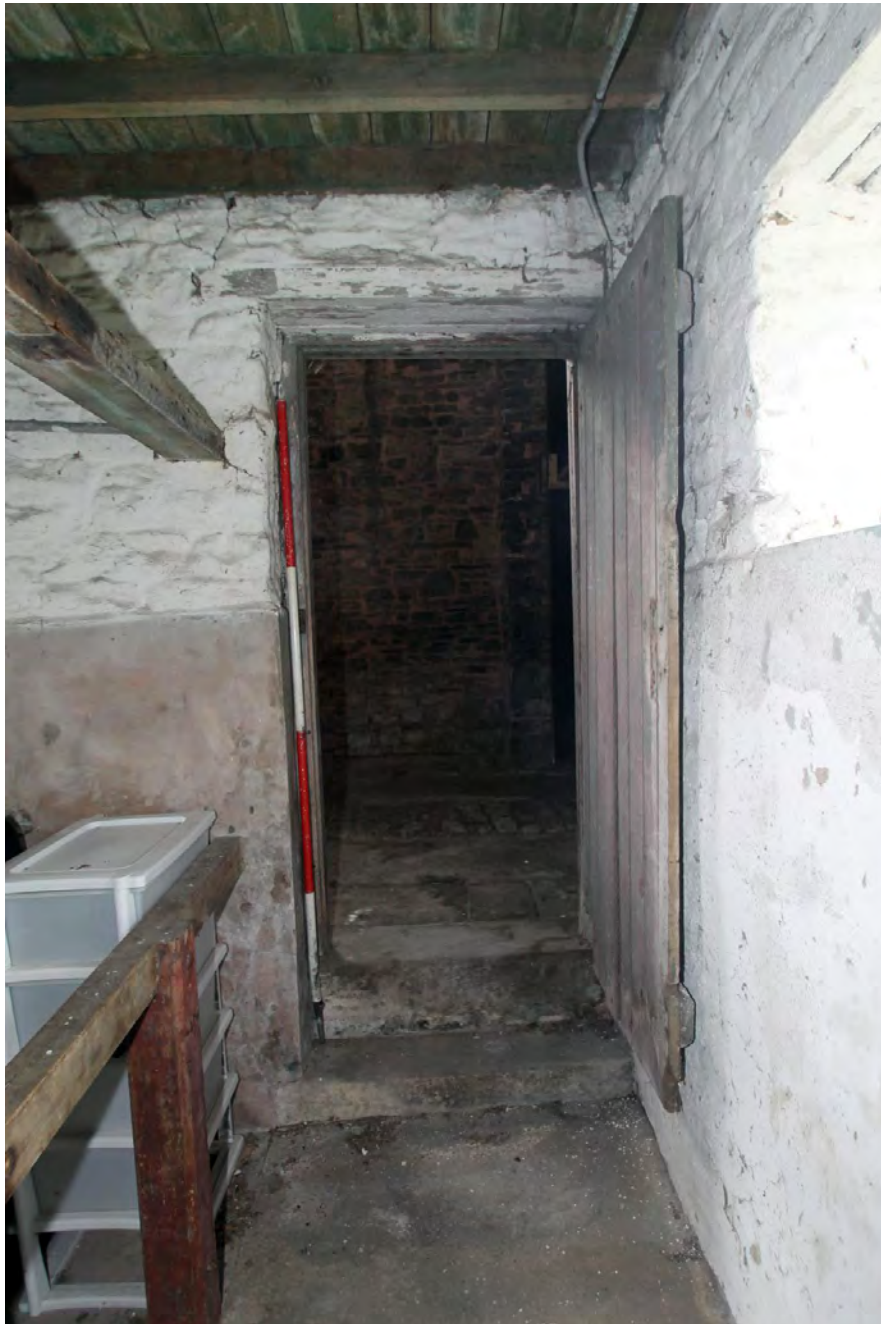
Plate 20. Barn, room G2, feed passage, viewed from south-west.

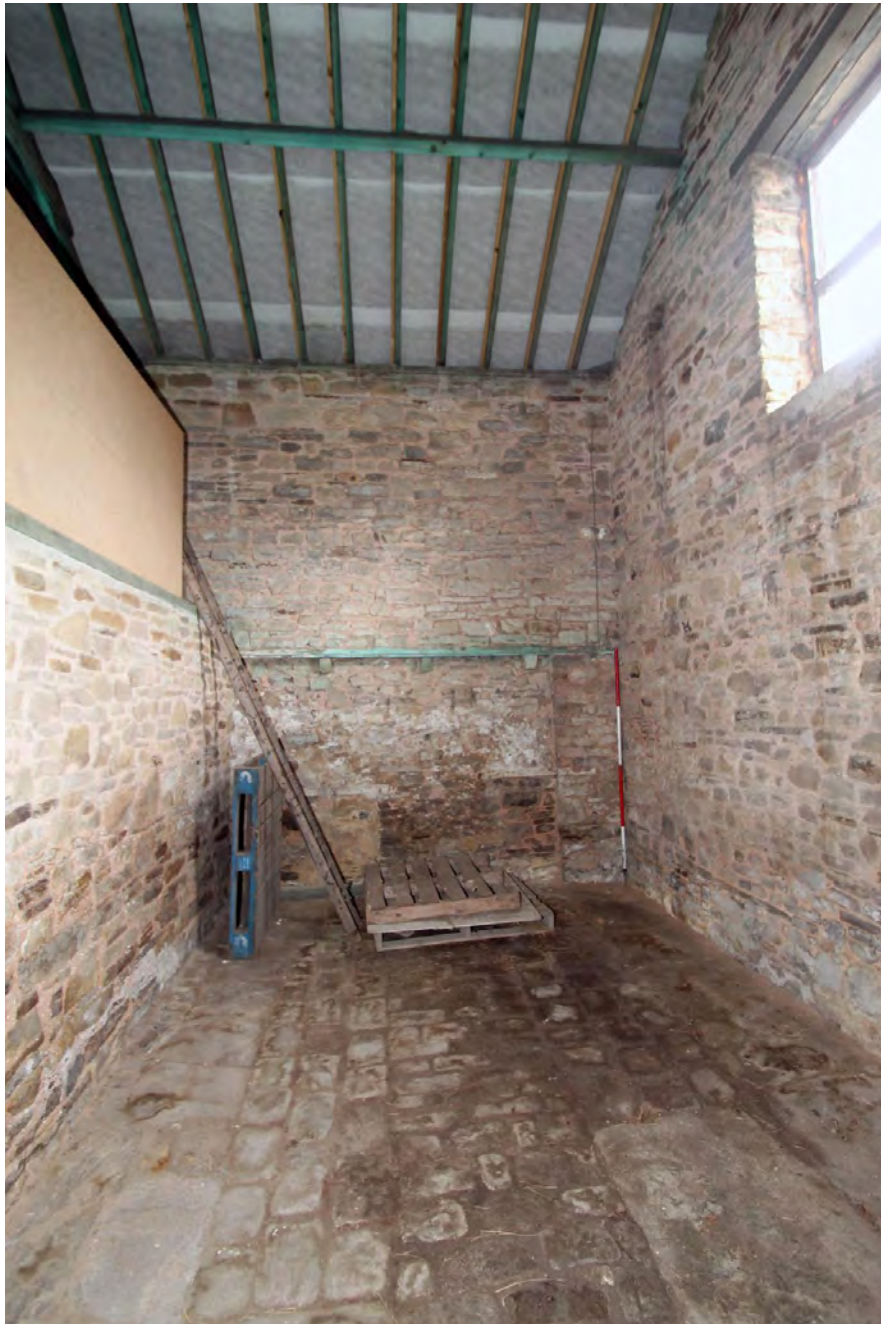
Plate 21. Barn, room G3, viewed from south-east.

This bay took the form of a drift house, open to the roof, with a tall double doorway providing access through the south wall. In the north wall was a

much lower blocked doorway, offset slightly to the west, which itself had two smaller rectangular blocked apertures. The floor was flagged, with a pair of distinctive runs of flagstones indicating the use of wheeled traffic. The internal (west) wall of the drift house was raised only to the loft floor level, leaving the loft open to the drift house.

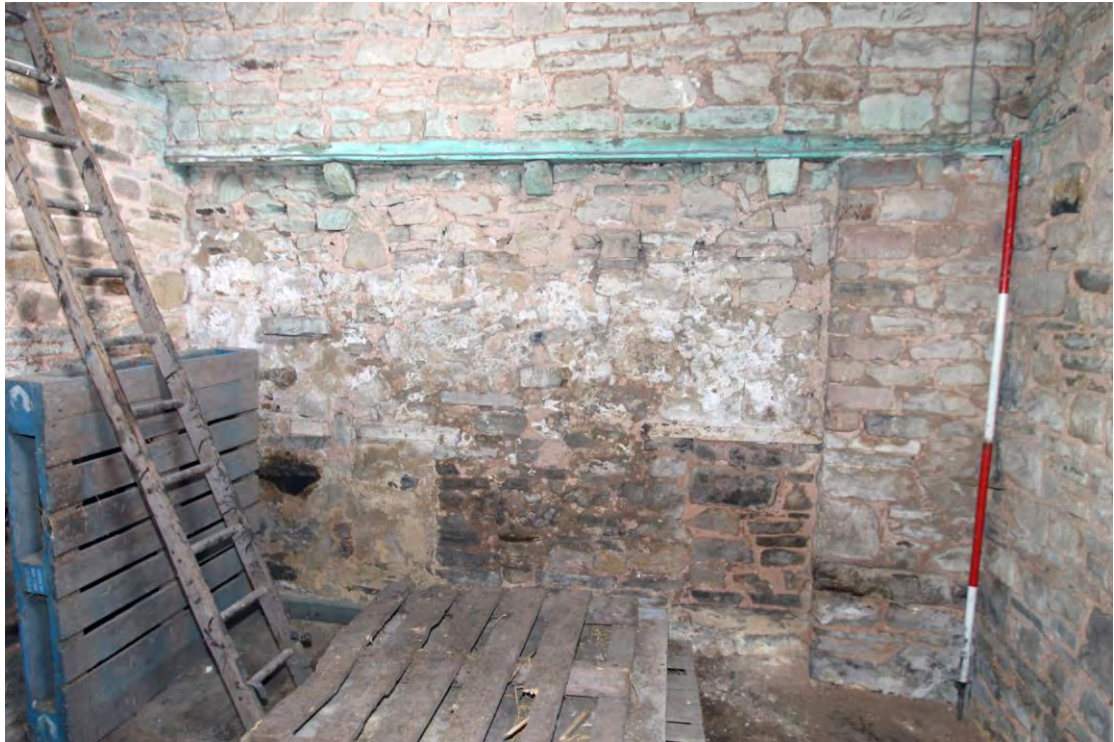
Plate 23. Barn, room G3, blocked doorway, viewed from south-east.

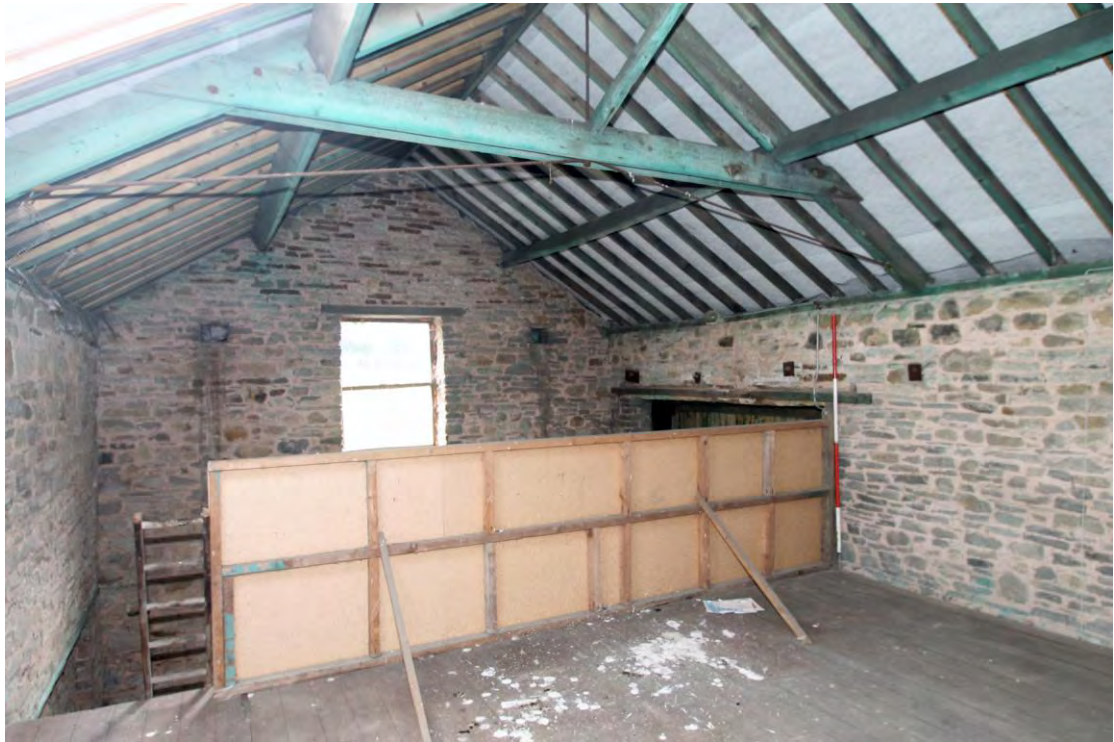
Plate 26. Barn, hayloft, viewed from south-west.

At the upper floor level, there was a single space over bays 2, 3 and 4; whilst the drift house (bay 1) was open to the roof, without a floor here. The roof was carried upon No.3 collared trusses, of lightweight composite design, the timber components all being machine-converted. The collars were doubled, with wrought-iron tie rods being inserted as king posts and angled struts to offset any lateral thrust. The trusses supported a ridge piece and a single purlin per roof pitch, which in turn supported common rafters.

The loft floor comprised softwood boards 120mm in width, and against the south side were a pair of original hinged hatches, which would have allowed hay to be dropped into the feeding passage beneath.

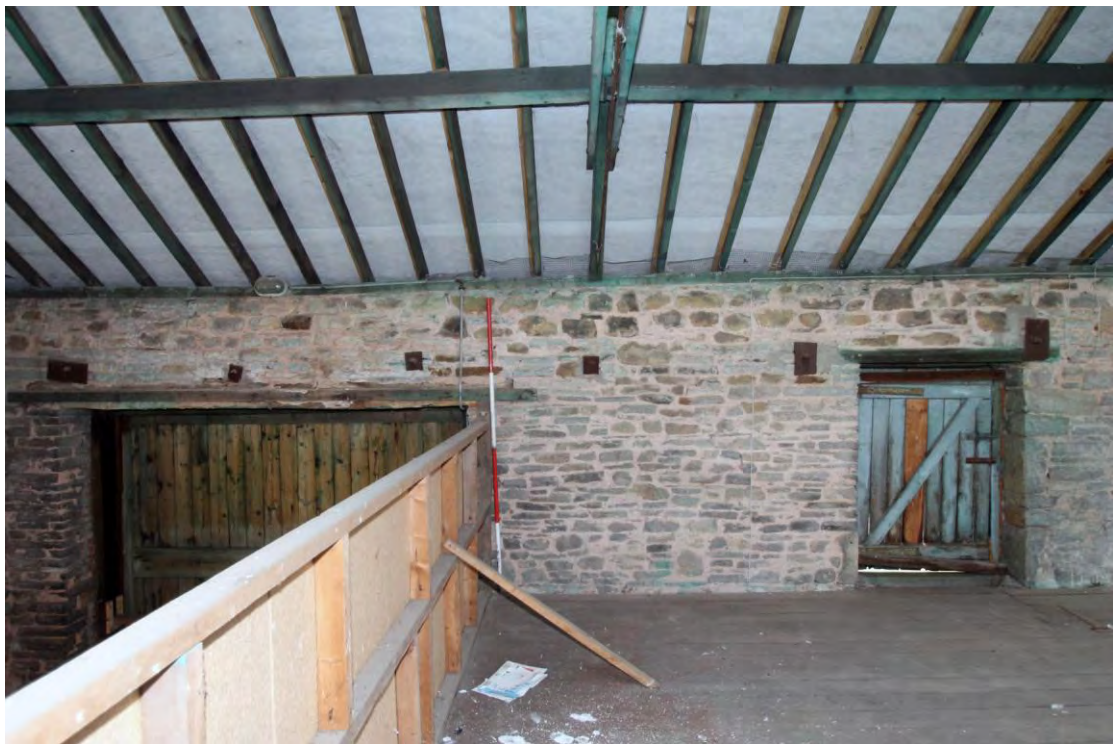
Plate 27. Barn, hayloft, viewed from north-west, pitching eye to right.
