THE BARN, TOP O'TH' HILL, RIVINGTON LANE, RIVINGTON, LANCASHIRE

Historic Building Survey

Matrix Archaeology

Report No. 2021-10
(Project Code: MA810)

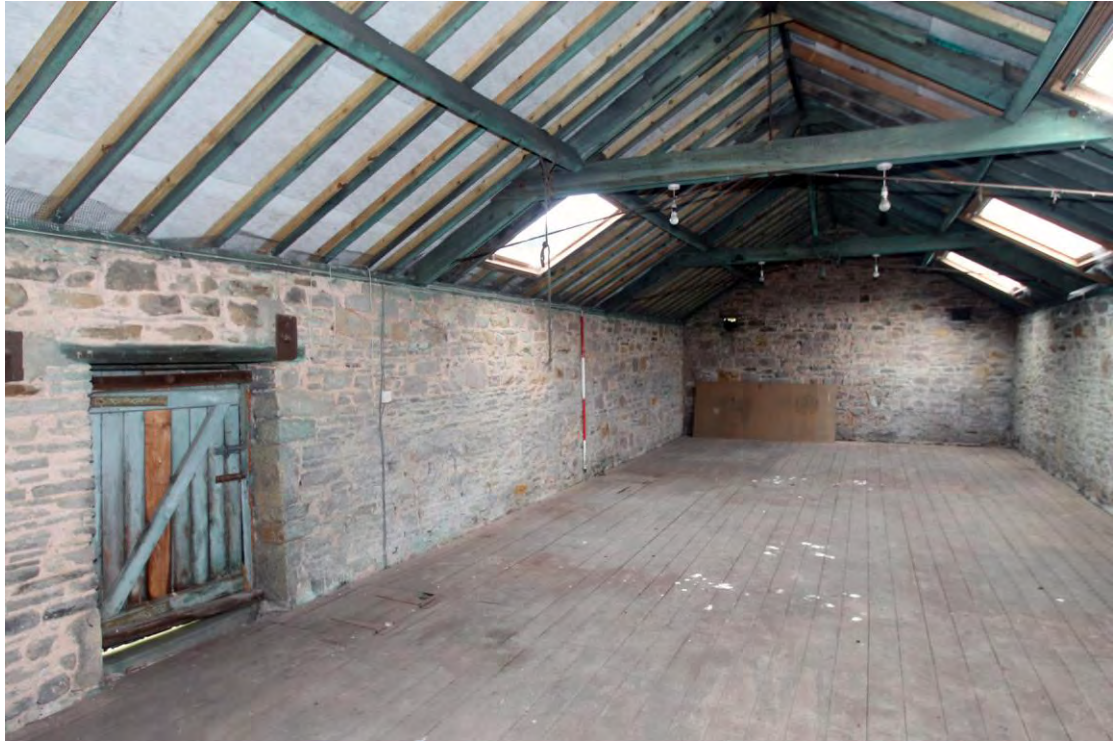
Plate 28. Barn, hayloft, viewed from north-east, pitching eye to left.

At the upper floor level, there was a single space over bays 2, 3 and 4; whilst the drift house (bay 1) was open to the roof, without a floor here. The roof was carried upon No.3 collared trusses, of lightweight composite design, the timber components all being machine-converted. The collars were doubled, with wrought-iron tie rods being inserted as king posts and angled struts to offset any lateral thrust. The trusses supported a ridge piece and a single purlin per roof pitch, which in turn supported common rafters.
