Report by: Mark Tunmore BSc, MCIEEM
The Boat House, Church Cove, Lizard,
Helston, Cornwall, TR12 7PH
T: 01326 290287
M: 0797 9013257
21 September 2023

Cove Ecological Surveys was instructed by Nikki Ainsworth in June 2023 to carry out a bat and nesting bird assessment of a two-storey house at Sunnyside Farm, Cambrose, Redruth, Cornwall, TR16 4HT. The survey was commissioned in preparation for a planning application to demolish the building and build a replacement dwelling within the existing footprint (PA23/00936/PREAPP). The survey was carried out on 14 June 2023 and identified the building as holding moderate potential for bats using the national survey guidelines (Collins, 2016), requiring two subsequent emergence surveys to establish whether bats were roosting there. This report presents the results of the surveys.

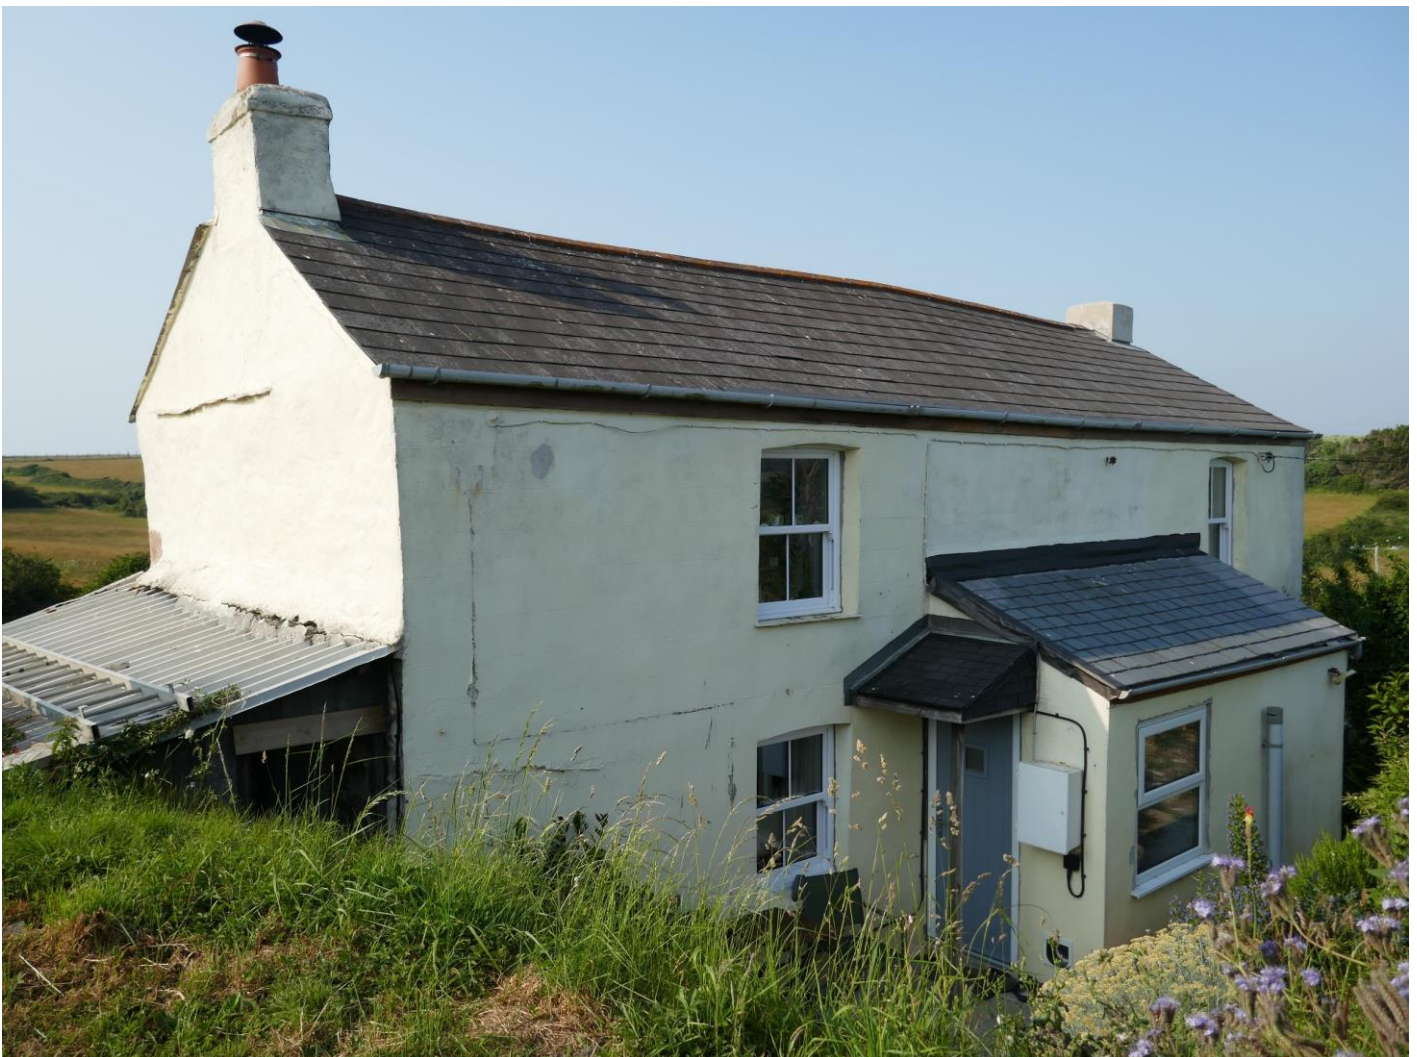
The survey site (SW6825645703) was a stone and block-built two-storey house (see Figures 1 & 2) located at the end of a private track, approximately 500m north-west of the village of Cambrose in west Cornwall. The building had a pitched slate roof with two chimneys (one at each end). Some suitable gaps for roosting bats were present beneath ridge tiles, lifting slates and beneath lead flashing around the base of the chimneys. No accessible roof void was present but the flat ceiling on the top floor indicated that an inaccessible space was present between the ceiling and the roof. A wooden fascia was present on the northern and southern aspects of the building; suitable gaps for roosting bats were present behind the fascia on the southern aspect.

Figure 1. Southern and western aspect of the building.

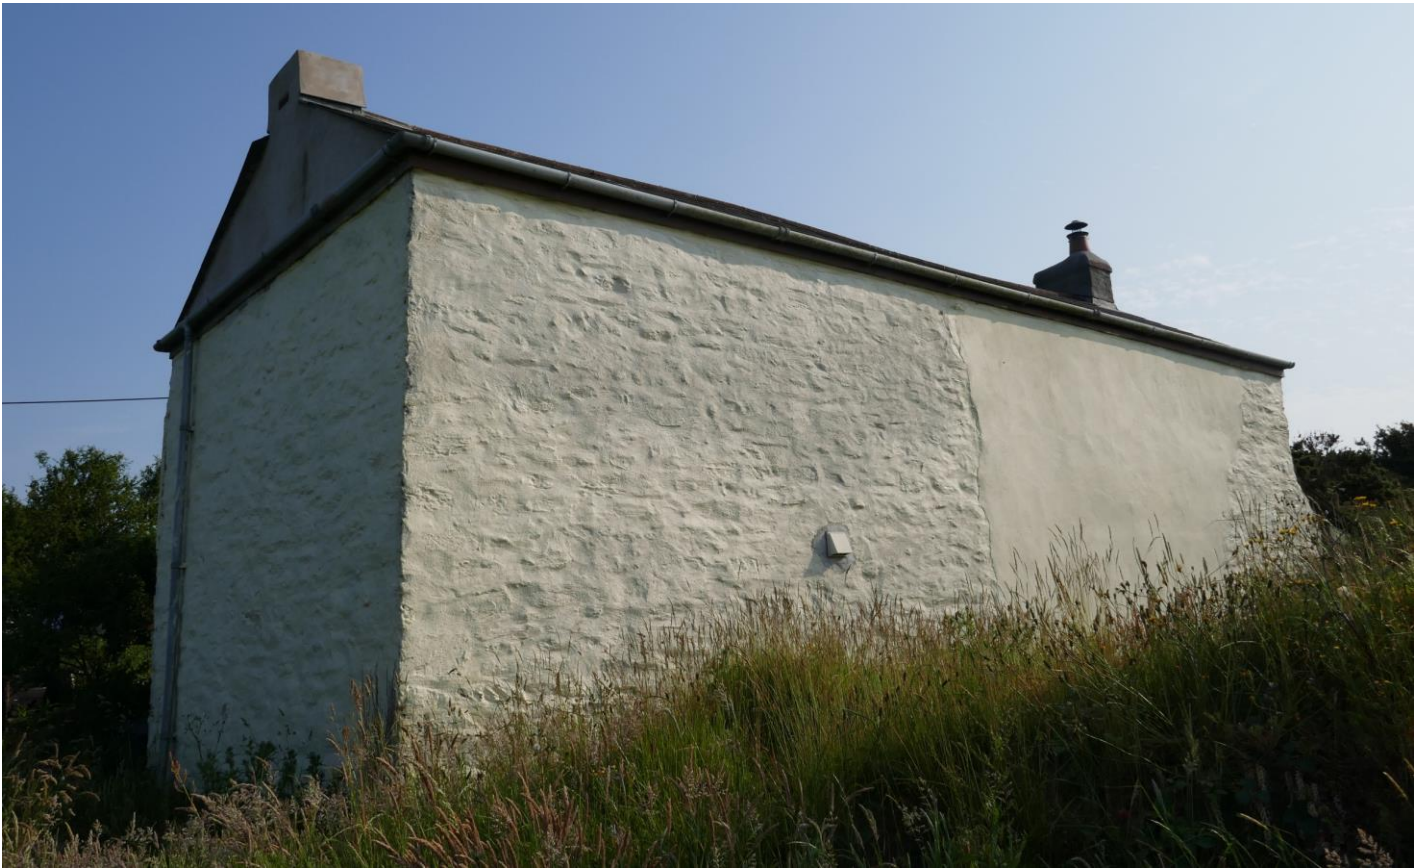
Figure 2. Northern and eastern aspect of the building.

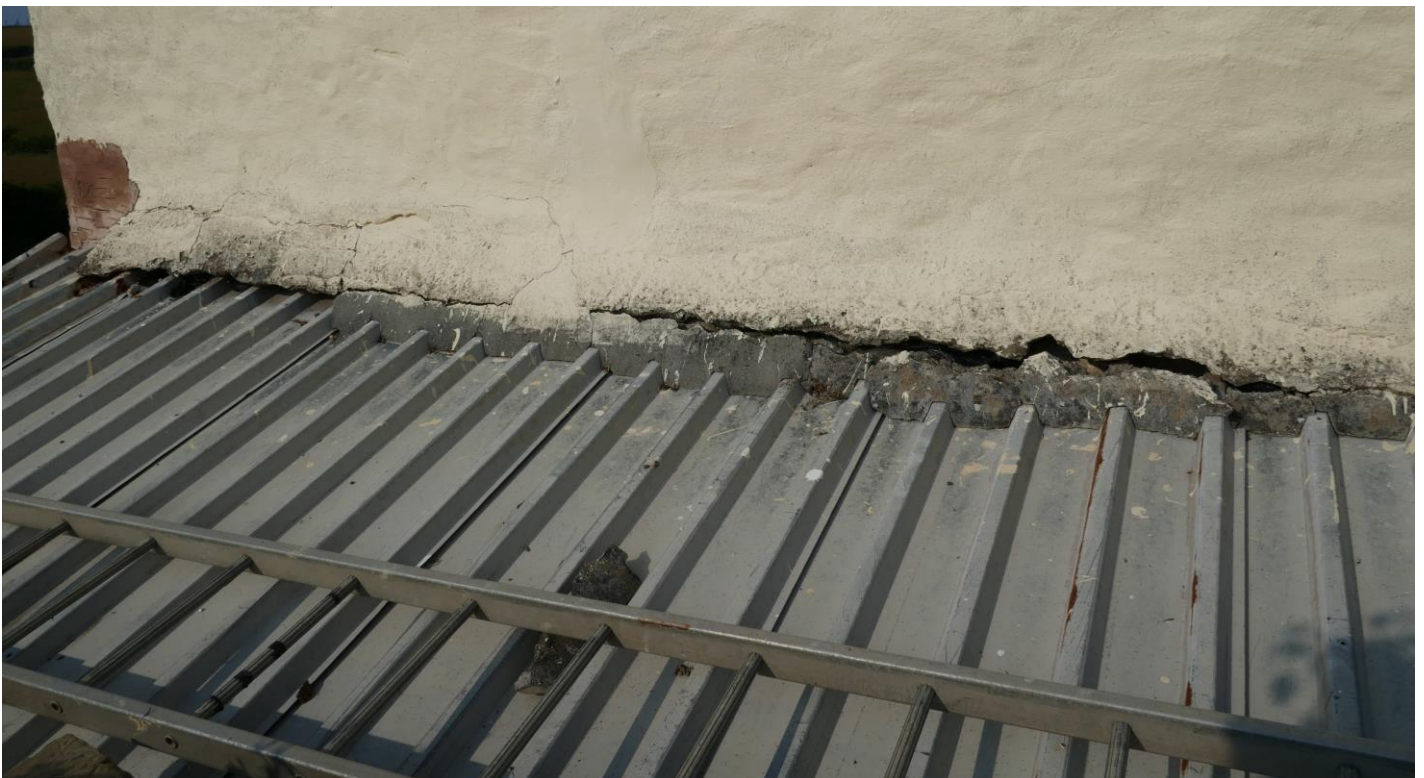
A small stone-built lean-to (internally rendered) was built on to the western aspect, which had a corrugated metal sheeted roof. A large split in the render was present at the junction between the house and the lean-to

(Figure 3), which offered a potential bat roost area. A window was present on the north side, which allowed light penetration within (Figure 4).

Figure 3. Large gaps at the junction of the house and the lean-to on the western aspect.

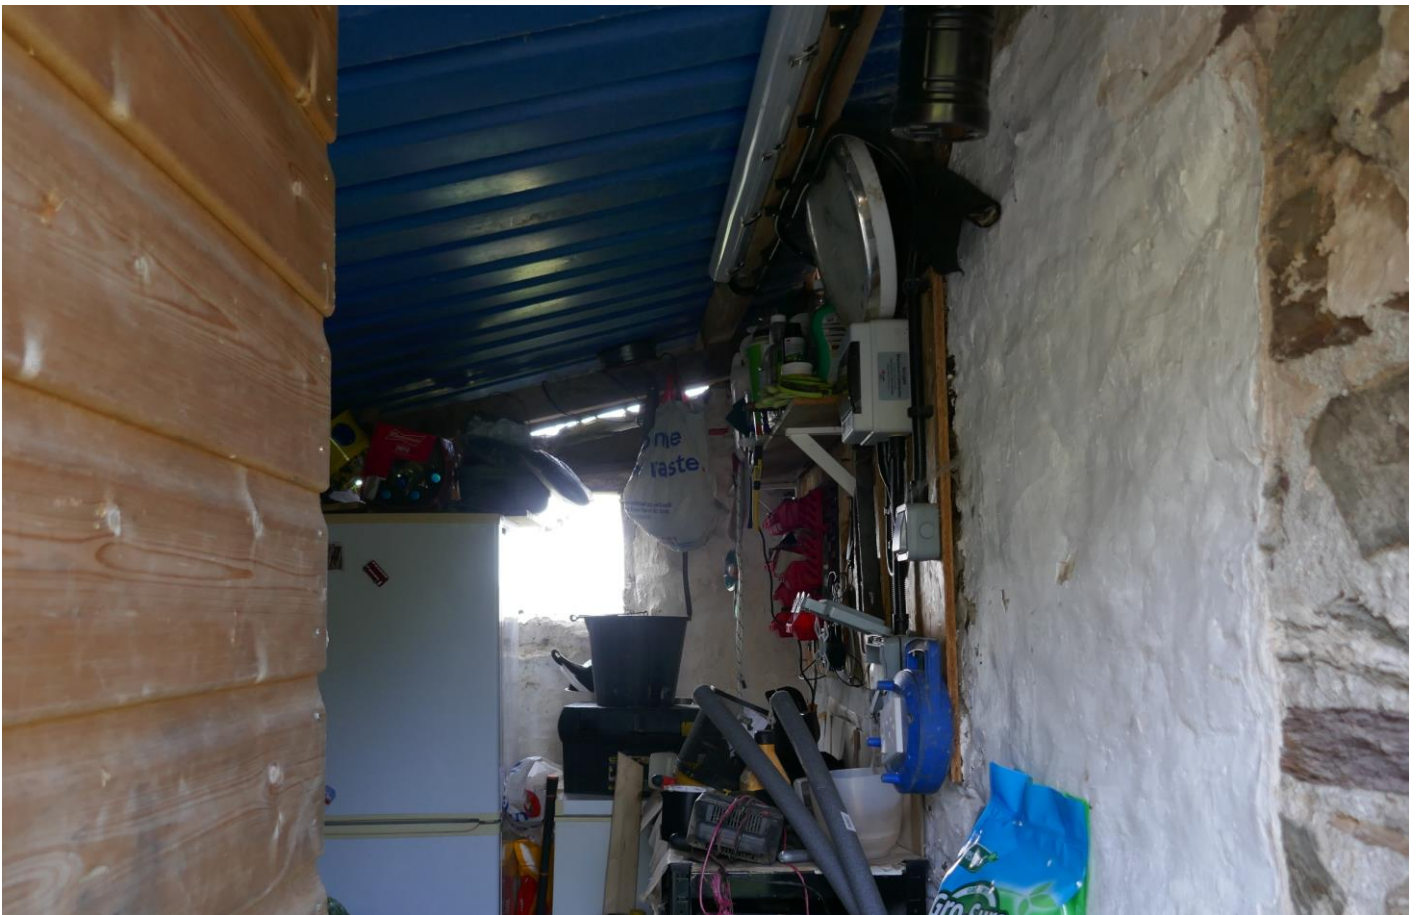
Figure 4. Interior of lean-to.

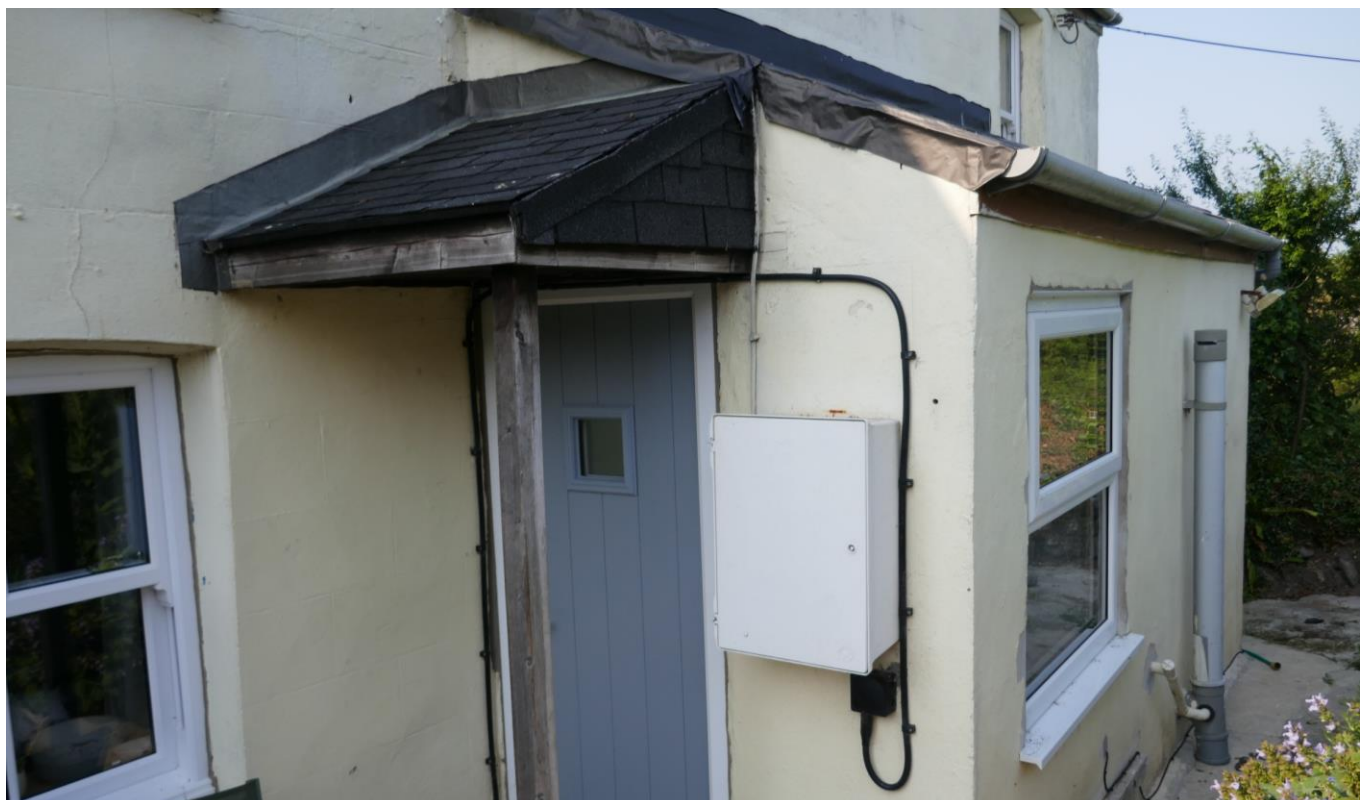
On the southern aspect of the building was a porched entrance with a sloping slate roof (Figure 5) and a small wooden constructed shelter over the door with a small area of vertical tiles. Some suitable gaps for roosting bats were present around these structures.

Figure 5. Porched entrance on southern aspect.

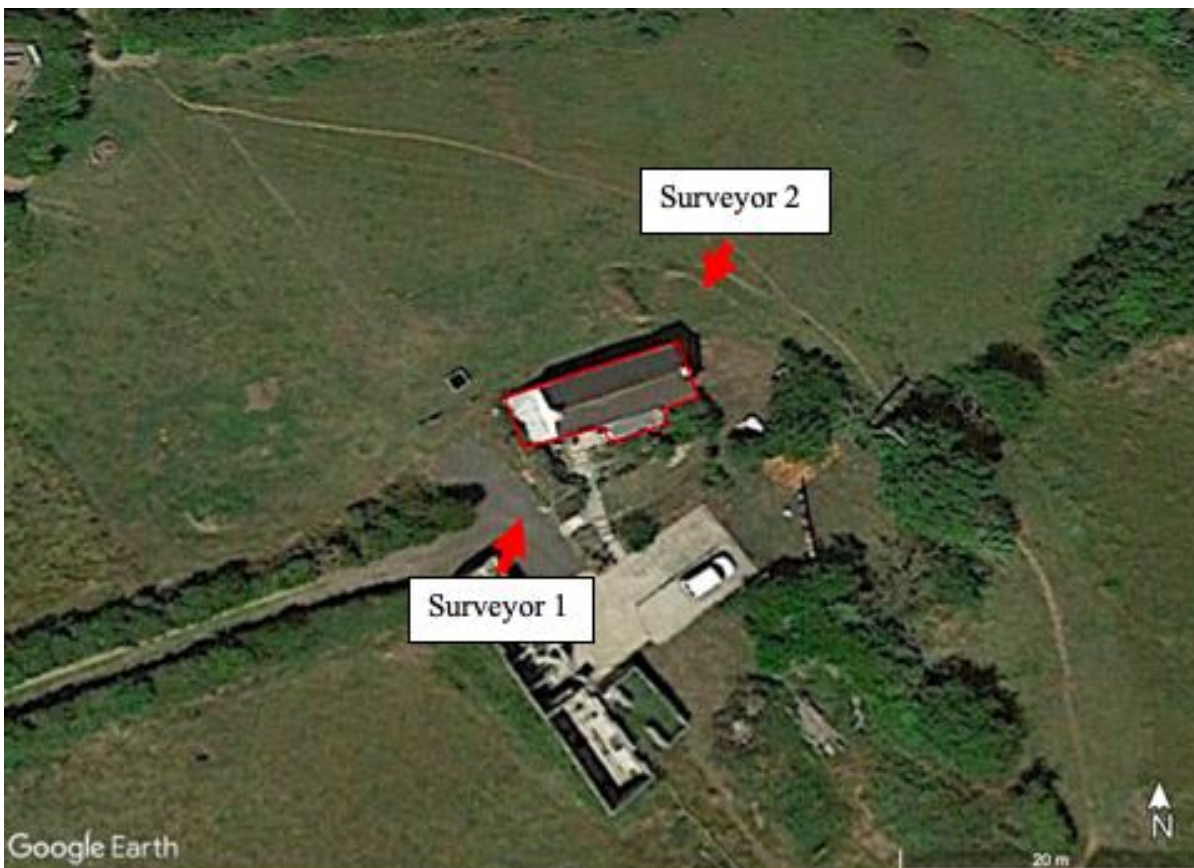
Two surveyors were present on each survey. Surveyor 1 was located on the drive to the south of the property viewing the southern and western aspects, with surveyor 2 located in the field to the north, observing the northern and eastern aspects. This strategy enabled all aspects of the building to be fully viewed during the two surveys. Table 1 summarises the personnel and equipment used, Figure 6 shows the surveyor locations and Figure 7 shows the infrared illumination on 11 August.

Figure 6. Surveyor locations.

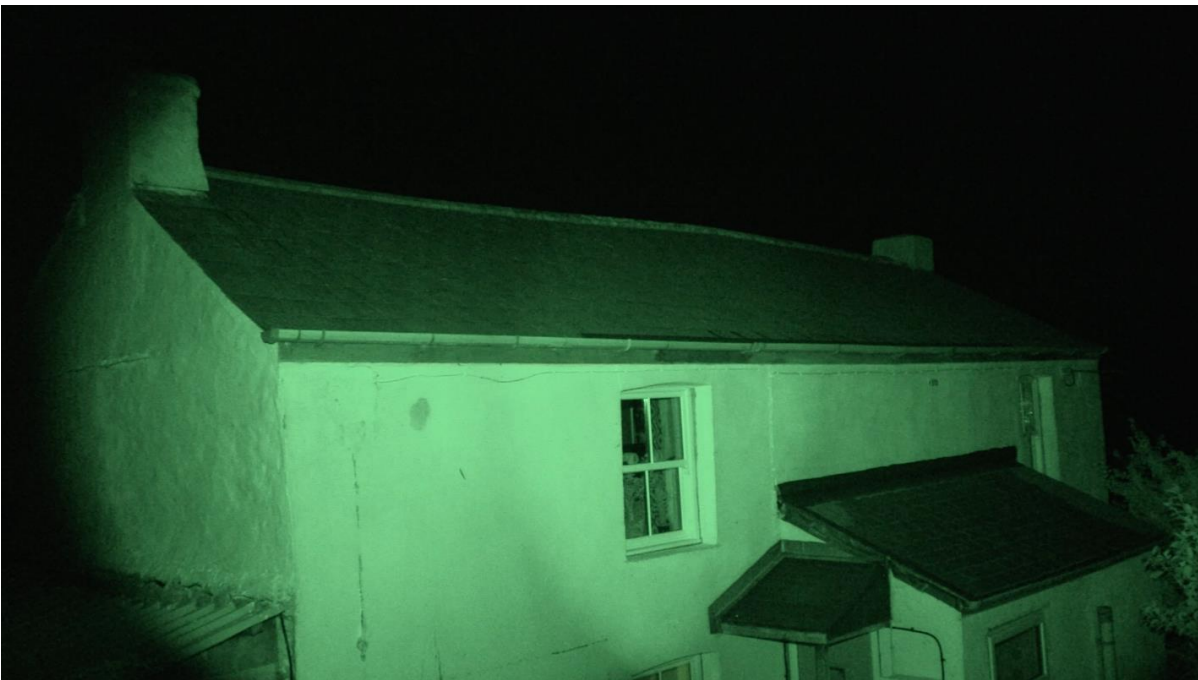
Figure 7. Infrared illumination for surveyor 1 on 11 August 2023.
