BAT ROOST ASSESSMENT

SHEEPWASH FARM (GARAGE), SHEEPWASH LANE, WATERLOOVILLE,
HAMPSHIRE

DRAFT REPORT

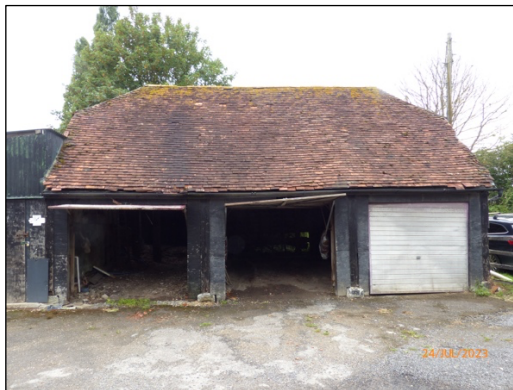
The garage building comprises a timber framed structure with a clay, peg tiled roof constructed in a pitched and half-hipped design (Figure 1). Several additional structures have been added to the building over time, these all comprise timber framed buildings with corrugated metal, mono-pitched roofs (Figures 2 and 3). These structures are attached to the northern and western elevations, the structure attached to the western elevation forms part of a larger building that extends in a northerly direction.

Figure 1: Southern elevation of garage.

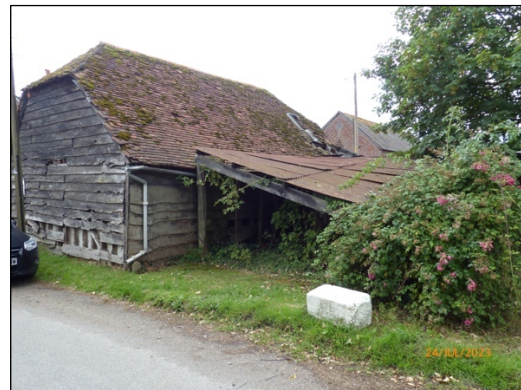
Figure 2: Northern and western elevation of garage.

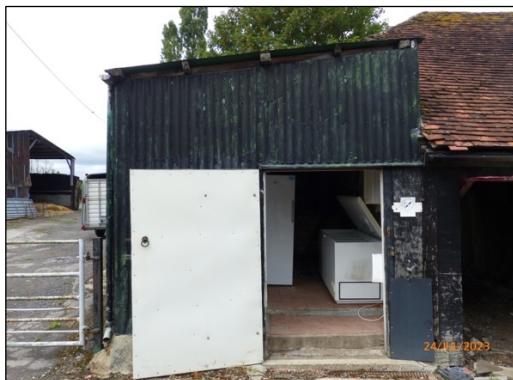
Figure 3: Metal clad extension on western elevation.

The southern elevation supports three up-and-over metal garage doors, with the remaining elevations wooden clad. The western extension is in good order and used to store refrigeration units (Figure 3), whereas the northern extension is partially collapsed and unused (Figure 4).

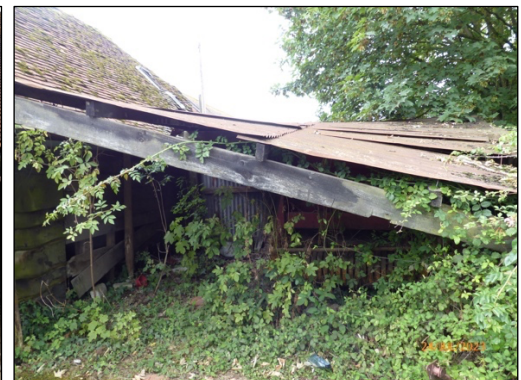
Figure 4: Metal clad extension on northern elevation.

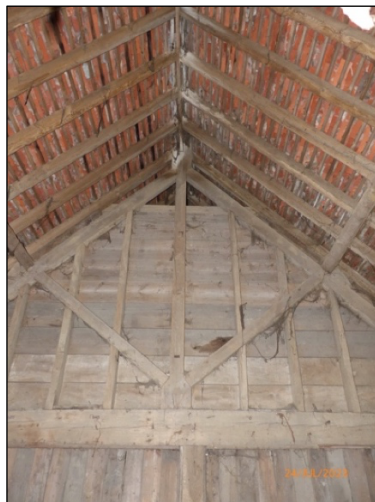
The building is constructed in a King post design, with the eastern side open plan. The western side is partitioned from the eastern side (Figure 5), and a ladder leads to a first-floor area. In the eastern part of the garage the clay peg tiles are unlined beneath and side elevations single skin. There are gaps in the roof where hip tiles have fallen off at the eastern end and along the ridge. The first-floor section is clad internally with timber and the underside of the tiles are not visible.

Figure 5: Interior view of eastern part of the building, showing timber partition wall.

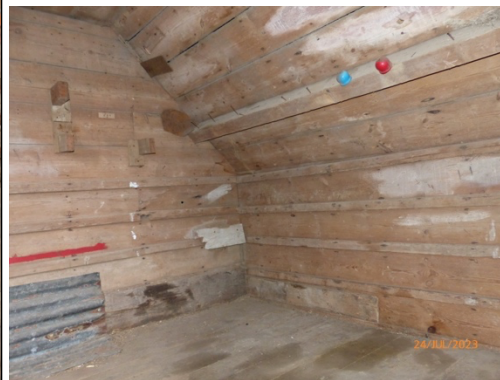
Figure 6: First floor section with wooden panelling beneath clay tiles and behind side panels.

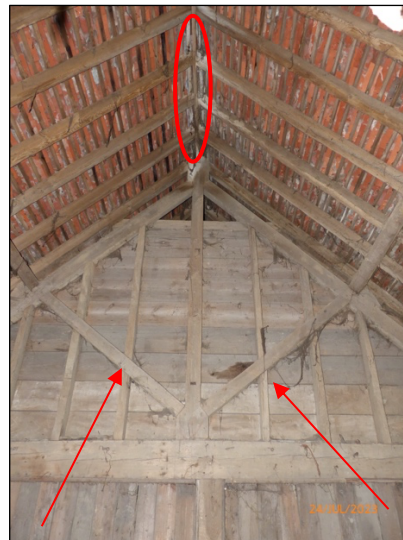
These features included, against the ridge board (Figure 7, red oval), in the apex of the roof, where the main support beams are situated next to wooden cladding (Figure 7, red arrows) and beneath ridge tiles.

Figure 7: Interior view of garage showing potentially suitable roosting locations.

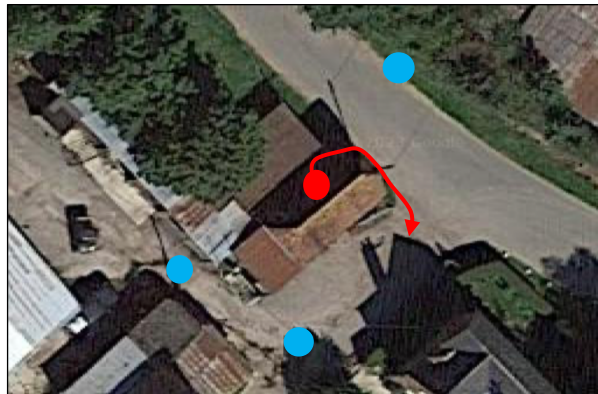
Figure 8: Emergence location of long-eared bat and flightpath (red dot and arrow) following emergence. Surveyor locations blue dots.

The first long-eared bat was recorded at 21:17 when a bat appeared from behind the surveyor in the farmyard, south of the garage, and flew north. At 21:25 a long-eared bat emerged from beneath a roof tile on the north facing elevation (Figure 8). Subsequent to the emergence the bat flew around the eastern end of the building and in a southerly

direction away from the building (Figure 8). The only other long-eared bat registrations were recorded at 21:29 and 21:30, but no further emergences were recorded.

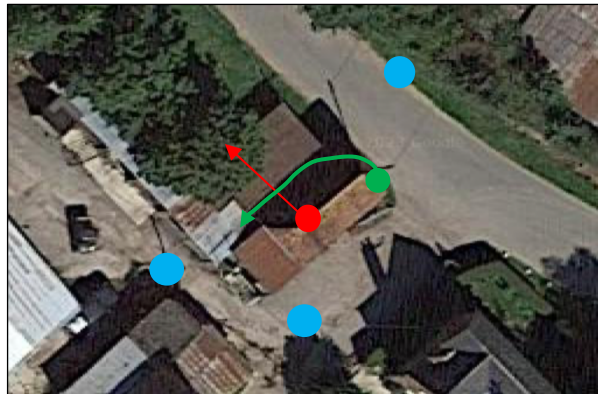
Figure 9: Emergence locations of soprano pipistrelle (green dot) and long-eared bat (red dot), followed by flightpath after emergence. Surveyor locations blue dots.

The first long-eared bat was recorded at 20:21, when it was seen emerging from beneath a ridge tile on the garage flying directly into the canopy of an adjacent tree (Figure 9, red dot). Subsequent registrations were recorded at 20:24, 20:37 and 20:47, but no other bats were seen to emerge.
