PRELIMINARY BAT ROOST ASSESSMENT

SHEEPWASH FARM (GARAGE), SHEEPWASH LANE, WATERLOOVILLE,
HAMPSHIRE

INTERIM DRAFT REPORT

August 2023

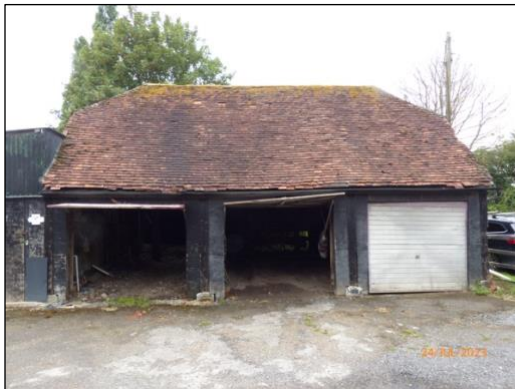
The garage building comprises a timber framed structure with a clay, peg tiled roof constructed in a pitched and half-hipped design (Figure 1). Several additional structures have been added to the building over time, these all comprise timber framed buildings with corrugated metal, shallow pitched, flat roofs (Figure 2). These structures are attached to the northern and western elevations, the structure attached to the western elevation forms part of a larger building that extends in a northerly direction.

Figure 1: Southern elevation of garage.

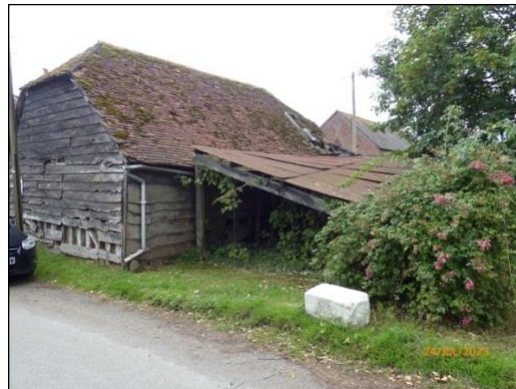
Figure 2: Northern and western elevation of garage.

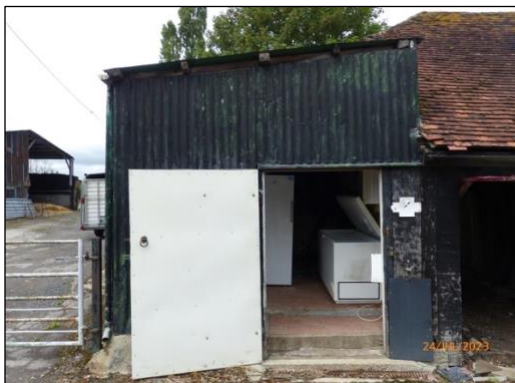
Figure 3: Metal clad extension on western elevation.

The southern elevation supports three up-and-over metal garage doors, with the remaining elevations wooden clad. The western extension is in good order and used to

store refrigeration units (Figure 3), whereas the northern extension is partially collapsed (Figure 4).

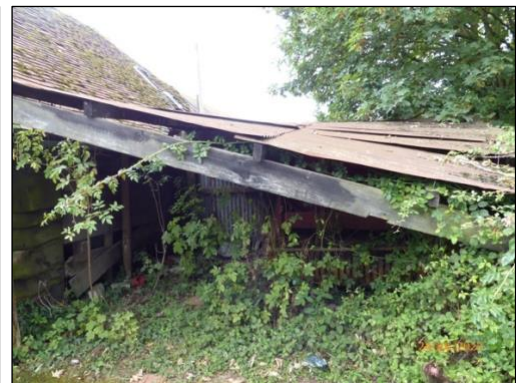
Figure 4: Metal clad extension on northern elevation.

Where the northern section of the building adjoins the northern elevation, the building has partially collapsed and large gaps are present in the roof tiles.

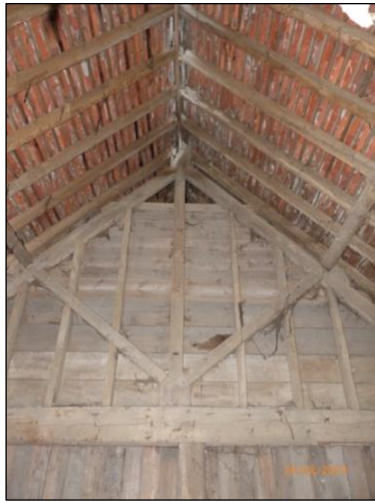
The building is constructed in a King post design, with the eastern side open plan. The western side is partitioned from the eastern side (Figure 5), and a ladder leads to a first-floor area. In the eastern part of the garage the clay peg tiles are unlined beneath and side elevations single skin. There are gaps in the roof where hip tiles have fallen off at the eastern end and along the ridge. The first-floor section is clad internally with timber and the underside of the tiles are not visible.

Figure 5: Interior view of eastern part of the building, showing timber partition wall.

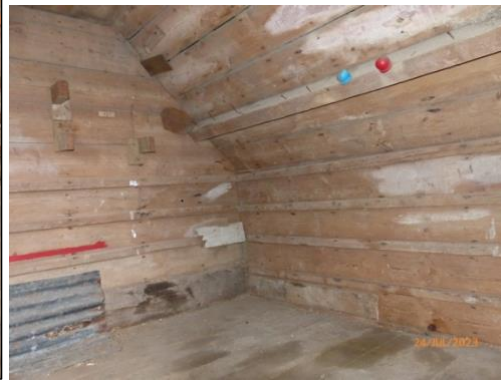
Figure 6: First floor section with wooden panelling beneath clay tiles and behind side panels.

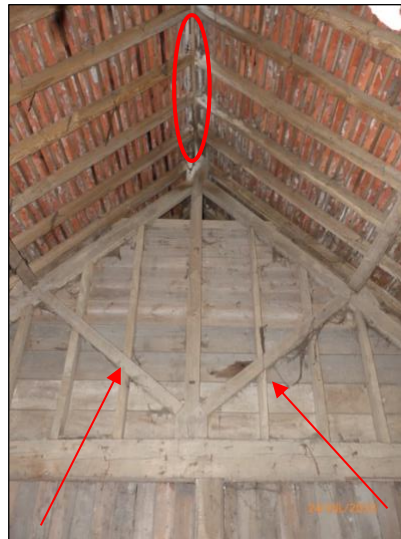
No evidence of bat activity was recorded during the survey, and parts of the building were in a dilapidated state, and therefore unlikely to support a high-status bat roost, such as a maternity roost. However, there were numerous features present, both externally and internally that could support roosting bats.

These features included, against the ridge board (Figure 7, red oval), in the apex of the roof, where the main support beams are situated next to wooden cladding (Figure 7, red arrows) and beneath ridge tiles.

Figure 7: Interior view of garage showing potentially suitable roosting locations.

When assessed against the criteria in Table 1, the garage at Sheepwash Farm, to be directly impacted by the proposals was assessed as providing moderate suitability i.e. “A structure which could be used by bats but is not likely to support a roost of high conservation status (e.g. maternity roost)”.

Given the overall condition of the building, it is considered that it has the potential to be used on an occasional basis, by small numbers of bats, for example a day roost or male

In accordance with the current guidelines, further survey effort will take the form of two surveys, comprising one dusk emergence and/or one dawn re-entry presence/absence survey, undertaken during the bat active season. The current recommended minimum number of presence/absence surveys for a building with moderate roost suitability is two. Each surveyor will be equipped with high specification time expansion or full spectrum bat detectors with digital recording capability. If the surveys identify higher than expected activity, a further survey may be required.

Each surveyor will need to be positioned to ensure that all identified access locations and suitable roosting features are visible. The surveyor will remain in place monitoring and recording bat activity from 15 minutes before sunset to up to 1.5 - 2 hours after sunset for a dusk visit or 2 hours before sunrise until up to 15 minutes after sunrise for a dawn visit. There needs to be a minimum of two weeks between each visit.

The bat active season extends from April until September. However, for a building with moderate suitability, it is recommended that the two of the surveys are undertaken between the beginning of May and end of August, inclusive, during suitable weather conditions. The first survey is scheduled for the evening of the 20th August 2023.
