Building Survey to investigate for evidence of bats at

The Cottage

Broadway Road

Willesley

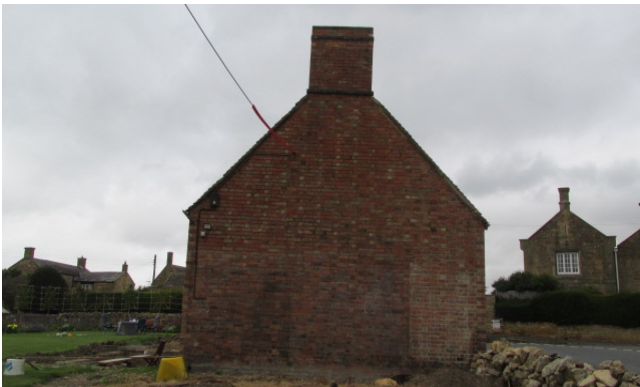
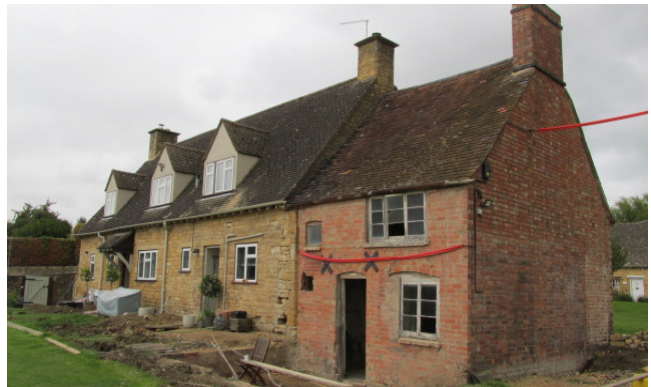
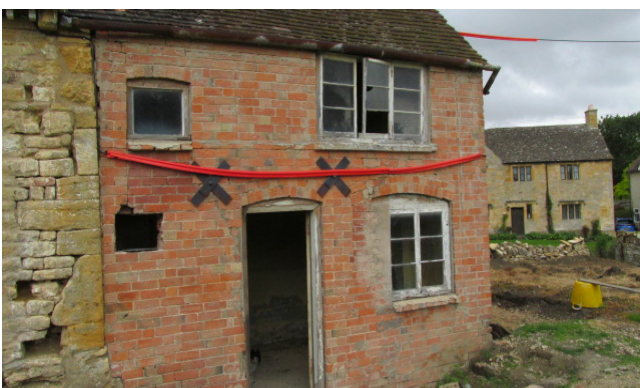
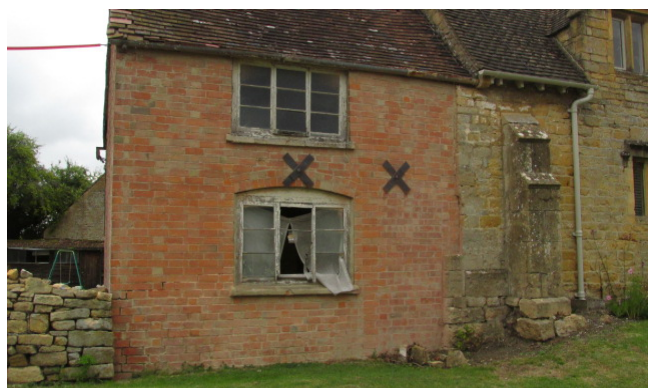
The Cottage is constructed from brickwork with plain clay roof tiles. The windows have wooden frames and none of the windows are intact.

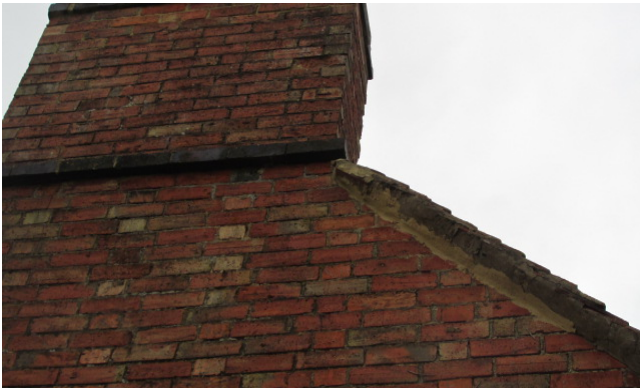
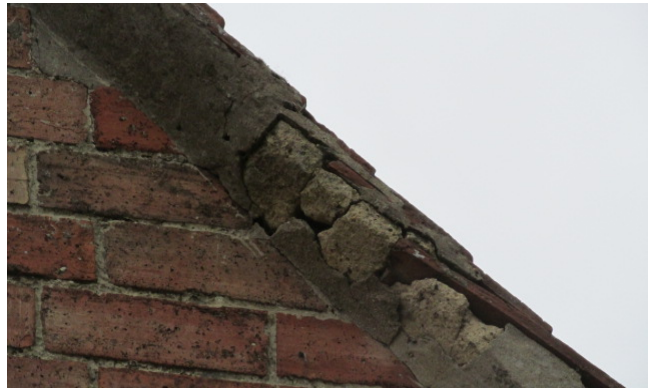
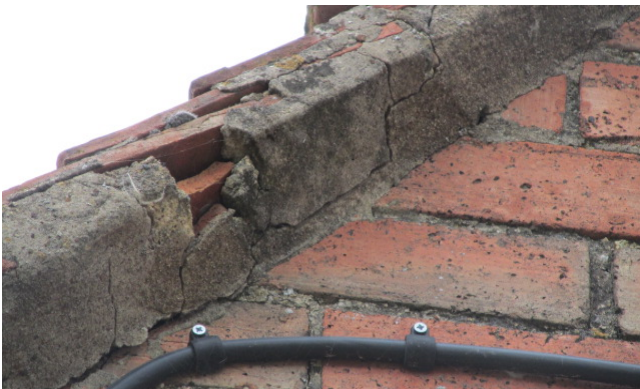
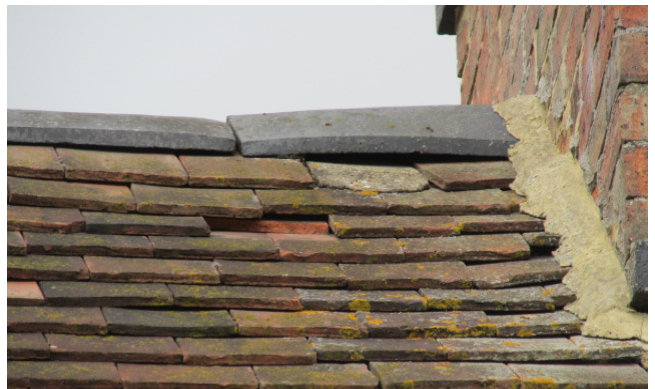
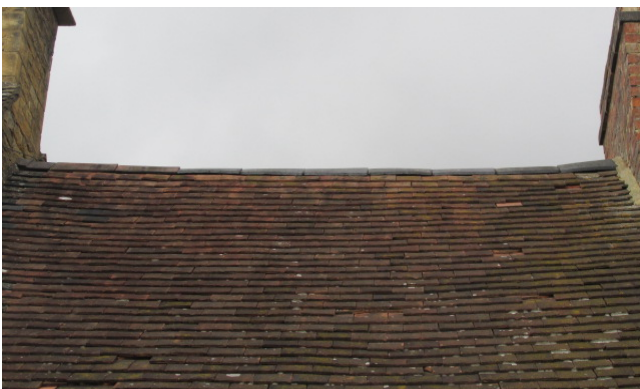
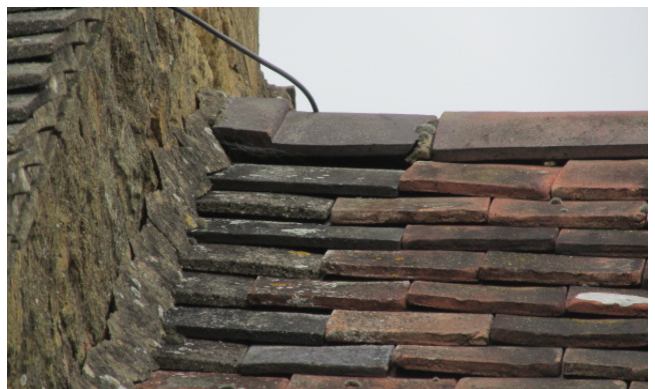
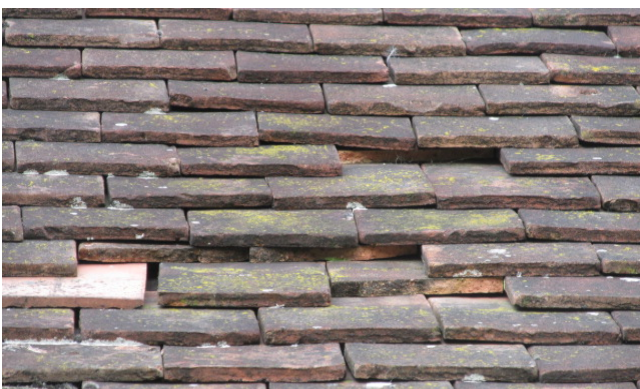
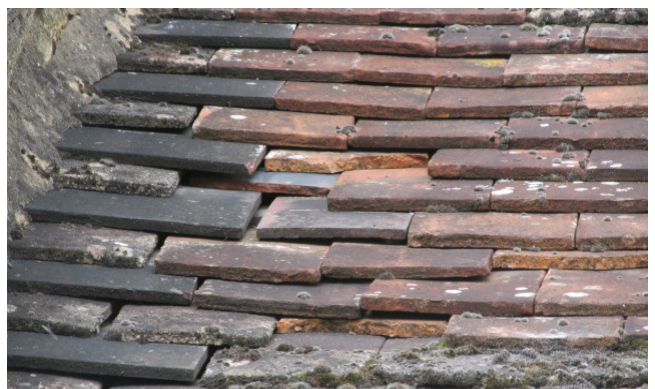
The roof slopes are not in great condition. The roof slopes are unlined and uninsulated. The tiles are suffering from weather impact and there are areas of missing mortar, missing and broken tiles and sections where the ridge tiles are not well bedded.

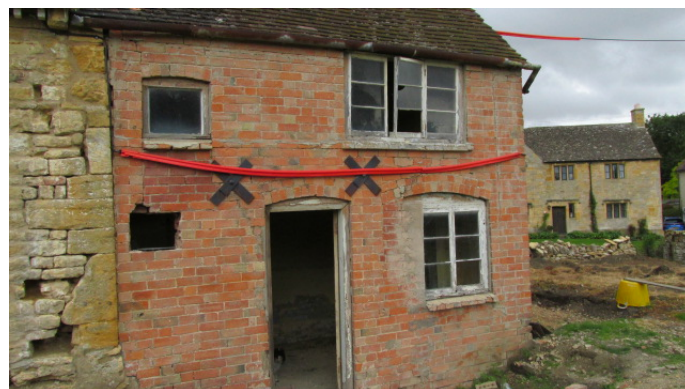
The Cottage is access via the door to the rear off the sunken garden.

The floor inside is mud. The inside has been stripped out.

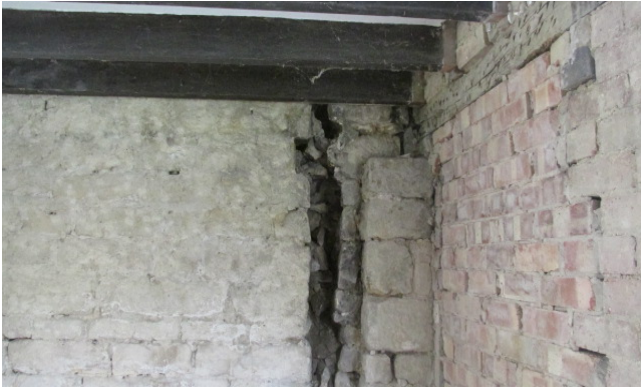
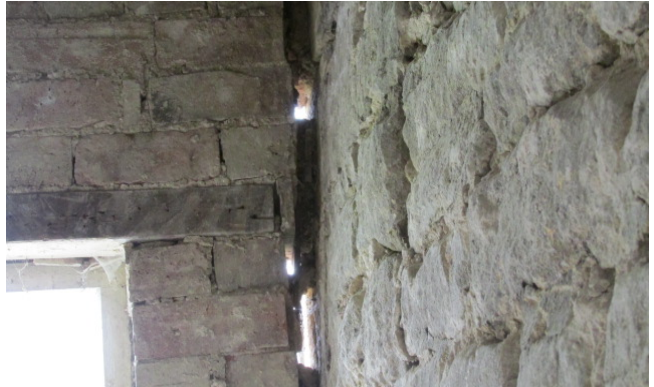
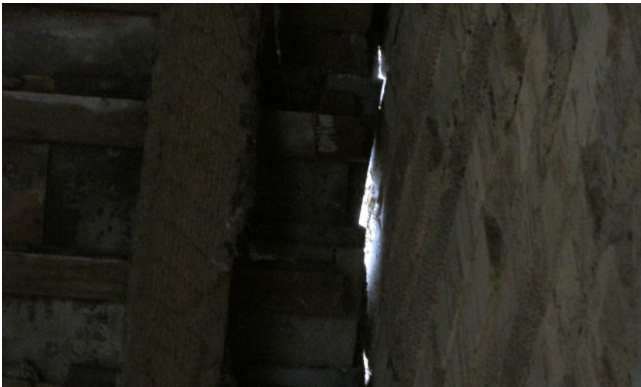
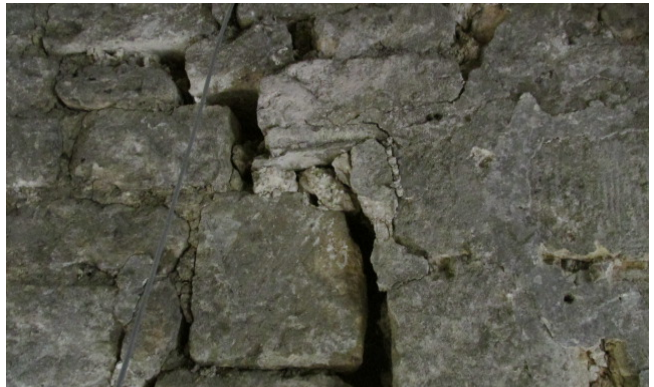
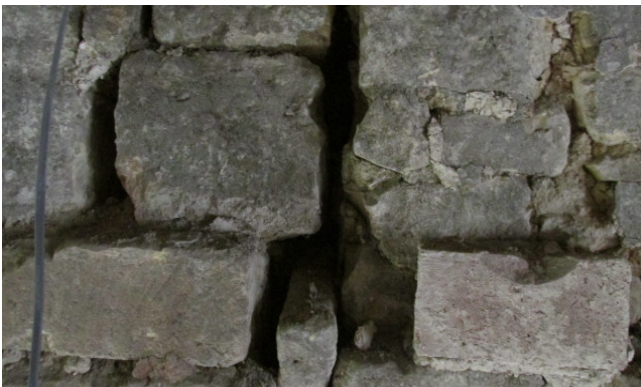
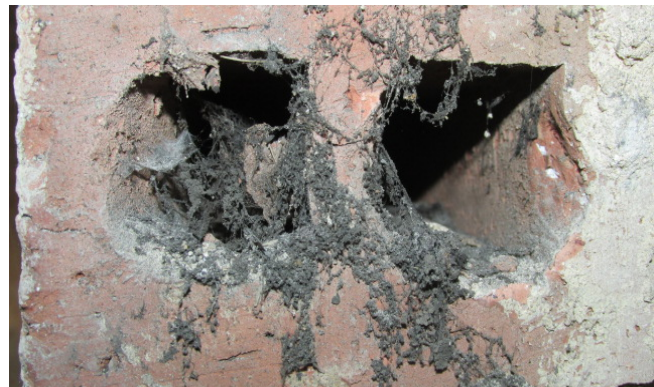
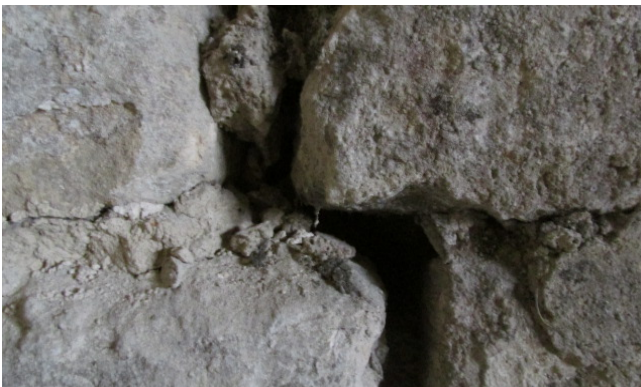
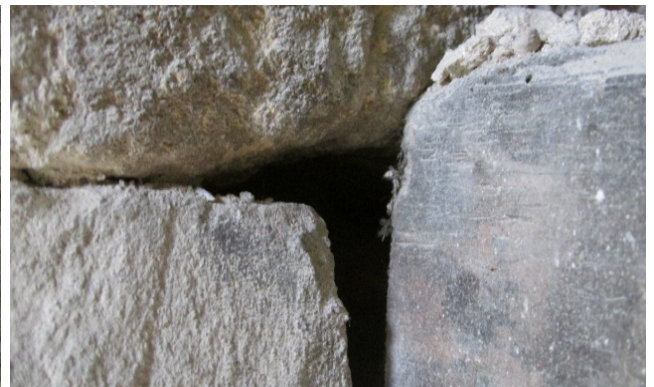
There are very few surfaces but these were carefully checked for evidence of use of the space by bats but none was found. The structure is very open due to the amount of missing panes to the windows and there is significant levels of light and draft ingress through The Cottage.

The walls are bare stonework. There are significant gaps throughout.

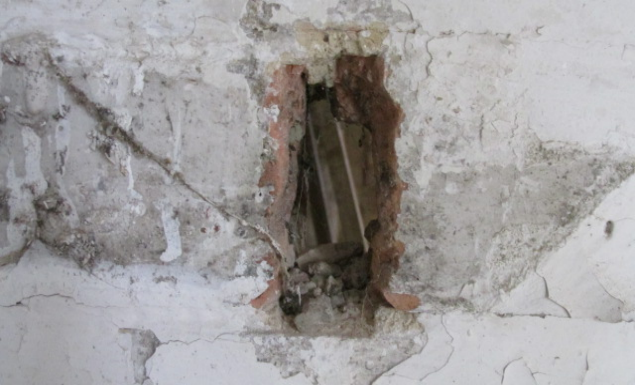
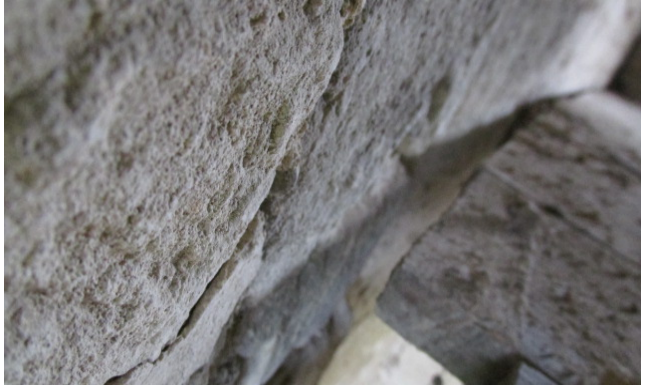
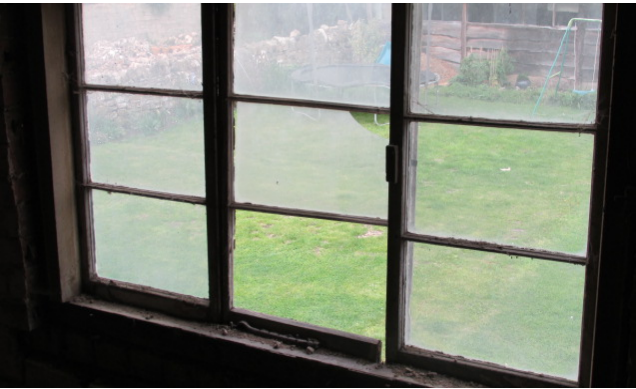
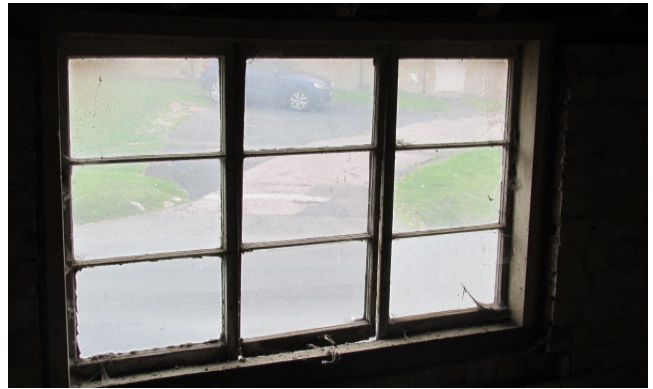
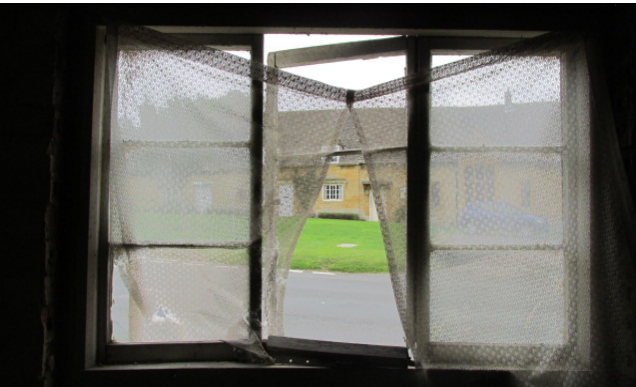
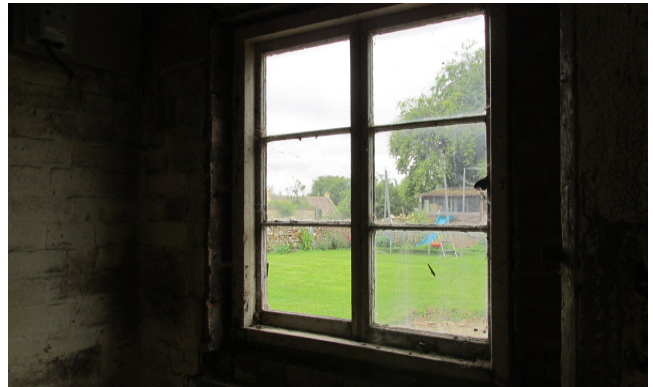
The windows are single glazed wooden framed, and none are intact

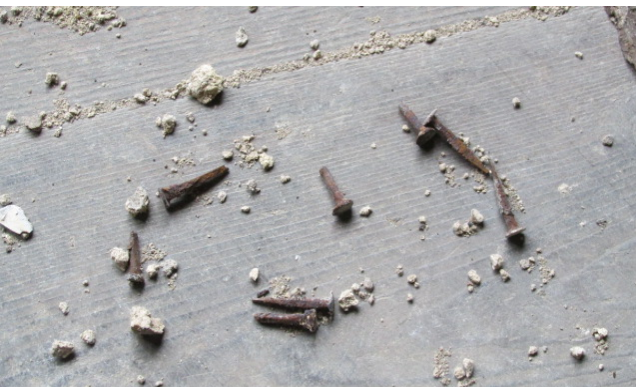
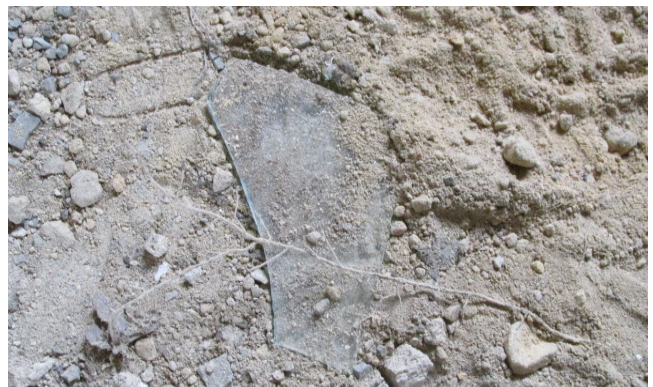
The floors are exposed, uncovered and very dusty.

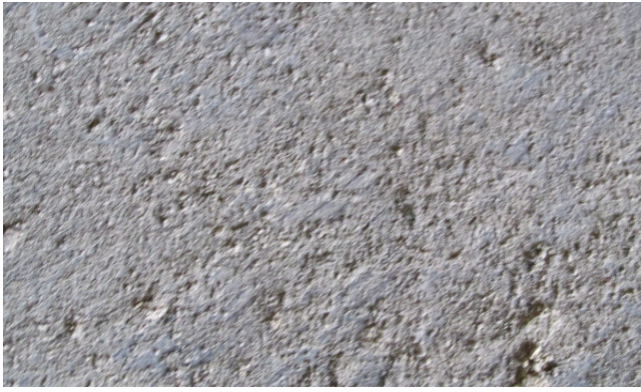
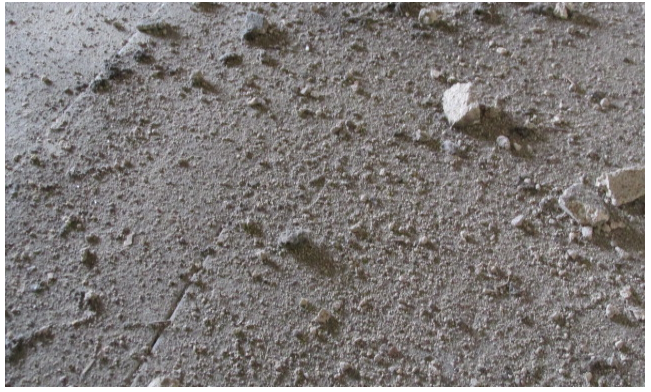
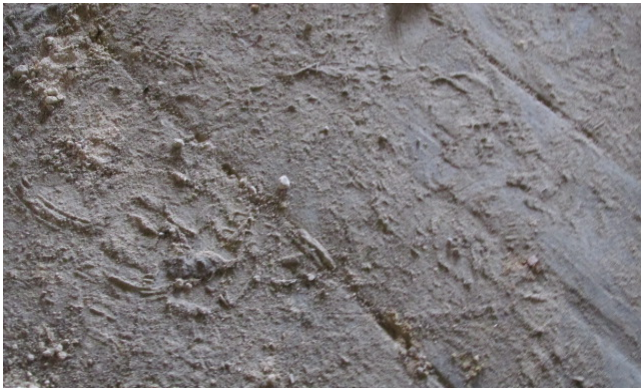
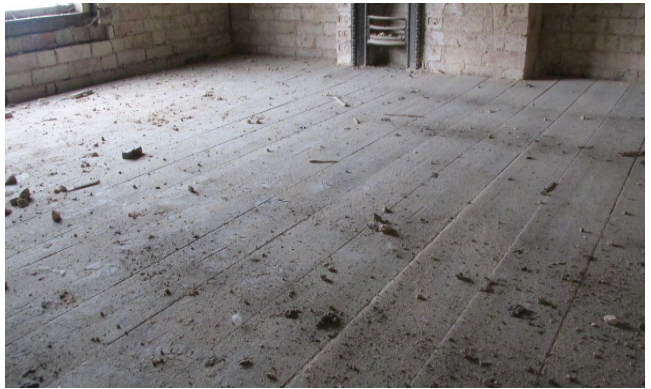
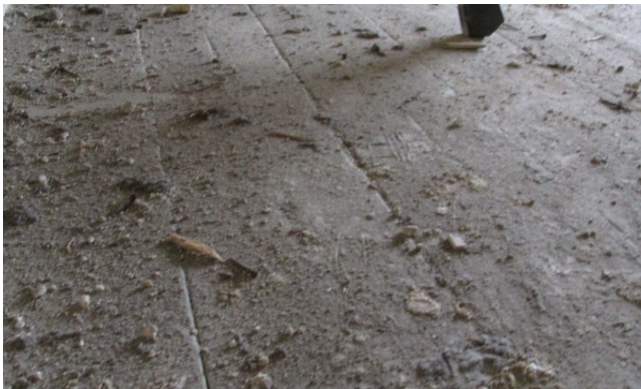
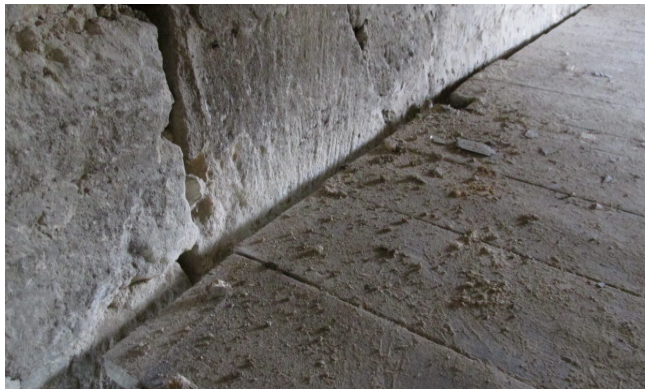
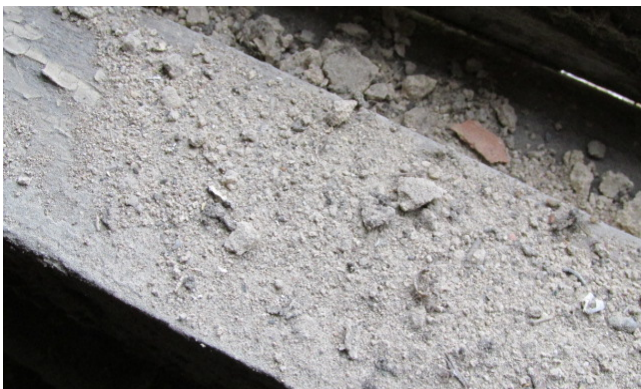
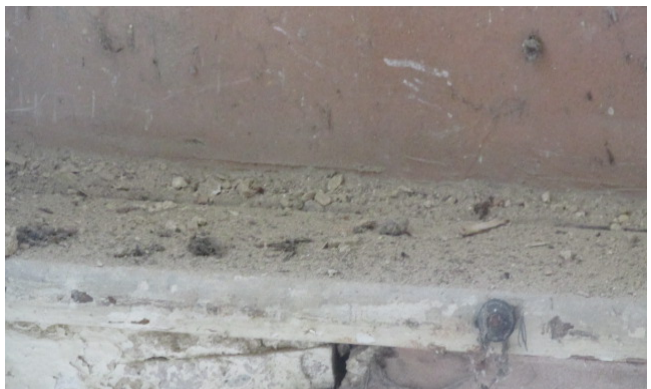
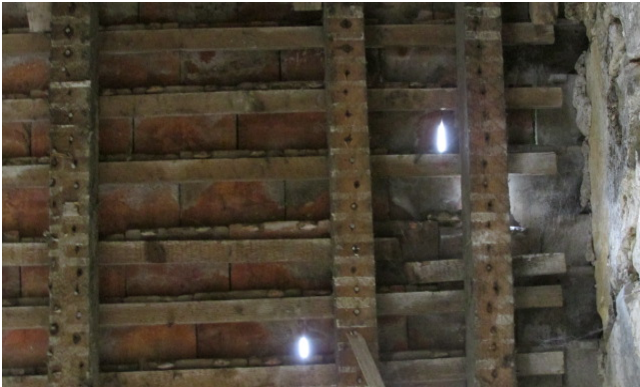
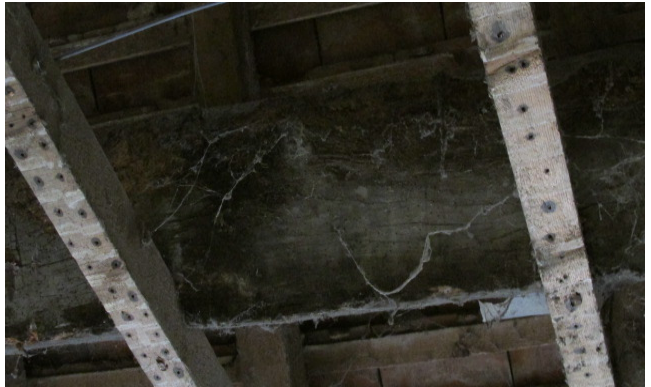
The underside of the roof tiles is visible from inside. Light ingress is obvious through the gaps and the space is very dusty and full of cobwebs.

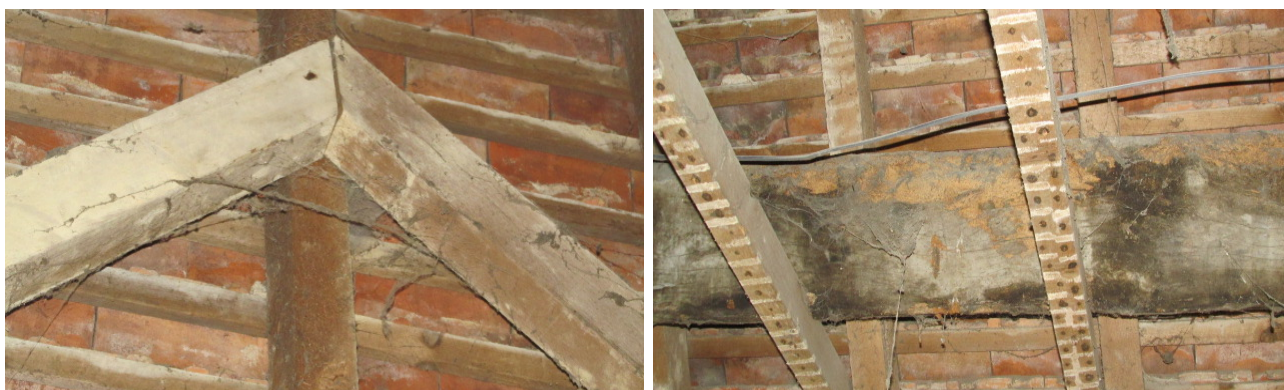
The Cottage is unremarkable in terms of construction and structure. There was no evidence of use of The Cottage by bats or birds.

Based on the lack of evidence found inside and taking the location of and the exposure of the elevations it is proposed that the south elevation of The Cottage have an external bat box installed and this mitigation approach will result in a biodiversity net gain.

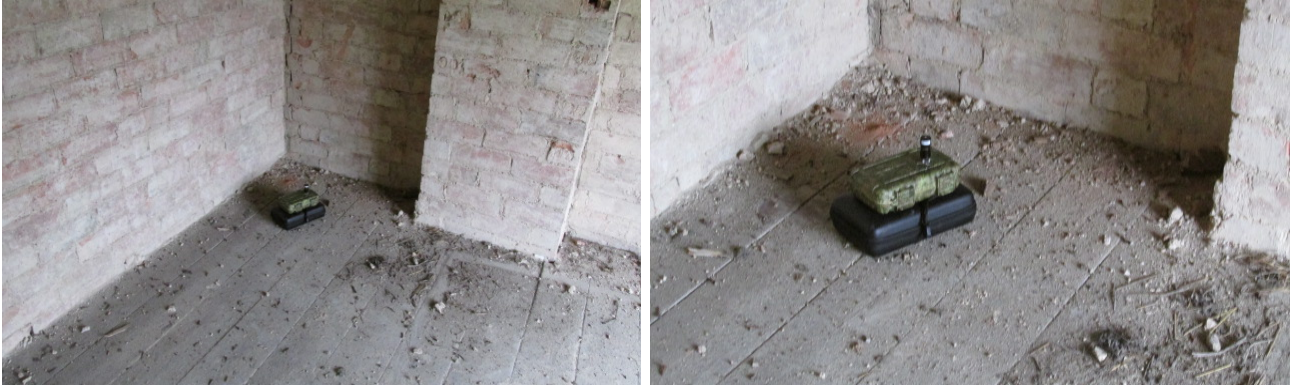
After the building survey was completed, an Anabat Express static detector was left in The Cottage. However, due to the open nature of the structure with the missing panes of glass, this was located as far away from windows as possible but with the knowledge that passing bats could potentially be recorded.

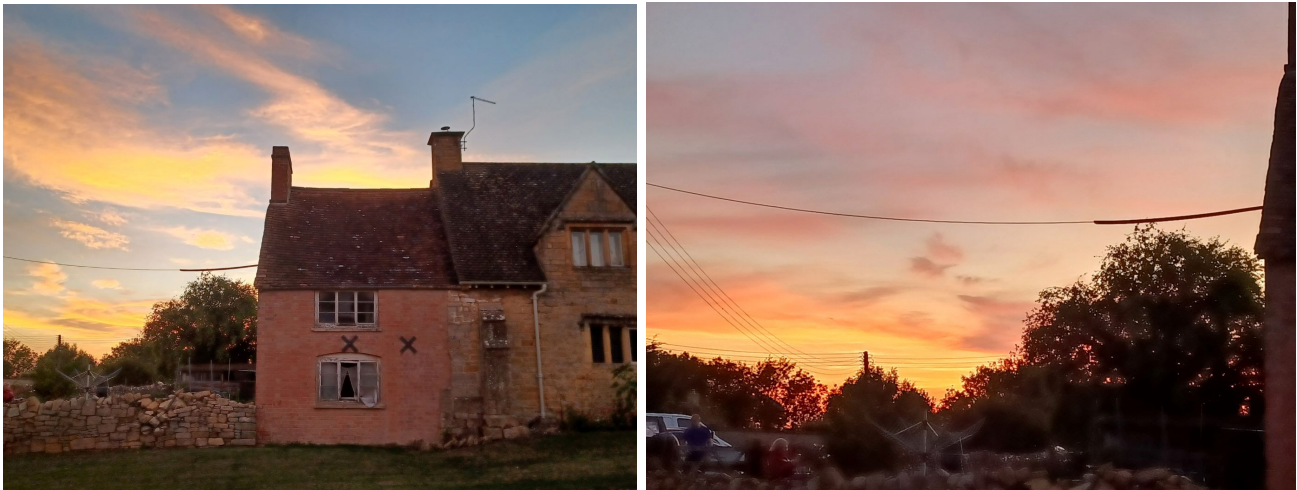
Each surveyor had clear sight of the elevation they were watching, positions shown below with orange stars. The evening was warm with a gorgeous sunset.
