**Hazelton Grange, Hazelton (Main House)**

**Preliminary Roost Assessment and Bat Emergence Surveys Report**

**Project Code: JM2023026ABv2**

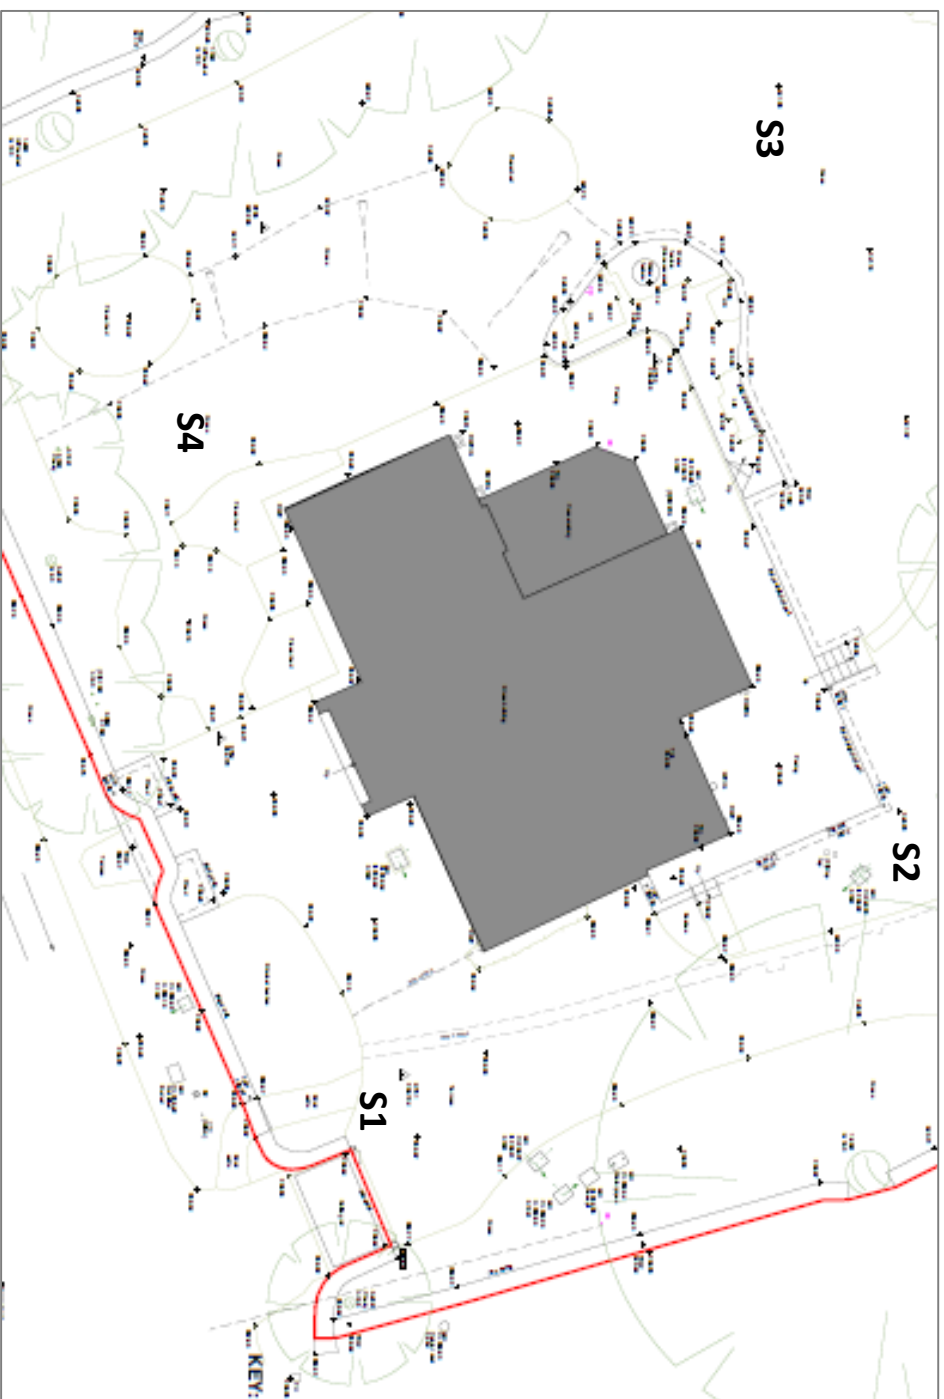
**Figure 2. Bat Surveyor Positions at Hazelton Grange (Main House)**  
*S1-S4 indicates surveyor number/location.*  
*(Plan provided by client and annotated by Wild Service)*

- 2.3.1 Surveyors were positioned around the house so that potential roosting features could be viewed (surveyor positions are provided in Figure 2). Each surveyor had a radio to facilitate communication between surveyors regarding bat roosting and foraging behaviour. The dusk emergence surveys began approximately 15 minutes prior to sunset and ended approximately 90 minutes after sunset.

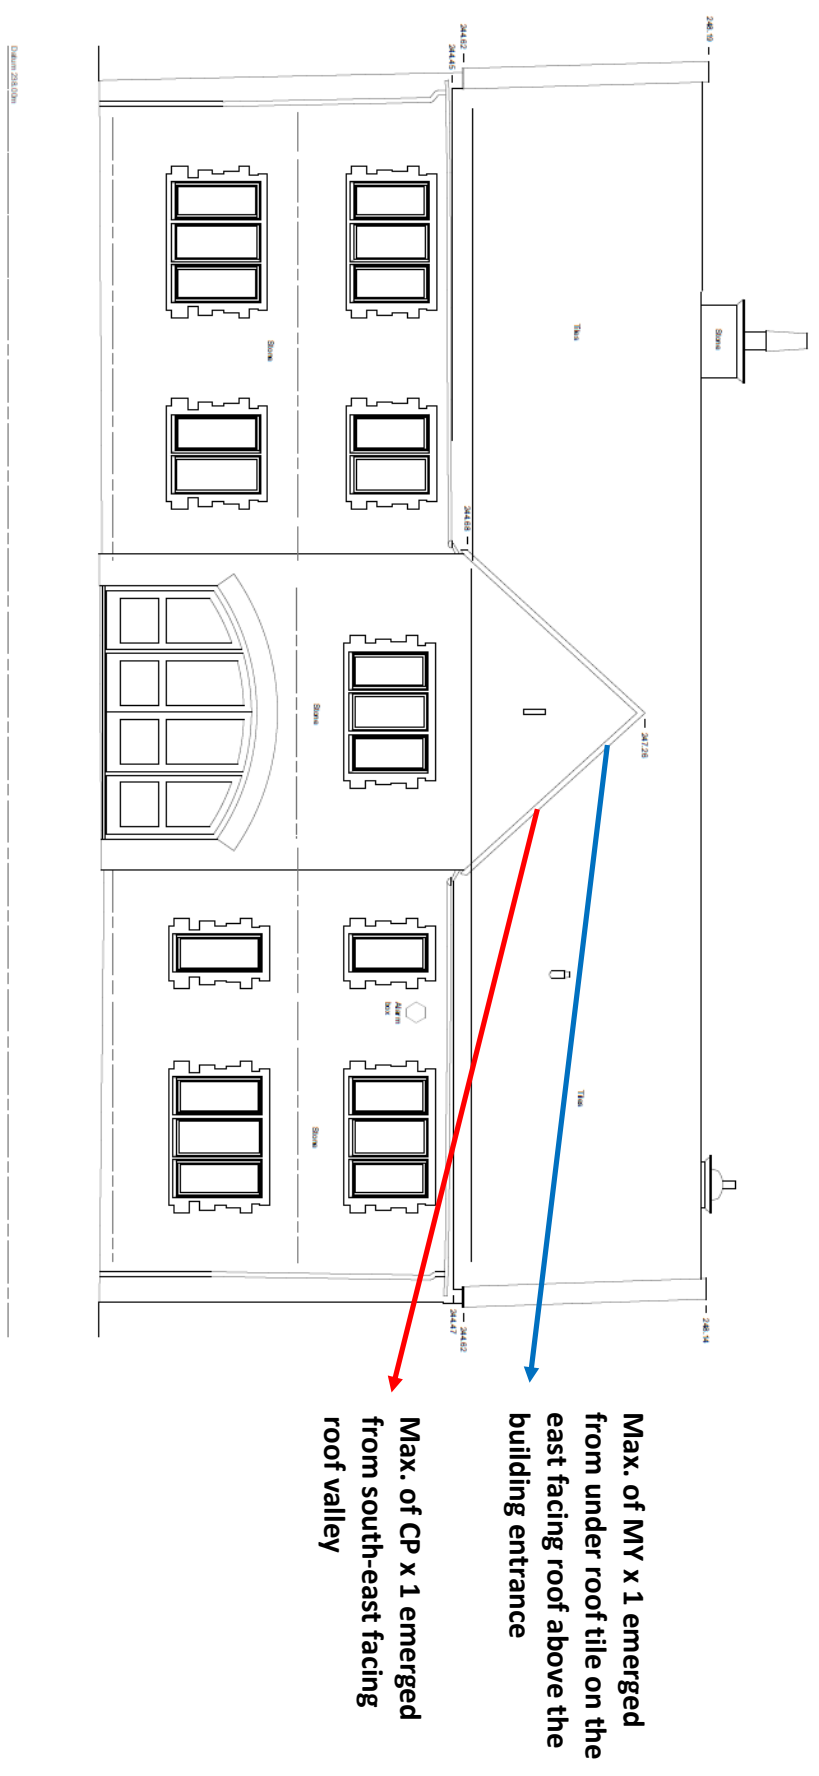
**Figure 4a. Bat Emergence Points from South Elevation Roof of Main House**  
**CP = Common pipistrelle, MY = Myotis species**  
*(Plan provided by client/annotated by Wild Service)*

3.3.3 A total of **one common pipistrelle bat emerged** from the house, from under a roof tile on the south-east facing roof valley, near the building entrance (Table 4.1. and Figures 4a & 4b).

3.3.4 A total of one ***Myotis species bat emerged*** from the house, from under a roof tile on the east facing roof above the building entrance, on the south elevation (Table 4.2. and Figures 4a & 4b).

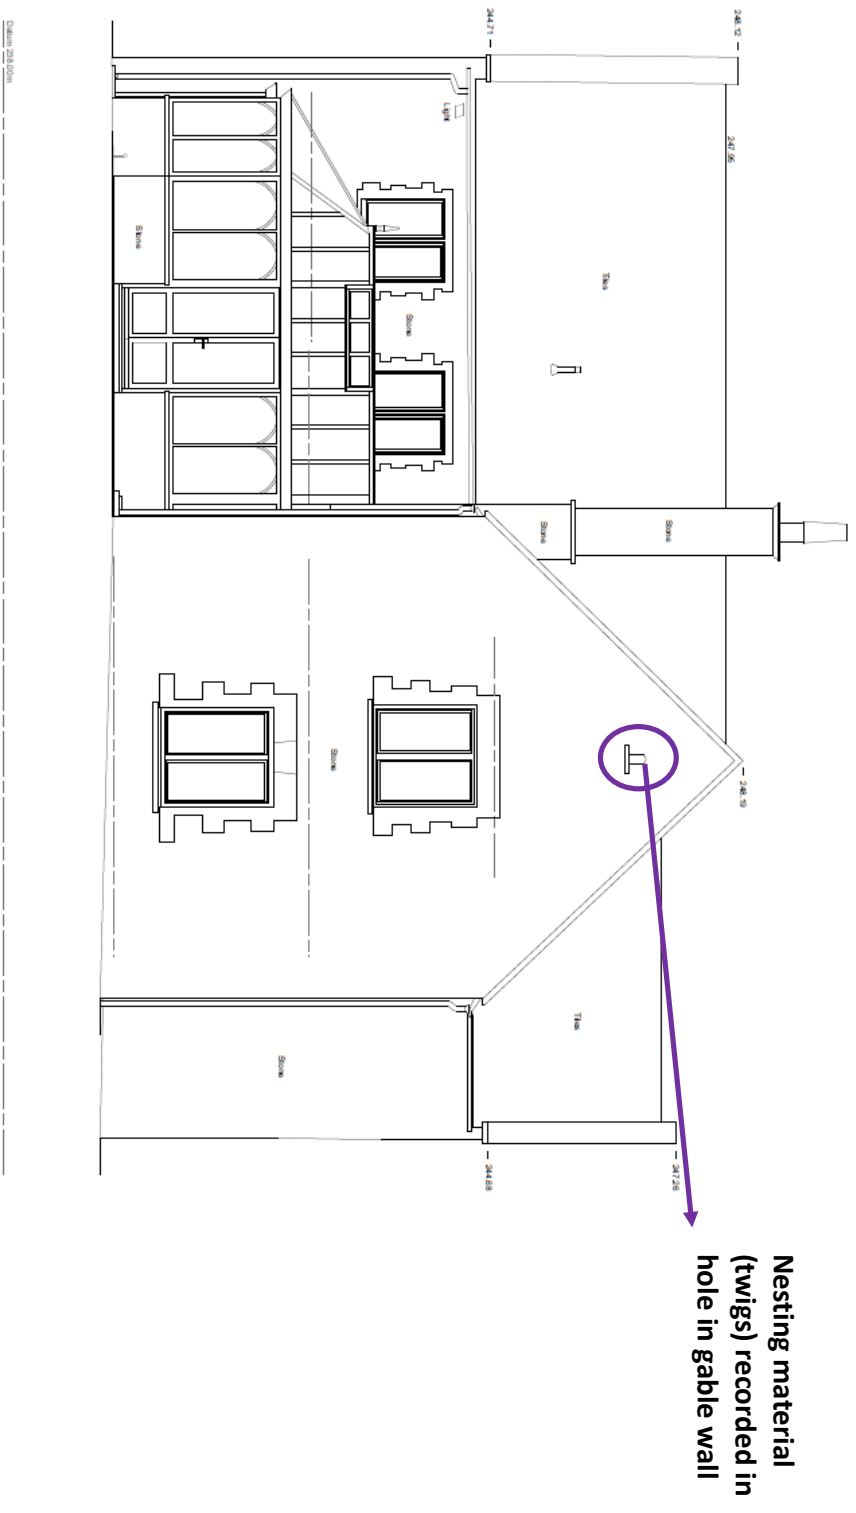
**Figure 4c. Location of Old Bird Nest on West Elevation Roof of Main House**  
*(Plan provided by client/annotated by Wild Service)*

3.4.2 Possible nesting materials (twigs) were seen in the hole in the external gable wall on the west elevation of the house, but no nesting bird activity was observed during any of the surveys undertaken on the house (see Figure 4c). A similar hole in the gable end wall on the south elevation of the house offered nesting opportunities for birds. In addition, gaps under the roof tiles on all elevations provided a potential nesting habitat for small birds.

- 4.1.5 Nesting material was observed in the hole on the west elevation wall, near the location of the proposed extension on the north-west corner of the house. No nesting activity was recorded during any of the surveys on site. However, it is considered possible that nesting birds may be present during the main nesting season (generally considered to be March to August inclusive).
- 4.1.6 A barn owl was recorded during the second and third dusk emergence surveys, flying out of a hole in the external gable wall at the east elevation of the house. It is unclear whether the hole in the wall leads to a cavity large enough to support a nest, though it is considered unlikely as there is no internal loft space directly behind the hole in the east elevation gable wall.

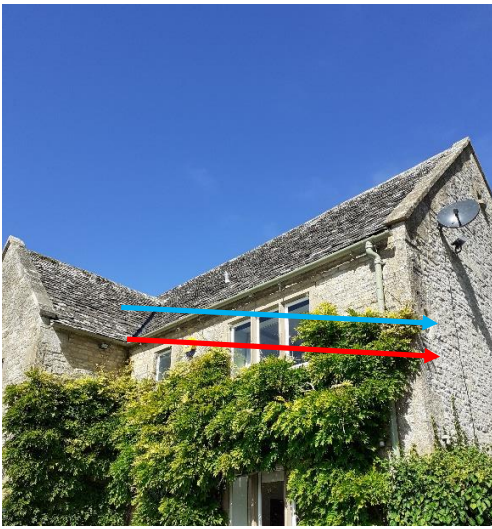
<p>A maximum of one <i>Myotis</i> species emerged from under a roof tile on the east facing part of the roof, above the entrance door on the south elevation of the house (indicated by blue arrow). A maximum of one common pipistrelle emerged under a roof tile near the roof valley (indicated by red arrow).</p>
2

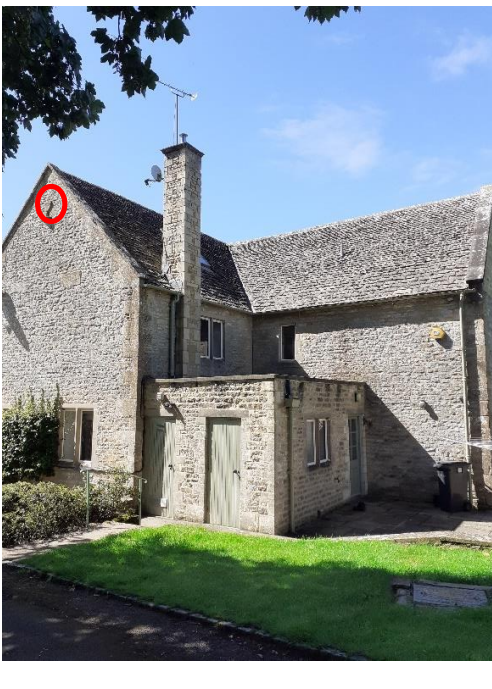
3.4.1 A barn owl *Tyto alba* was recorded during the second and third dusk emergence surveys, flying out of a hole in the external gable wall at the east elevation of the house (see Figure 4b for location).

<p>A barn owl flew out of the hole in the east elevation wall (circled in red) during the second and third emergence surveys of the house.</p> <p>Proposed works include a single storey extension to the flat roof area of the house pictured across.</p>

- 4.3.1 All birds are protected under Section 1 of the Wildlife and Countryside Act 1981 (as amended). It is therefore generally unlawful to intentionally kill or injure a bird, damage, or destroy an occupied nest or take or destroy eggs other than in exceptional prescribed circumstances. Additional protection is given to species listed on Schedule 1 of the Act (such as barn owl) insofar as it is unlawful to disturb them during nest building, at the nest or when caring for dependent young. Therefore, development operations should take care to avoid the risk of harm to birds and their nests. Barn owls can nest at any time of year, but it is recommended that if works are undertaken between October and February the chance of disturbance to breeding birds is greatly reduced. If works are undertaken at any time during the main nesting bird season (i.e. March to September), further barn owl surveys would be required to establish whether the owls are breeding and to inform appropriate mitigation as although the proposals do not directly affect the cavity, birds could be disturbed by the works.

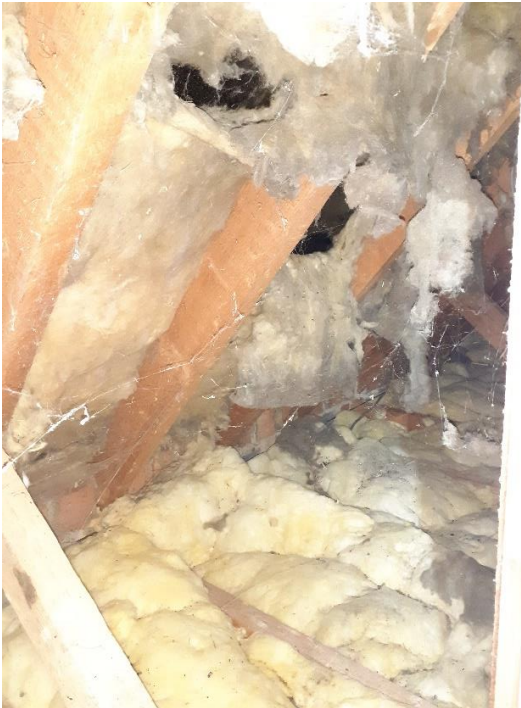
A photograph showing a small, cluttered internal loft space. The floor is covered with yellow insulation. Wooden joists and rafters are visible, along with some debris and a dark opening in the ceiling.	View of small internal loft space on the second floor (along the south elevation of the house).
8

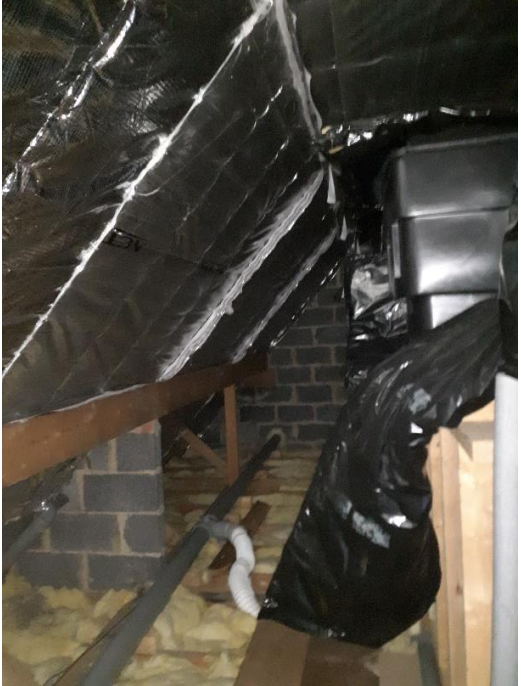
A photograph showing a loft space with a brick wall on the left. A large black plastic bag is hanging from a wooden beam. The floor is covered with yellow insulation. A white pipe is visible on the floor.	View of loft space above the north elevation of the house.

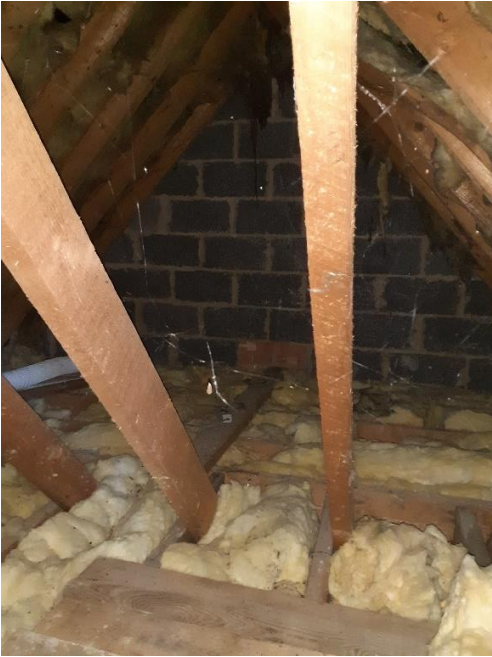
A photograph showing the interior of a loft space. The view is looking up at a wooden beam structure. The floor is covered with yellow insulation. A brick wall is visible in the background.	View of loft space above the south elevation of the house (above the entrance).
10

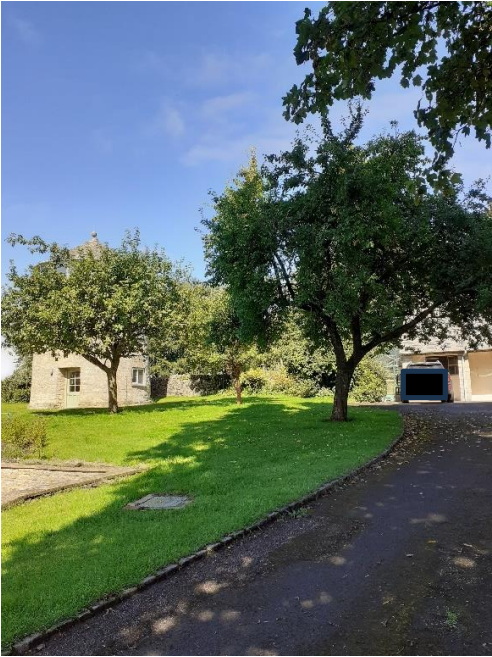
A photograph showing a view of a rear garden from a driveway. The driveway is paved and leads to a garage. There is a large green lawn with several trees scattered around. A house is visible in the background.	View of rear garden (from driveway), with amenity lawn and scattered trees.

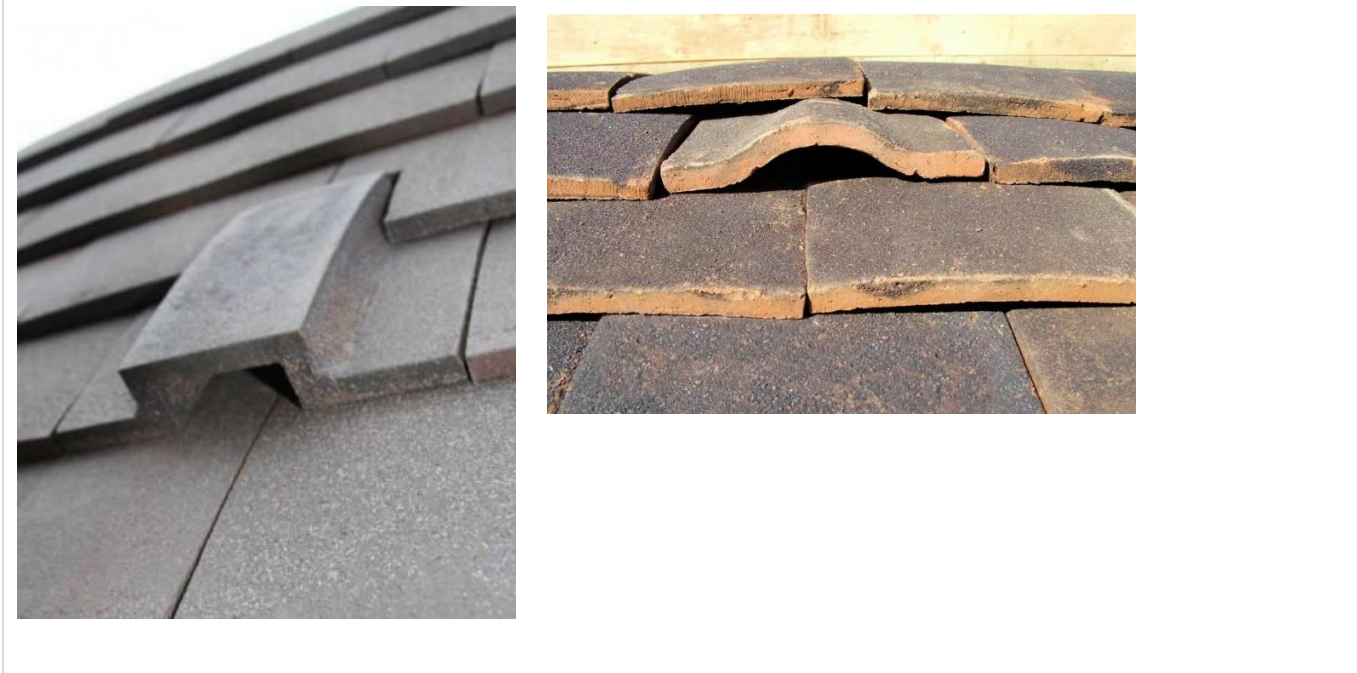
**Diagrammatic view of ridge tile and cross section through ridge tile** showing access point (taken from Scottish Natural Heritage 1996). Bitumastic lining must be used near/on the ridge beam to ensure bats can only have contact with this type of membrane to avoid any possible entanglement with a breathable membrane.
