**Bat Survey Report for
The Bothy,
58 Main Street, Coln St. Aldwyns,
Cirencester, GL7 5AN**

NKM Associates

2nd August and 22nd August 2023

Report Number: 37723-01 NKM Assoc

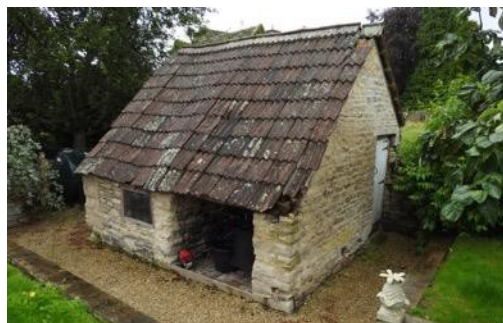
The survey site comprised of a detached pitched roofed tiled building (Figs. 1).

Figs. 1 Pitched roof building

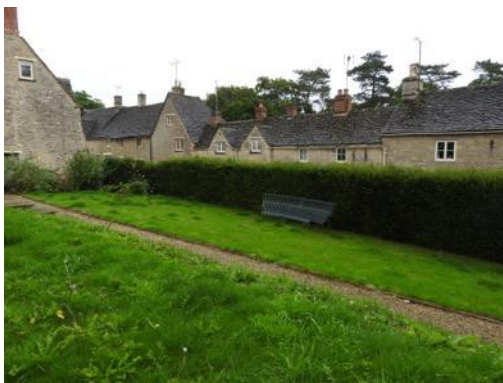
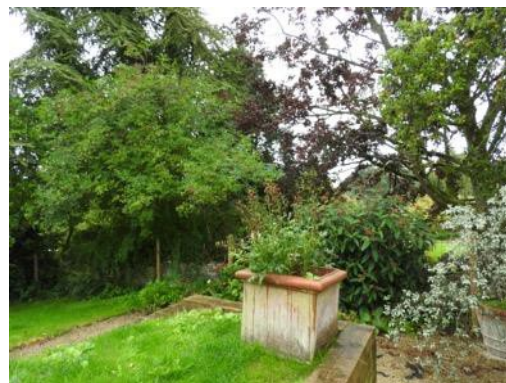
Figs. 2 & 3 Views to the east and south

To the east of the building was number 58's garden with pitched roofed houses on the other side of the street, to the south were mature trees (Figs. 2 and 3).

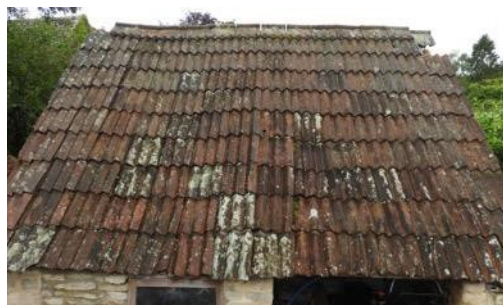
The ridge was intact with two missing tiles at the gable ends, the roof tiles were tightly overlapping, (Fig. 4).

Figs. 4 Ridge and roof tiles to the east

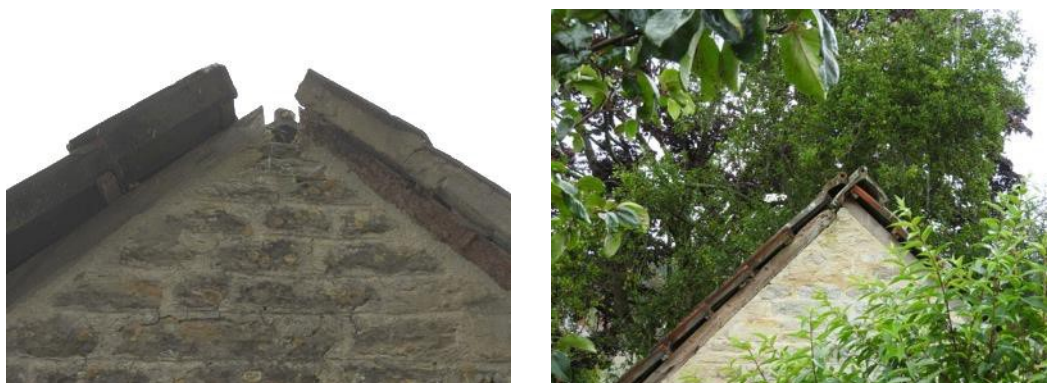
The south gable was sealed with the roof verge cement sealed to the gable wall plates (Fig. 5). The north gable had gaps under the roof verges which opened straight into the inside of The Bothy (Fig. 6).

Figs. 5 & 6 Sealed south gable (L) and gaps under the roof tiles north gable (R)

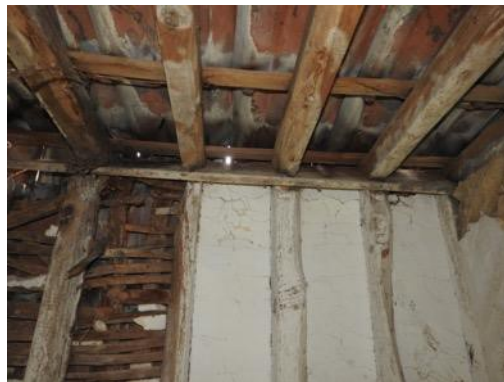
The room against the south gable wall was divided from the rooms to the north by a dividing wall running east to west, the roof was partially lined and cobwebbed on its ridge and gable ends (Fig. 7).

Fig. 7 Partially lined room against the south gable wall

Light penetrated the room through the gaps in the ridge tiles and open eaves.

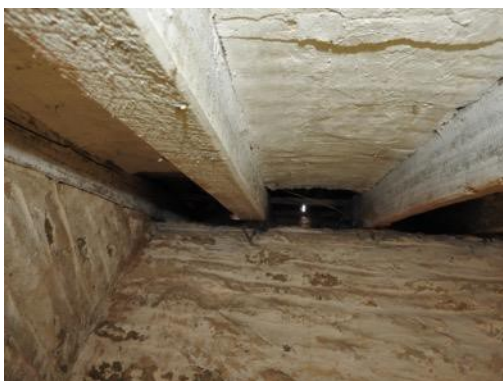
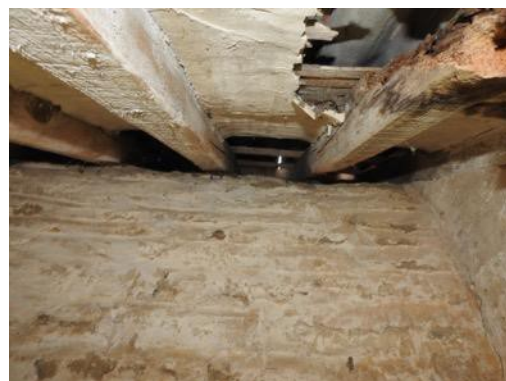
The room to the east was open sided and was cobwebbed along the ridge (Figs. 8 and 9).

Figs. 8 & 9 East room against the north gable wall

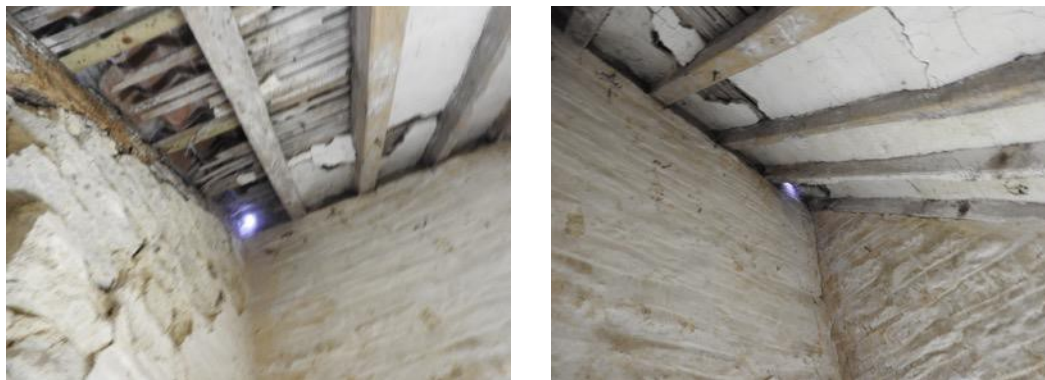
The room to the west was enclosed and was cobwebbed along the ridge (Figs. 10 and 11).

Figs. 10 & 11 West room against the north gable wall

Light penetrated both rooms.

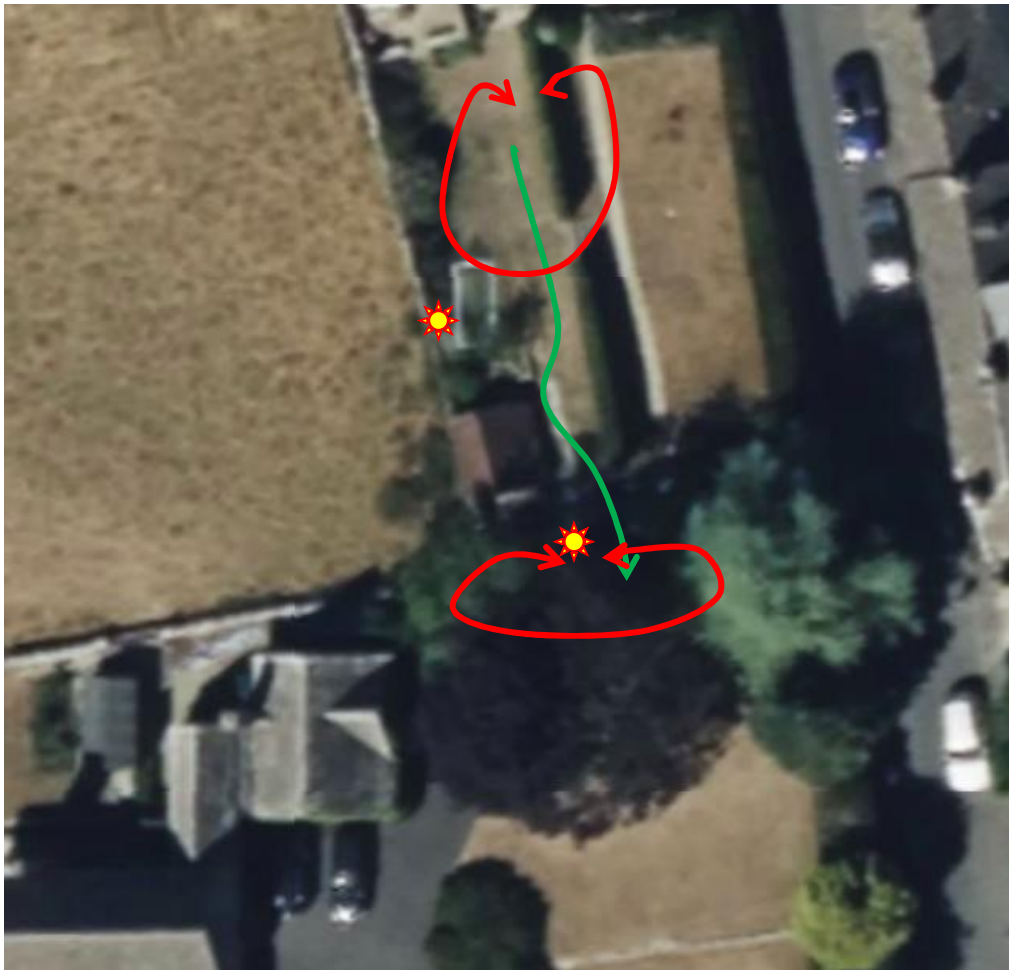
Plan 2 Bat flight paths at emergence on 22nd August 2021

The nocturnal survey recorded Common Pipistrelles and Noctules flying round and over the site. No bats emerged from The Bothy.

The bats flight paths at emergence are shown on Plan 1 overleaf.

Common Pipistrelle Bats →

Noctule Bats →

Positions of observers ✨
