BUILDINGS AT HOLLY TREE FARM, OXTON - PROTECTED SPECIES APPRAISAL

AUGUST 2018

REPORT PREPARED BY:

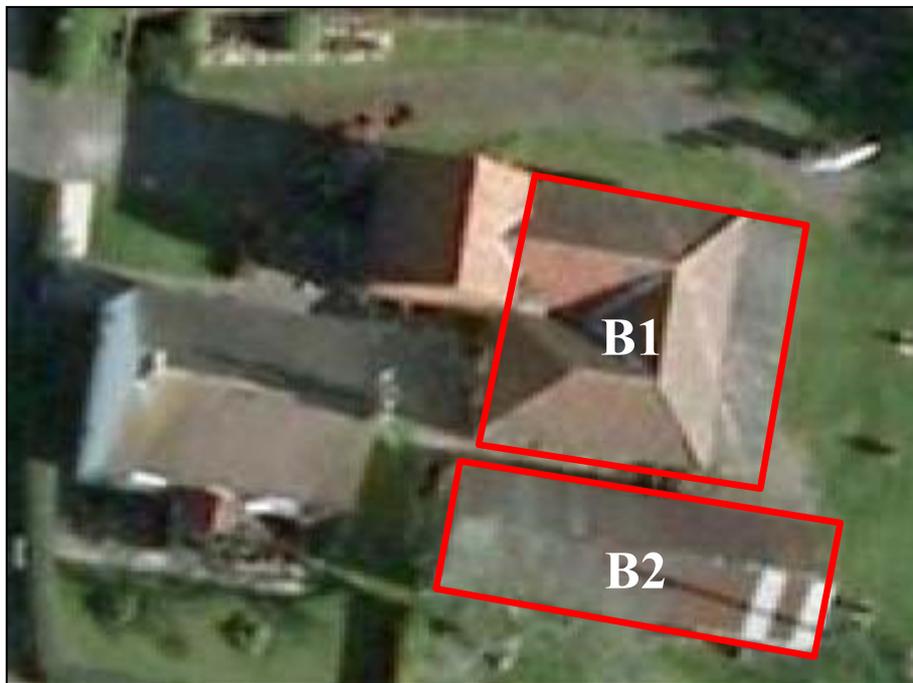
Plate 1 - Aerial view of building with sections surveyed in red

The site lies in the south-west of the village of Oxton at OSGR SK 62802 51046 and consists of two outbuildings within a complex of farm buildings (see Plate 1).

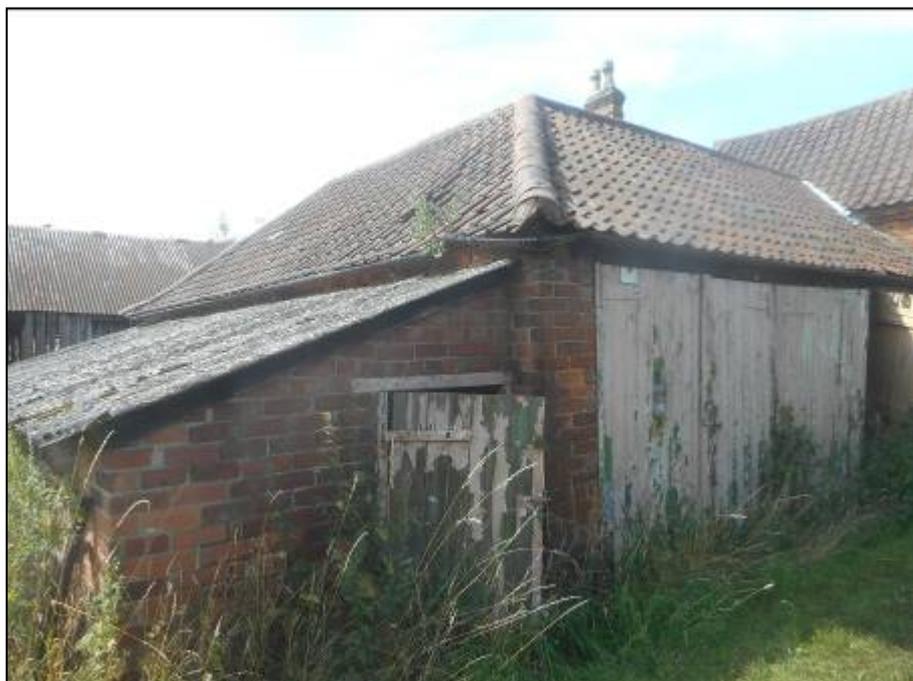
Photograph 1 - Northern aspect of Building 1

The building is of brick construction, with pitched roof sections with a clay pantile covering. There is an additional section on the eastern end of the building which has a sloped corrugate asbestos roof (see Photographs 1 and 2).

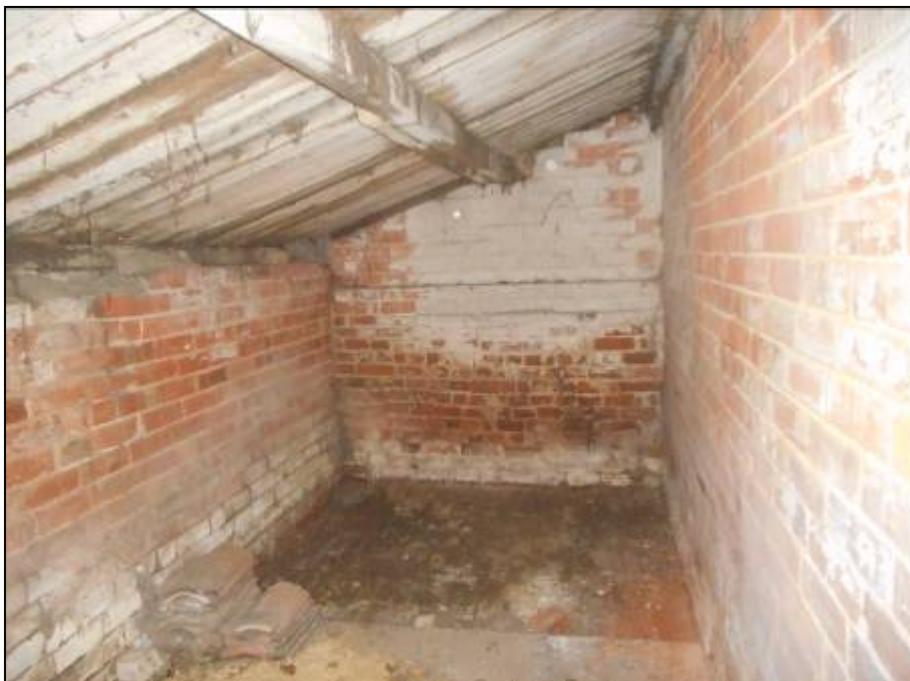
Photograph 3 - North-eastern internal section of Building 1

Internally the building has three separate sections on its northern and southern aspect (see Photographs 3 - 8).

There are no roof voids internally and there is no lining present, with the exception of the eastern room on the northern aspect which has a makeshift lining of what appears to be plastic sacking material. This lining is coming away from the beams in many places, or has gaps large enough to insert an endoscope, and it was possible to investigate the majority of it during the survey.

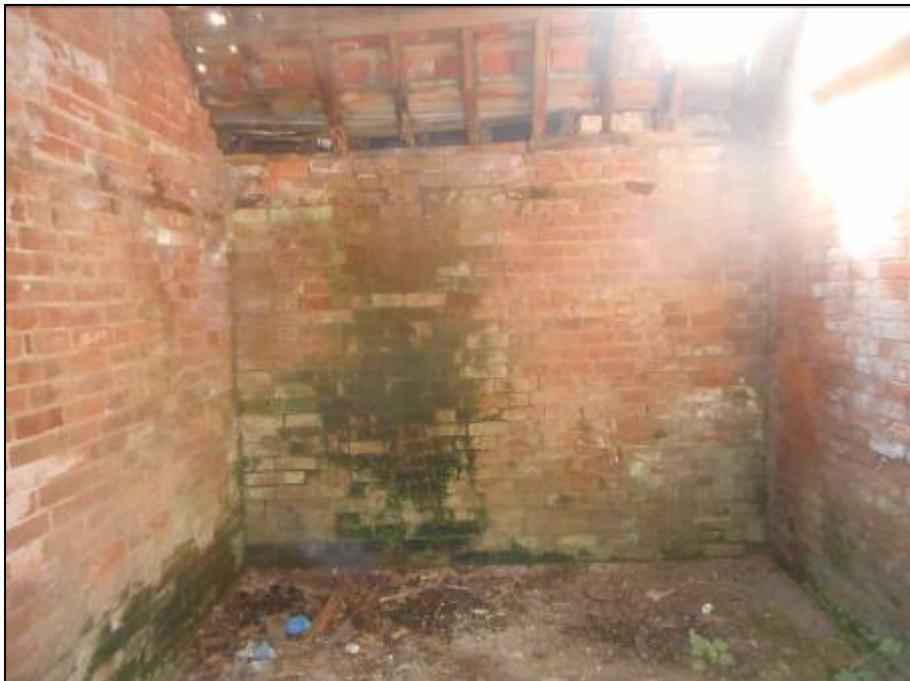
Photograph 5 - North-western internal section of Building 2

A single disused house martin (*Delichon urbicum*) nest and a single disused wren (*Troglodytes troglodytes*) nest were located in the north-western section of the northern side of the building.

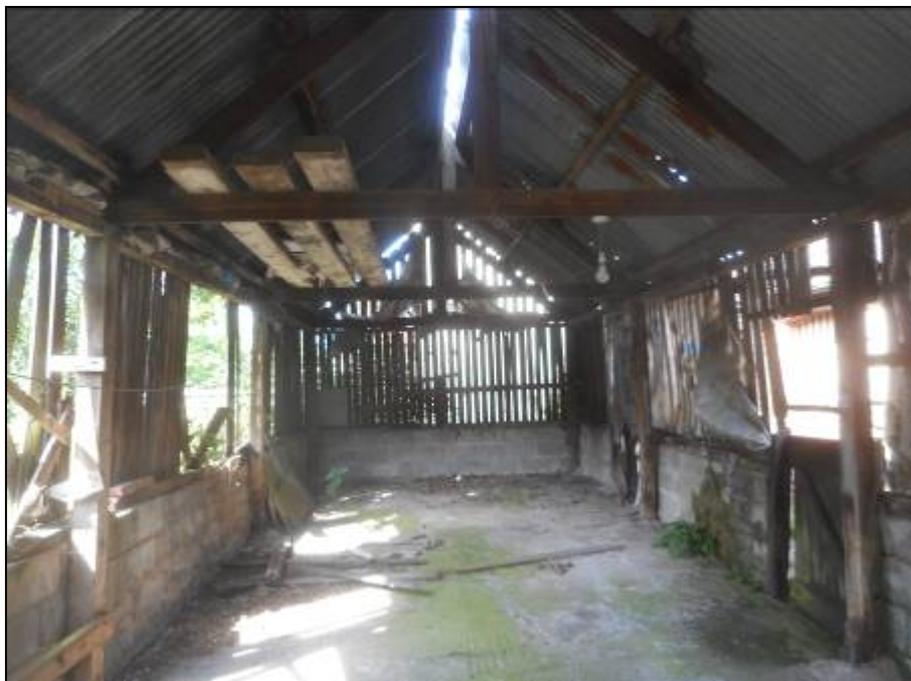
Photograph 9 - Building 2

This is a barn of stone and wood construction to the south of the main building. The building has a corrugate asbestos roof which is unlined and there is no roof void present (see Photograph 9).

This building was assessed to have no potential for bats. The building is bright, draughty and open to the elements due to its derelict condition.
