BUILDINGS AT HOLLY TREE FARM, OXTON -
UPDATE PROTECTED SPECIES APPRAISAL

MARCH 2020

REPORT PREPARED BY:

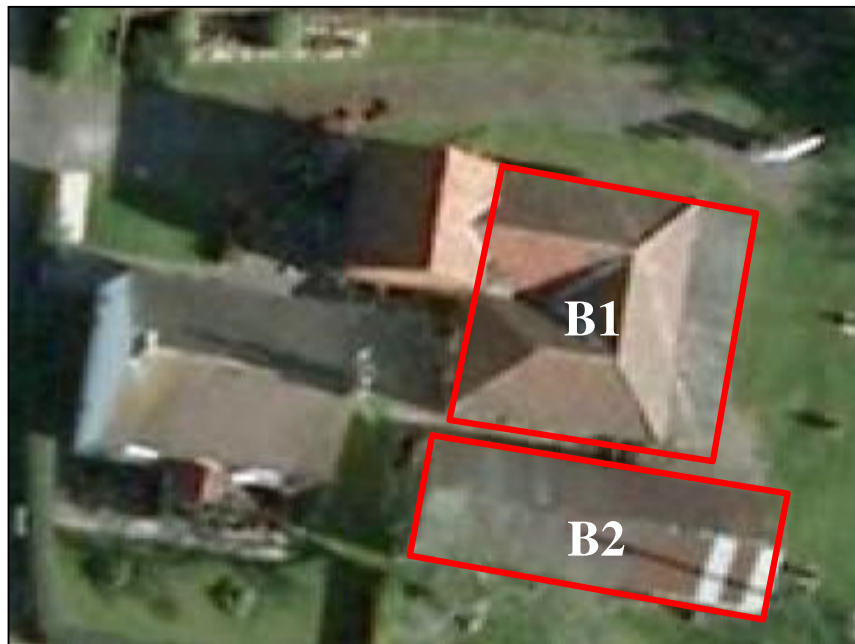
Plate 1 - Aerial view of building with sections surveyed in red

The site lies in the south-west of the village of Oxtun at OSGR SK 62802 51046 and consists of two outbuildings within a complex of farm buildings (see Plate 1).

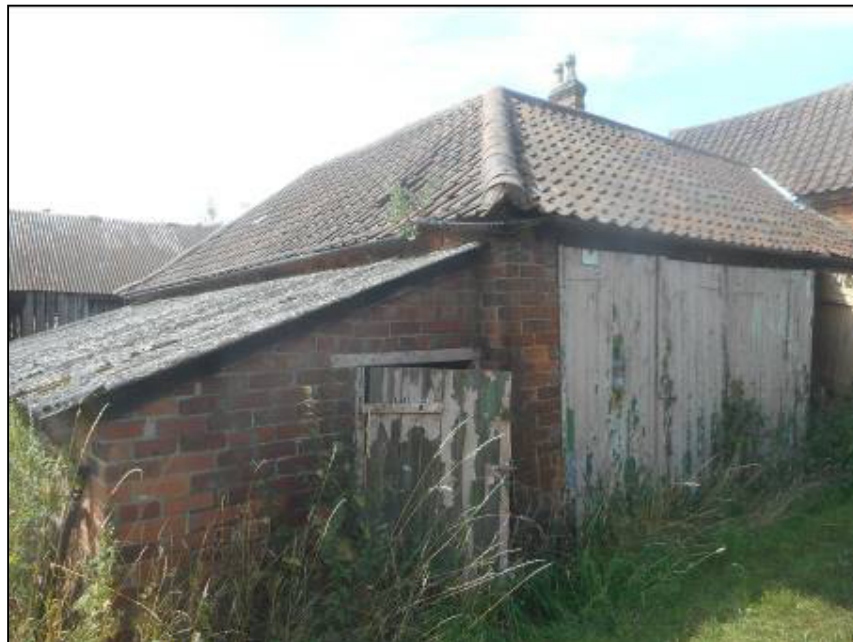
Photograph 1 - Northern aspect of Building 1

The building is of brick construction, with pitched roof sections with a clay pantile covering. There is an additional section on the eastern end of the building which has a sloped corrugate asbestos roof (see Photographs 1 and 2).

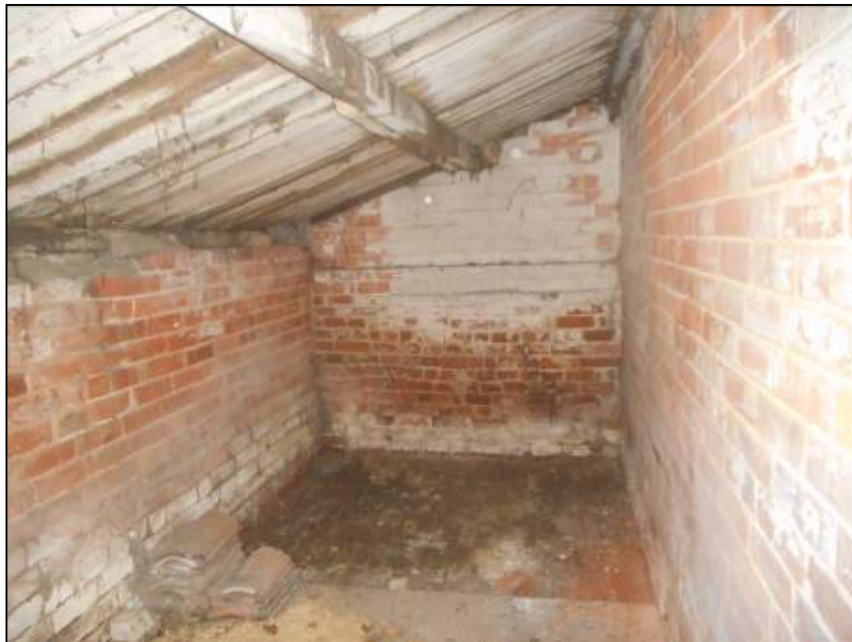
Photograph 3 - North-eastern internal section of Building 1

There are no roof voids internally and there is no lining present, with the exception of the eastern room on the northern aspect which has a makeshift lining of what appears to be plastic sacking material. This lining is coming away from the beams in many places, or has gaps large enough to insert an endoscope, and it was possible to investigate the majority of it during the survey.

The building has been subject to considerable water ingress throughout since the previous survey, with the main beams being soaked through and showing signs of collapse and water running down the internal walls, notably in the northern sections of the building, but also to a lesser extent in the southern sections.

Further areas of the sack lining in the northern sections have become detached and are hanging loose from the roof beams.

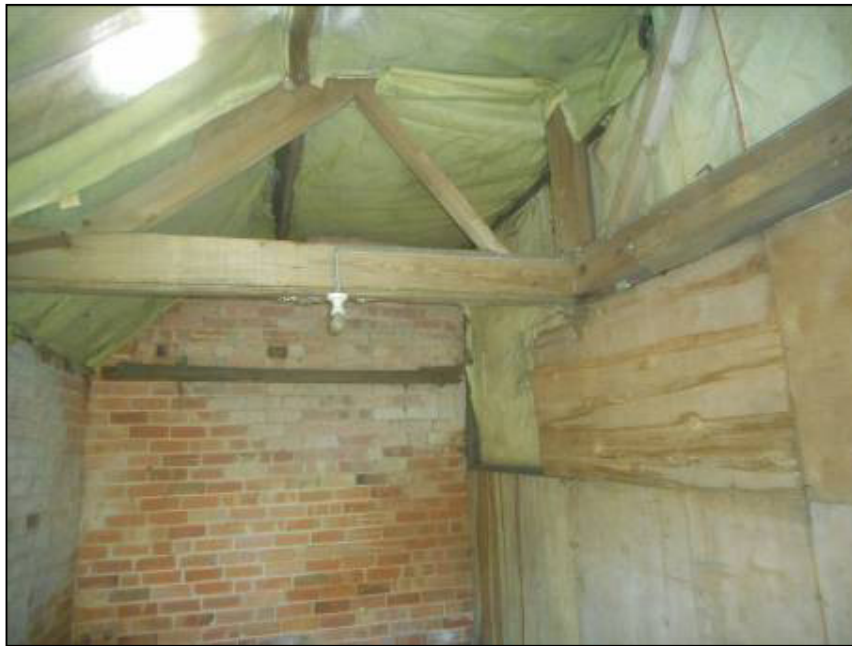
Photograph 4 - Central internal section on northern side of Building 1

Internally the building has three separate sections on its northern and southern aspect (see Photographs 3 - 8).

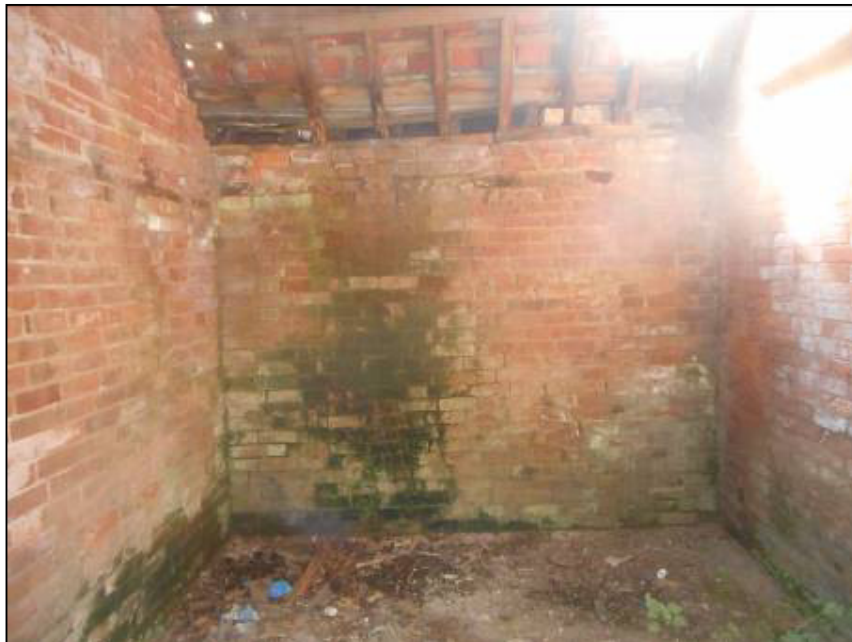
Photograph 5 - North-western internal section of Building 2

A single disused house martin (*Delichon urbicum*) nest and a single disused wren (*Troglodytes troglodytes*) nest were located in the north-western section of the northern side of the building.

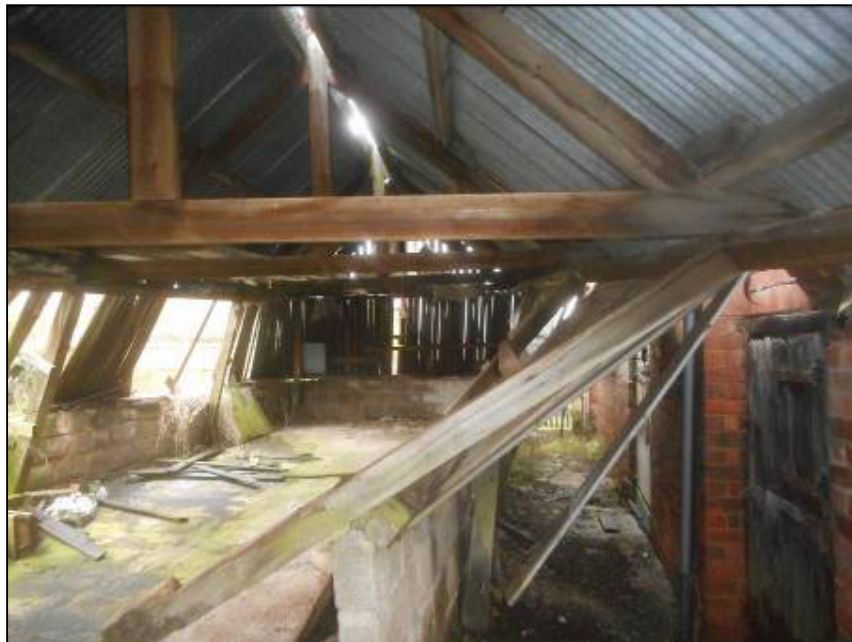
Photograph 9 - Building 2

This is a barn of stone and wood construction to the south of the main building. The building has a corrugate asbestos roof which is unlined and there is no roof void present (see Photograph 9).

UPDATE.- Since the previous survey, due to unusually inclement weather conditions, this building has collapsed and is now only supported by its own framework resting on the ground and the fact that it is leaning against Building 1 at its eastern end. Photograph 9 has been updated to demonstrate this.

This building was assessed to have no potential for bats. The building is bright, draughty and open to the elements due to its derelict condition.
