HERITAGE STATEMENT FOR

THOBY PRIORY

MOUNTNESSING

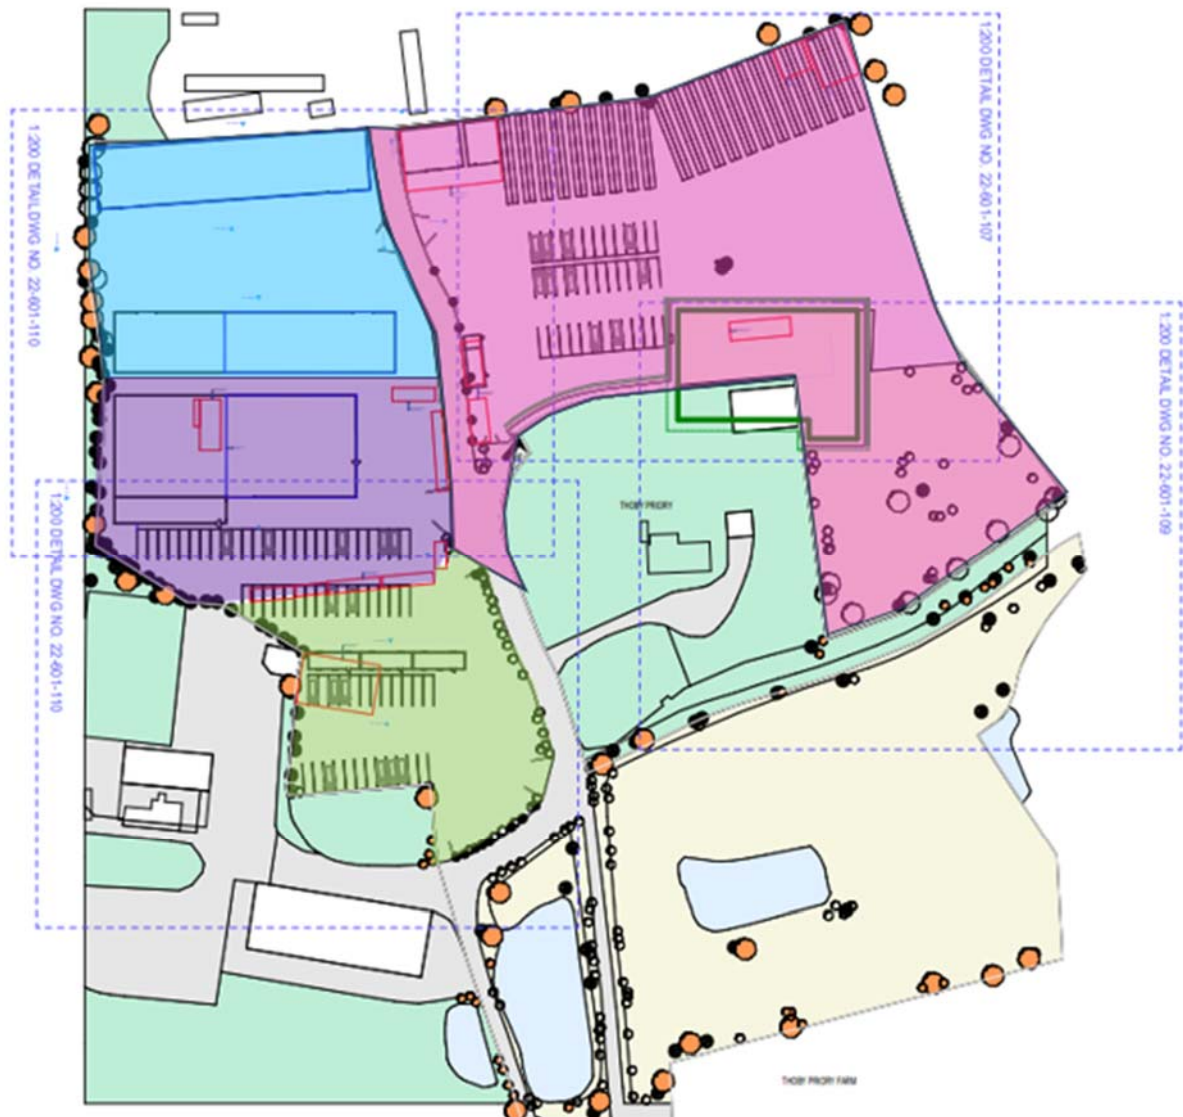
Figure 3. Proposed layout with Plot identification as follows:

Plot 01 Pink

Plot 02 Blue

Plot 03 Purple

Plot 04 Green

The Monument is identified with a green outline.

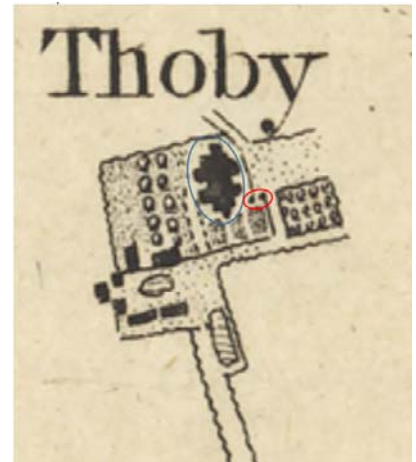
Right: Figure 4. 1777 Chapman and André Map. North is generally upwards.

- 3.15 The Chapman and Andre map shows the former Thoby Priory House (circled blue), the SAM Priory Ruins (circled red), and orchards, formal gardens, farmstead and ponds.

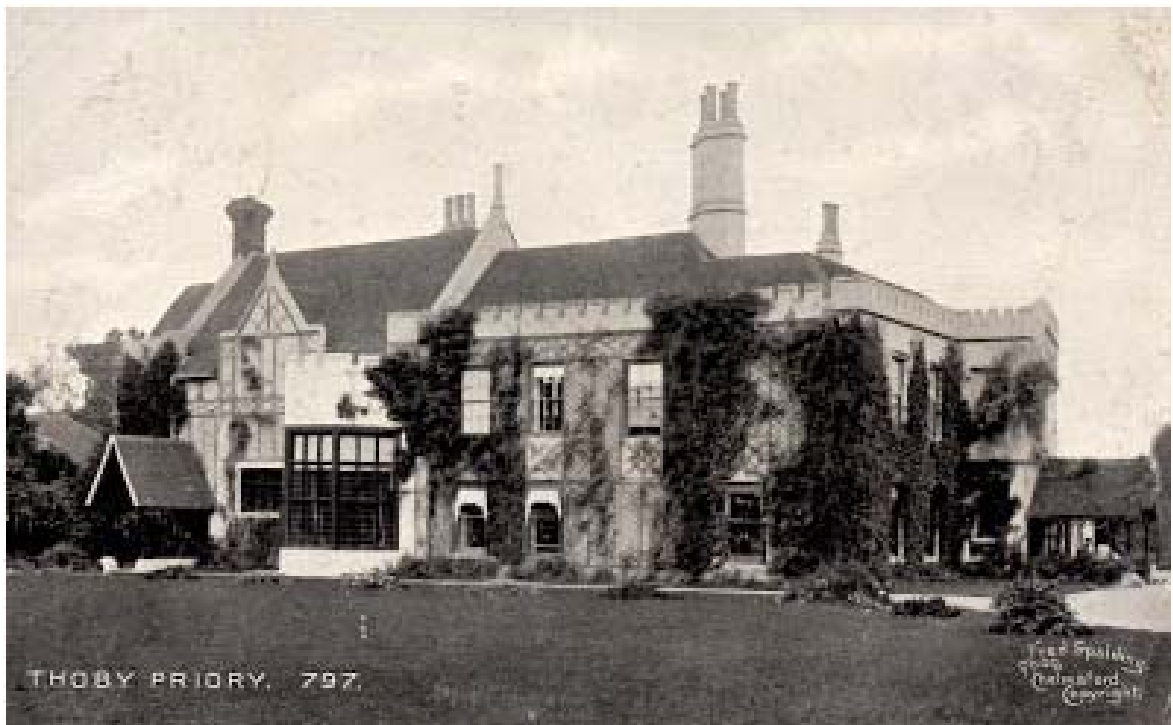
Figure 7. Circa 1906 photograph of Thoby Priory House from the south-west (Andrew Smith)

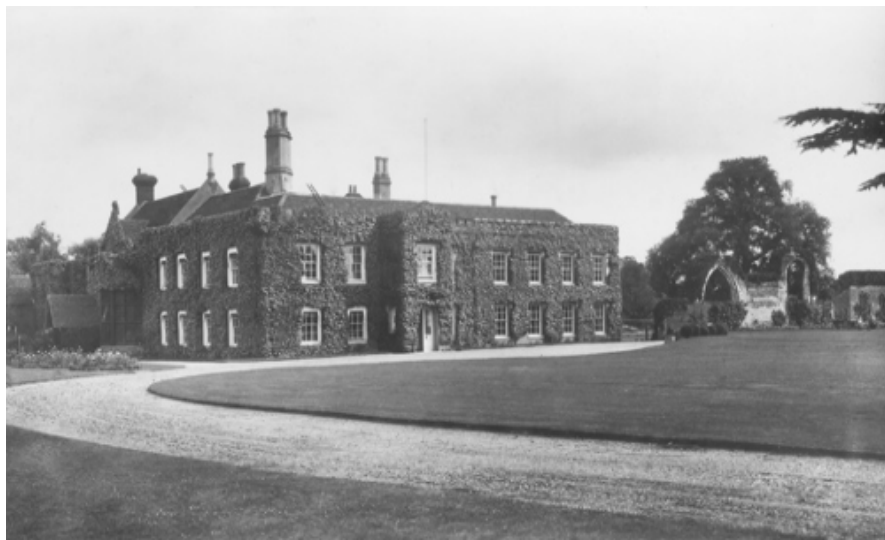
Figure 11. Circa 1950 photograph of Thoby Priory House. Priory Ruins on right. (LostHeritage.Org.UK)

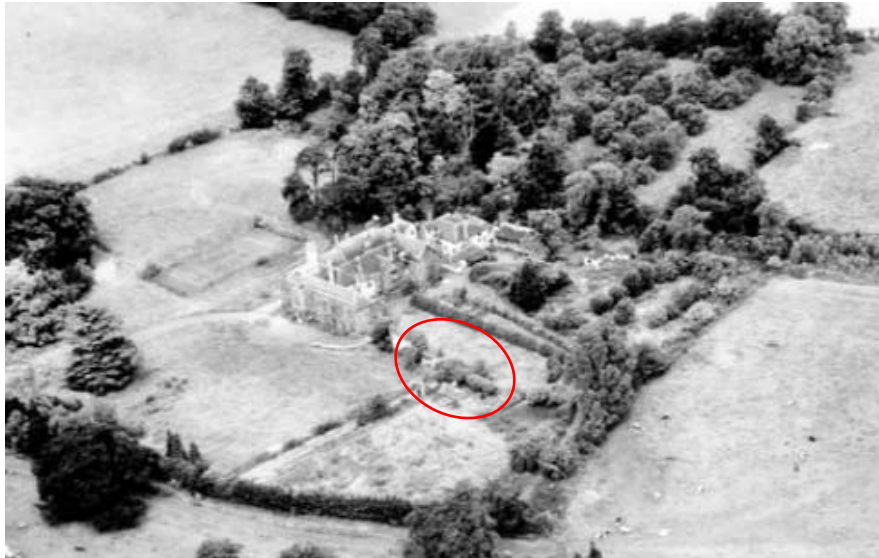
Fig 13. 1952 Aerial. Ruins front right. Cambridge University Collection of Aerial Photography HJ66.

The position of the monument is circled. Plot 01 incorporates the foreground D-shaped enclosure, main buildings and gardens to the right.

Plots 02 and 03 are within the former parkland beyond the tennis court.

Plot 04 is within the former wooded area on the far left.

- 3.18 The 1952 aerial and ca1946 map show the extent of development within the Green Belt, for the purposes of assessing the 'original building' as it existed on 1 July 1948, as defined in the NPPF glossary.**

The 1952 photograph shows that the majority of the footprint and volume of 1 July 1948 was at least two storey.

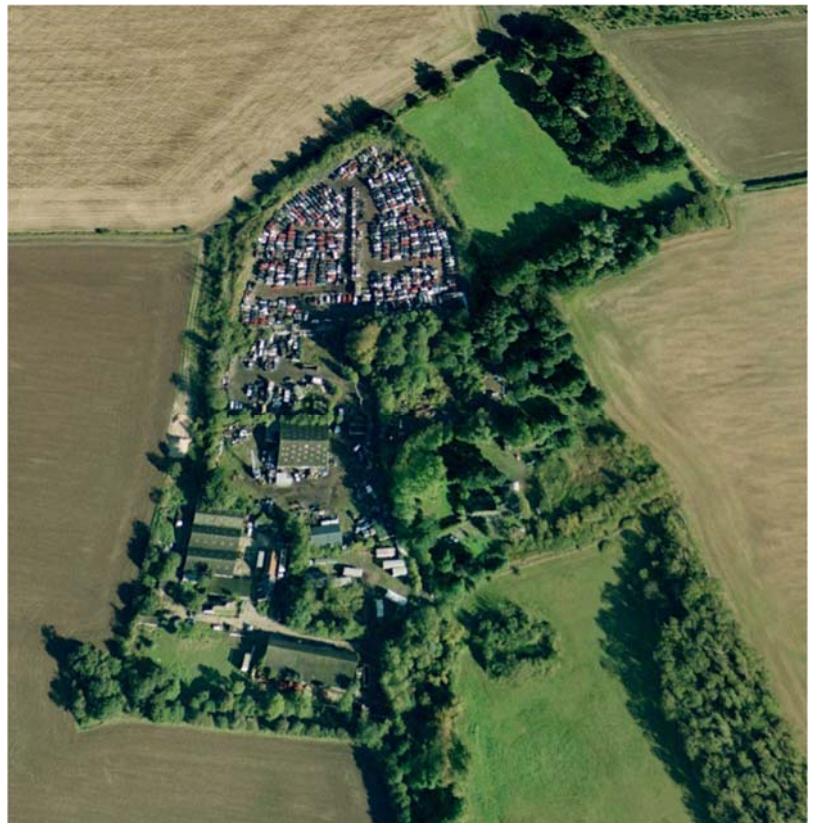
Figure 15. 2000 Google Aerial showing the extent of the scrapyard. Comparison with the drawn survey the previous year shows that trees obscured a number of the buildings that were located in Plot 01 and the centre of the site.

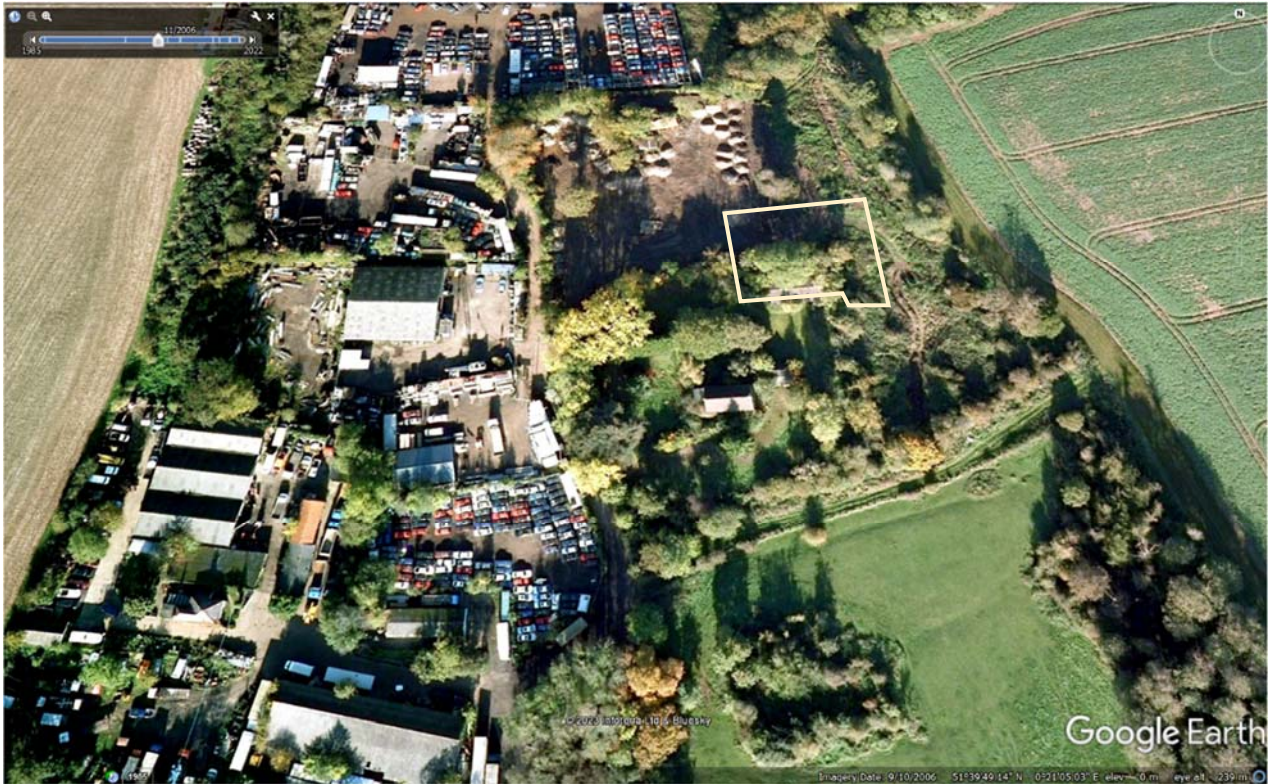
*(Above) Figure 16.
October 2006*

*The largest
buildings are
along the western
plots. Those on
Plot 01 are visible
below trees.*

*Comparison with
the 1999 survey
indicates that the
apparent
greenness of the
earlier Aerial of
2000 was
undergrowth over
previously
developed land,
such as the
scaffolding yard*

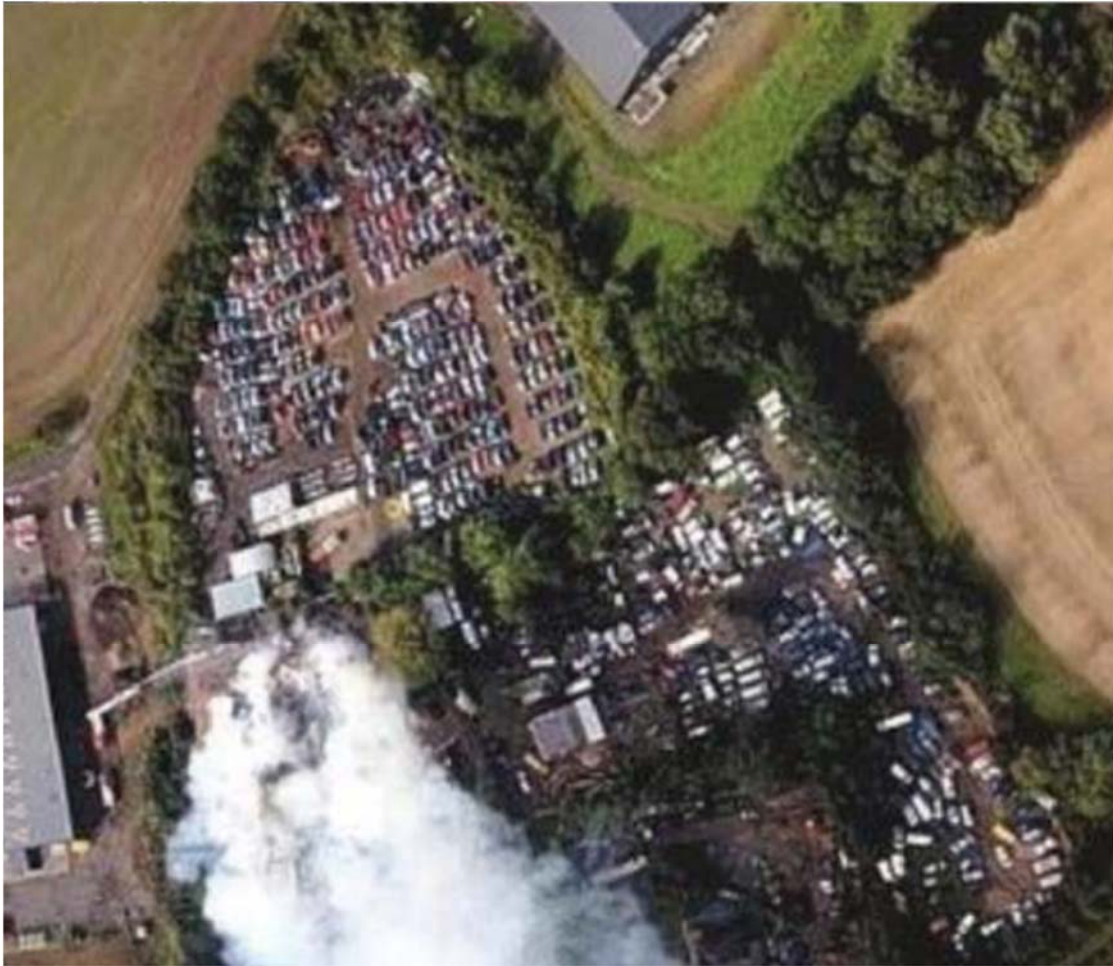
Figure 18. 2015 Aerial (from DAS 15/00527/OUT) showing the fire of January 2015 within Plot 02, the structures along its northern and eastern edges, and the buildings on the western edge of Plot 01 and hard surfacing the full extent of its eastern boundary.

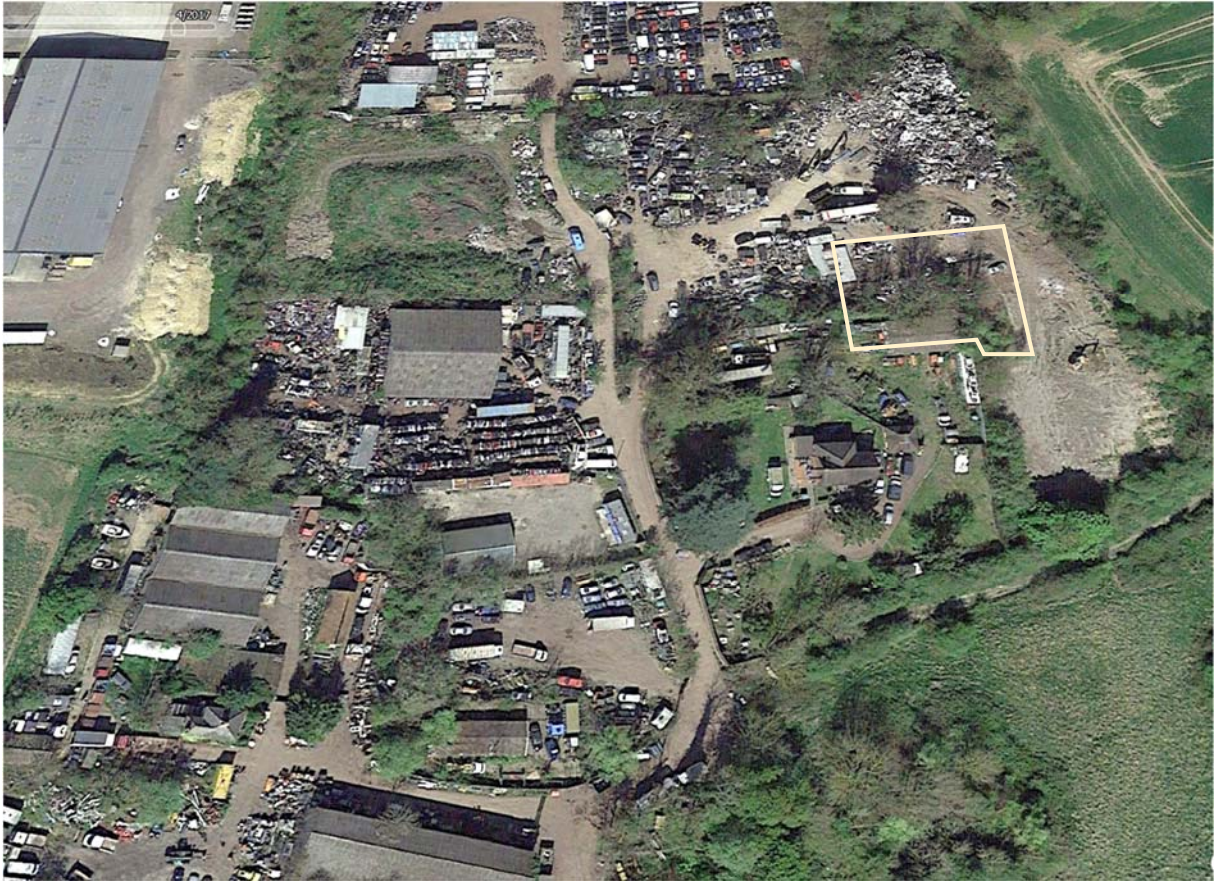
Figure 19. September 2017. This shows the hardsurfacing similar to that in 2015. Plot 01 was a vehicle breaking yard with crushed vehicles in the NE corner, a building within the Monument and hard-surfacing north and east of Thoby Priory. Plot 02 was either still used for burning or it had recently ceased. Plot 03 was the most heavily developed apart from Plots beyond the application boundary.

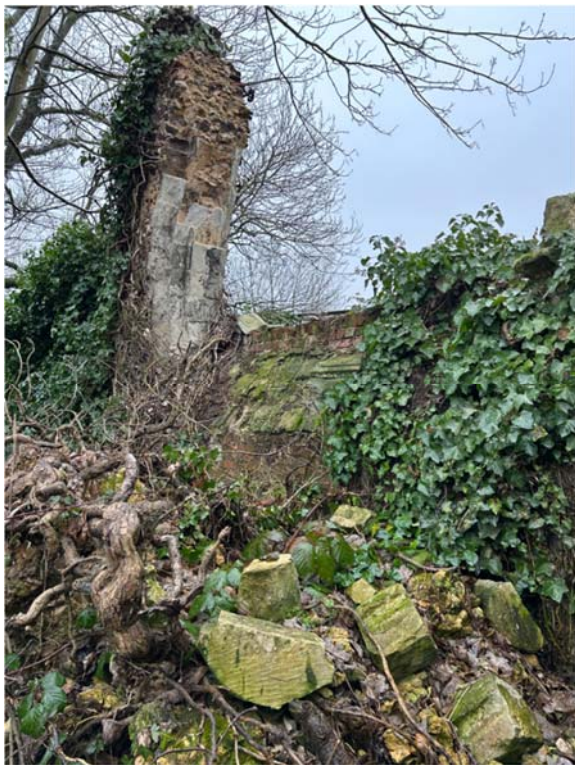
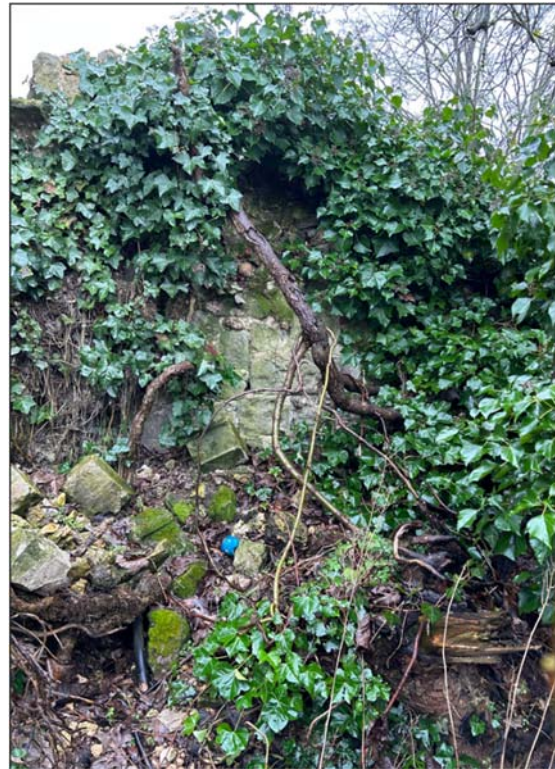
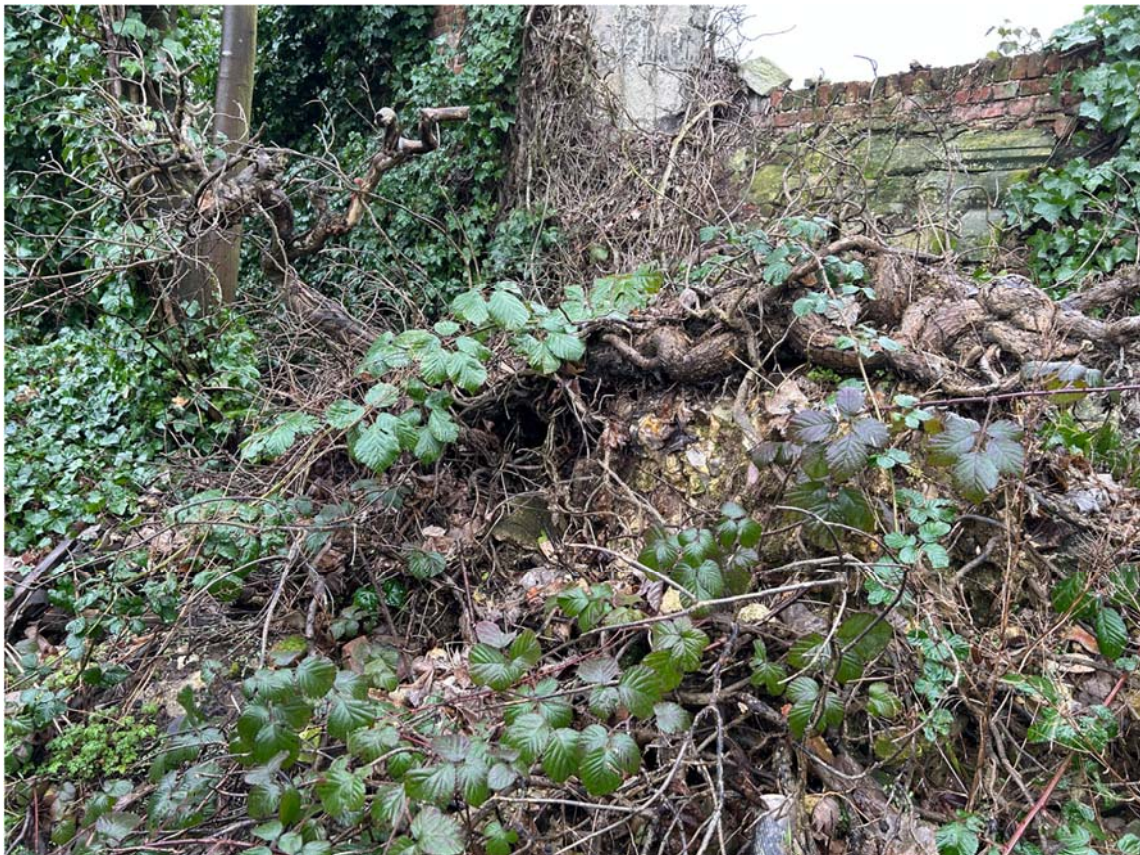
Figures 21a-c. Thoby Priory wall and remains of window arch.

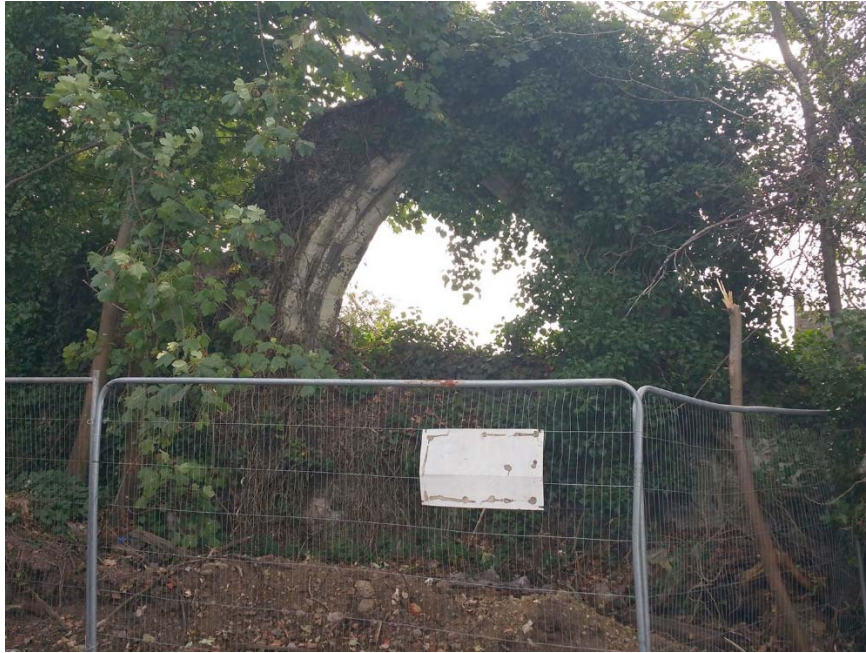
Figure 22. Priory Ruin West Window

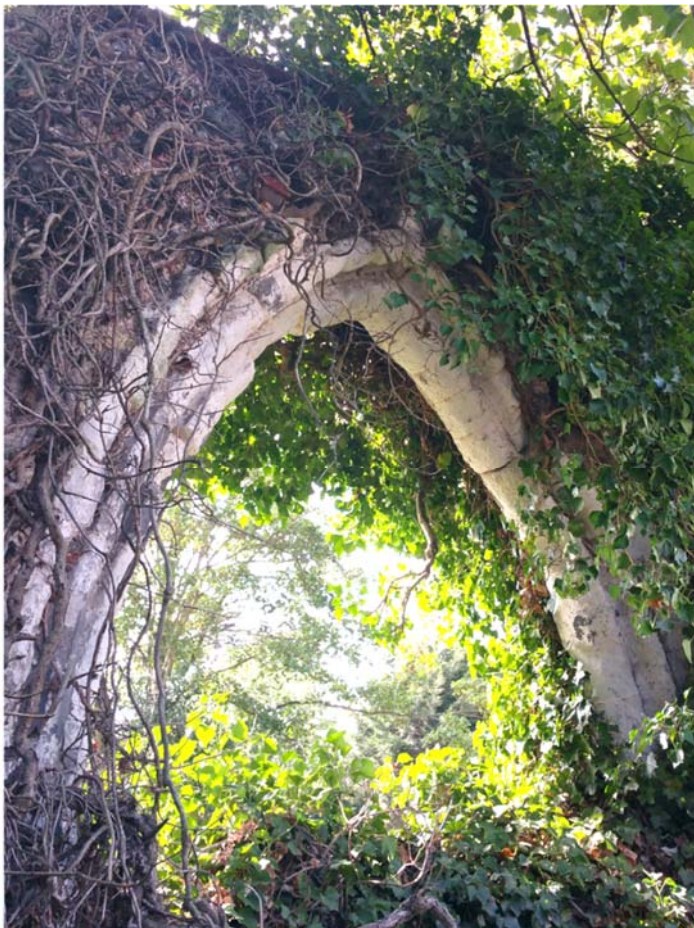
Figure 23 (Left):
West window arch mouldings detail

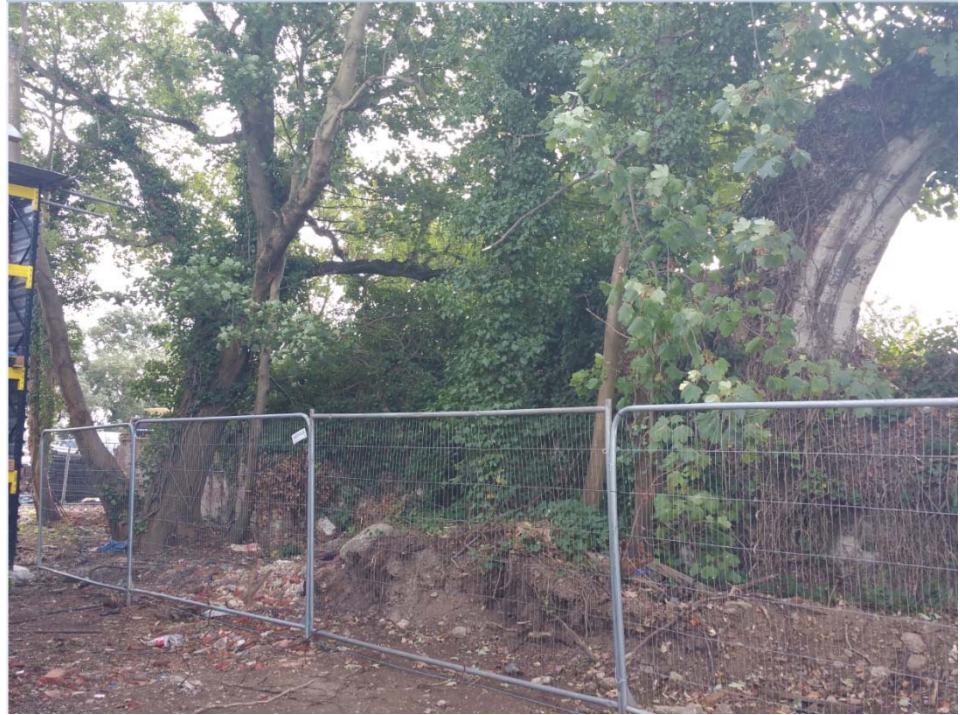
Figure 24.

Priory Ruin and West Window, showing protective fencing and gap to the nearest storage unit.

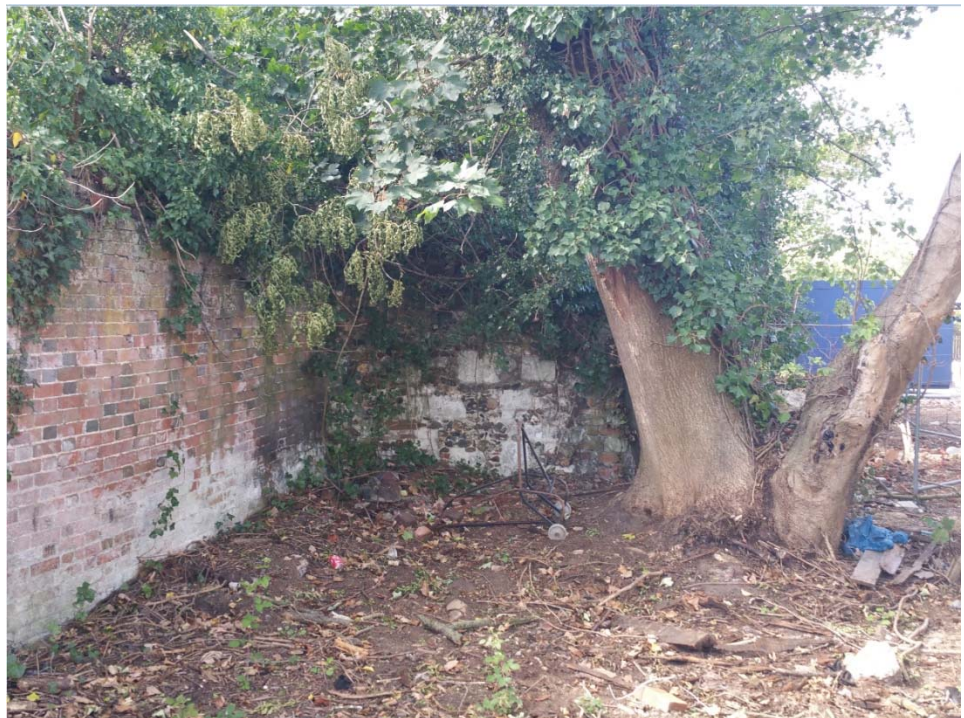
Figure 25. East elevation of the Priory Ruin abutting the C18 garden wall.

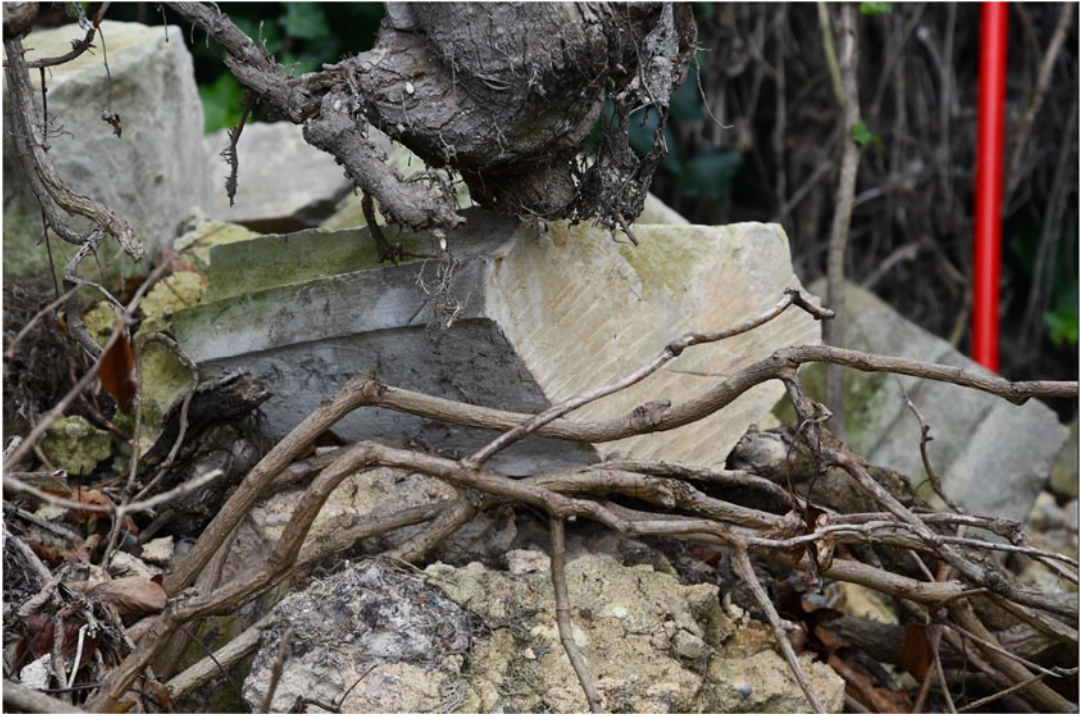
Figure 26. Fallen masonry detail

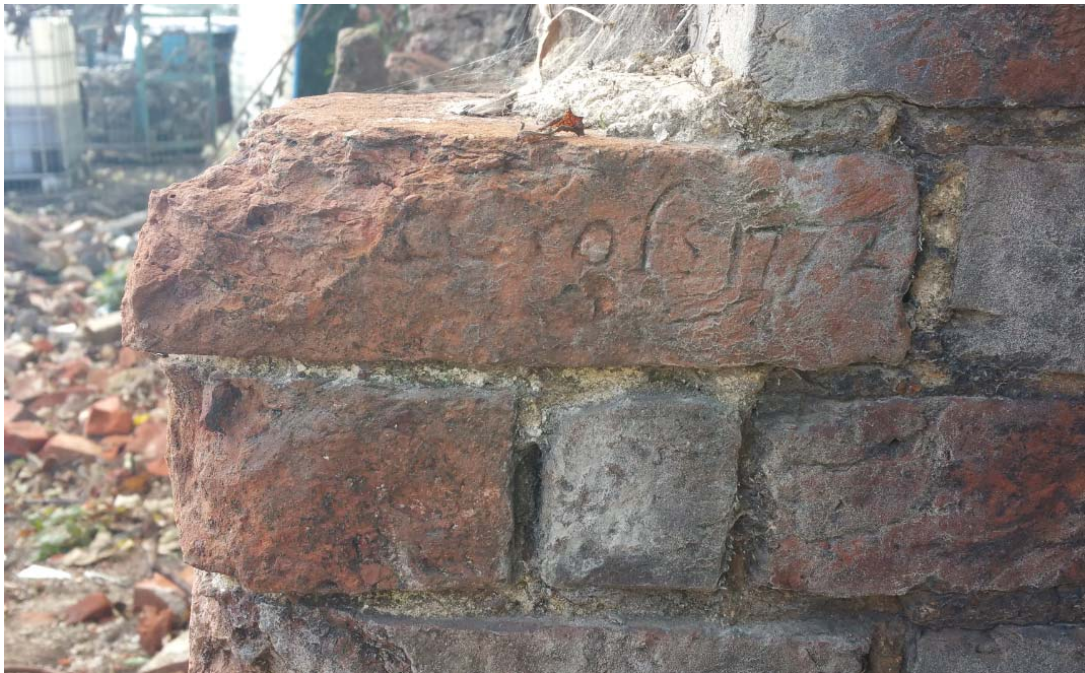
Figure 27. Dated brick within the C18 garden wall – “__ Crofs 1772”

The purpose of any works within this application is to preserve and enhance its fabric, longevity and setting to include preservation of the dated brick.
