## 75 Hammerton Street, Burnley.

### Bat Activity Survey Report

Report number: HAMM01/2023

Leigh Ecology Ltd was commissioned by Mr. Chris Marsden to undertake a series of bat activity surveys on a two-storey brick building; the subject building has been highlighted for removal. The site is located at 75 Hammerton Street, Burnley.

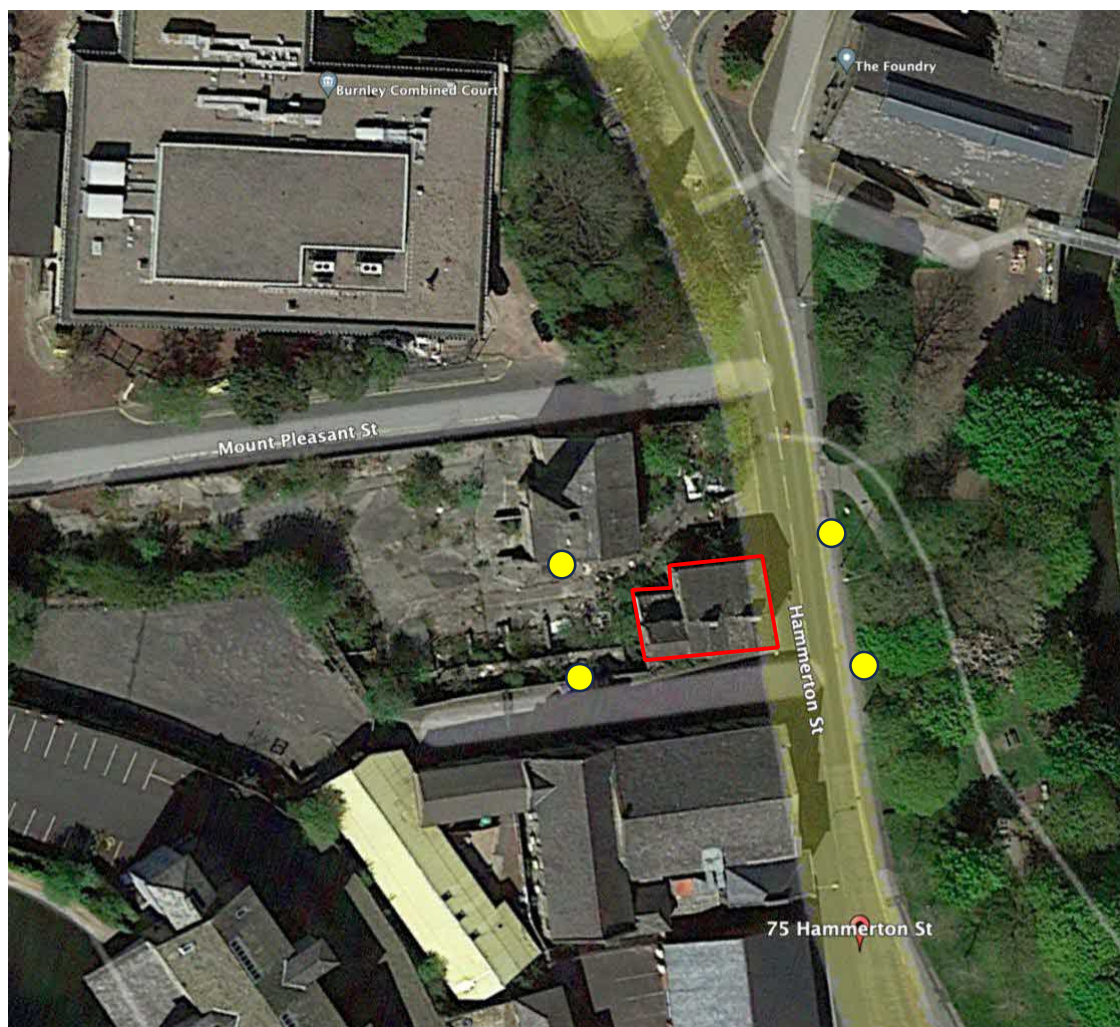
Figure 1 - Surveyor Positions.

The surveyors were positioned at each face of the dwelling in order to view the elevation, and roof, and gain full coverage simultaneously (see surveyor location plan below).
