Stone Farm Barn Leighterton Gloucestershire

Preliminary Roost Assessment

October 2023

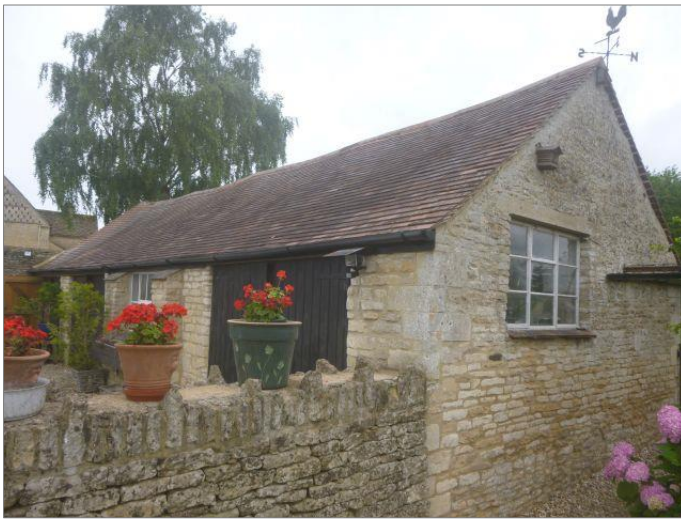
Plate 1: View of the East and North Elevation of the Barn

- 4.7 This is a single-storey barn with a pitched roof measuring approximately 13m long, 4.6m wide and 3.7m high to the ridge (1.8m at the eaves) with coursed limestone walls; the roof is covered in clay tiles (Plate 1 and Plate 2). The barn is considered to be a later addition to the adjacent Grade II listed house which is understood to have been constructed c.1800 (2023, Pers. Comm., Kathie Thomas, 11 July).

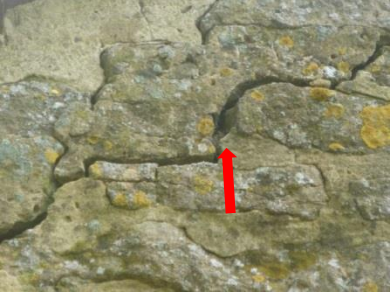
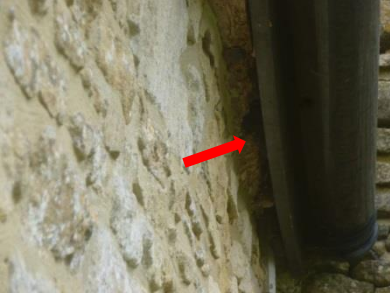
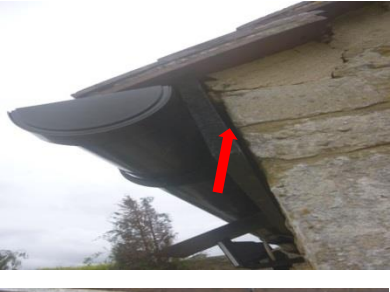
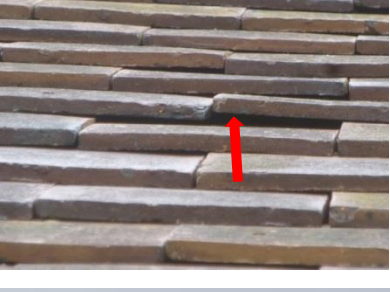
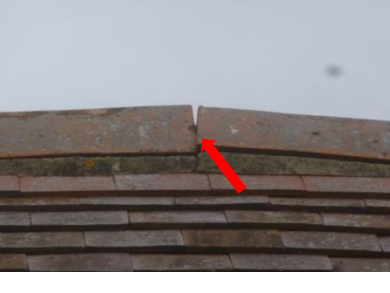
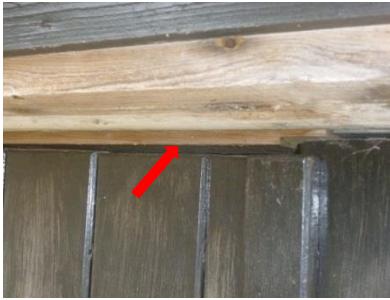
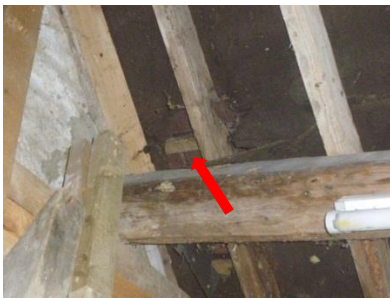
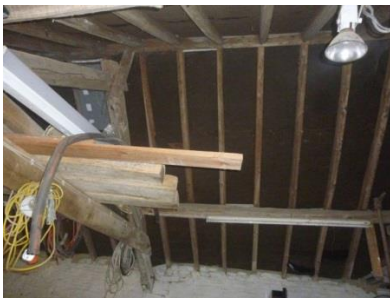
Table 1: Description and Results of the Building Searches of the Barn

- 4.8 The building is described in further detail with any features that were recorded in Table 1 below together with the results of the building searches and accompanying photographs. Red arrows in Table 1 indicate potential roosting features (PRF's) or other pertinent features that were recorded during the building searches. All measurements given are approximate.

<p>Walls</p> <ul style="list-style-type: none"> • Coursed limestone walls • Small crack (4mm – 5mm wide at widest point and 20mm to 30mm deep at deepest point) in south gable end wall (negligible/low potential); otherwise walls are well-pointed and in good condition • Three double wooden doors on east elevation tight apart from a small gap over the southernmost door • Gaps around rotting wooden wall plate at eaves in SW corner of building. No obvious ingress/egress over wall top • Two metal windows; tight with no gaps • No weatherboarding, hanging tiles or cladding • External lighting present on east elevation of the barn • ‘Vintage’ style street lighting with no downward deflectors is present 10m S and 25m NW of the barn at the nearest point. Some light spill onto the barn is likely • Vegetation cover (Scattered Tree) immediately adjacent to S elevation otherwise somewhat lacking obvious linear features and/or other vegetation cover with potential connectivity to wider landscape in the vicinity <p>Roof</p> <ul style="list-style-type: none"> • Pitched roof covered with clay tiles • Frequent gaps between/under tiles across both pitches of the roof • Gap between ridge tiles and between mortar and lower edge of tiles on E elevation toward S end of roof. Remainder of ridge tiles appear tight • No chimneys or lead flashing • Wooden fascia’s with some limited gaps, otherwise generally tight • No soffits or bargeboards • No bats, droppings or bird nests <p>Potential ingress/egress and possible roosting opportunities present within the external fabric of the building predominantly associated with gaps in roof tiles. Further more limited opportunities associated with cracks in S gable end wall and small number of gaps behind wooden fascia’s</p>	<ul style="list-style-type: none"> • Open to the ridge; no enclosed loft spaces are present • Internal temperature 18c (ambient 18c) • 13m long, 4.6m wide and 3.7m high to the ridge (1.8m at the eaves) • Divided into two sections by a blockwork dividing wall; dark and sheltered in S compartment. Sheltered with relatively high light levels in N compartment due to two windows • Some limited potential crevice opportunities e.g. sections of some wall tops • Building is regularly used throughout and electric lighting present so disturbance possible • Timber purlins and rafters supporting the roof tight with no obvious gaps. No gaps between end rafters and gable end walls • Extensive cobwebs throughout the unenclosed roof space suggest possible lack of recent disturbance • Roof lined with bituminous felt with hole measuring 0.3m x 0.2m on W pitch 0.7m from eaves and 0.7m from S gable, otherwise in good condition • Some daylight observed through the hole in the underfelt. Roof tiles that can be seen through the hole in the underfelt appear tight, however, there are several gaps in the roof tiles externally in close proximity to the hole in the underfelt (see External) • No bats, bat droppings or bird nests <p>No ingress/egress for free-flying bats. Limited potential ingress/egress opportunities for crevice-dwelling bats and limited potential crevice opportunities inside the barn</p>

- 5.1 The barn has moderate potential to support crevice dwelling bats; predominantly associated with the roof tiles. The proposed development will entail internal conversion of the barn, including possible insulation on the underside of the roof and replacement windows together with construction of a separate adjacent garage. External works to the roof will be limited to installation of ridge ventilation and adjustment of the lower courses of tiles on the pitches of the roof. No other external works are proposed to the roof in its entirety including the wooden fascias.

- 5.4 In order to determine the presence of absence of bats and whether mitigation to avoid impacts is required one dusk emergence survey and one dawn re-entry survey of the building would need to be undertaken during the optimum period (May to August) in accordance with best practice guidance^{5,6,7}. Two surveyors would be needed for adequate coverage of the building.

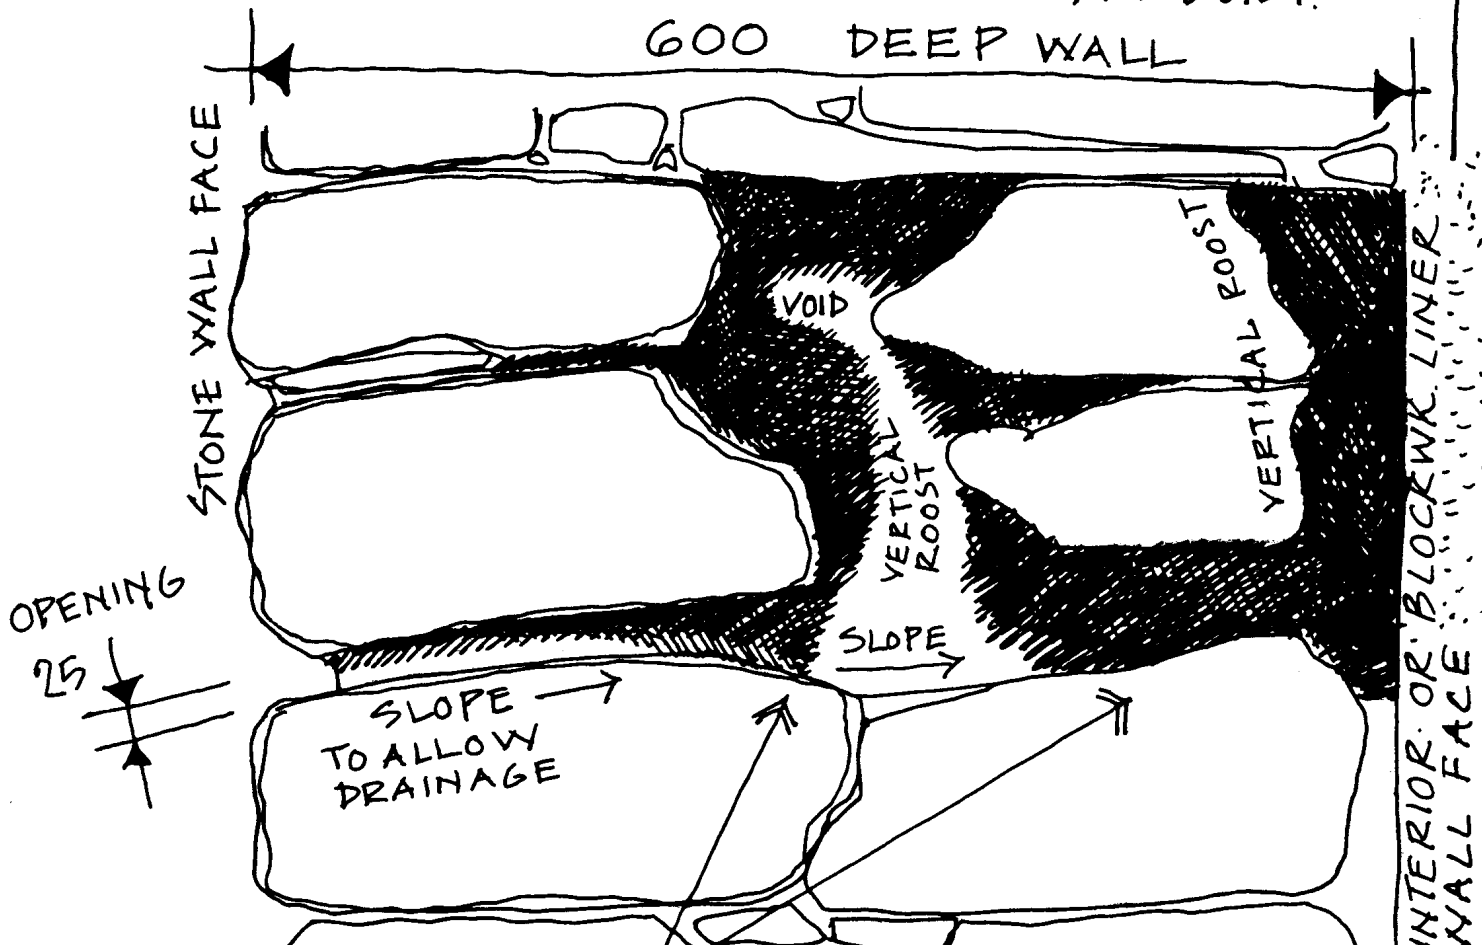
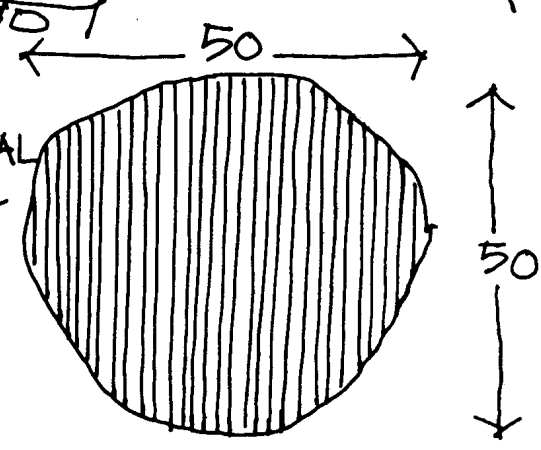
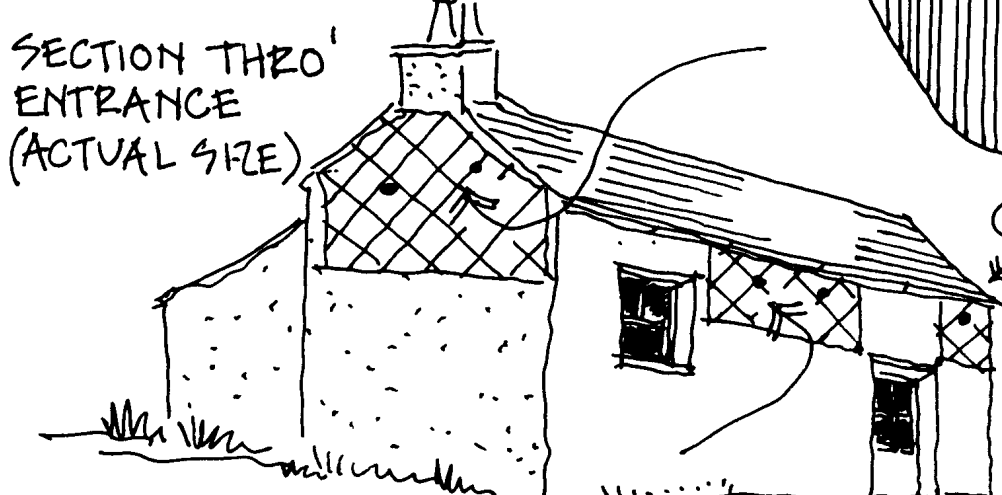
DETAIL G

SECTION THROUGH WALL
IE; BARN CONVERSION
WHERE THICK STONE
WALLS ARE BEING
KEPT/RE-BUILT.

MAINTAIN
INTERIOR CAVERN-
OUS AREA - VERTICAL
SURFACES ARE WELL
USED.

SECTION
THROUGH BAT
NICHE
(ACTUAL SIZE)

PROVIDE A SERIES OF THESE BAT NICHES
THROUGHOUT THE WALLS OF YOUR BARN
CONVERSION - HATCHED AREAS ARE IDEAL
LOCATIONS - AWAY FROM WINDOWS + DOOR.

- Incorporate one or two Vivara Pro or similar internally mounted bat boxes¹⁰ (or similar) in the walls of the proposed garage in appropriate locations to provide compensatory roosting opportunities for crevice-dwelling bats, if present, and/or some proportionate biodiversity enhancement in line with planning policy requirements through the provision of long-term optimal roosting opportunities. Alternatively, a solid stone wall bat roost and/or bat access slates/ridge access tiles on any suitable areas of roofing could possibly be used, depending on requirements (see Appendix 1 for possible designs of these features¹¹);

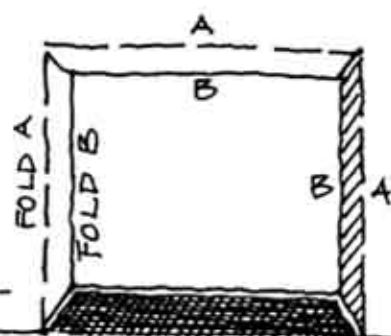
BAT ACCESS 'SLATE'
DETAIL 1A

~ SECTION THROUGH ~
ROOF

~ BAT ACCESS
SLATE

~ BAT SLATE BUILT INTO SLOPE ~

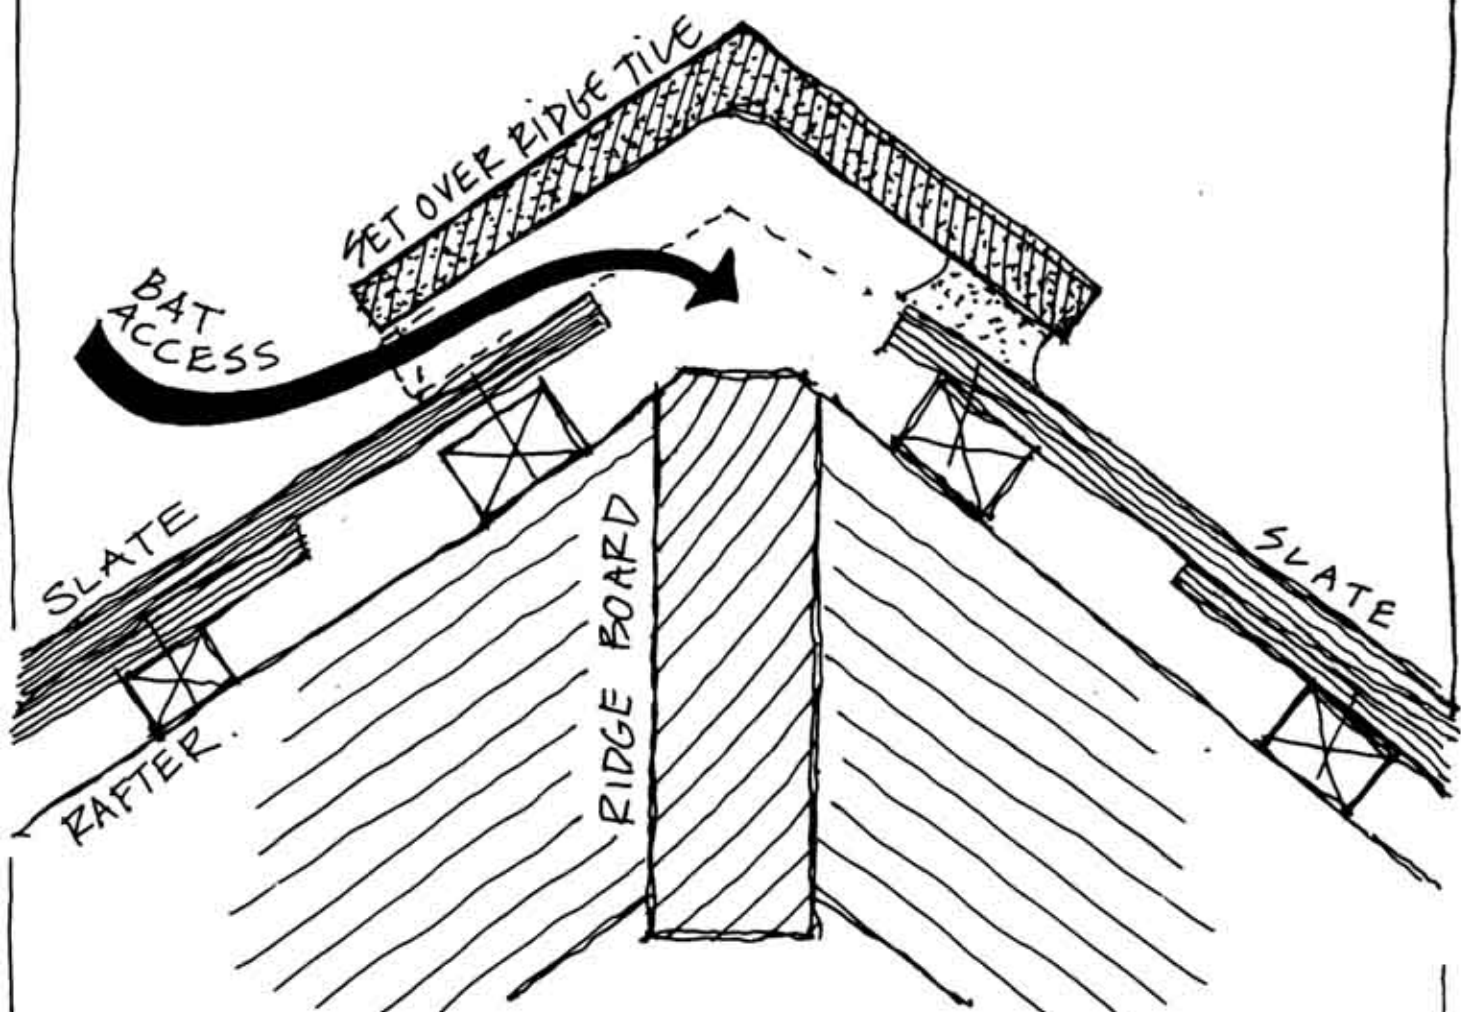
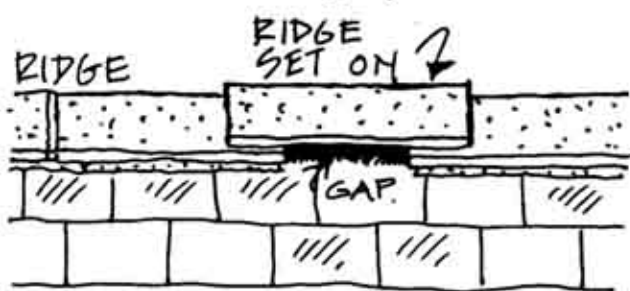
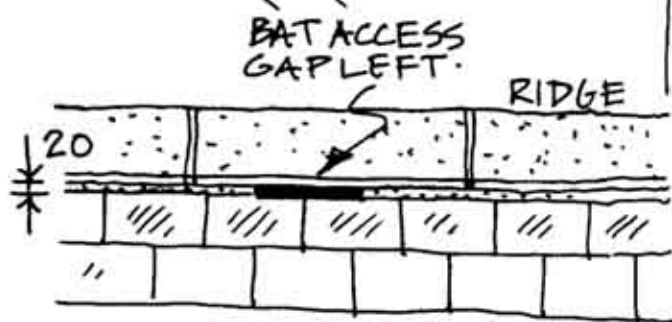
RIDGE TILE ACCESS DETAIL 4A

ROOF RIDGE SET ON TOP OF GENERAL RIDGE TILES TO FORM BAT ACCESS GAP.

MAINTAIN 20MM MORTAR GAP. & LEAVE A SECTION OUT.
