Heritage Assessment – Lower Dean Manor

Heritage Assessment

Lower Dean Manor

Our ref: DS_0356_CHF_v1
May 202

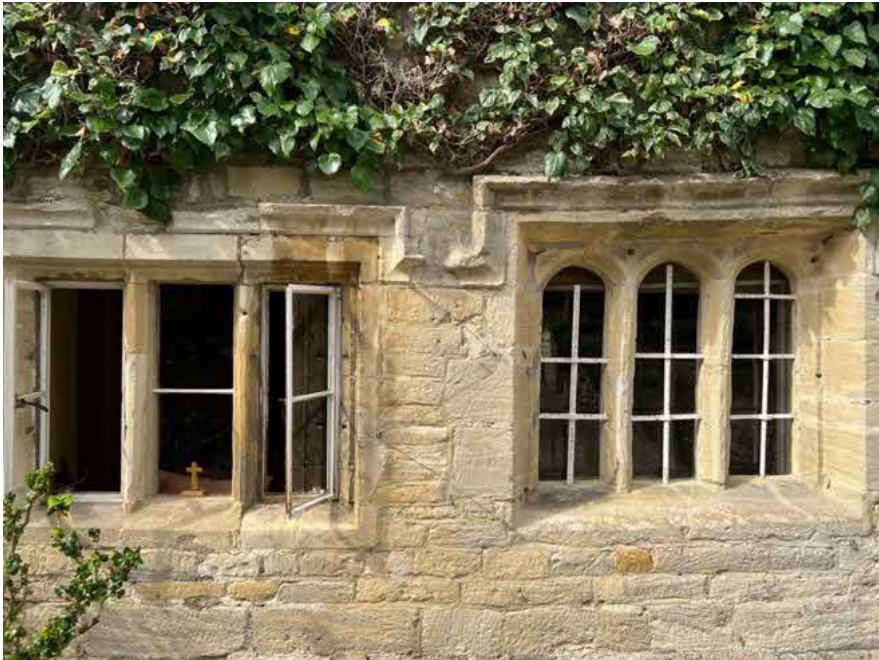
Photo showing the pair of mullion windows on the east elevation. Note the difference in detail, head detail, depth of stooling, and lancet forms of the RHS window.

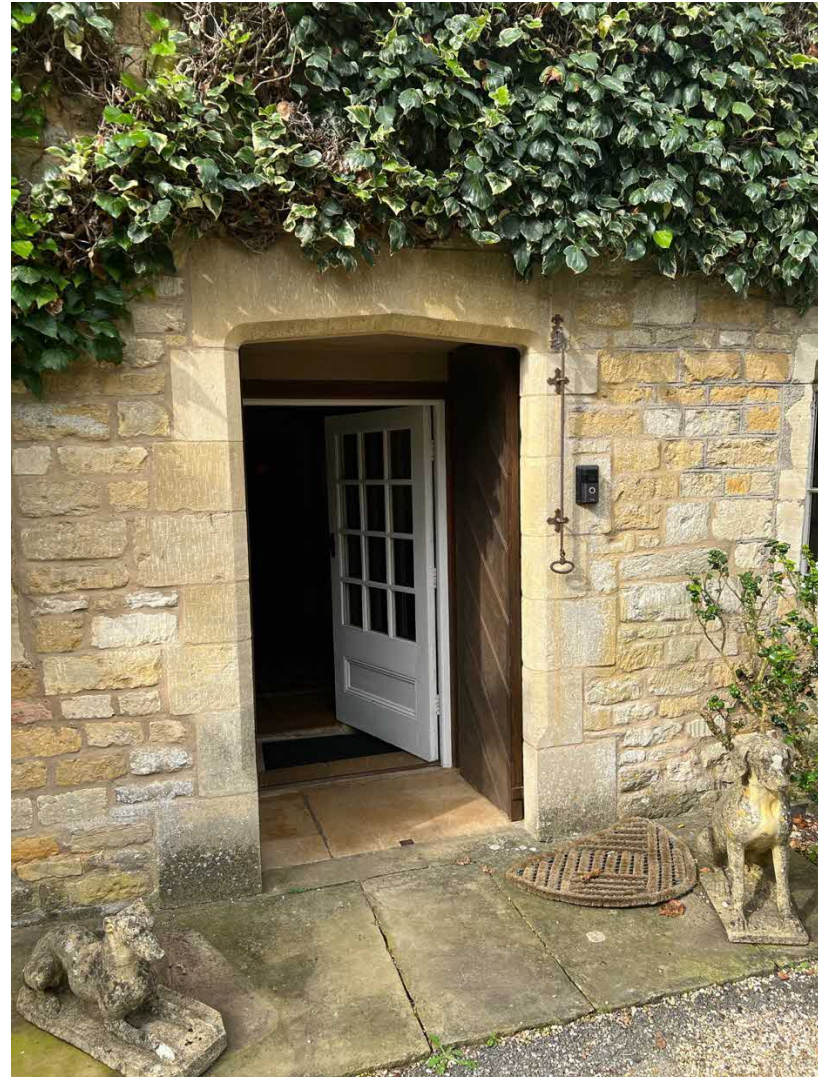
Image above: photo showing the current front door, on the E elevation. This is a C20 insertion.

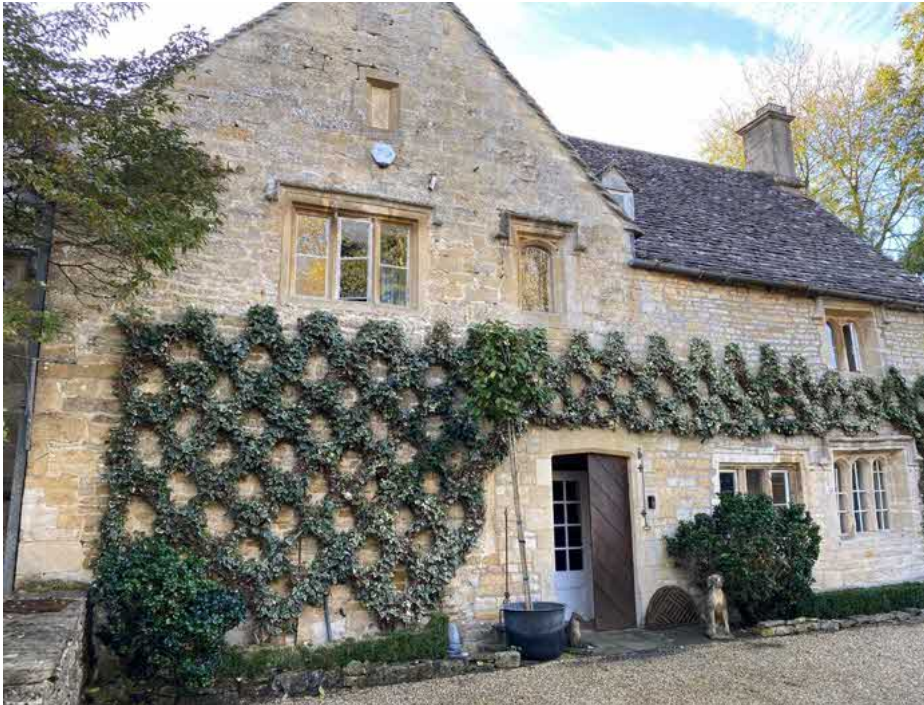
Image above: photo showing the full E elevation. Note the change in masonry coursing, thickness and pointing of the LHS gable, above the eaves line. This is believed to be part of a successive phase, C17, see below.

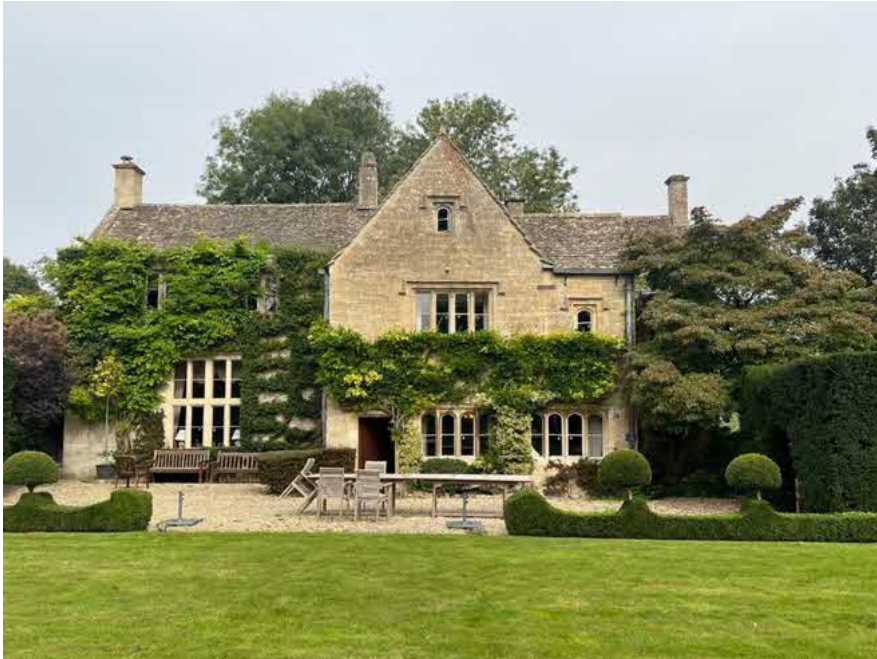
Image above: photo showing the front south elevation. The late C16 / early C17 phase is on the RHS. Note the lack of a break line in the masonry between this S front gable and the SE nose return, see below commentary .

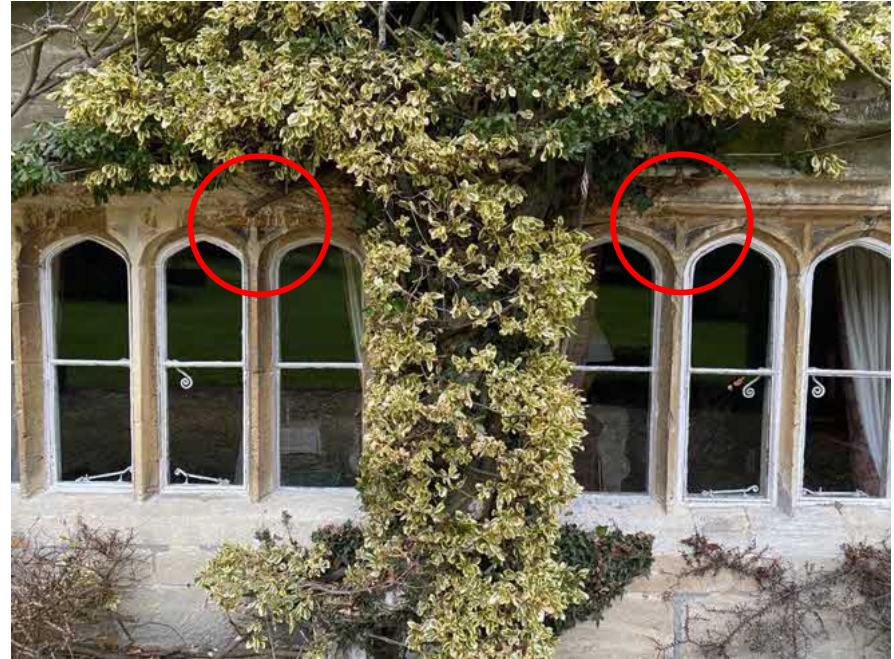
Image above: photo showing the 2 4-light mullions on the front elevation. Note the different spandrel details to the lancet heads. It is thought the RHS window was taken from Rectory Farm, in Turkdean.

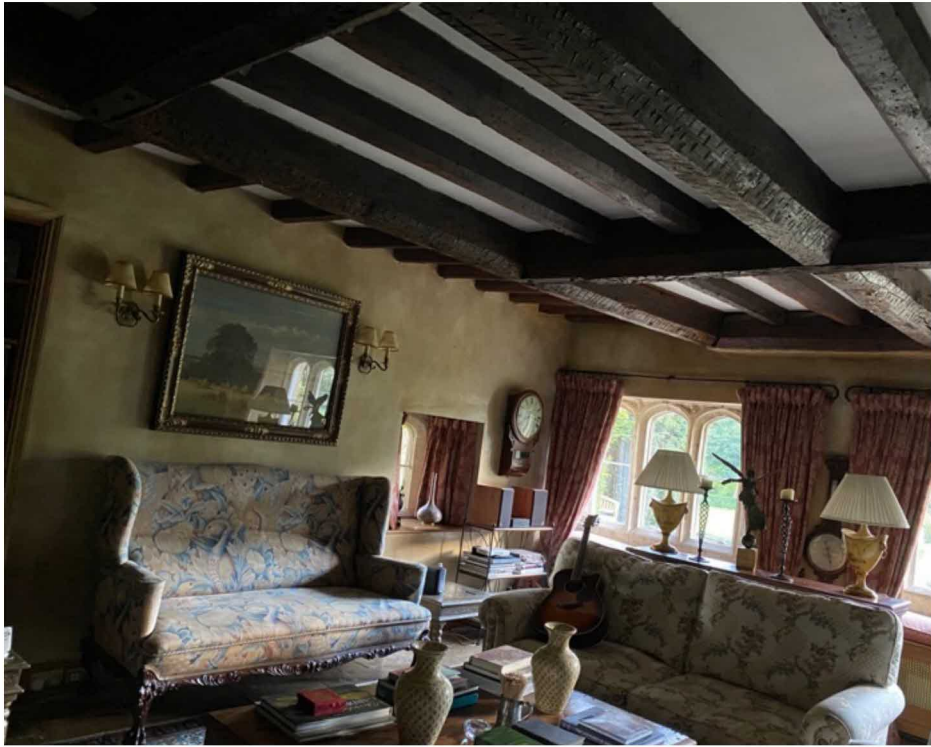
Image above: photo showing the main cruciform timber beams with the smaller section of joists on the LHS. This is likely where the stairs once existed.

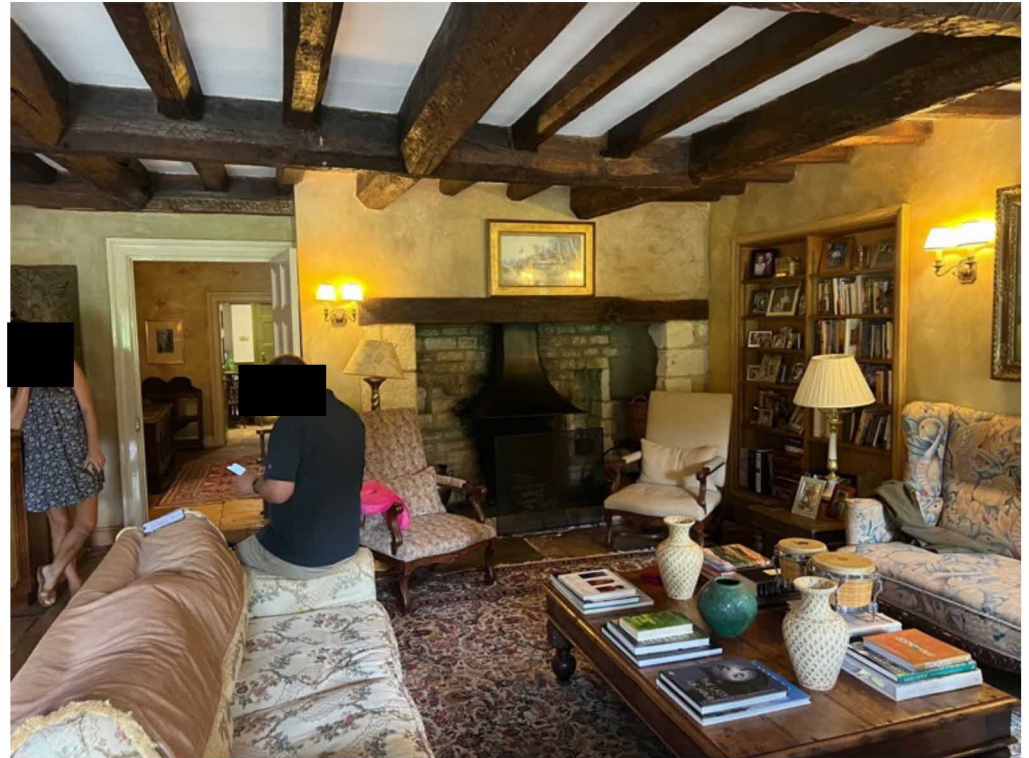
Image above: photo showing the same joists on the RHS. Note the fireplace is entirely modern.

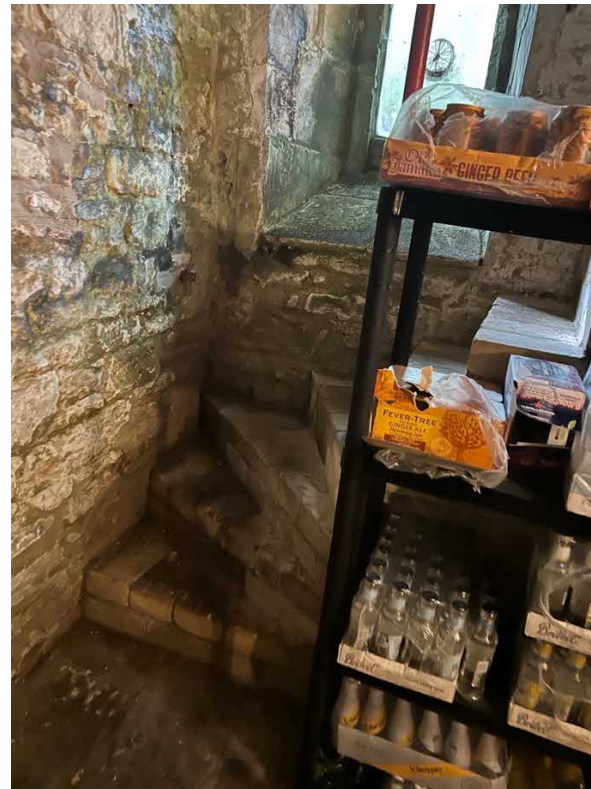
Image above: photo showing the C20 cellar stairs, albeit likely in their original position, probably lowered to ease access.

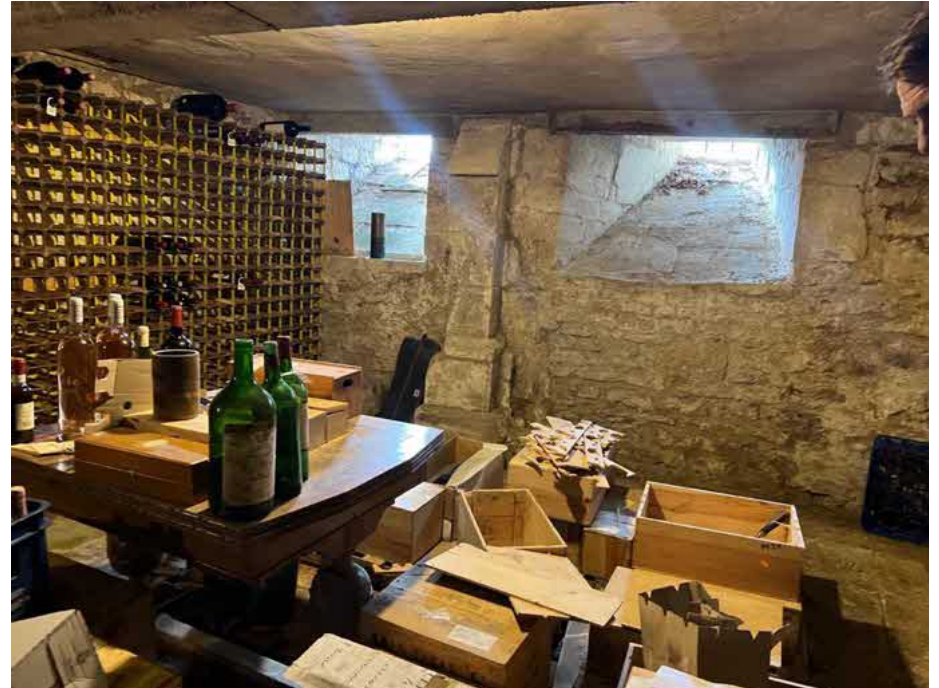
Image above: photo showing the fine buttressed cellar.

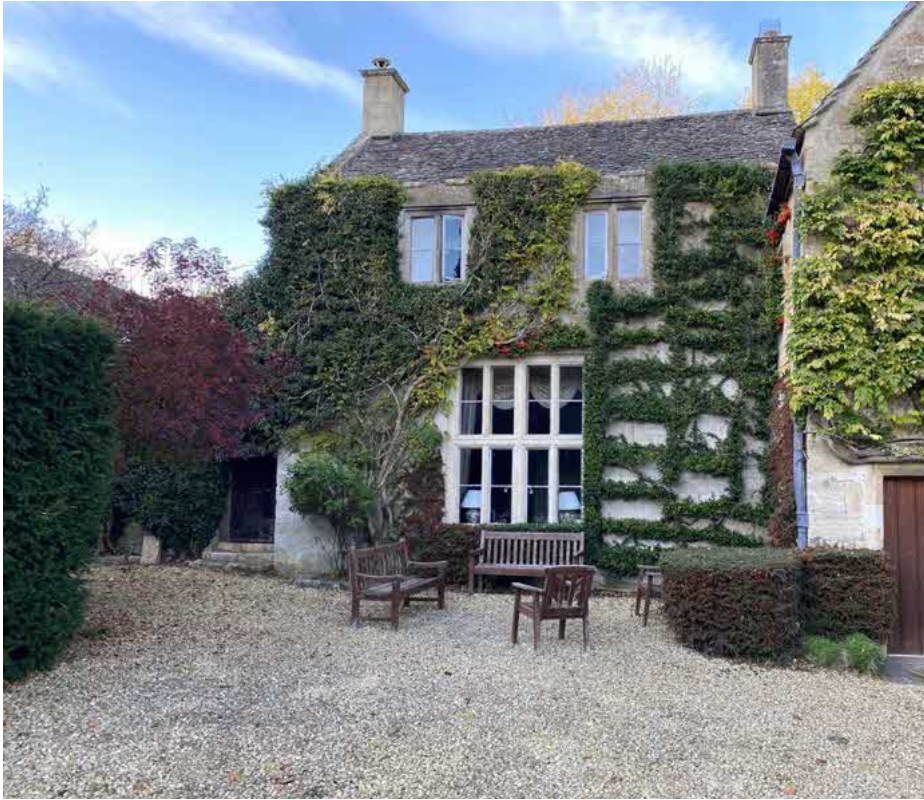
Image above: photo showing the south elevation of the early / mid C17 phase. The double height mullion window has a fine double ovolo moulding whilst the 1F window is only single. The double ovolo moulding is seen at Rectory Farm in Turkdean and is mid C17. It is thought the same mason worked on both these buildings consecutively.

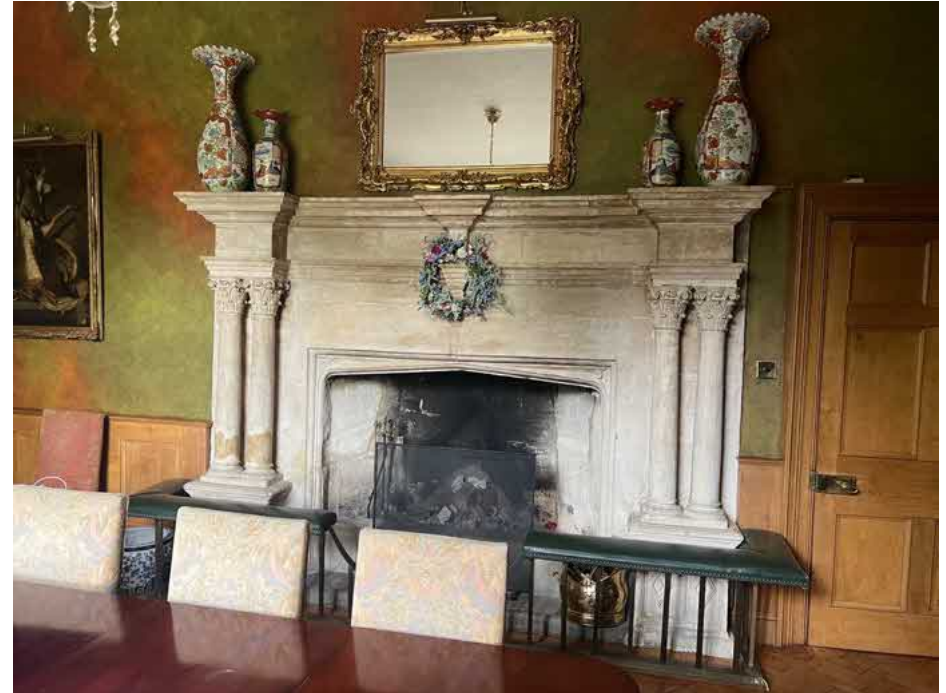
Image above: photo showing the fine chimney piece inside. The chimney piece itself is reminiscent of some of the very early C17 aedicules like Bolsover, where classicism had started taking a hold in the country. Here are Tudor and Classical elements in juxtaposition, confirming an early / mid C17 origin. In any case a very fine piece of detailing and workmanship.

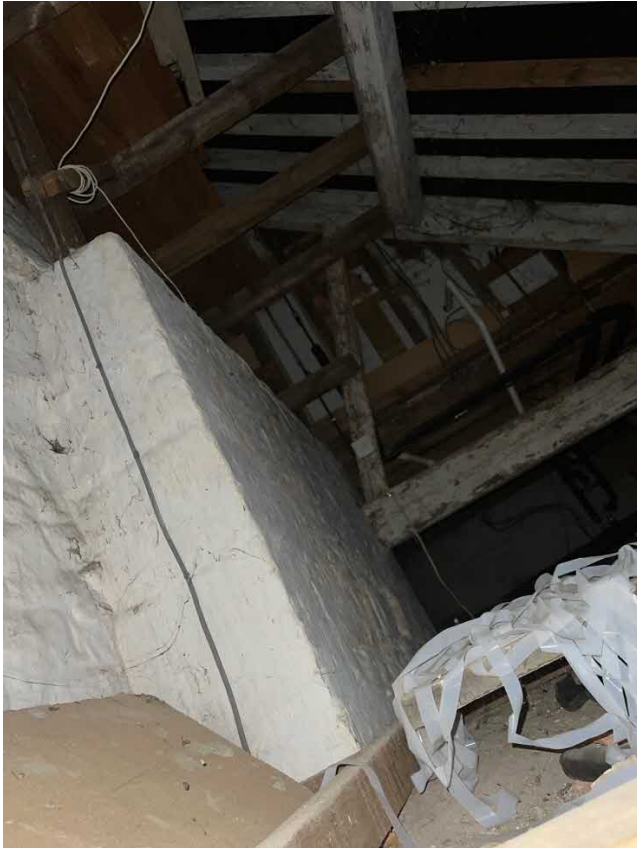
Image above showing roof void above the lean-to, where the old kitchen was located in the 1960s. Note the square purlin section and corded truss and liming of the timbers, typical of Victorian workmanship.

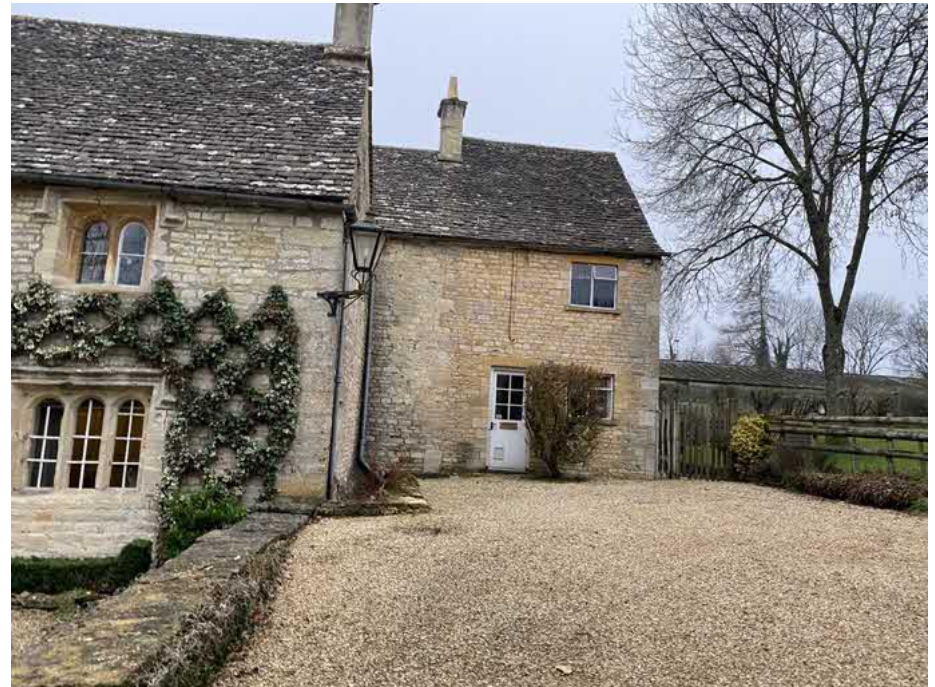
Image above: photo showing the tothing of the quoins, bleeding the earlier C19 range with the modern C20 range on the right. The C20 range might appear passable from this elevation, but the north and west flanks are constructed in Bradstone – see following sections.

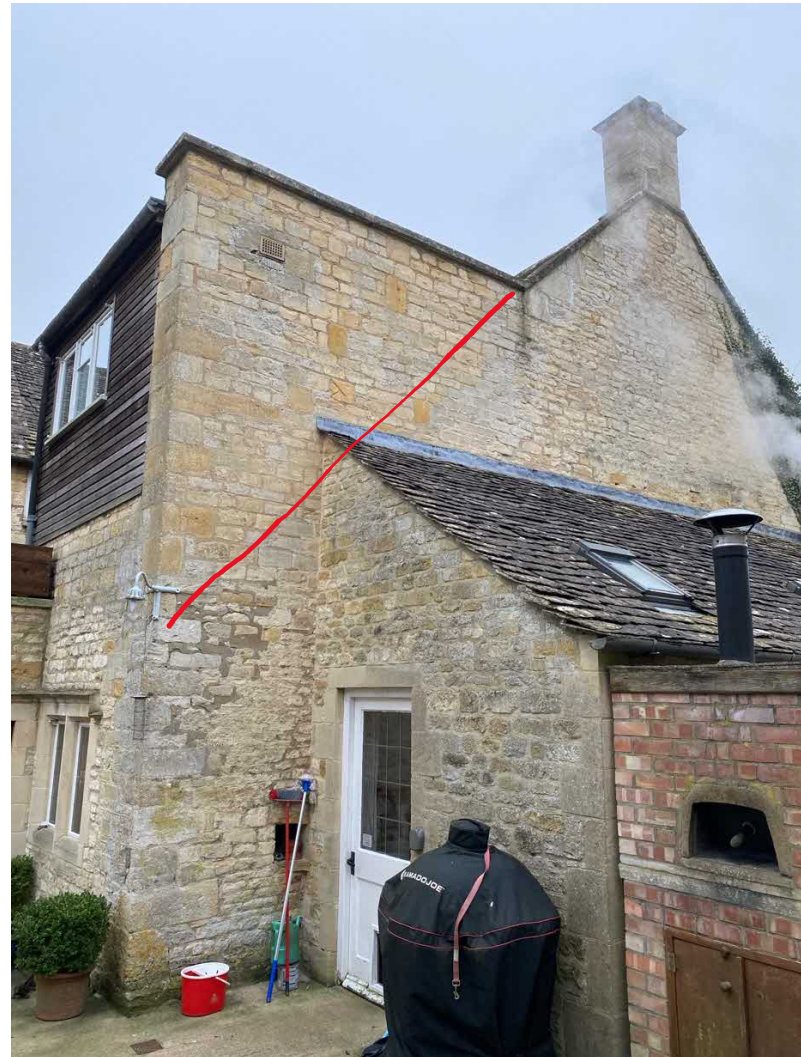
Image above showing modern 1950 bathroom extension. The masonry above the red line is part of the 1950 works.

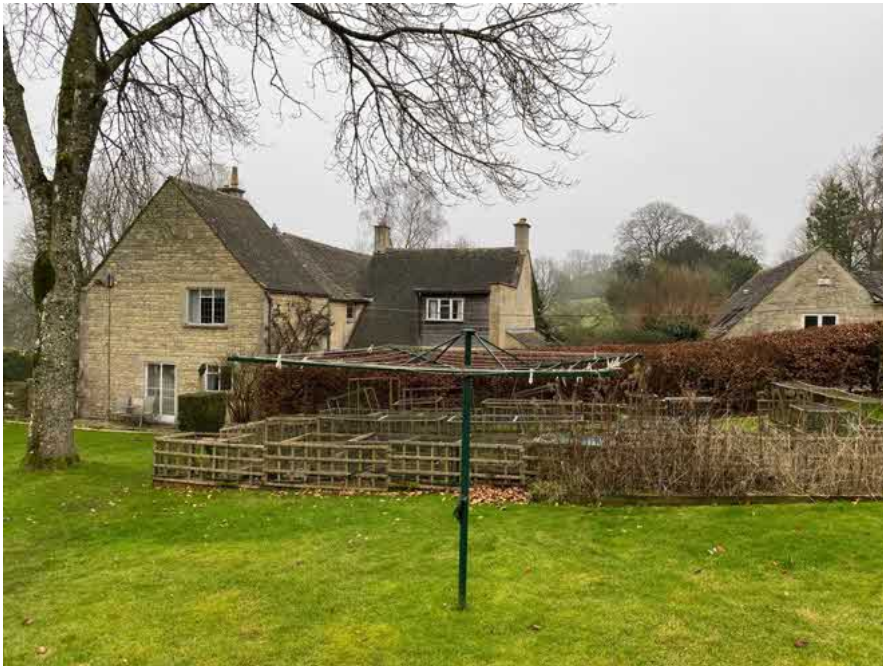
Image above: photo showing a longer view of the north range with the harmful 1950s rear extension. Note the modern tiles, modern stonework (or imitation stone face) and the flat roof 1F bathroom extension , all clearly harmful in various ways.

Note the lack of authentic stone tiles to this rear C17 range. The 4” concrete tiles diminish this elevation considerably, as well as the flat roof addition. To the east (LHS), the Bradstone 1950s range is another diminishment to this rear elevation. These elements are causing harm to the character and aesthetic values and should be remedied.

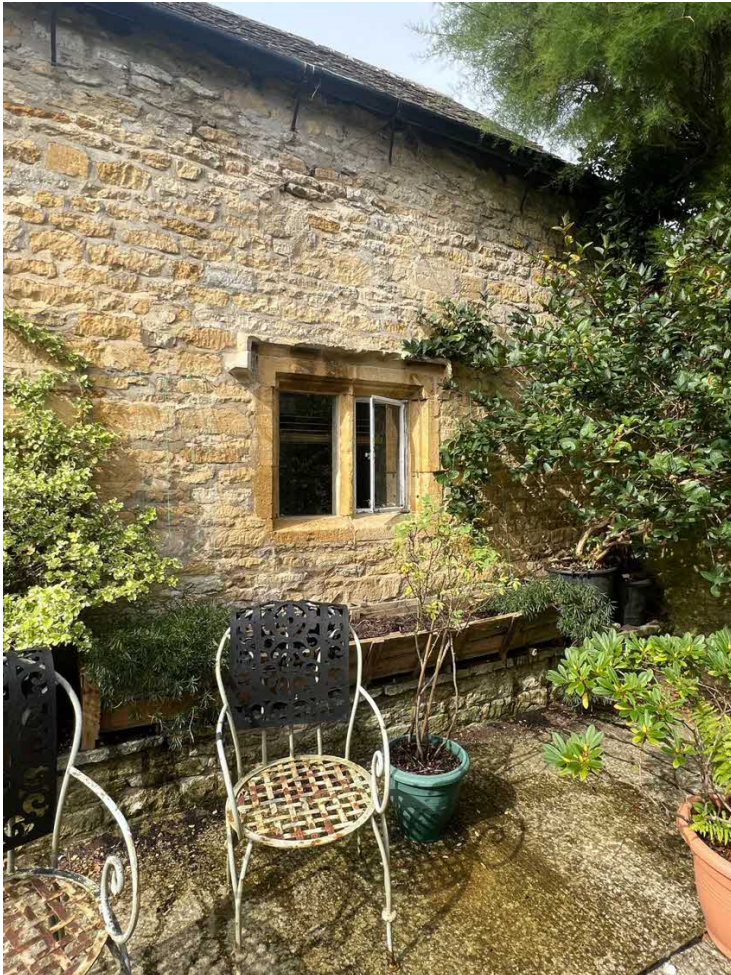
Image above: photo showing mullion window of C17 barn.

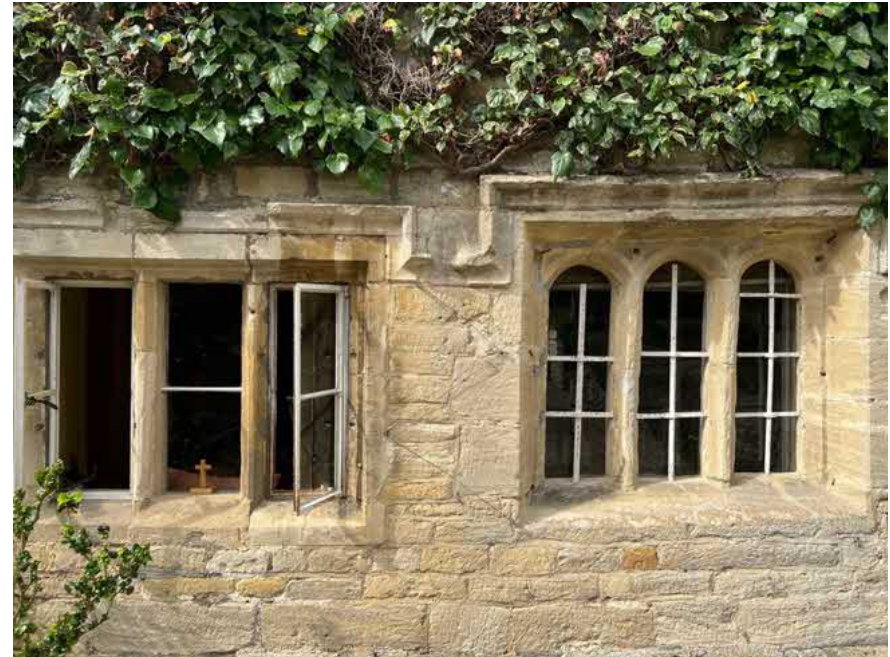
Image above: photo showing the mullion windows of the early C16 range to the east. The window on the LHS is probably later to the window on the RHS, owing to the thinner mullions and short stooling. Also the lancet heads show elsewhere on this range, implying they are the original detail. The similarity of the LHS window to the Store window are close enough to be contemporaneous.

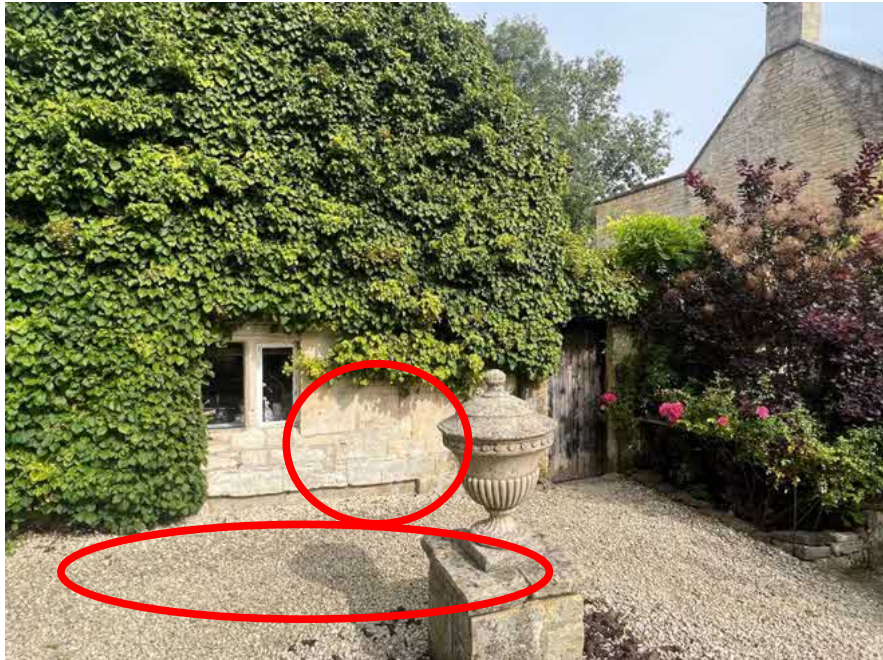
Image above: photo showing south gable of the C17 Store Building. Note the mullion head of what appears a basement or lower ground floor space; and the blocked-in window to the RHS of the existing window.

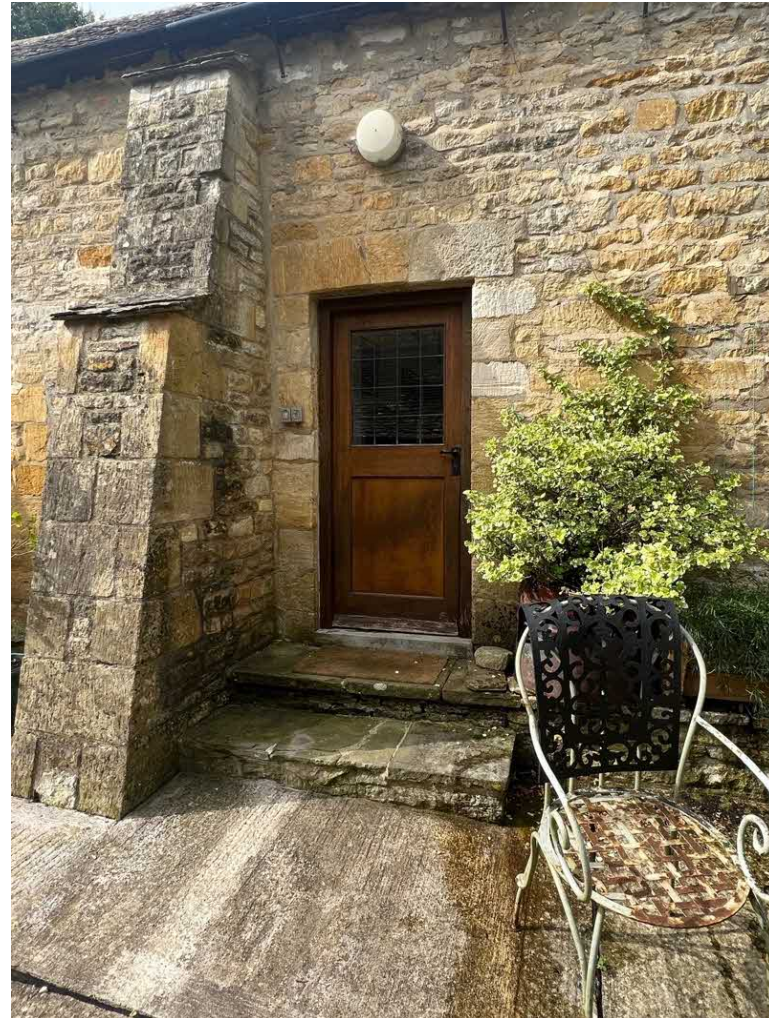
Image above: photo showing C20 buttresses to the east flank of the Store. Note the cementitious mortar, the absence of tothing, and the clean corners of the masonry.

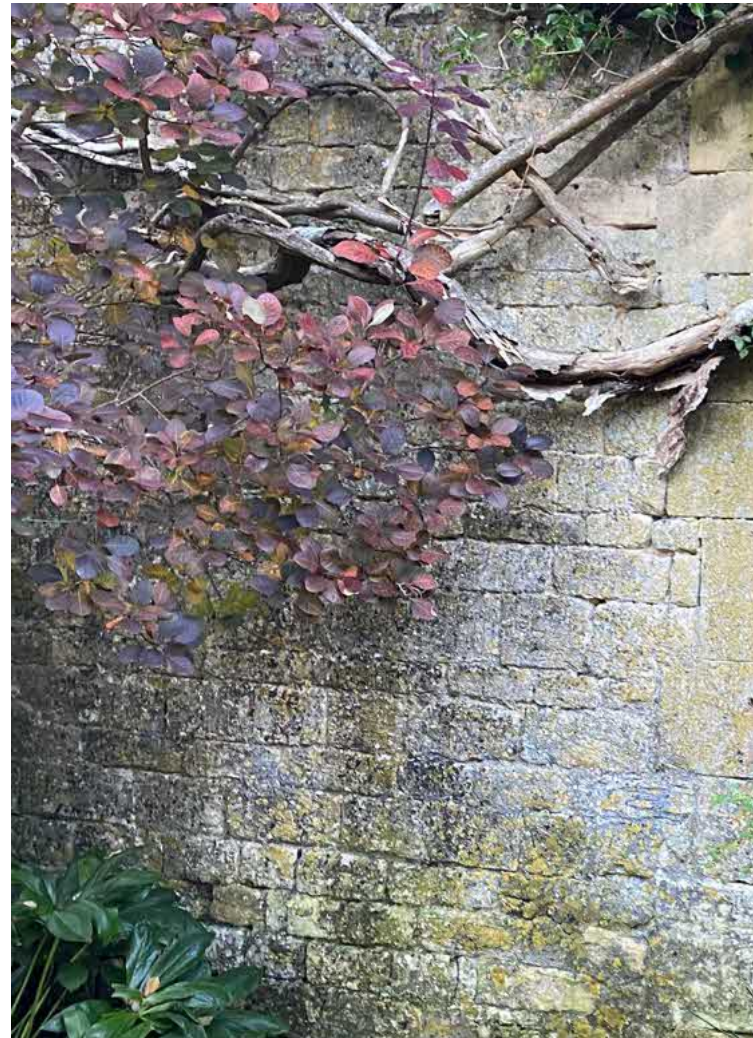
Image above: photo showing south (lawn) side of wall, with coursed and square faced stonework which appears C19 in origin.

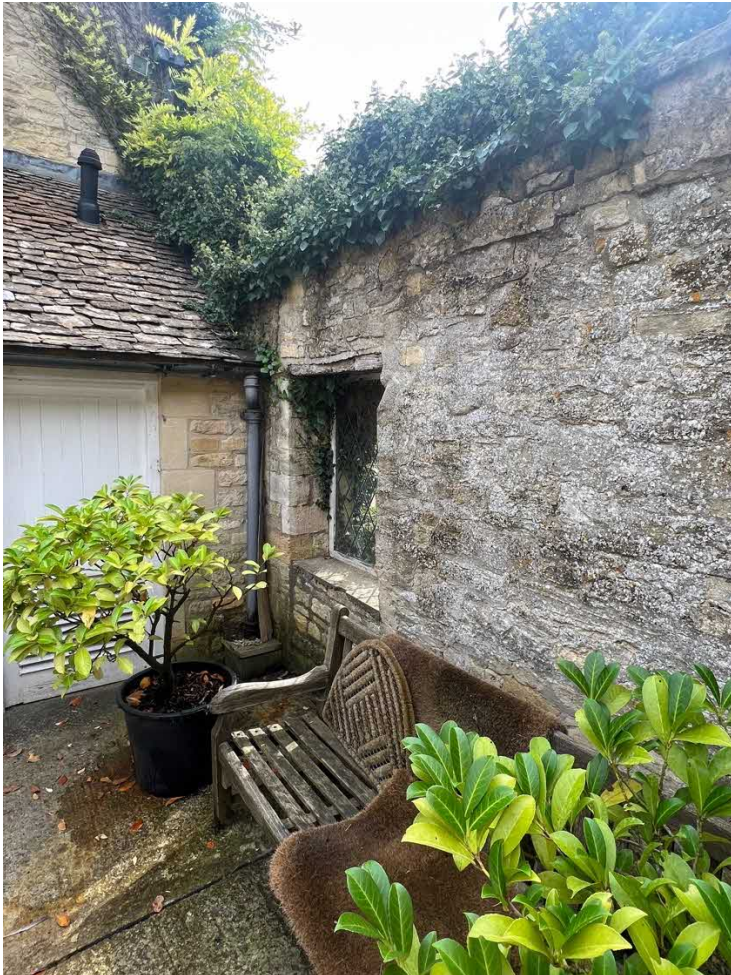
Image above: photo showing the rear, north (courtyard) side of the connecting wall. Note the more random rubble stonework, different to the S side.

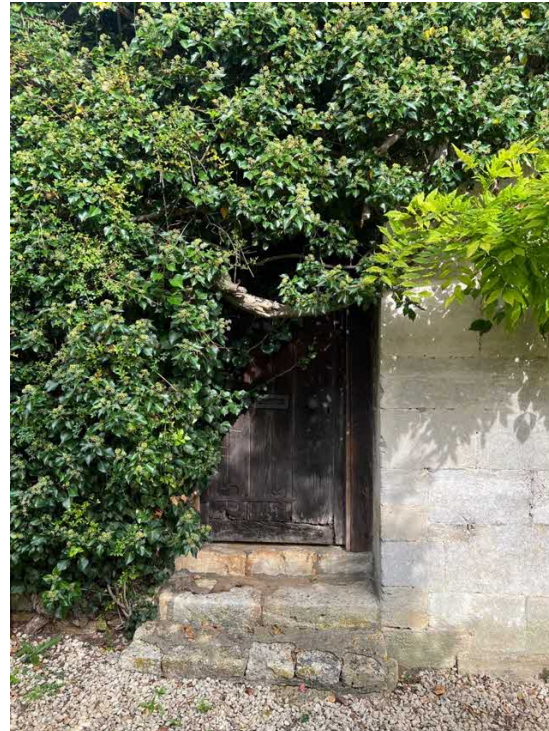
Image above: photo showing partial view of the older original door which belonged to the front door to the east of this. The frame is modern; the door allowed rain ingress and hence new frame.

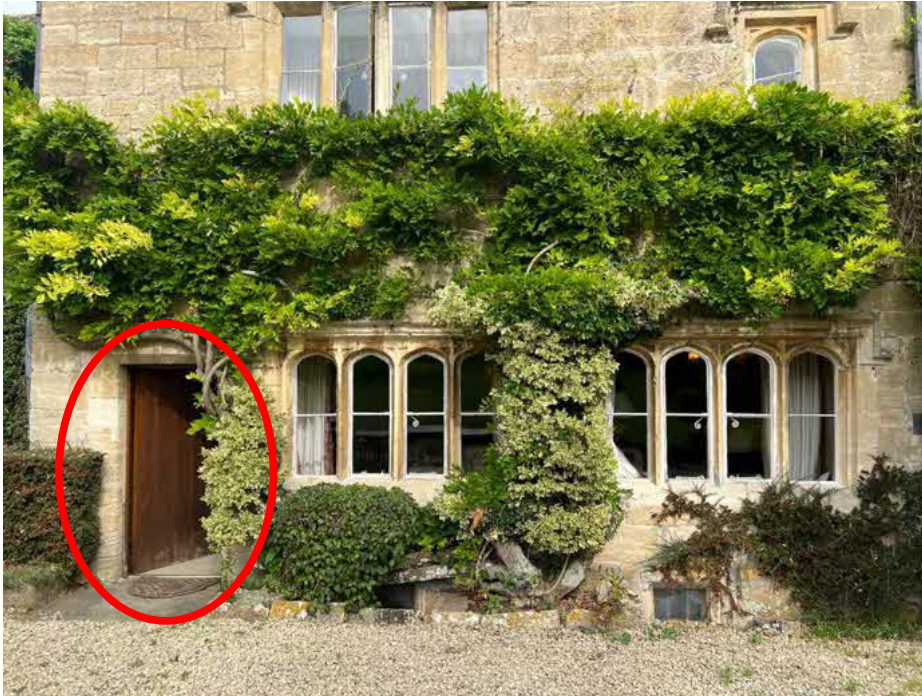
Image above: photo showing south elevation of main range with the modern door, in the historic opening from where the garden wall door was taken. The modern door was replaced during the 1970s phase of works as the older door allowed rain ingress.

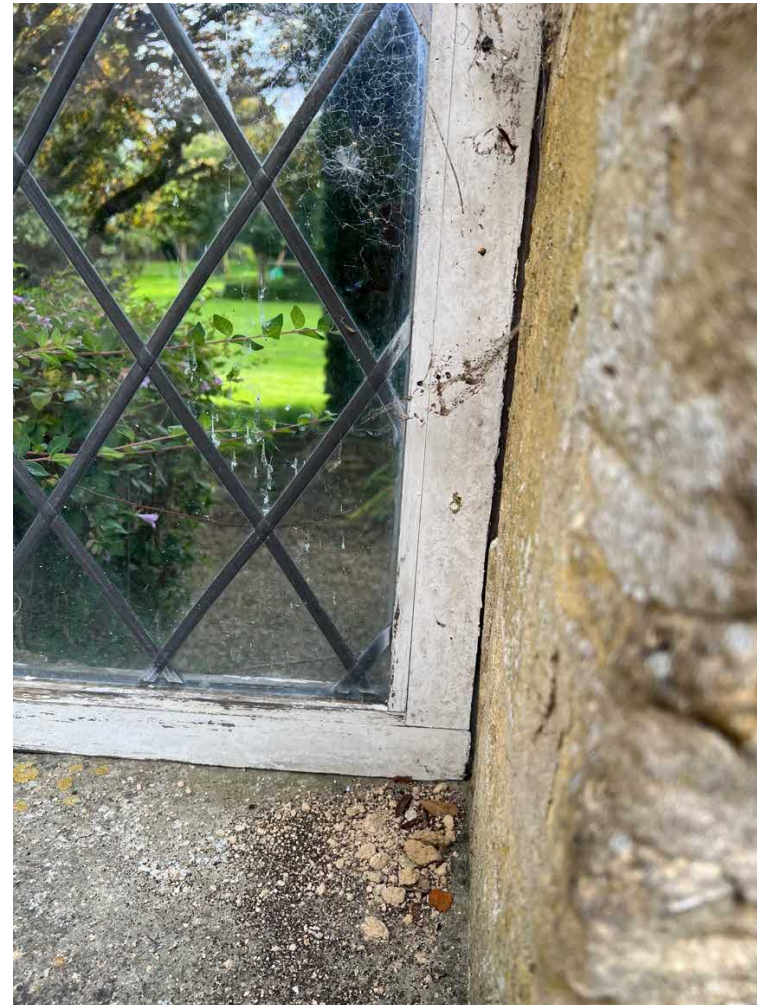
Image above: photo showing infilled opening, undertaken by Alan Mansfield Smith in the 1950s. Note the lead is clipped short and the beading is tacked on, clearly C20.

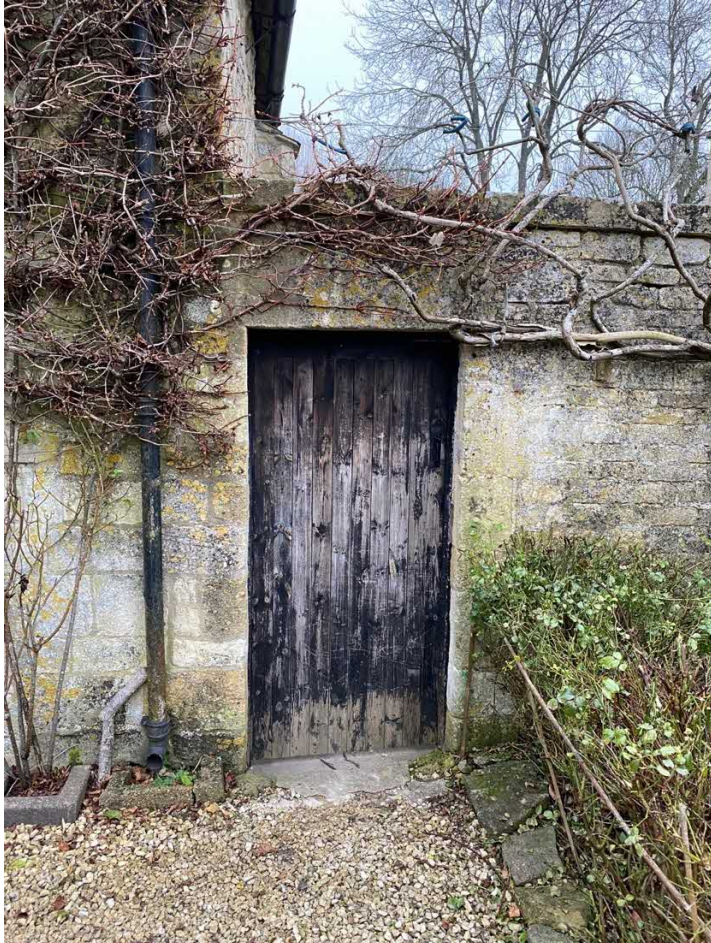
Image above: photo showing north side of third opening. This appears more historic with weathered masonry to the RHS and the Store barn gable to the LHS.

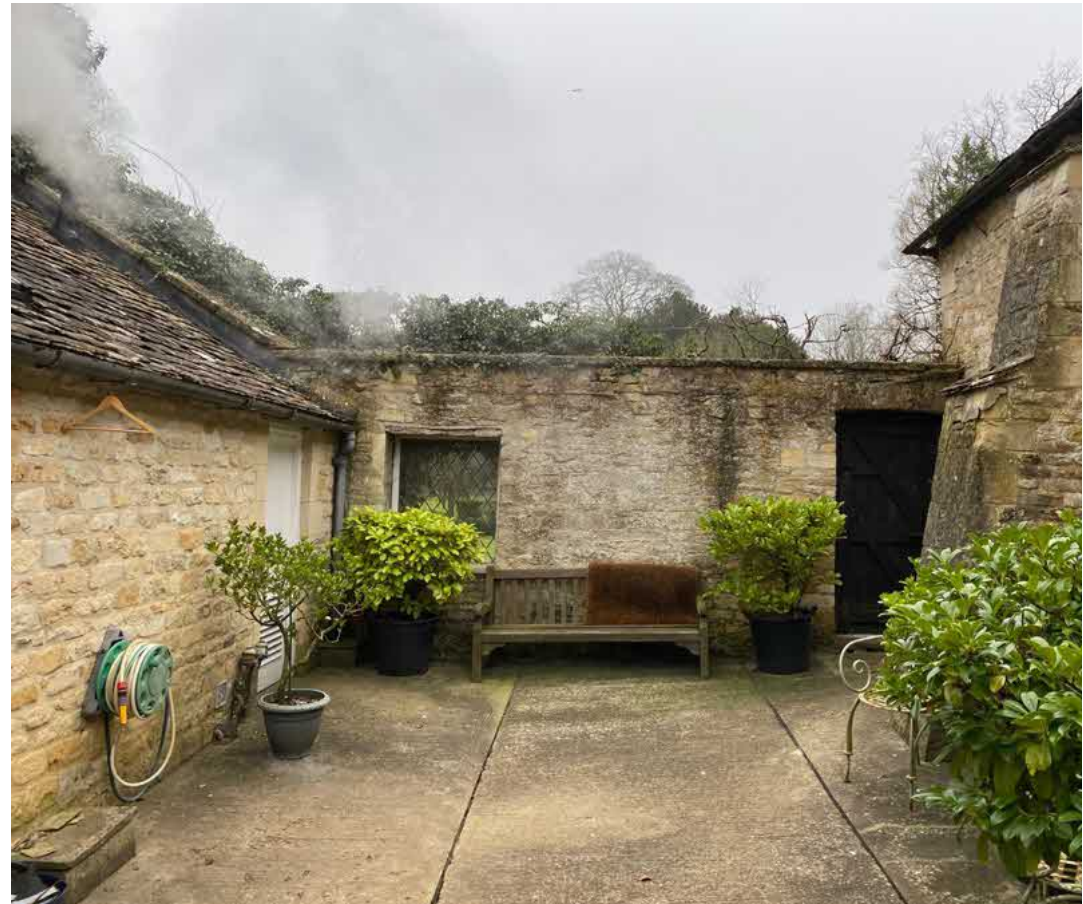
Image above: photo showing the reverse face of the same third opening.

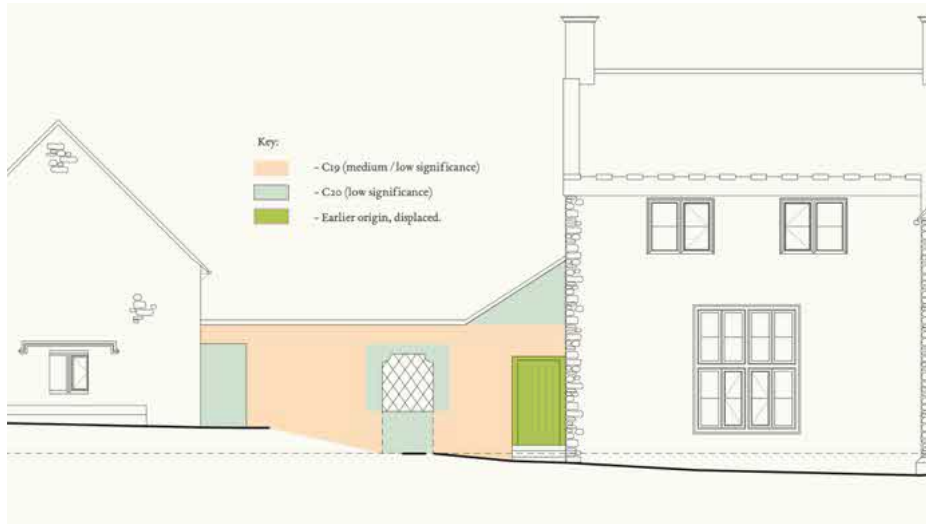
Image above: extract showing likely phases of the wall.
