PLANNING STATEMENT

Site: Eastleigh
38 Gaddesden Row
Hemel Hempstead,
Herts
HP2 6HL

Project Ref: 23008_PS

HERITAGE STATEMENT

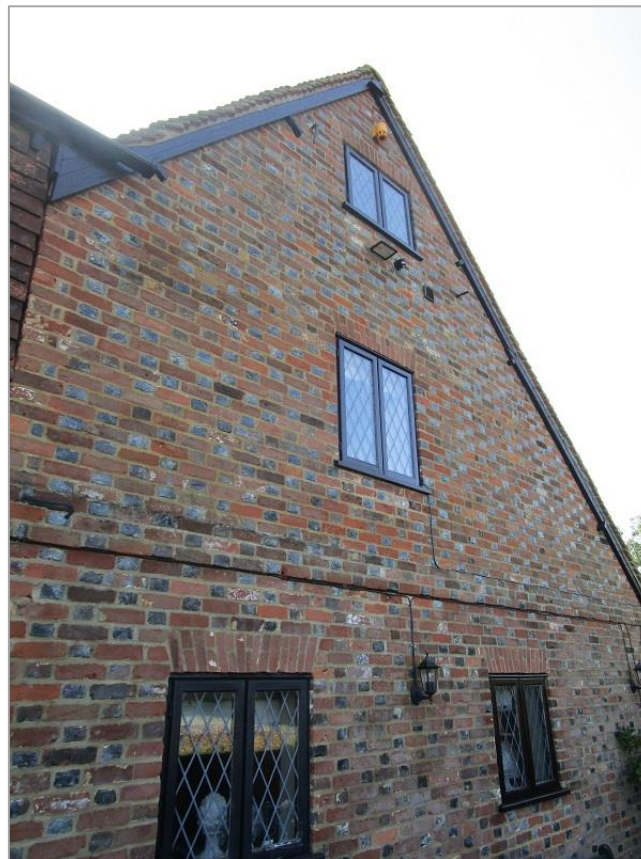
Fig. 2: North elevation of C18 north addition, in red brick with vitrified blue headers. A raised band separates the ground and first floors. The casement windows are all modern. Matching brickwork in the 1981 catslide addition to right.

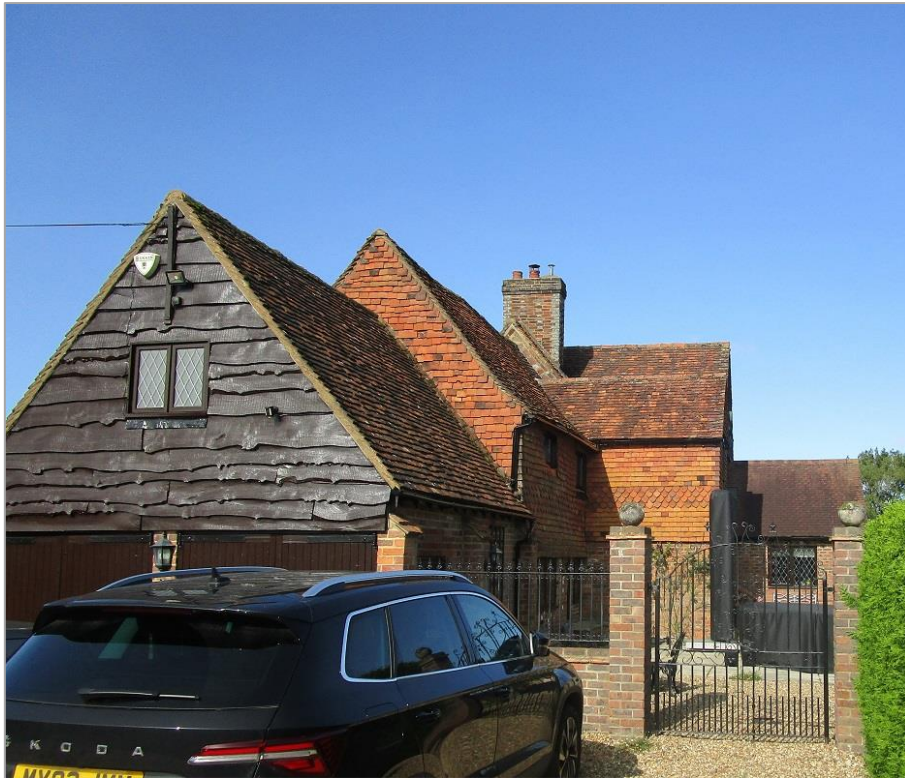
Fig. 3: The building from the south, with 1980s garage in foreground, tile hung and slightly higher original range centre, rebuilt C17 stack and higher ridge of C18 north range beyond. Giving off to the right are the lower ridge of the 1990-approved two-storey addition (attached to the original range) and the higher ridge of the 1991-approved addition (giving off the north range). To the right is the lower ridge of the 2010-approved kitchen addition.

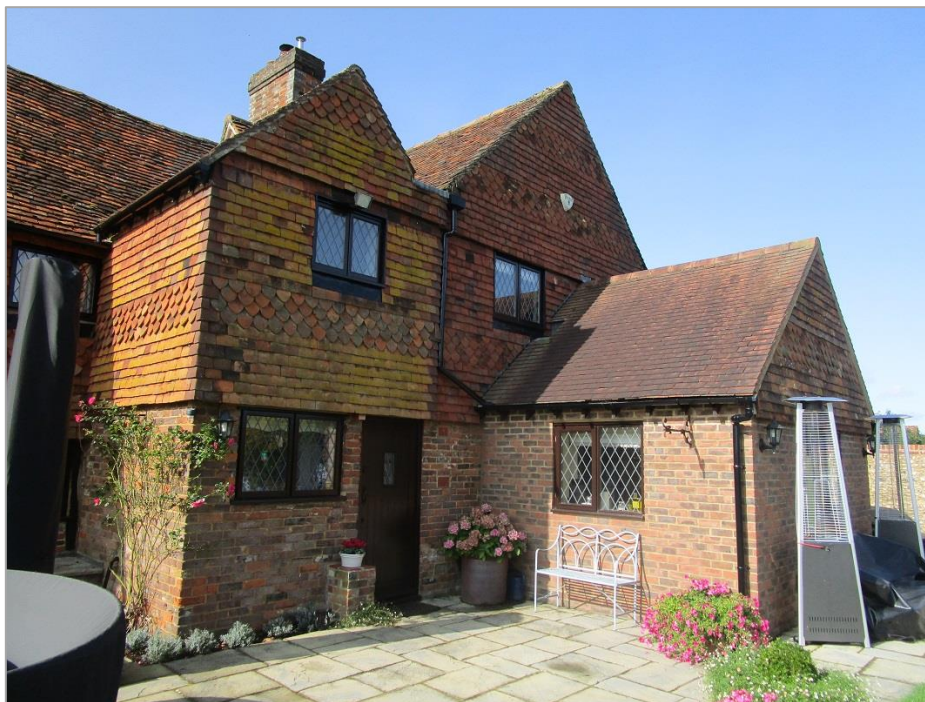
Fig. 4: The 1990 (left) and 1991 two-storey gabled additions are faced with reclaimed bricks on the ground floor and tile hung above, with alternating broad bands of rectangular and scalloped tiles; they have plain tile roofs. The 2010 addition has less well-matching brickwork, and machine-made roof tiles.

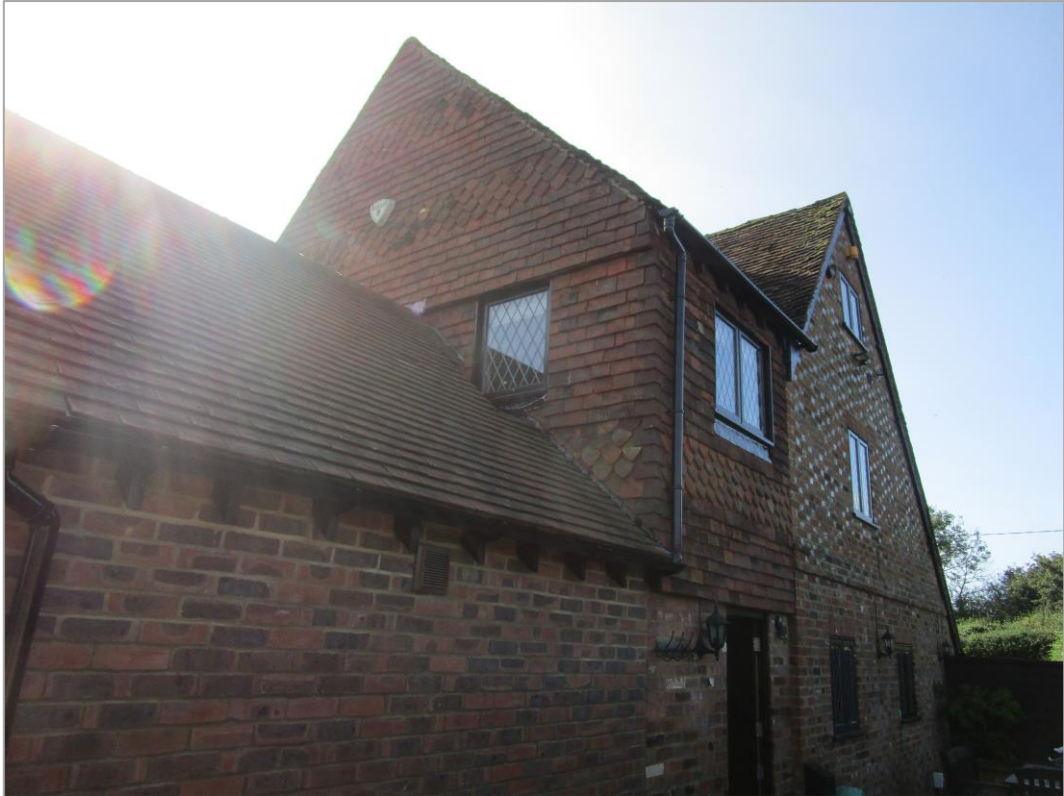
Fig. 5: The roof of the 2010 kitchen addition awkwardly abuts the first floor window of the 1991 addition.

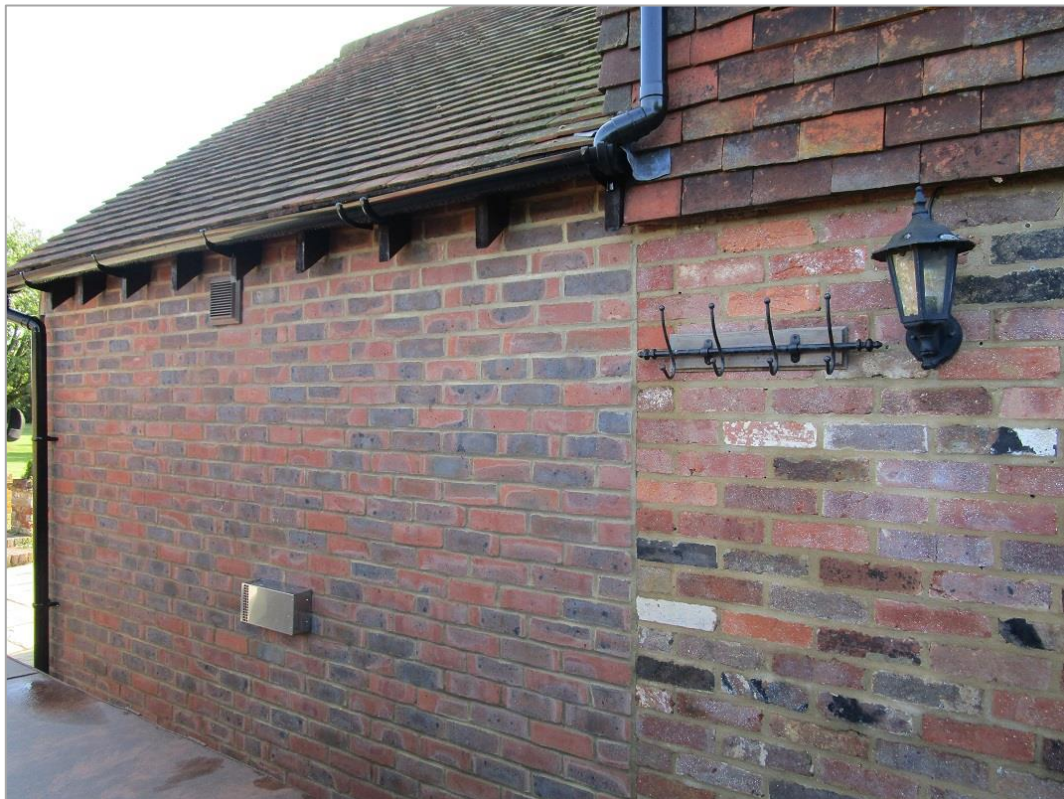
Fig. 6: North elevation of 2010 addition, showing abutment with 1991 addition.

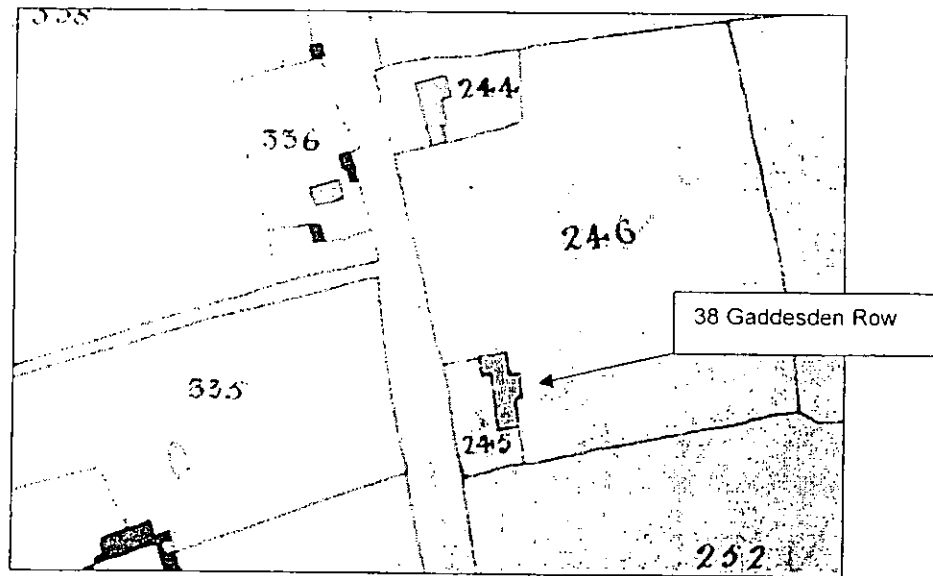
Figure 5: Extract from the 1838 Tithe Map (HALS DSA4/40/2)

The first clear cartographic evidence for 38 Gaddesden Row is given on the Great Gaddesden Tithe map of 1838; it clearly shows the plan of the property with its small area of land to the east of the road, labelled as plot 245 (Fig. 5). The property is shaded in red and appears as a long rectangular building with a central extension to the rear (east) and an extension to the front (west) at its northern end. Although no divisions are apparent within the property or its garden the Tithe award states that plot 245 was '2 cottages and gardens'. The property has no land to its rear (east) or north side nor are there any associated outbuildings. Plot 245 was owned by The Reverend John Fitz Moore Halsey and the two cottages were occupied by Thomas Parkins and James Mitchell, who may have been agricultural farm workers working on the Gaddesden Estate.

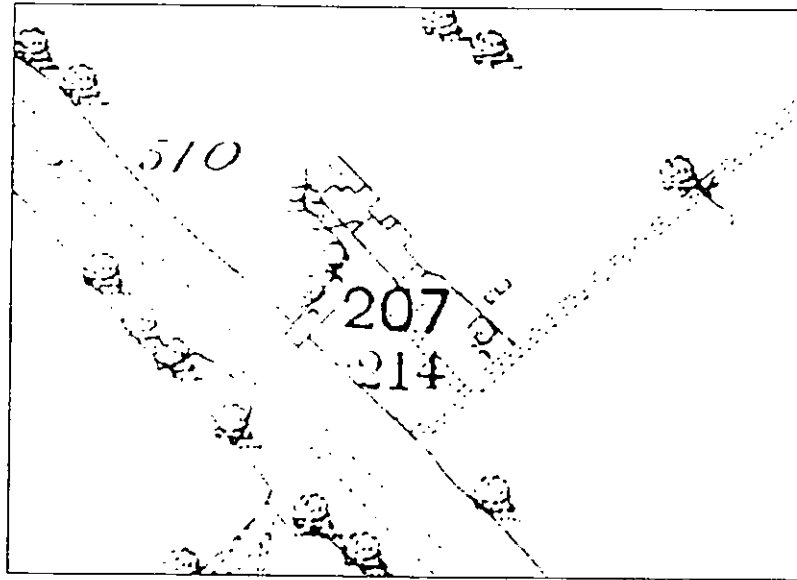
Figure 6: Extract from the Ordnance Survey Map 1878

The 1878 Ordnance Survey map shows 38 Gaddesden Row in slightly more detail and appears to show a dividing line through the building indicating the two separate cottages (Fig. 6). The location of the divide suggests that the timber frame of the original dwelling was one cottage and the northern extension was a separate cottage. The northern 'cottage' has been extended to the rear but has lost its extension to the front (west). The southern 'cottage' of the property is also extended to the rear; this extension may be the same as shown on the tithe map of 1838. There also appears to be a small extension to the south end of the property, which might have been there before 1838 but was not indicated on the earlier map. A track appears to lead from the road to the front of the property and there is a path which leads to the south and joins with the path along the field boundary. There is a small outbuilding to the southeast of the house, apparently outside the property boundary. The plot size appears to remain the same. A number of trees are shown around the site and there is a pond directly opposite the house, on the other side of the road (Gaddesden Row).

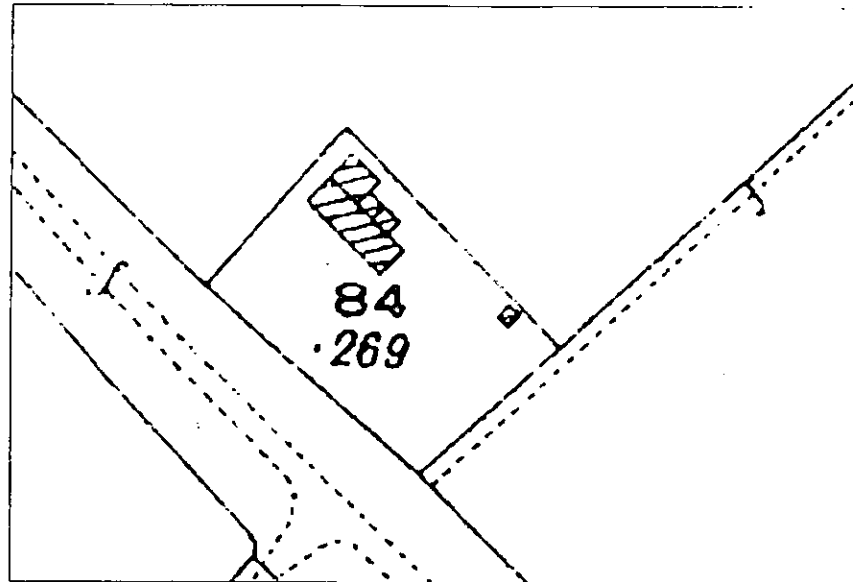
Figure 9: Extract from the Ordnance Survey Map 1924

The 1924 Ordnance Survey map shows the property has again been extended to the rear; there is a large extension to the north east corner and two smaller rear extensions. The southernmost rear extension may be the same one as seen on the 1898 Ordnance Survey map (Fig. 9). The house occupies the same sized plot as it did in 1898.

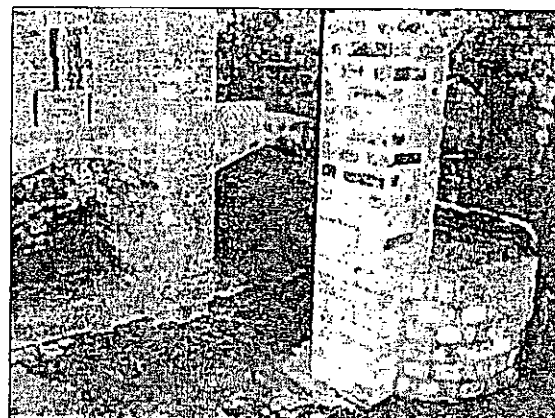
Figure 19: Cellar, modern brick supports and well head / top

The cellar occupies the area under the kitchen (room 2) and is accessed from a door in the northwest corner of the lounge. To the east and west, at the top of the steps leading down to the cellar are two narrow vertical stained glass panel windows; these may date to the early twentieth century. There is a cupboard with timber doors above the stairs. A set of brick steps leads to the north, down in to the cellar. All the walls are brick; the south wall is the base of the chimney stack and has been rebuilt / re-faced in modern red brick. The north, east and west walls are brown brick laid in both English and Flemish bond (irregular) and contain small niches with curved brick header arches, the bricks appear to date to the eighteenth century. Later alterations have been made including the addition of further brick supporting walls at right angles to the west wall with two modern brick 'shelves' in between. A brick pillar has been constructed to support the principal ceiling beam. Between the brick pillar and the north wall of the cellar is a deep well, the brick built circular well top is a modern addition or a rebuild of an earlier well top.

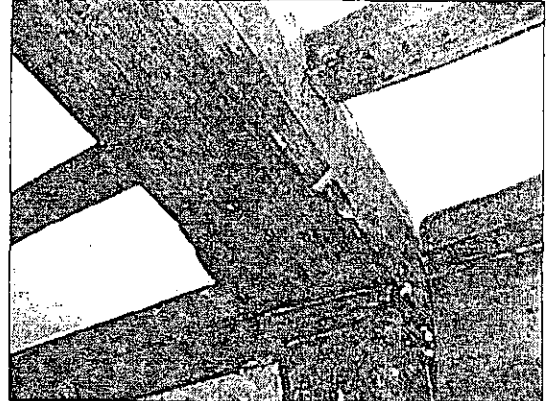
Figure 21: Room 2, kitchen. Axial ceiling beam with flat chamfer and lambs tongue stop (eighteenth century)

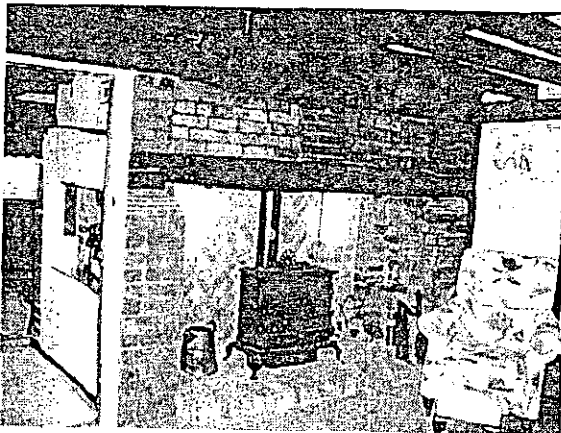
Figure 22: Room 3, lounge. Inglenook fireplace to north elevation

North elevation: There is an inglenook fireplace to the east side of the room which now contains a wood-burning stove; it has been largely rebuilt with modern herringbone brickwork to the rear, a modern brick hearth and modern brick and clay tile jambs. A brick niche has been constructed in the eastern side wall of the fireplace; this may have replaced a previous niche. The chamfered timber lintel over the fireplace appears original and the brickwork above the timber lintel is slightly older, perhaps a nineteenth century rebuild. To the west of the inglenook is an opening which leads through to the kitchen. At the west end of the north elevation is a modern timber board doorway.

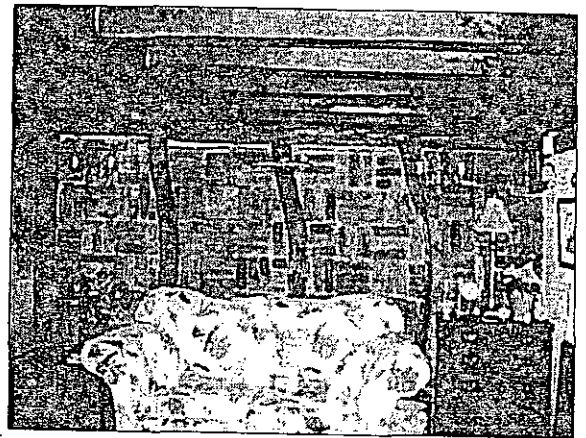
Figure 23: Room 3, lounge. Timber frame partition to south elevation with modern brick infill

South elevation: Timber frame consisting of timber sill beam at base of wall, a timber beam along top of wall, corner posts and a series of timber studs. The patterned brick infill between the studs is a late twentieth century replacement of the earlier infill panels. A late nineteenth century 'arts and crafts' style boarded door at the east end leads in to the dining room (room 4), the timber post directly adjacent to this was also added at this time. The timber sill appears to have been cut away to floor level suggesting this doorway was a later addition. There are iron pintles on the east end post indicating an earlier door existed but has been subsequently replaced. At the west end of this wall the sill beam stops just to the west of the westernmost timber stud, this suggests there was a doorway at this point originally, it was infilled and the doorway inserted at the eastern end of the south wall.

The timber partition wall on the ground floor between the lounge and dining room (rooms 3 and 4) would originally have contained lath and plaster infill panels; these panels were replaced with modern brick in a decorative pattern. The inglenook fireplace was largely remodelled at this time and rebuilt in modern red brick.

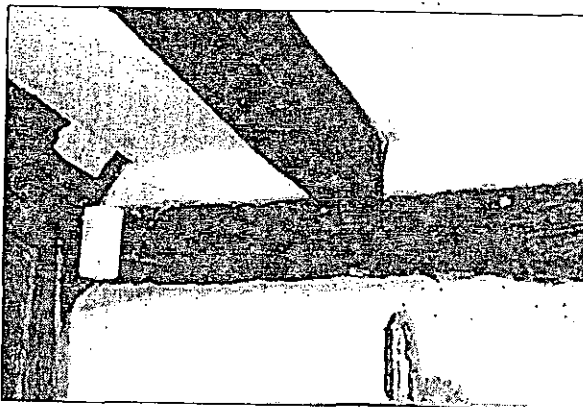
Figure 24: Room 3, lounge. South end of west wall. The cut back section of timber beam may suggest the position of a former entrance door.

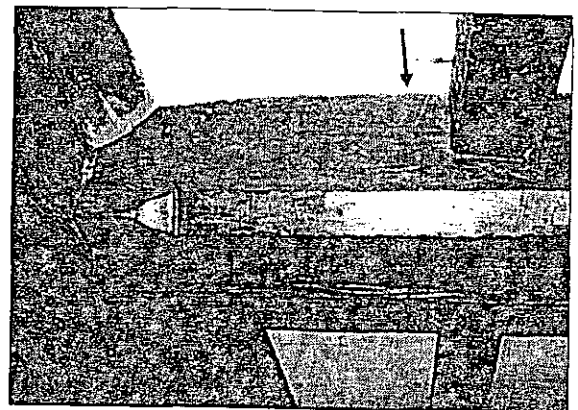
Figure 25: Room 3, lounge. Axial timber beam with flat chamfer and stepped stop. The arrow points to a V-shaped carpenter's mark.

Ceiling: A chamfered and stopped axial timber beam runs north to south across the centre of the ceiling. Either side are seven substantial timber joists which support the floor above. These joists are square cut and are covered in nail holes and horizontal lines which suggest the joists held a lath and plaster ceiling (now removed).

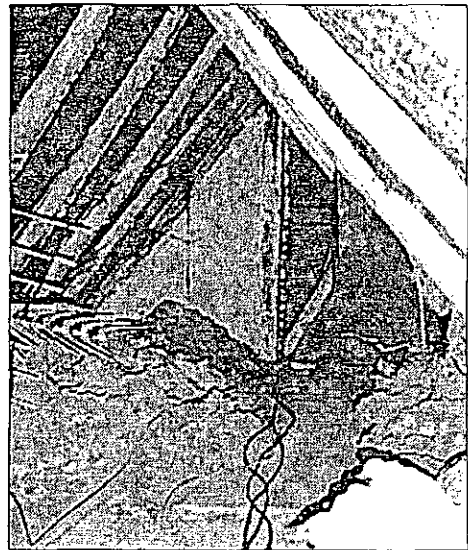
Figure 55: Southern end of roof space. Timber rafters and the lath and plaster partition are visible
