WELLOW WOOD COTTAGE, WELLOW WOOD  
ROAD, WEST WELLOW, SO51 6EP

**HERITAGE APPRAISAL**

An assessment of surviving historic fabric at Wellow Wood Cottage, a Grade II listed building partially destroyed by fire in March 2023.

August 2023

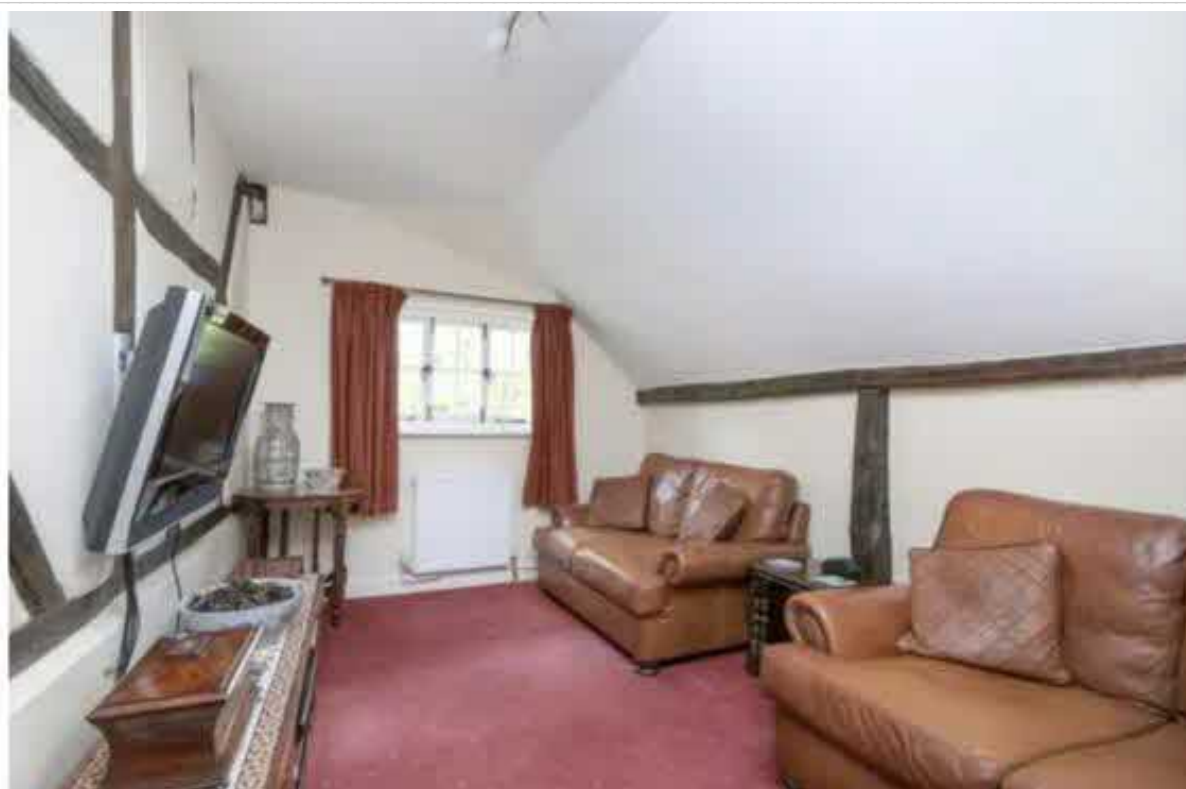
Figure HP5: Room G3 prior to fire (sales particulars cXXXX?)

- 4.14 Room G3 is the late 19<sup>th</sup>/early 20<sup>th</sup> century western extension to the original plan, but potentially partially or fully rebuilt at some time, possibly when the large rear extension was added. There is a late 19<sup>th</sup>/early 20<sup>th</sup> century three light casement (W1) to the front elevation with glazing bars (heavily damaged) (**Figure 14 Appendix D**). And Window W7 (**Figure 15 Appendix D**) is also possibly late 19<sup>th</sup>/early 20<sup>th</sup> century in origin, heavily compromised by the later rear extension.

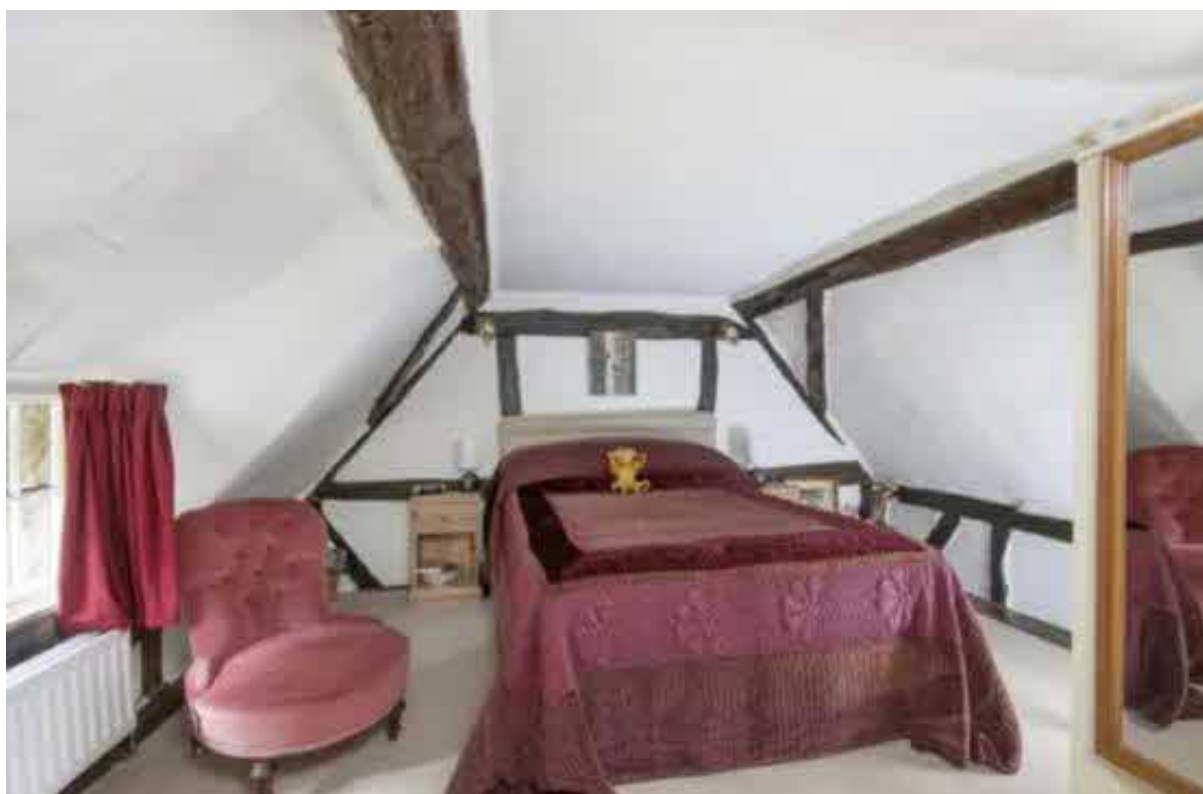
Figure HP6: Room F1 prior to fire (sales particulars cXXXX?)

- 4.18 There is a jowled post to the centre of the rear wall which survives along with its tenon (**Figure 19 Appendix D**). This does not correspond to a post to the front elevation (although this has been altered) and is probably a re-used timber (incorporated into the box framing of the present house). Photographs of this room prior to the fire (see **Figure HP6 Appendix C**) do not show a principal rafter in this location.

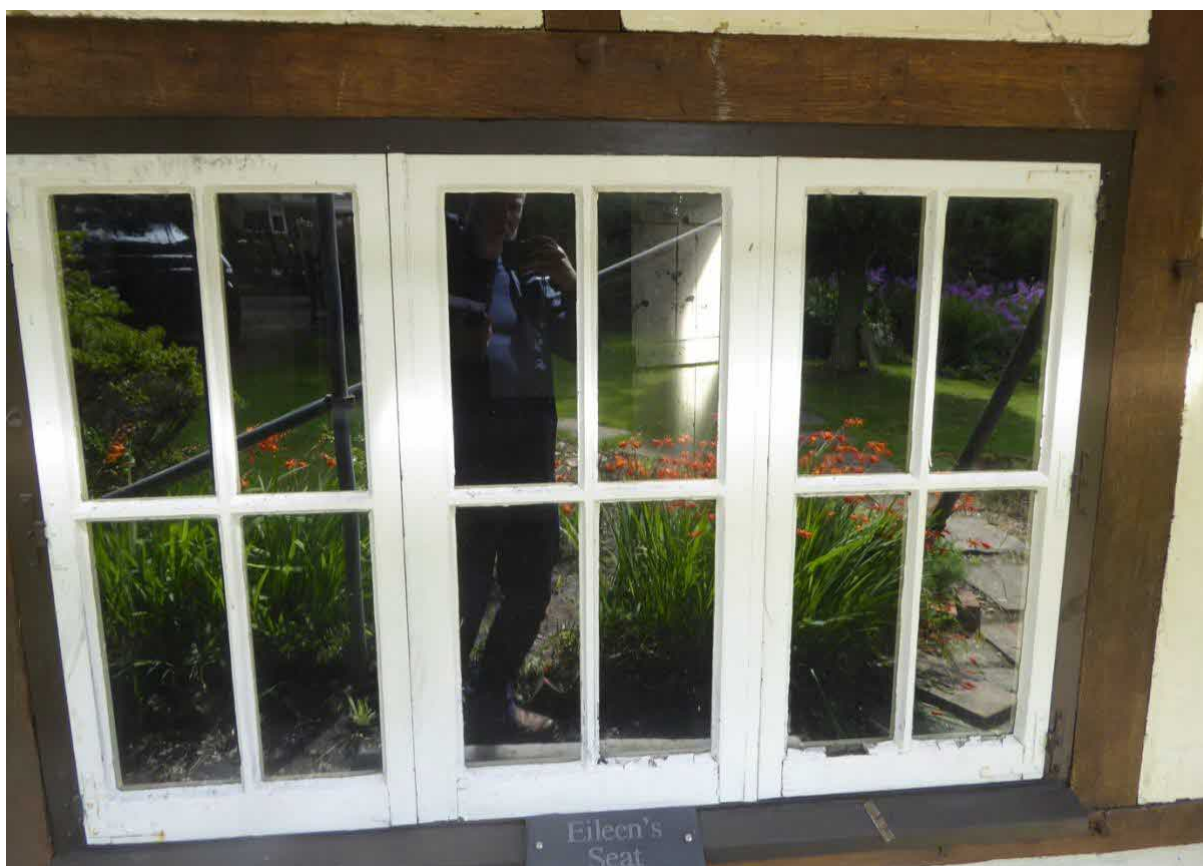
**Figure 2:** Window W2 – part of c2000 restoration works

- 4.11 Doors D2 (access to modern lobby to rear) and D3 (access to stair) are both oak and part of the c2000 restoration. Window W2 is part of the c2000 restoration.

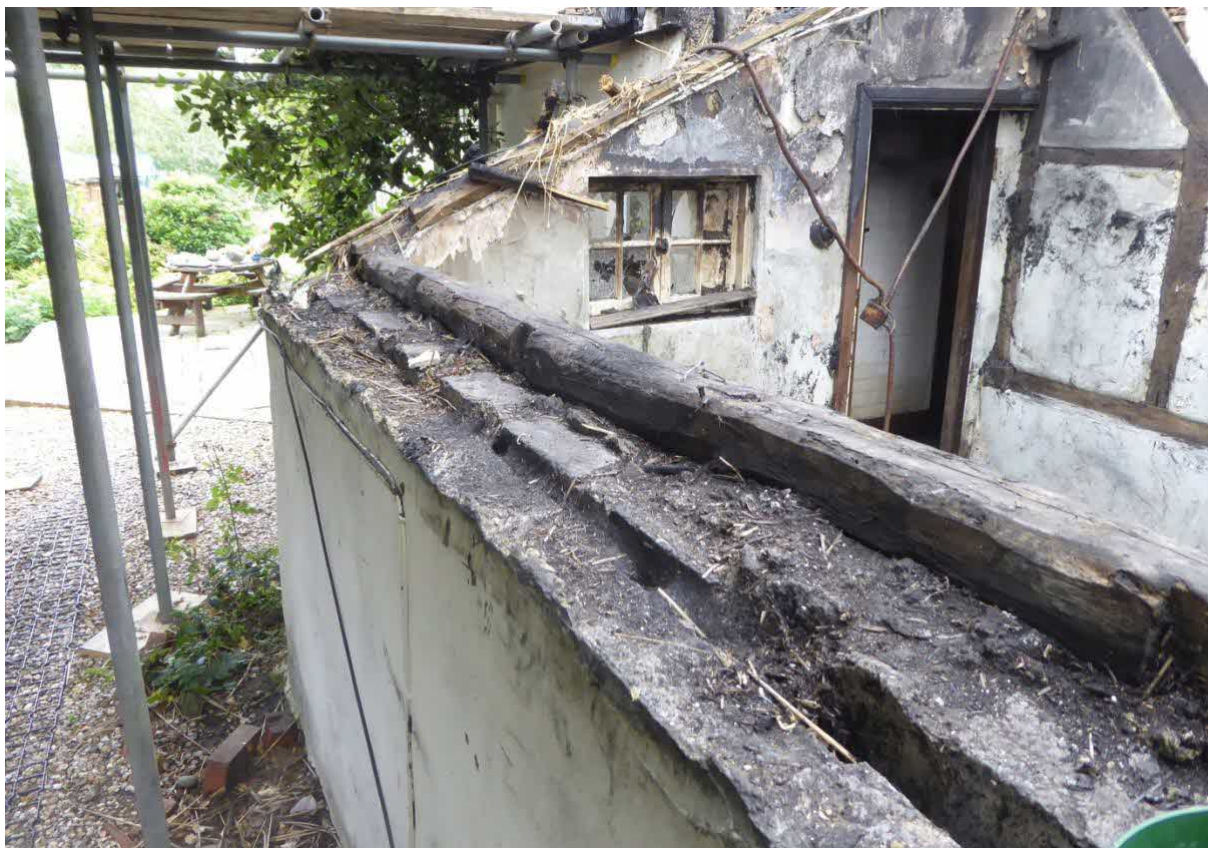
- 4.1 The list description at **Appendix E** provides a summary description of the south elevation of the building.
- 4.2 The following is a detailed description of the surviving fabric of the building.
- 4.3 The external elevations comprise small box framing with straight braces with brick infill panels. Most infill panels are replacement for earlier wattle and daub. Some wattle and daub panels exist at first floor (**Figure 1 Appendix D**). Major framing and remodelling of the fenestration was undertaken around Window W2 (**Figure 2 Appendix D**). The window replaced a bay c1970s bay window in c2000.
- 4.4 The original two room lobby entry plan was extended to the west between 1870 and 1896. However, the extension appears to have been rebuilt probably some time in the early 20<sup>th</sup> century as it is now in cavity wall construction (**Figure 3 Appendix D**)

**Figure 3:** Cavity wall to west wall of ground floor extension to west

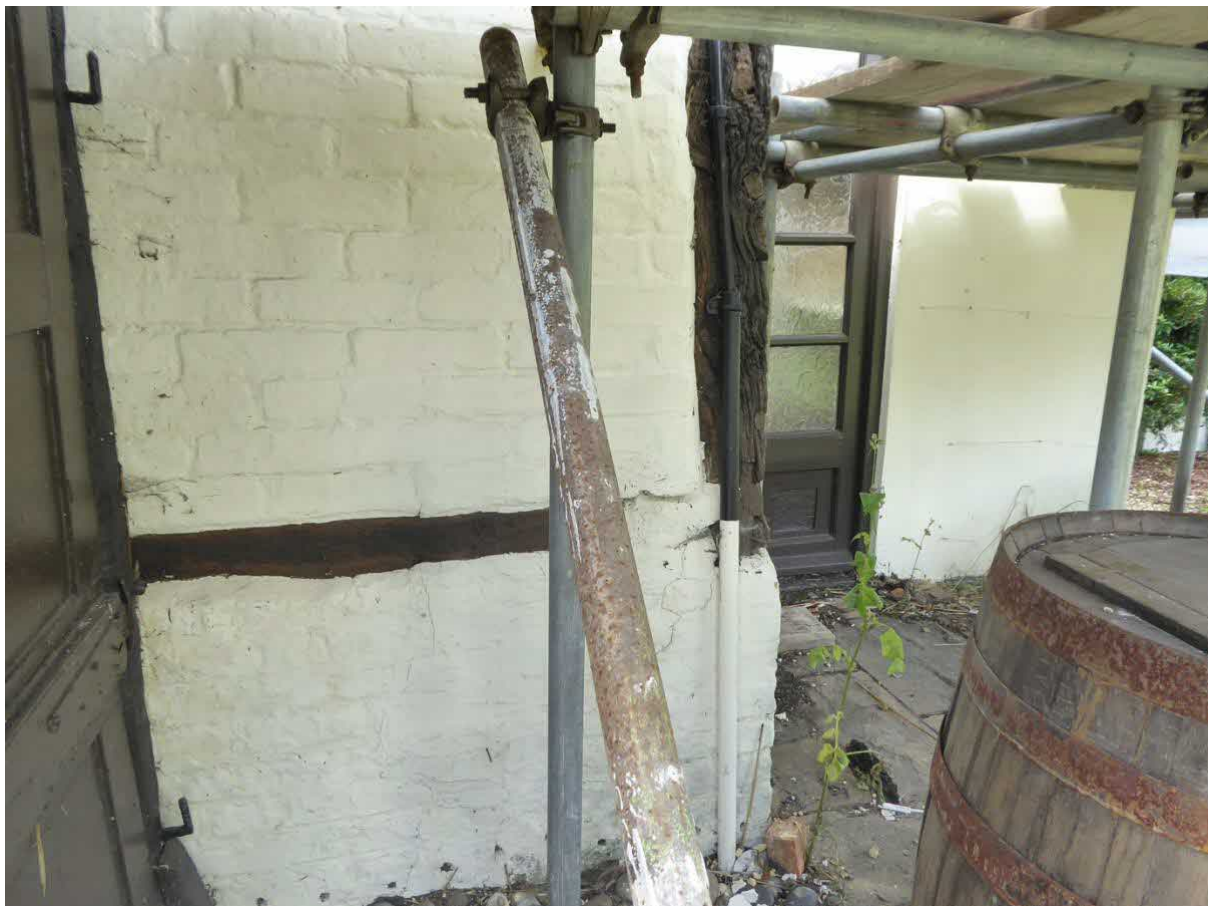
- 4.5 There is a small outshut rendered cavity blockwork extension to the rear separate to the 1970s enlargement which dates to the mid 20<sup>th</sup> century (**Figure 4 Appendix D**). There is a further small store to the east elevation which is late 19<sup>th</sup>/early 20<sup>th</sup> century in date and thatched (**Figures 5 and 6 Appendix D**).
- 4.6 The roof prior to the fire was multi-layered wheat straw thatch with the most recent spar coat applied c2000.
- 4.7 The main front entrance door is vertical boarded unpainted oak and dates from the c2000 'restoration' project.

**Figure 4:** Mid 20<sup>th</sup> century outshut to rear

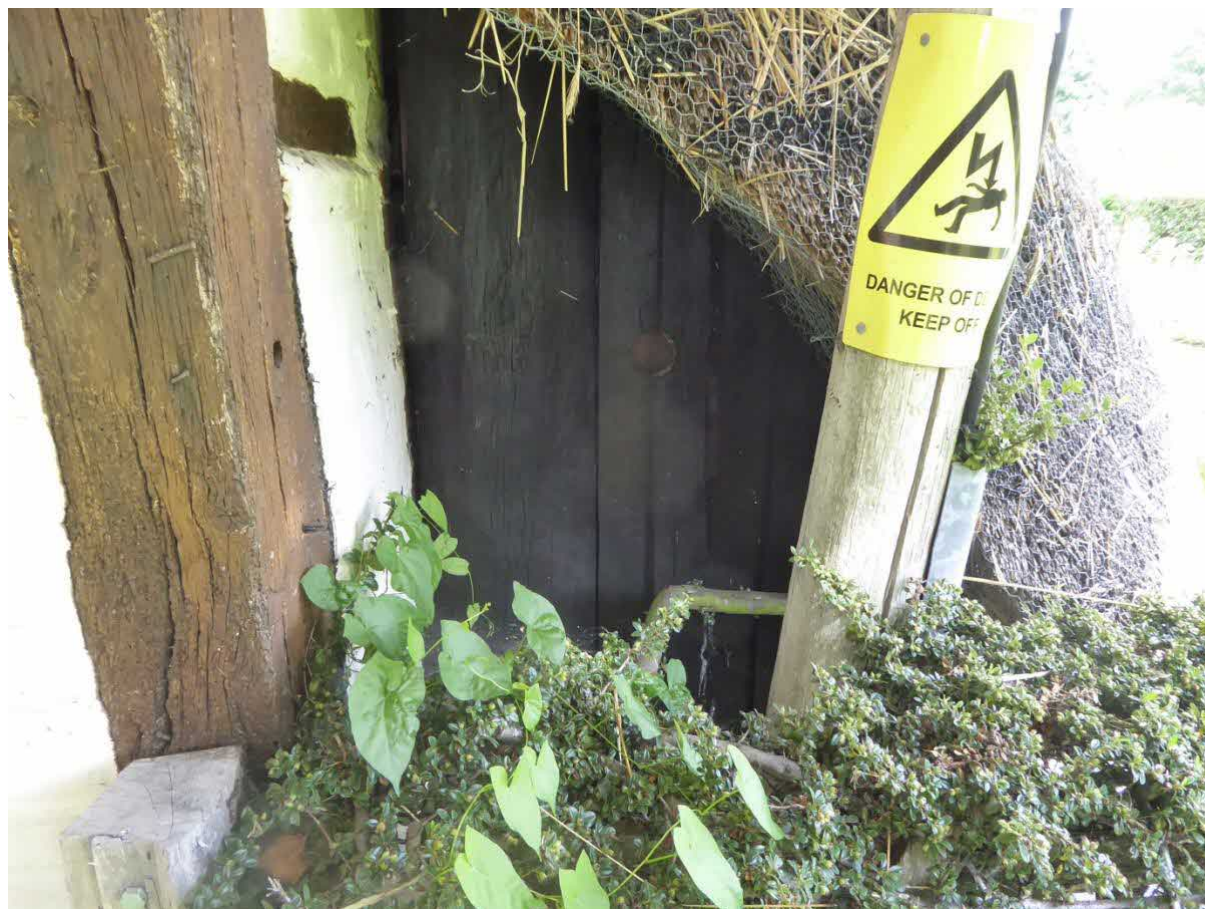
**Figure 5:** Store to east elevation -south side

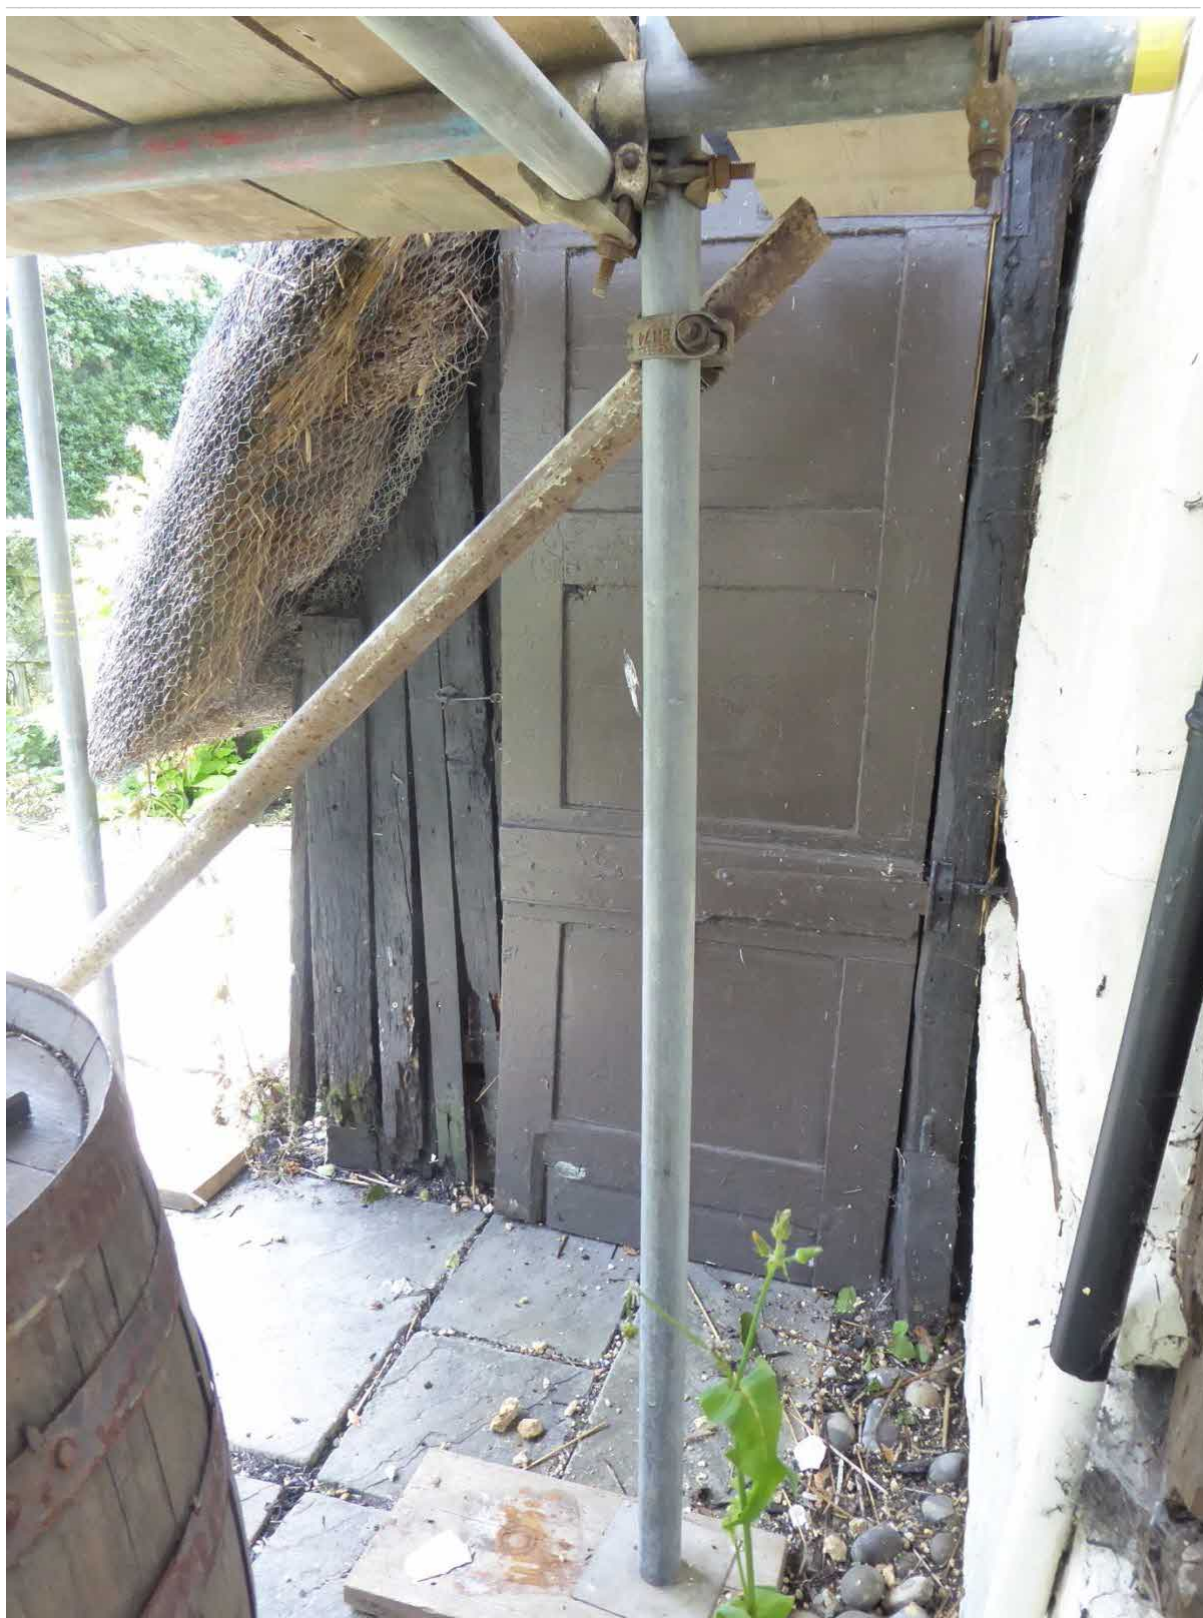
**Figure 6:** Store to east elevation – north side

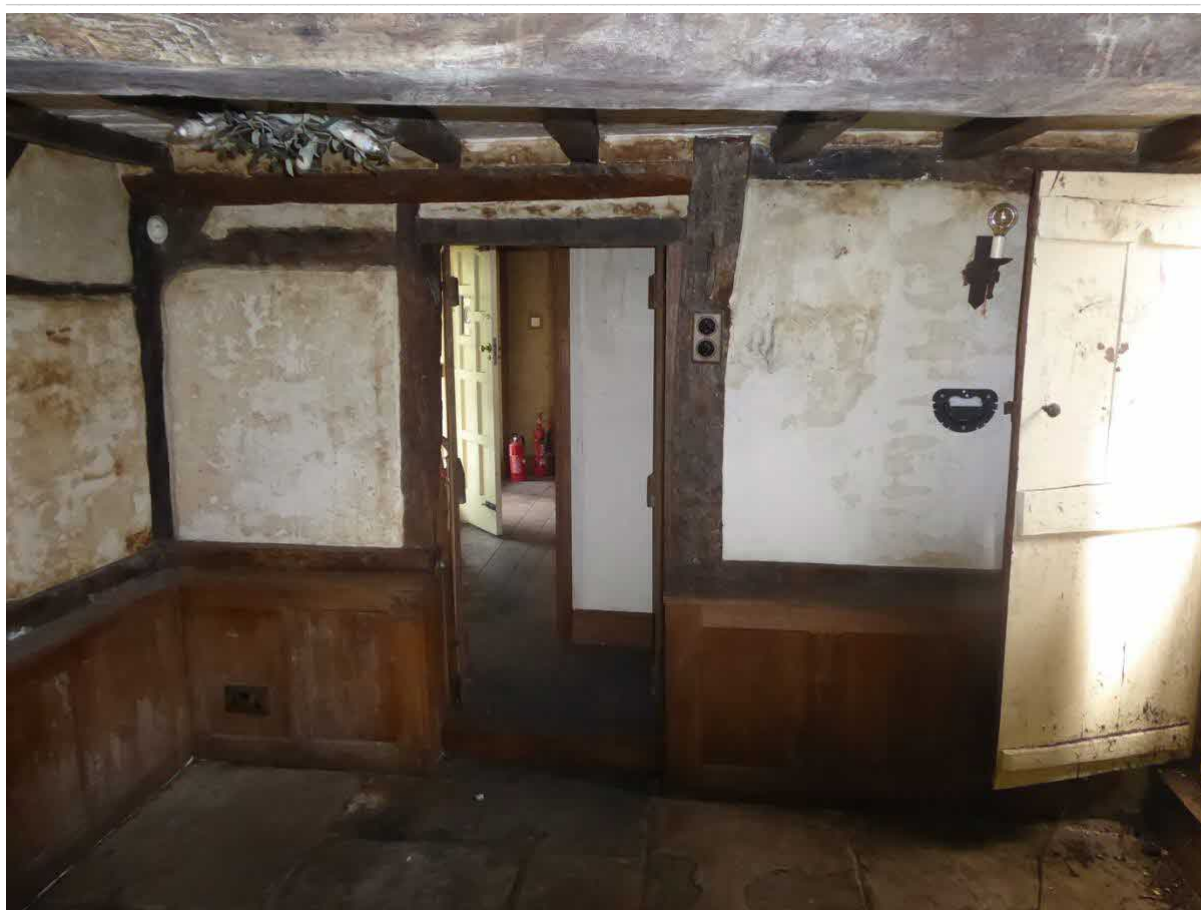
- 4.8 The main entrance (lobby entry) gives access to two rooms either side of the principal central stack. Room G1 has a modern stone flag floor and c2000 oak panelling up to dado rail (**Figure 7 Appendix D**). There is exposed framing to the west wall (formerly the external wall now internal between G1 and G3) (**Figure 8 Appendix D**). Of note is the fact that none of the braces or intermediate members of the framing is pegged. Only the central post is pegged. This would suggest that this may be later framing.

**Figure 7:** Oak panelling to dado rail part of c2000 'restoration'

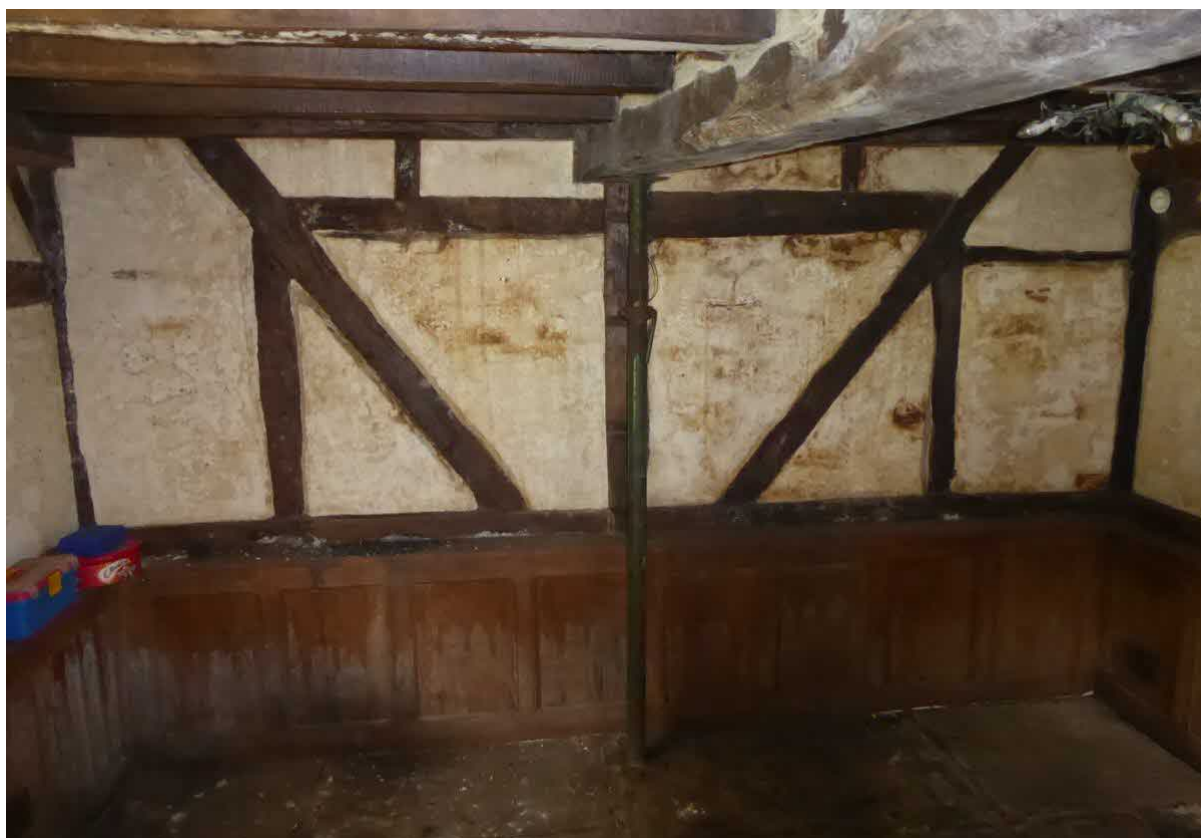
**Figure 8:** Room G1 – framing to west wall (now internal wall with G3)

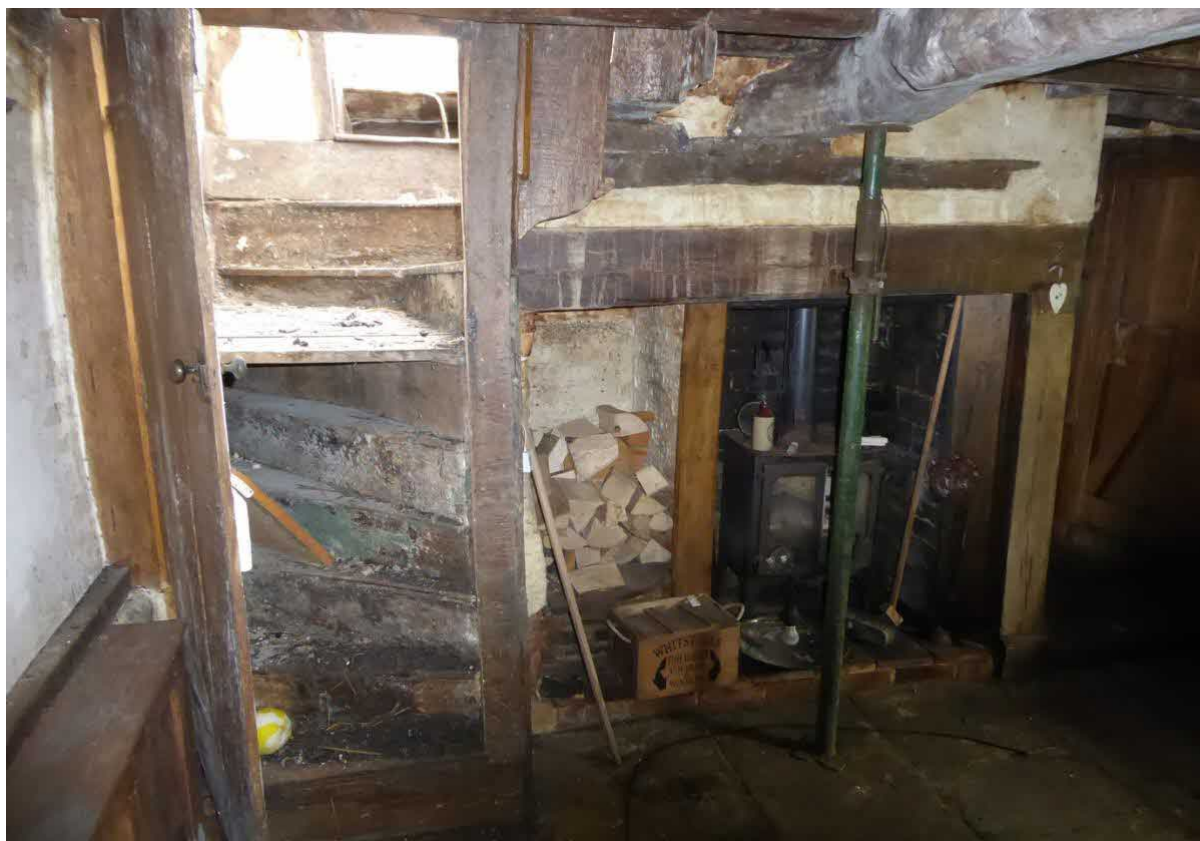
- 4.9 There is a fireplace (F1) (**Figure 9 Appendix D**) to the east wall. This has a chamfered bressummer beam which it is suspected formed part of the c2000 restoration work. Above this there is the survival of the former bressummer beam to a much larger (former) opening. The spine beam to the room sits on top of this. To the north of the fireplace there is what is probably an 18<sup>th</sup> century staircase but in the original staircase position for the house.

**Figure 9:** Room G1 – fireplace and staircase (floored at first floor)

- 4.16 The first floor is now accessed via a 1970s link to the rear extension which includes a modern staircase. The existing stair to the earlier range has been floored at first floor to create a landing with the 1970s link (see **Figure 9 Appendix D**).

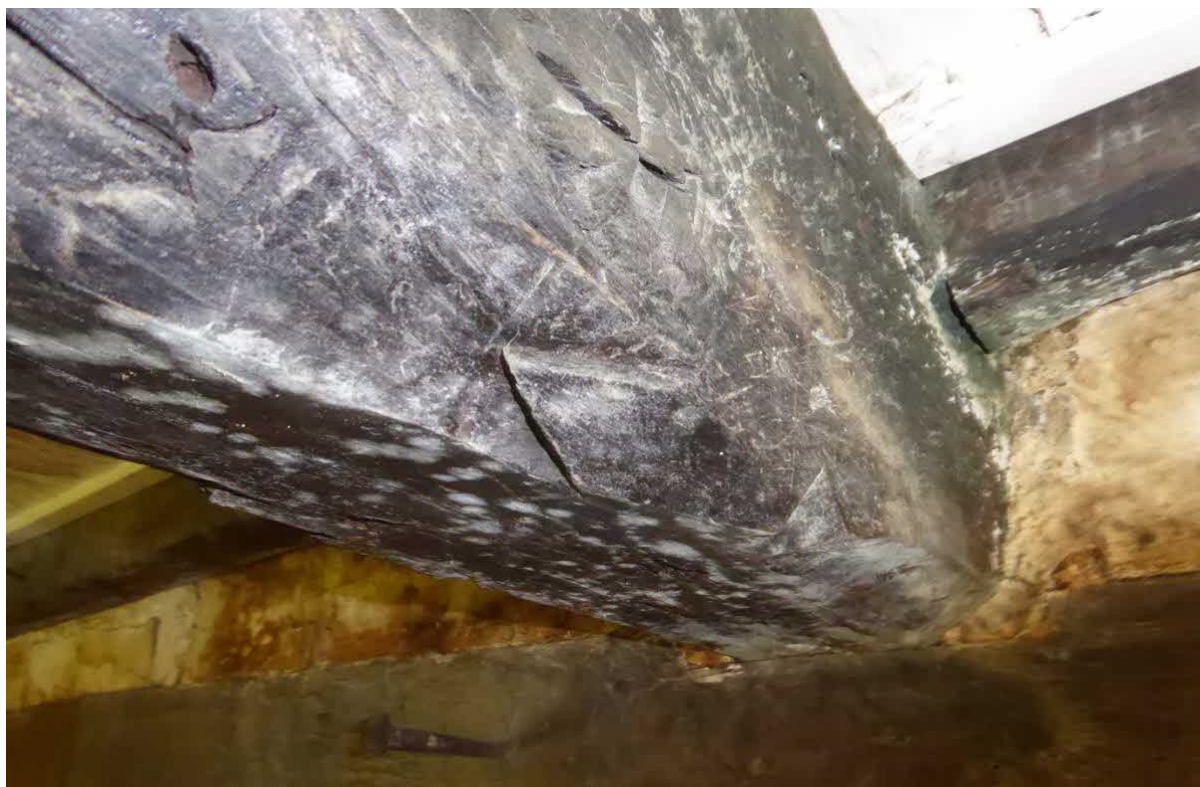
- 4.10 The spine beam to the room is stop chamfered at both ends with a distinctive jewel or spear stop (**Figure 10 Appendix D**). The beam also has a very unusual kink to its eastern end. There are exposed joists tenoned into the beam (these appear to be original).

**Figure 10:** Chamfered stop to spine beam, Room G1 – early 17<sup>th</sup> century

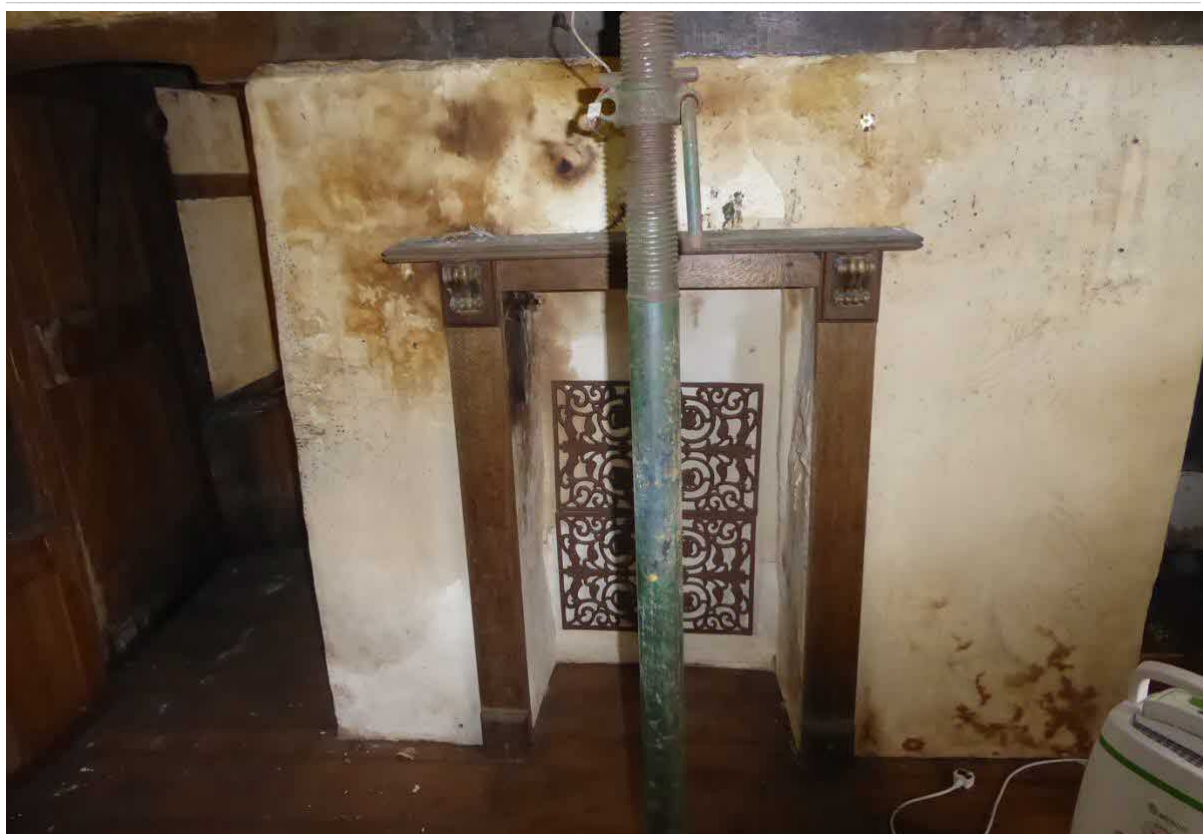
- 4.12 Room G2 is to the east side of the chimney stack has modern timber floorboards and a modern fireplace (F2) surround to a former opening (**Figure 11 Appendix D**). There is a spine beam and exposed joists which are tenoned into the beam. These appear lightly chamfered in places (**Figure 12 Appendix D**). Window W3 is a two light replica casement (probably forming part of the c2000 restoration) but with attractive (replica) wrought iron catches and stays.

**Figure 11:** Fireplace F2 to Room G2

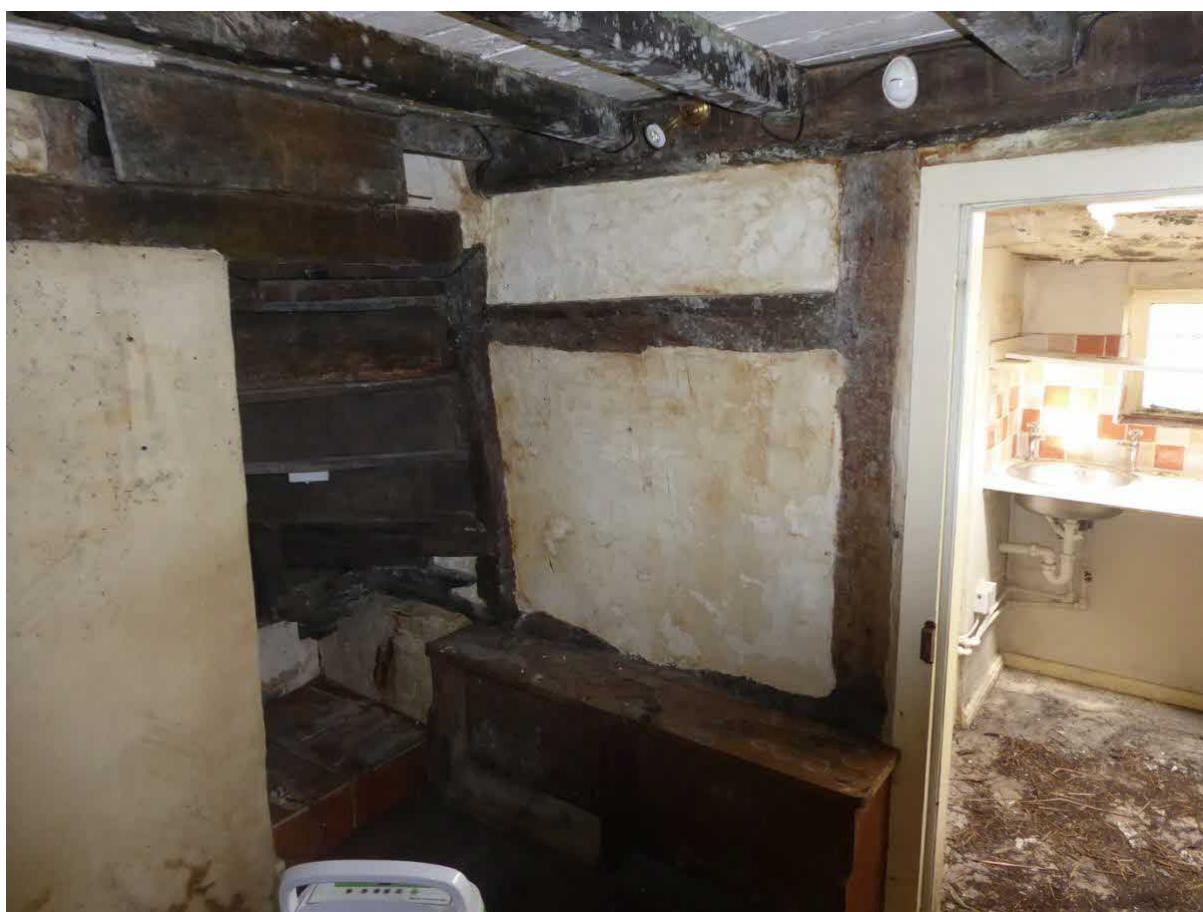
**Figure 12:** Lightly chamfered joists to Room G2

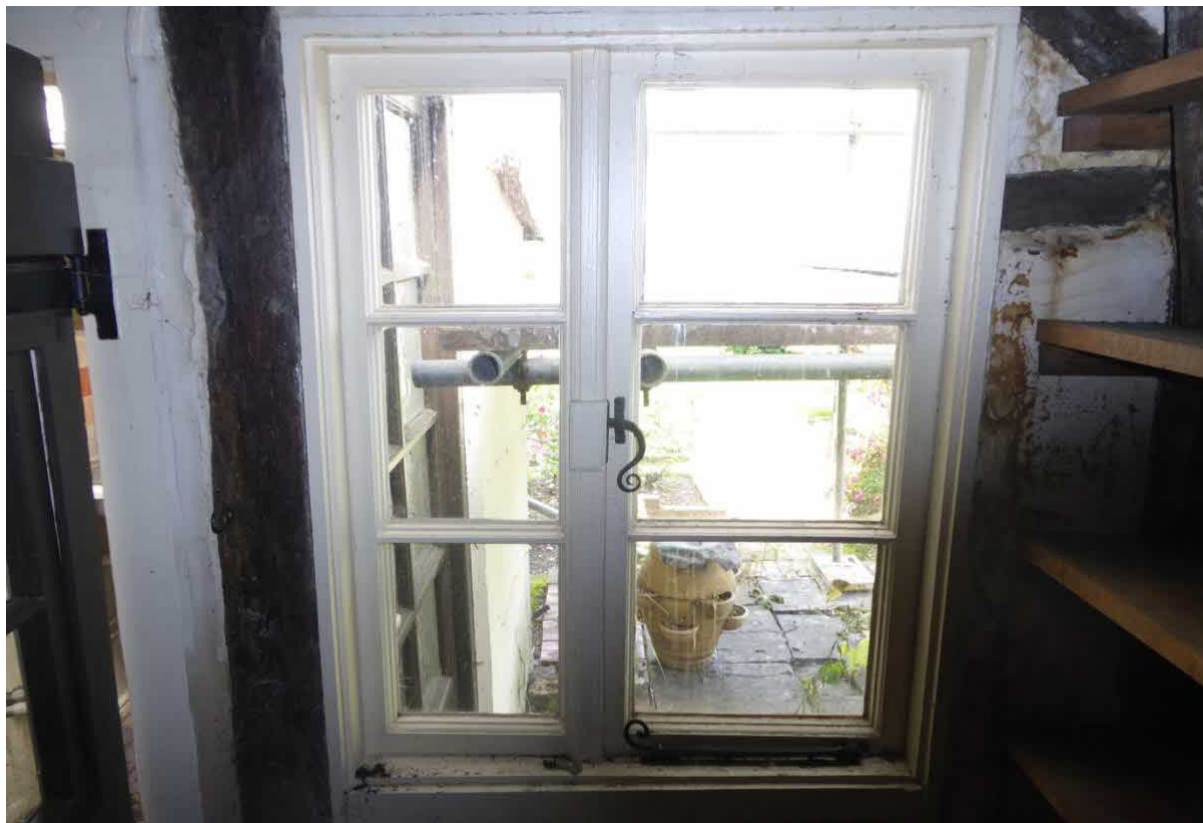
- 4.13 Window D5 to north wall (**Figure 13 Appendix D**) is a cut down 19<sup>th</sup> century casement with astragal glazing bars and wrought iron catches (replica) and a painted timber ovolo mullion.

**Figure 13:** Window D5 - 19<sup>th</sup> century, altered

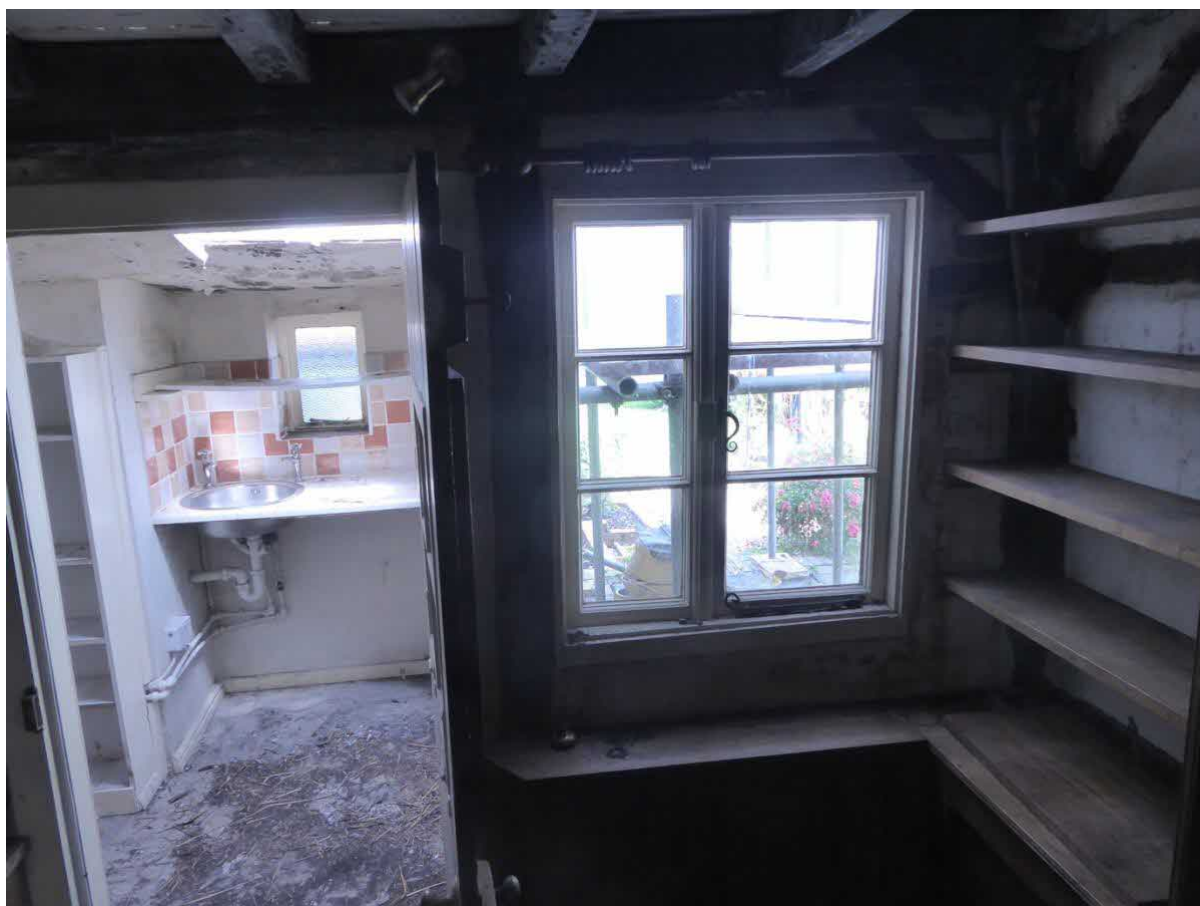
- 4.15 Room G4 (**Figure 16 Appendix D**) is mid 20<sup>th</sup> century in date with mid to late fittings, ceiling, and floor. Windows W5 and W6 are modern timber casements. Door D6 is mid to late 20<sup>th</sup> century half glazed timber door.

**Figure 16:** Room G4 from G2

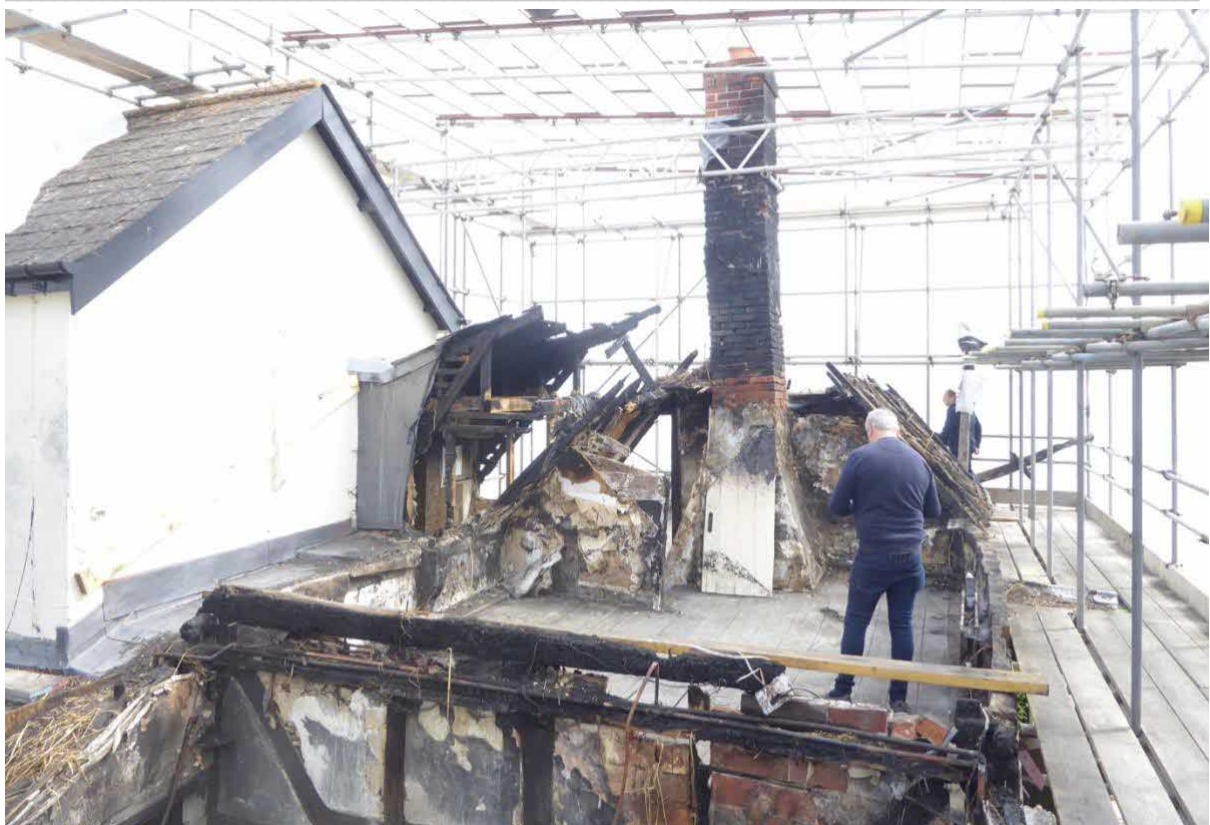
- 4.17 The 1970s landing gives access to two rooms either side of the chimney stack. The brick stack survives between rooms but is in a parlous state and appears fire damaged. Room F1 (**Figure 17 Appendix D**) has modern softwood floorboards. The stack projects into the room to the east wall and the wall plate and upper framing is exposed throughout. There is almost no survival of historic roof structure to this part of the house except for a short section of common rafters and a section of purlin above the landing (**Figure 18 Appendix D**).

**Figure 17:** Room F1

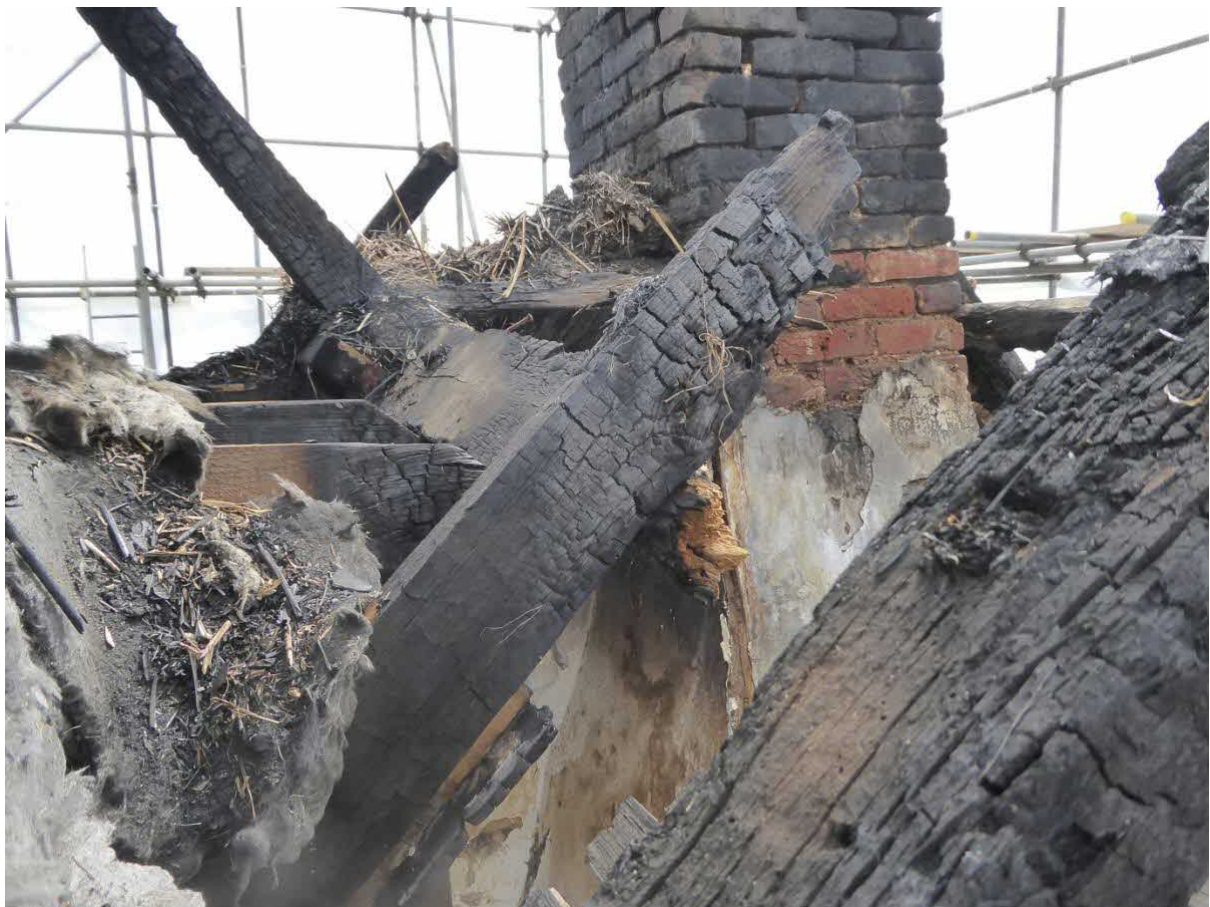
**Figure 18:** Small section of roof above landing/stair

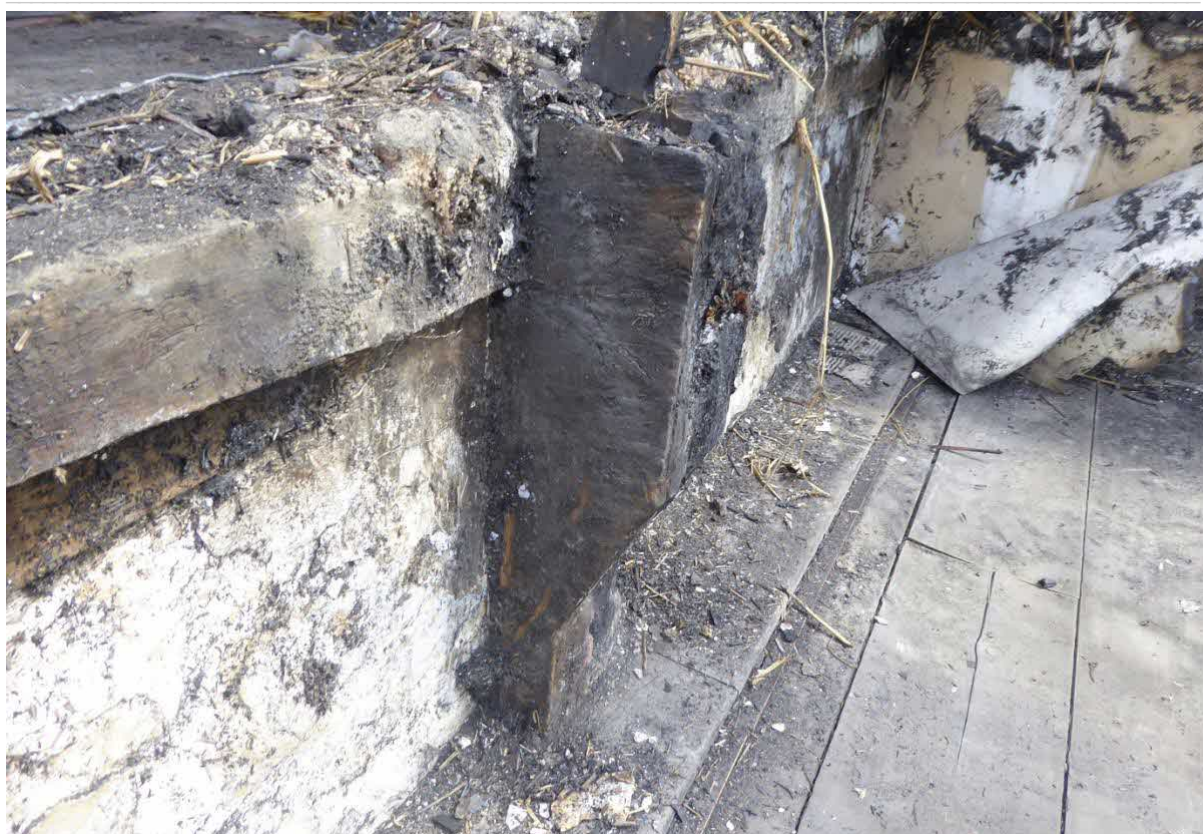
**Figure 19:** Jowled post to north side of Room F1

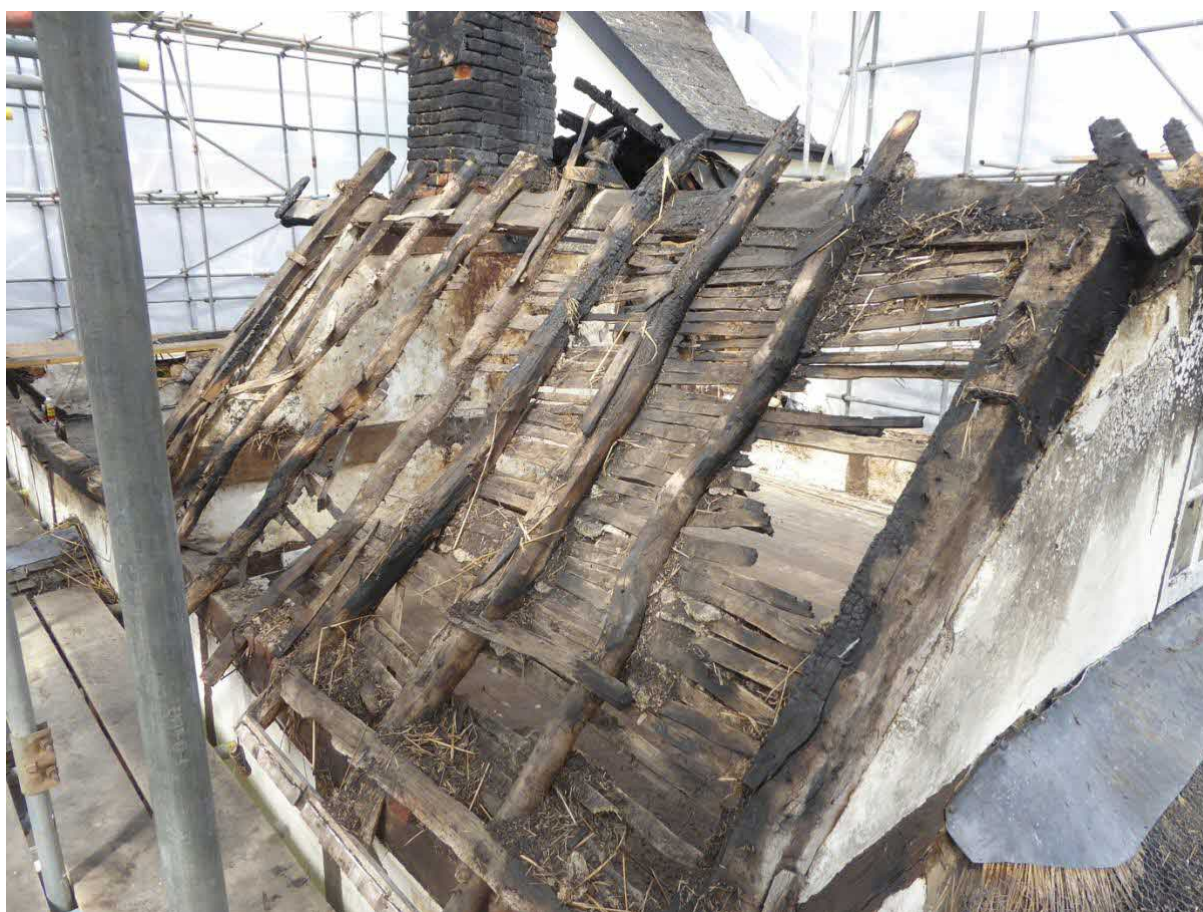
- 4.19 Room F2 has some survival of roof structure to its south elevation (**Figure 20 Appendix D**). This comprises pole rafters which have been pegged to the purlin. To the underside there is some survival of riven chestnut lath.

**Figure 20:** Room F2 -surviving section of roof
