#### CHURCH OF ST PETER AND ST PAUL OSBOURNBY

## Statement of Significance – Major projects

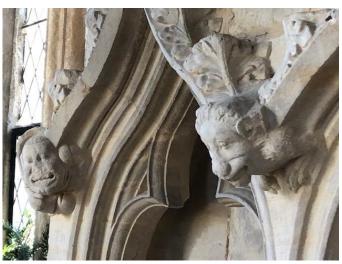
**The south aisle porch** is faced with a mesh gate for bird prevention purposes. The C14 gabled south porch has a moulded triple engaged shafted outer doorway with annular impost and double chamfered arch, with setback gabled buttresses. This leads into the main porch area which contains the significant four bay nave arcades comprised of moulded columnettes with stone seats on both sides, embellished with stone carved heads, ogee arches and cusp tops with finials.

The central church entrance is through a triangular headed early C18 four panelled oak door.

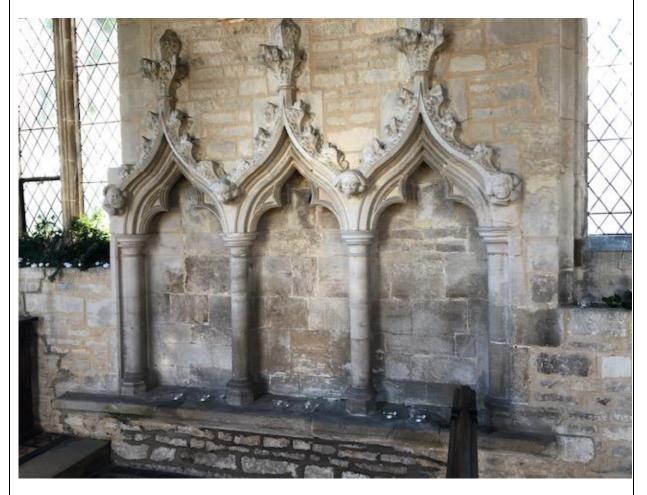
Within the sanctuary area, the chancel south wall features a sedilia of medium / high significance with ogee topped arches with foliate carvings and finials and human head figurative details above each column and respond. The sedilia is comprised of columnettes and end carvery responds with a clergy bench seat, similar to the arcading in the porch, but more elaborately designed. There are three windows, each two lights wide with early English style tracery. There is also a priest door, currently partially blocked by the choir stalls.

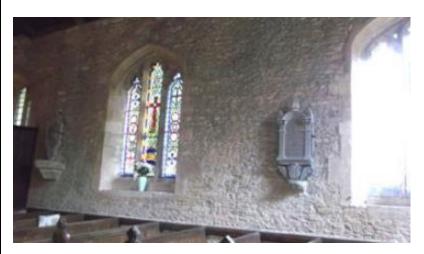
A number of fine monuments are featured on the north and south aisle walls dating from the 1720s. There is also a fine and unusual painted stone wall plaque. More specifically, in the north aisle between the central window and the window within the vestry there is a fine early wall monument dated 1720. The bottom of the plaque has a figurative detail, which is partially concealed and set within a carved stone corbel, which looks fairly early in date and appears to be the top of a capital or a respond to an arcade or arch.

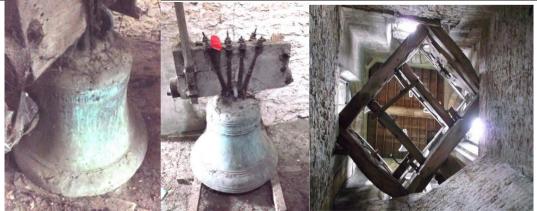
The west tower retains three bells; none of which are currently being used due to the lack of a belfry floor. There is a mediaeval bell frame mounted diagonally in the tower with 3 bell pits. The bell frame is in a poor condition and the bells have been removed and mounted on the intermediate chamber floor as a temporary measure. There is currently a loudspeaker bell system.
