WELLOW WOOD COTTAGE, WELLOW WOOD  
ROAD, WEST WELLOW, SO51 6EP

**HERITAGE APPRAISAL**

An assessment of surviving historic fabric at Wellow Wood Cottage, a Grade II listed building partially destroyed by fire in March 2023.

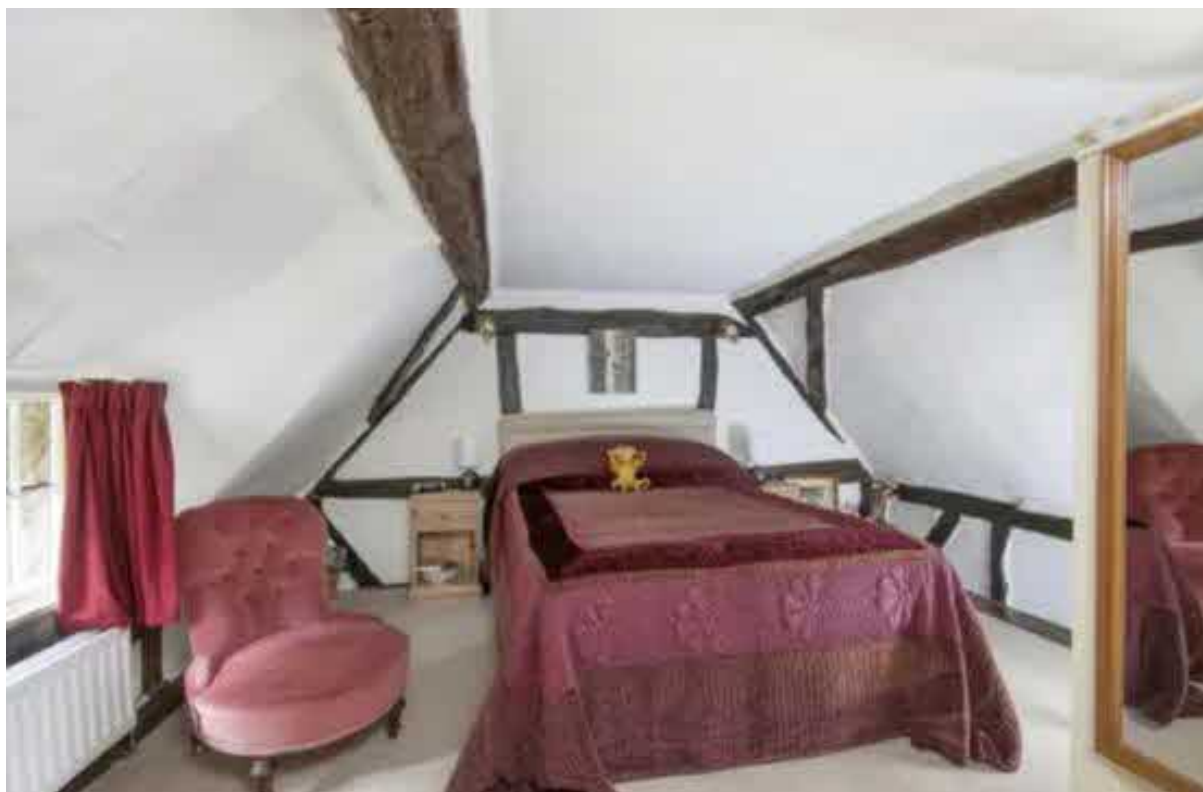
Figure HP6: Room F1 prior to fire (sales particulars cXXXX?)

- 4.18 There is a jowled post to the centre of the rear wall which survives along with its tenon (**Figure 19 Appendix D**). This does not correspond to a post to the front elevation (although this has been altered) and is probably a re-used timber (incorporated into the box framing of the present house). Photographs of this room prior to the fire (see **Figure HP6 Appendix C**) do not show a principal rafter in this location.

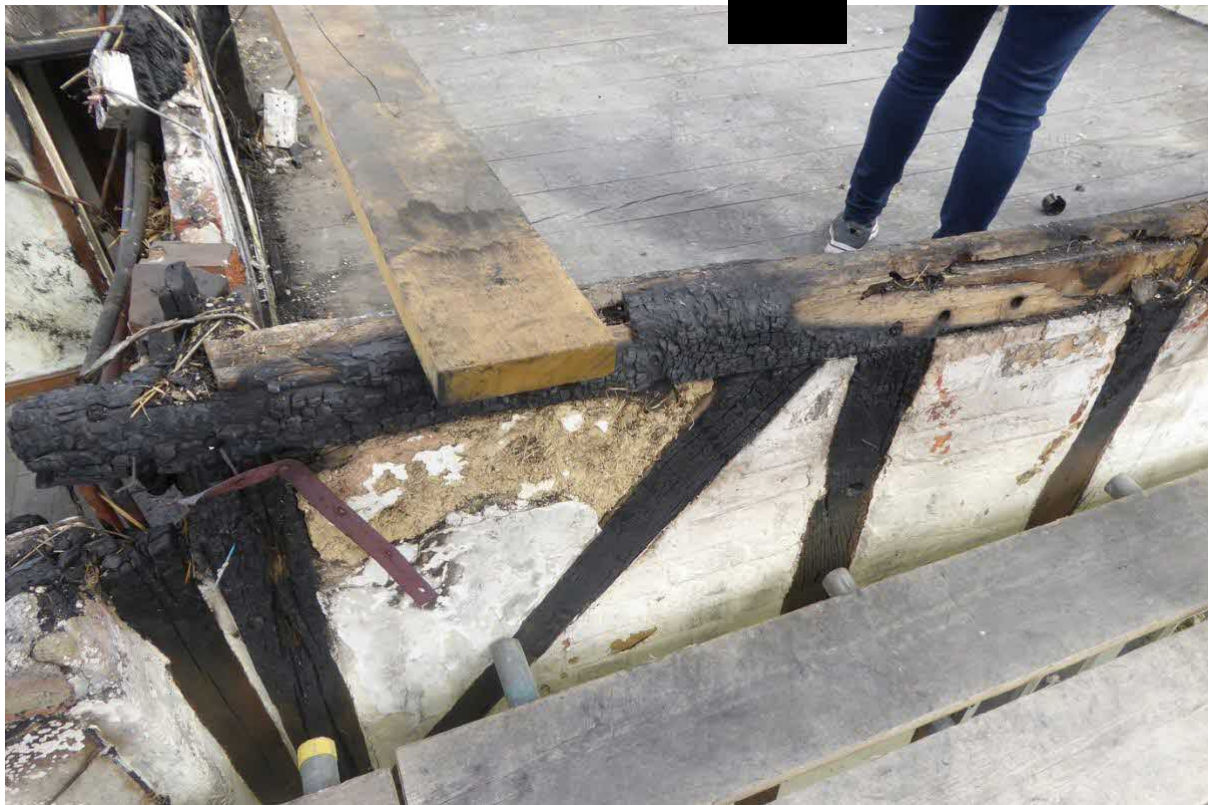
**Figure 1:** Surviving panels of wattle and daub- first floor, south elevation

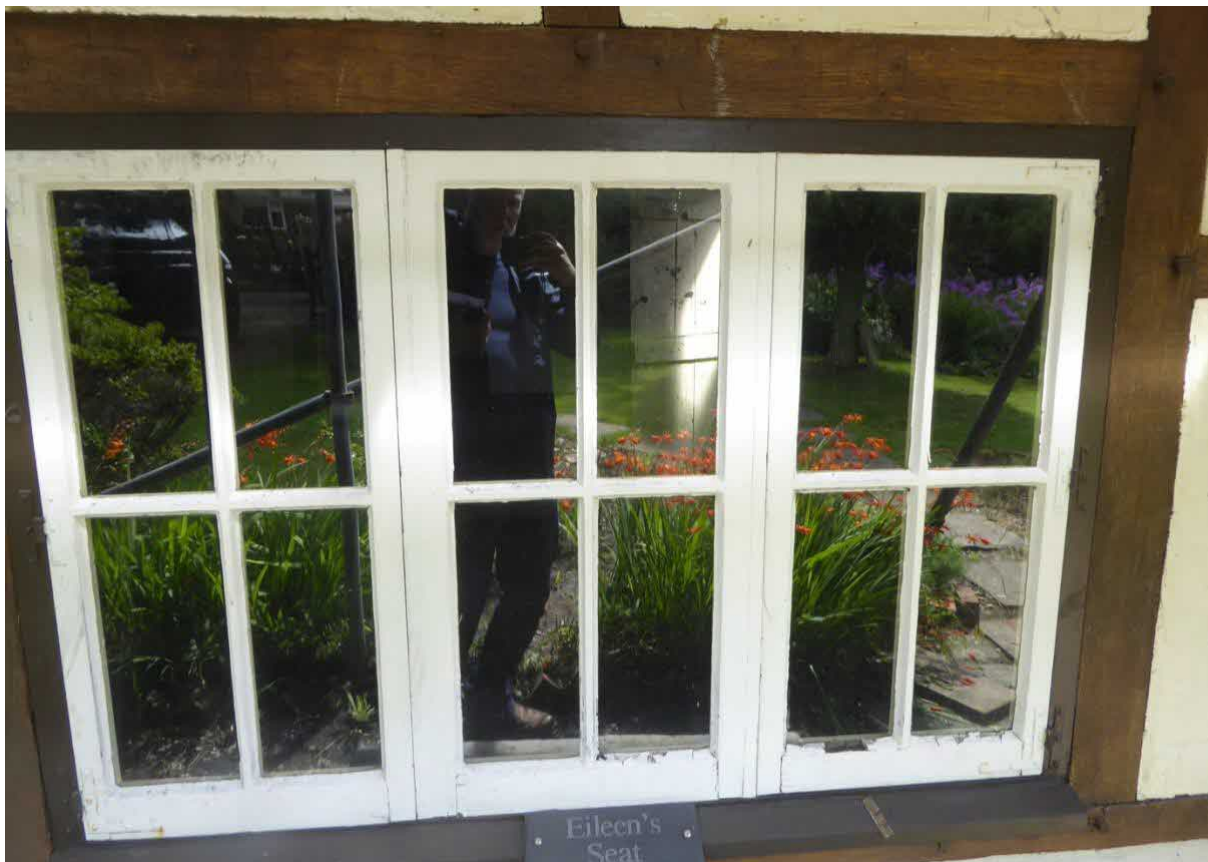
**Figure 2:** Window W2 – part of c2000 restoration works

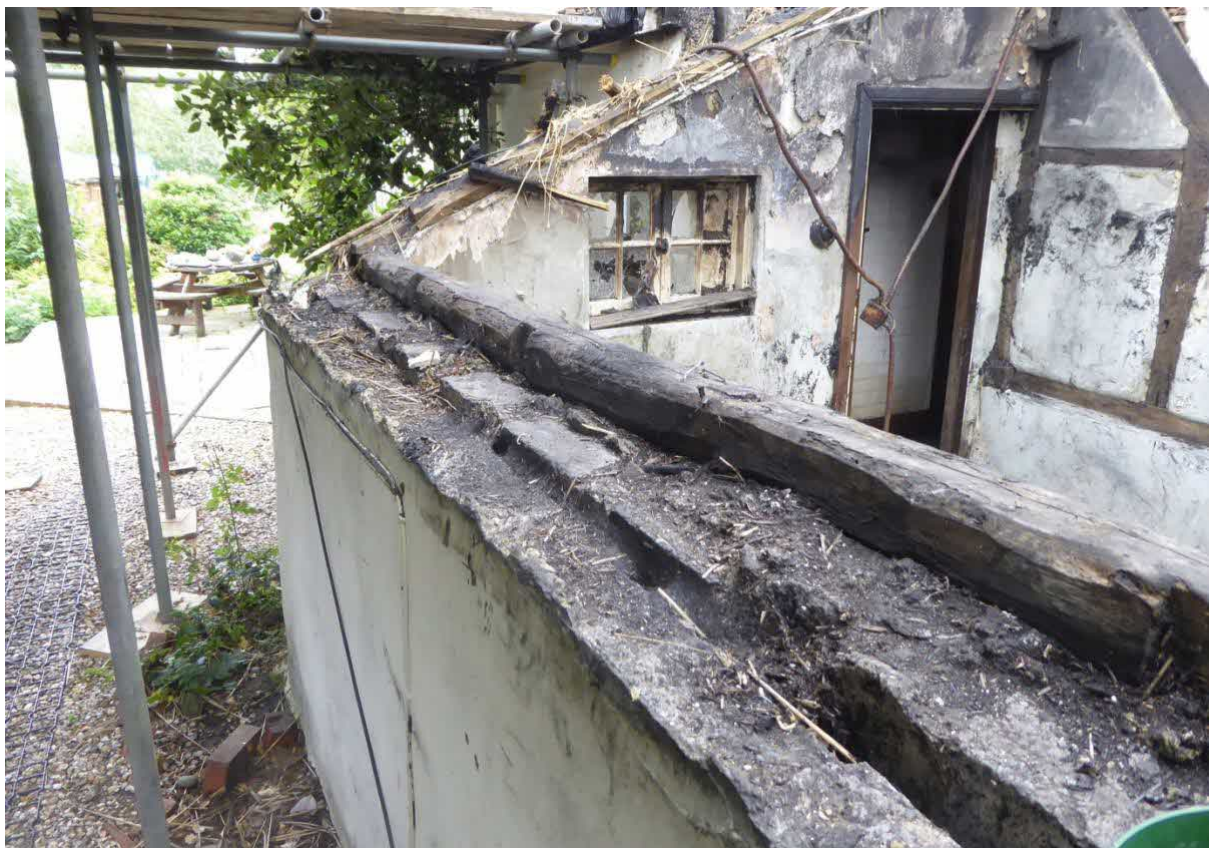
- 4.1 The list description at **Appendix E** provides a summary description of the south elevation of the building.
- 4.2 The following is a detailed description of the surviving fabric of the building.
- 4.3 The external elevations comprise small box framing with straight braces with brick infill panels. Most infill panels are replacement for earlier wattle and daub. Some wattle and daub panels exist at first floor (**Figure 1 Appendix D**). Major framing and remodelling of the fenestration was undertaken around Window W2 (**Figure 2 Appendix D**). The window replaced a bay c1970s bay window in c2000.
- 4.4 The original two room lobby entry plan was extended to the west between 1870 and 1896. However, the extension appears to have been rebuilt probably some time in the early 20<sup>th</sup> century as it is now in cavity wall construction (**Figure 3 Appendix D**)

**Figure 3:** Cavity wall to west wall of ground floor extension to west

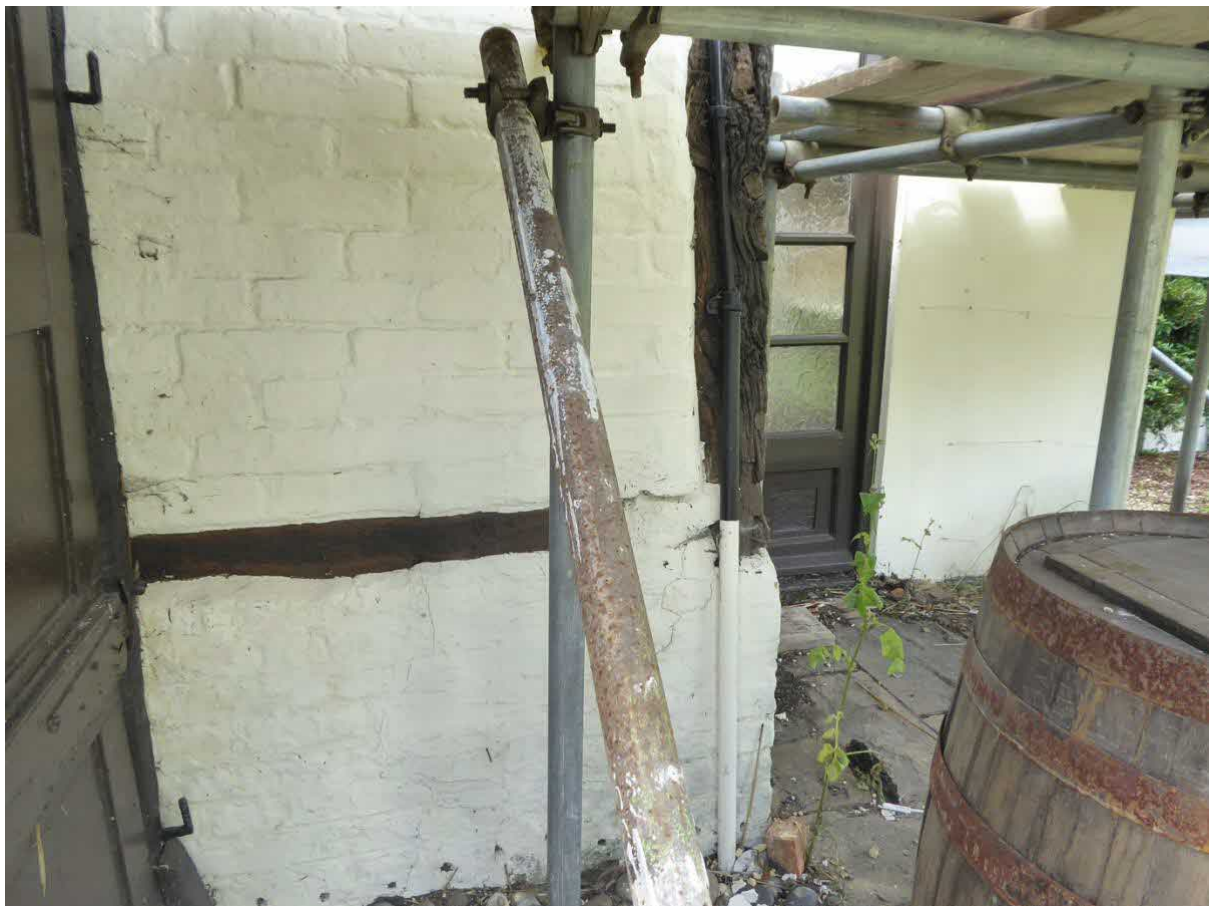
- 4.5 There is a small outshut rendered cavity blockwork extension to the rear separate to the 1970s enlargement which dates to the mid 20<sup>th</sup> century (**Figure 4 Appendix D**). There is a further small store to the east elevation which is late 19<sup>th</sup>/early 20<sup>th</sup> century in date and thatched (**Figures 5 and 6 Appendix D**).
- 4.6 The roof prior to the fire was multi-layered wheat straw thatch with the most recent spar coat applied c2000.
- 4.7 The main front entrance door is vertical boarded unpainted oak and dates from the c2000 'restoration' project.

**Figure 4:** Mid 20<sup>th</sup> century outshut to rear

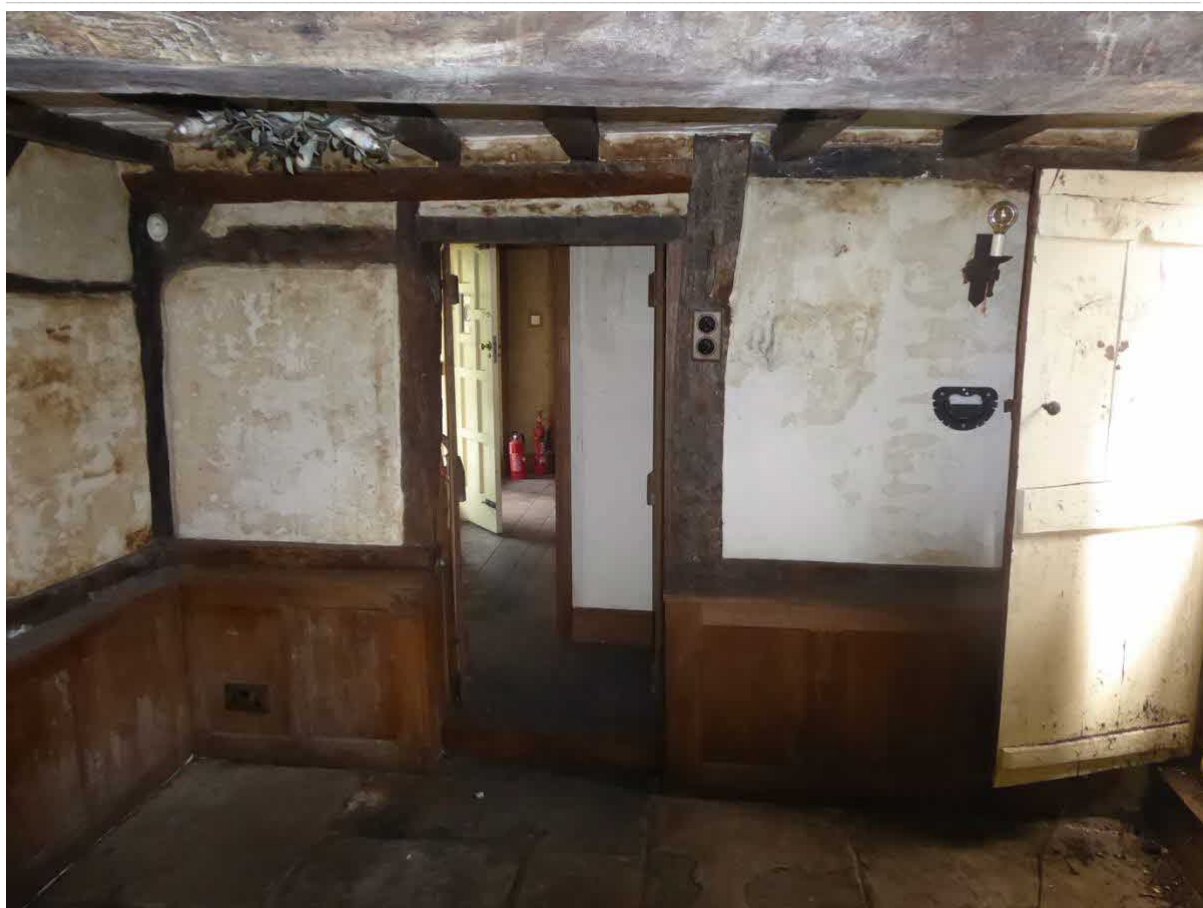
- 4.8 The main entrance (lobby entry) gives access to two rooms either side of the principal central stack. Room G1 has a modern stone flag floor and c2000 oak panelling up to dado rail (**Figure 7 Appendix D**). There is exposed framing to the west wall (formerly the external wall now internal between G1 and G3) (**Figure 8 Appendix D**). Of note is the fact that none of the braces or intermediate members of the framing is pegged. Only the central post is pegged. This would suggest that this may be later framing.

**Figure 7:** Oak panelling to dado rail part of c2000 'restoration'

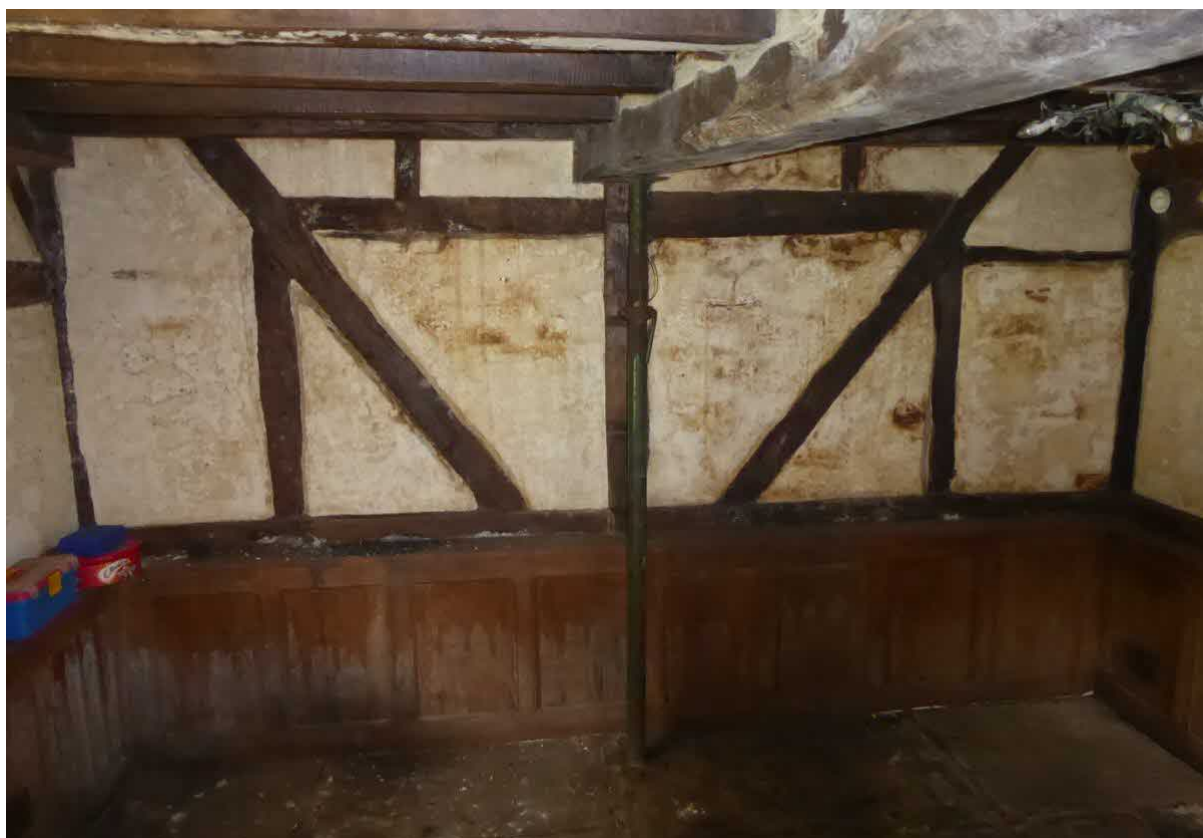
**Figure 8:** Room G1 – framing to west wall (now internal wall with G3)

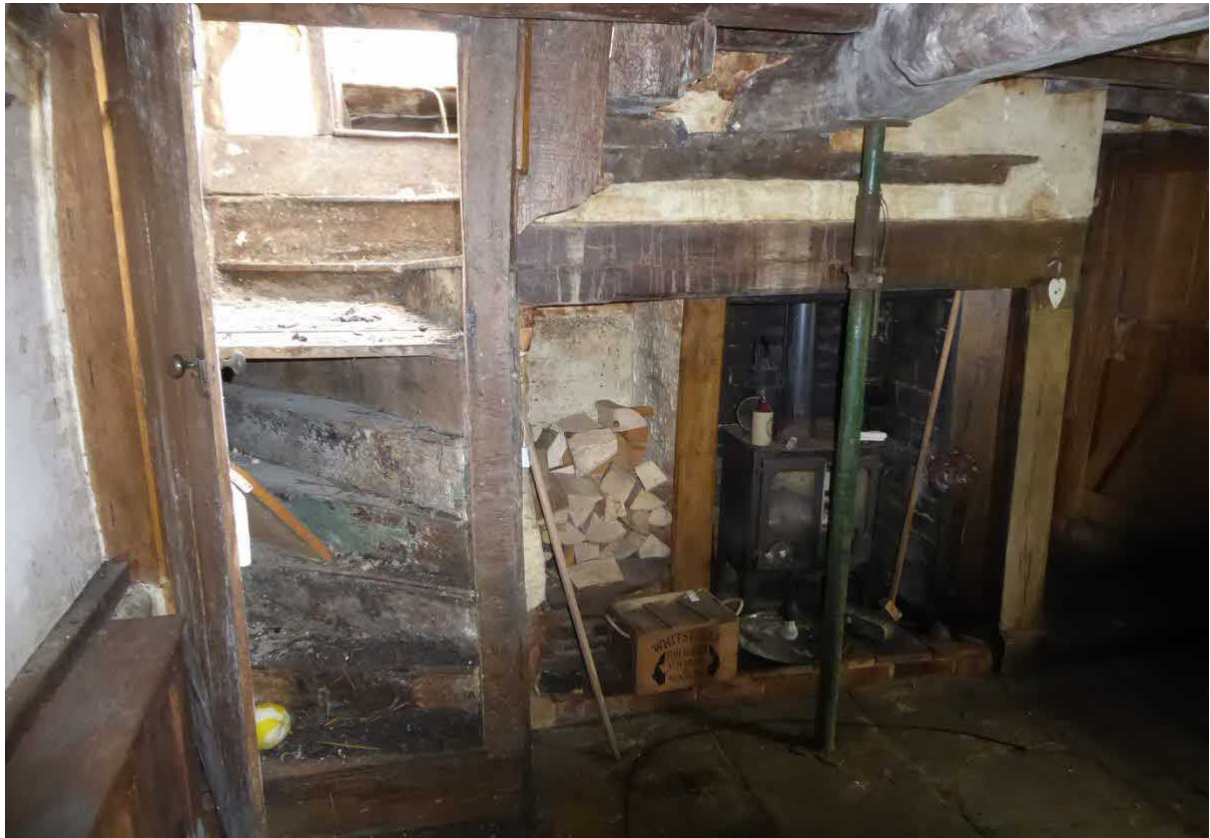
- 4.9 There is a fireplace (F1) (**Figure 9 Appendix D**) to the east wall. This has a chamfered bressummer beam which it is suspected formed part of the c2000 restoration work. Above this there is the survival of the former bressummer beam to a much larger (former) opening. The spine beam to the room sits on top of this. To the north of the fireplace there is what is probably an 18<sup>th</sup> century staircase but in the original staircase position for the house.

- 4.16 The first floor is now accessed via a 1970s link to the rear extension which includes a modern staircase. The existing stair to the earlier range has been floored at first floor to create a landing with the 1970s link (see **Figure 9 Appendix D**).

**Figure 9:** Room G1 – fireplace and staircase (floored at first floor)

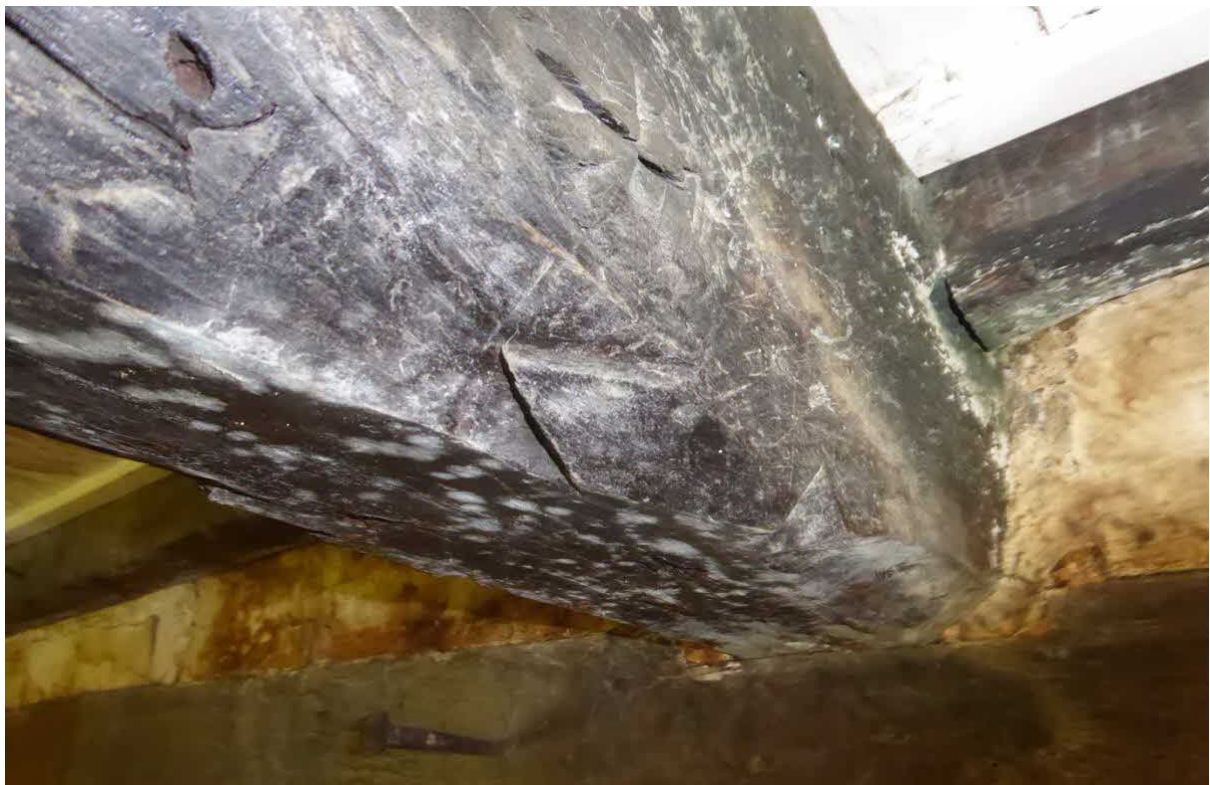
- 4.10 The spine beam to the room is stop chamfered at both ends with a distinctive jewel or spear stop (**Figure 10 Appendix D**). The beam also has a very unusual kink to its eastern end. There are exposed joists tenoned into the beam (these appear to be original).

**Figure 10:** Chamfered stop to spine beam, Room G1 – early 17<sup>th</sup> century

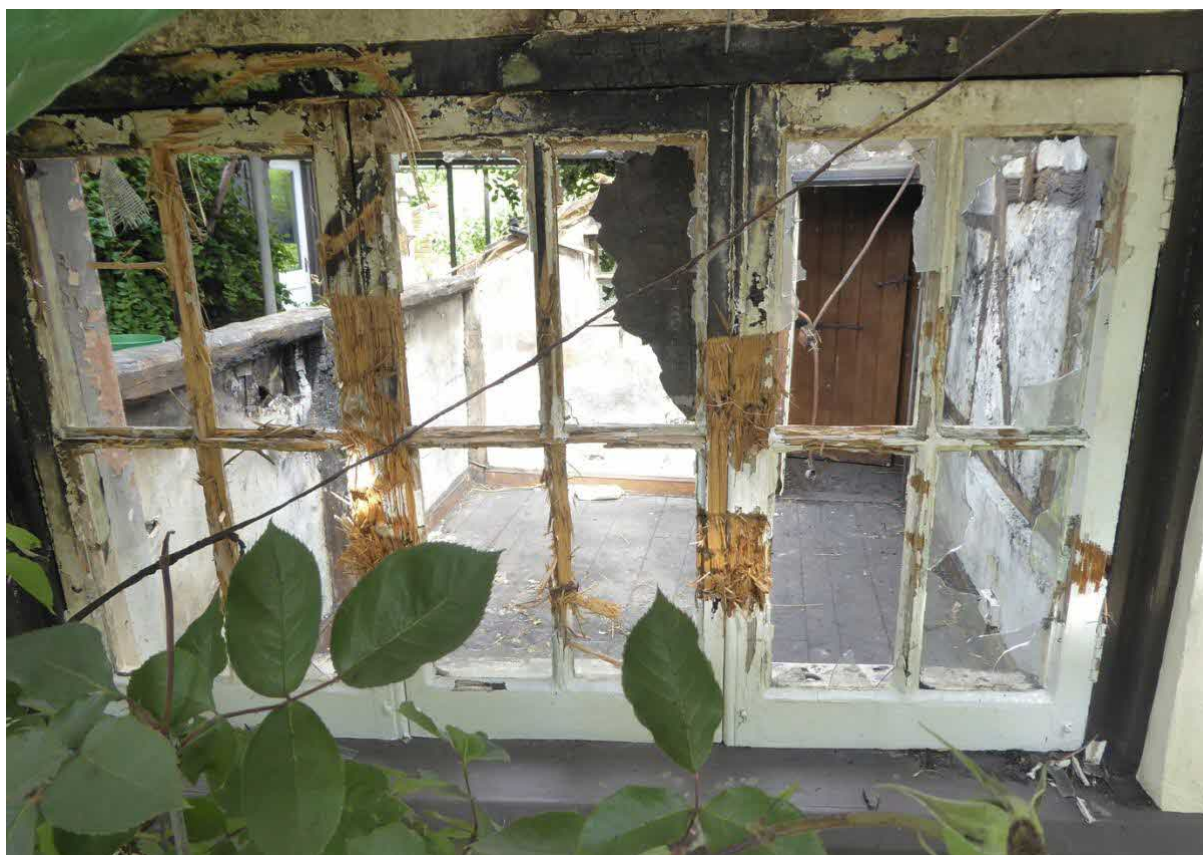
**Figure 14:** Window W1 (external view)

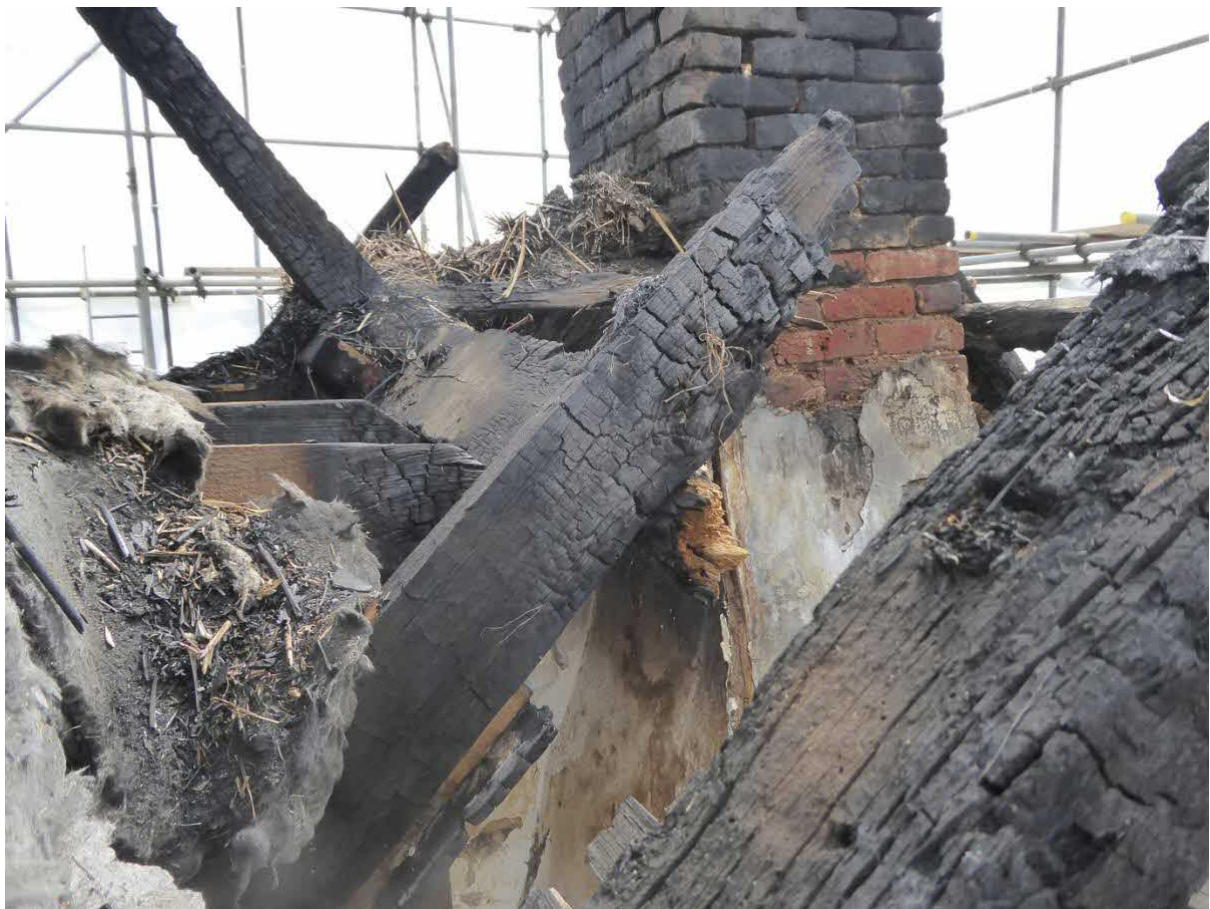
**Figure 18:** Small section of roof above landing/stair

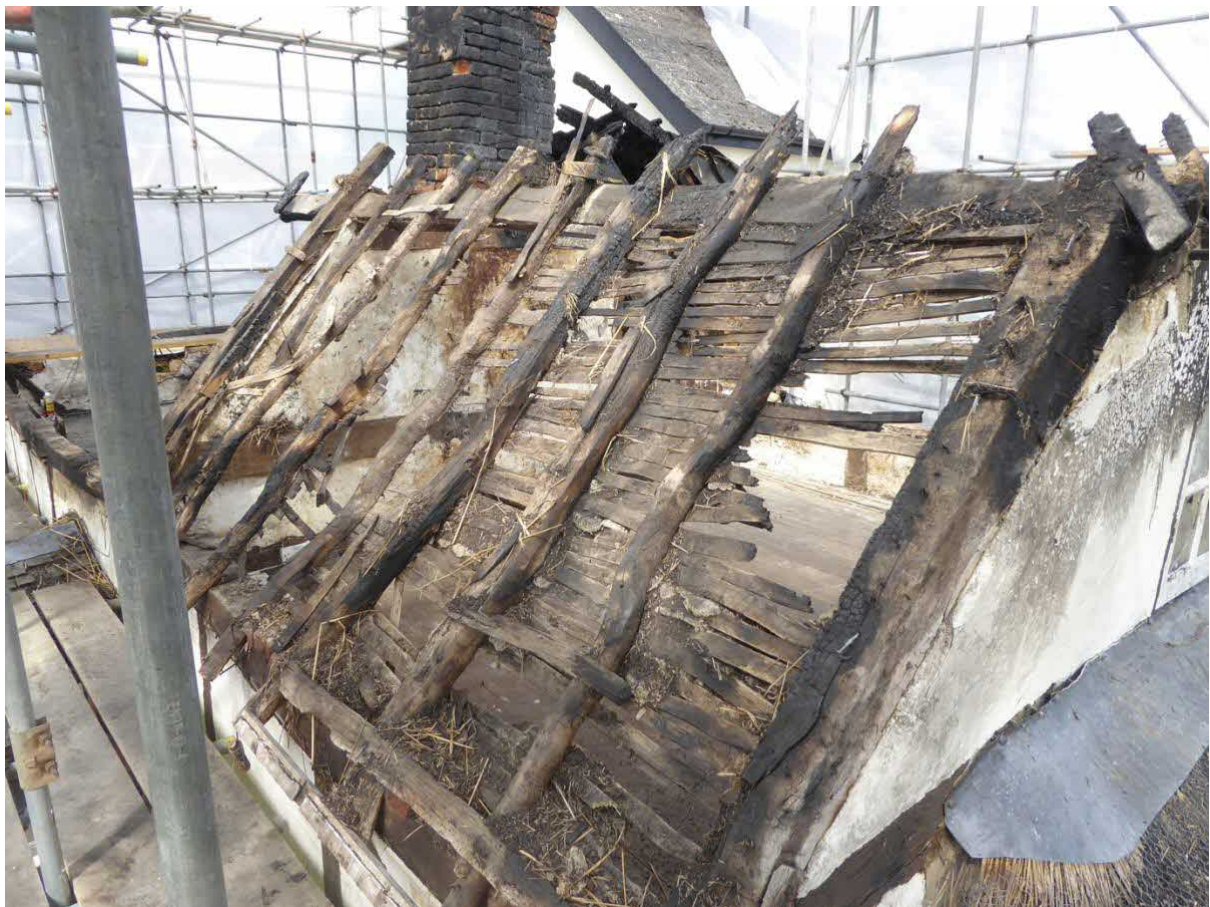
- 4.19 Room F2 has some survival of roof structure to its south elevation (**Figure 20 Appendix D**). This comprises pole rafters which have been pegged to the purlin. To the underside there is some survival of riven chestnut lath.

**Figure 20:** Room F2 -surviving section of roof
