cornwall  
environmental  
consultants LTD

Bat and Barn Owl Assessment  
8 Prospect Close  
Ashton  
Helston  
TR13 9RS

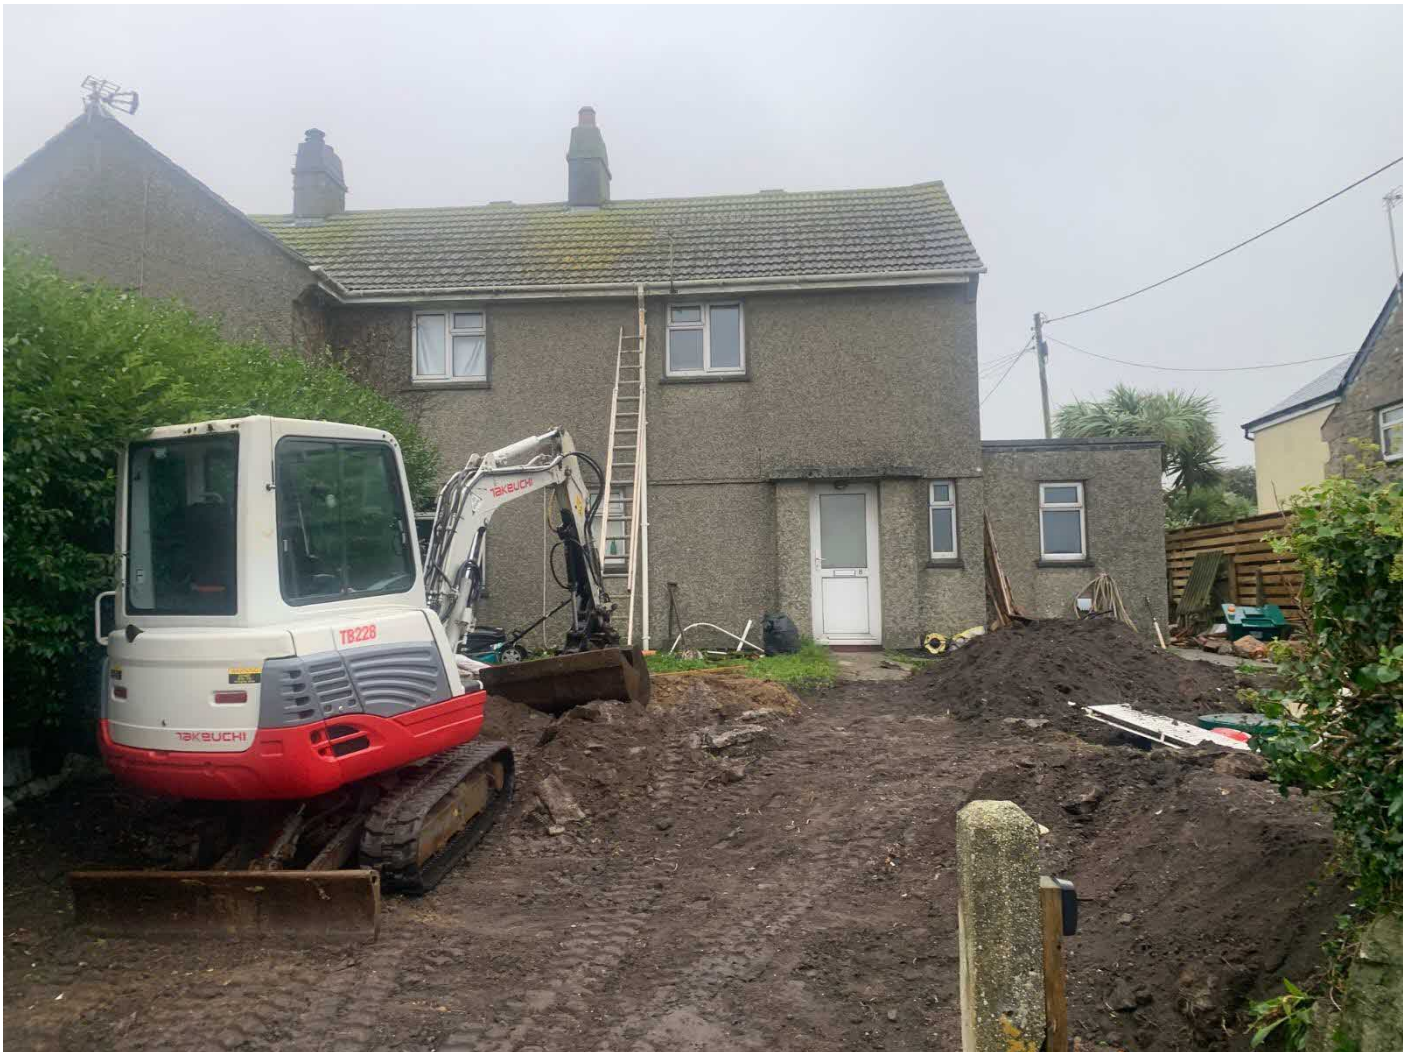
*Figure 1: Eastern elevation of property assessed*

The property is a two storey, semi-detached residential house with a single storey extension on the northern elevation. The building is constructed from rendered cavity block wall, a concrete tile roof underlined with bitumen felt, two vents in the ridge tiles and vented UPVC soffits. The single storey extension has a pitched roof constructed from corrugated cement fibre board with a wooden fascia on the western elevation.

Externally the roof and soffits are well sealed with no gaps seen that would allow access to bats. The ridge tile on the northern gable end appears lipped but closer inspection with a ladder confirmed it was well sealed. The underside of the corrugated roof on the single storey extension is sealed and no access could be found on this section of the building. The walls, windowsills and floor around the exterior of the property were checked for signs of bats.

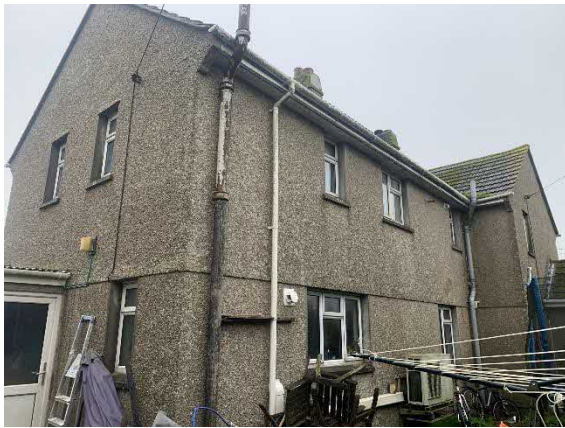
*Figure 2: Western elevation*

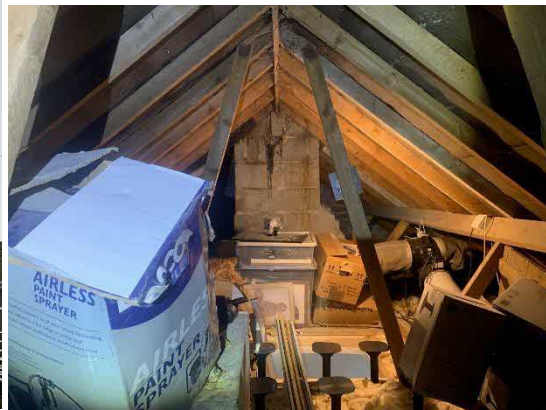
Internally the loft space uses mineral wool insulation on the floor and is used for storage. The floor, insulation, gable ends and rafters were all searched for signs of bats, as well as under a damaged section of bitumen felt towards the northern elevation.

No evidence of bats was found on the property at the time of the assessment.

*Figure 3: Loft interior*
