**GEO-ENVIRONMENTAL AND GEOTECHNICAL
DESK STUDY AND SITE INVESTIGATION
REPORT**

**BARN AT DUCK END FARM
GREEN ROAD
LINDSELL
DUNMOW
CM6 3QH**

**Reference Number 3293/Rpt 1v1
July 2023**

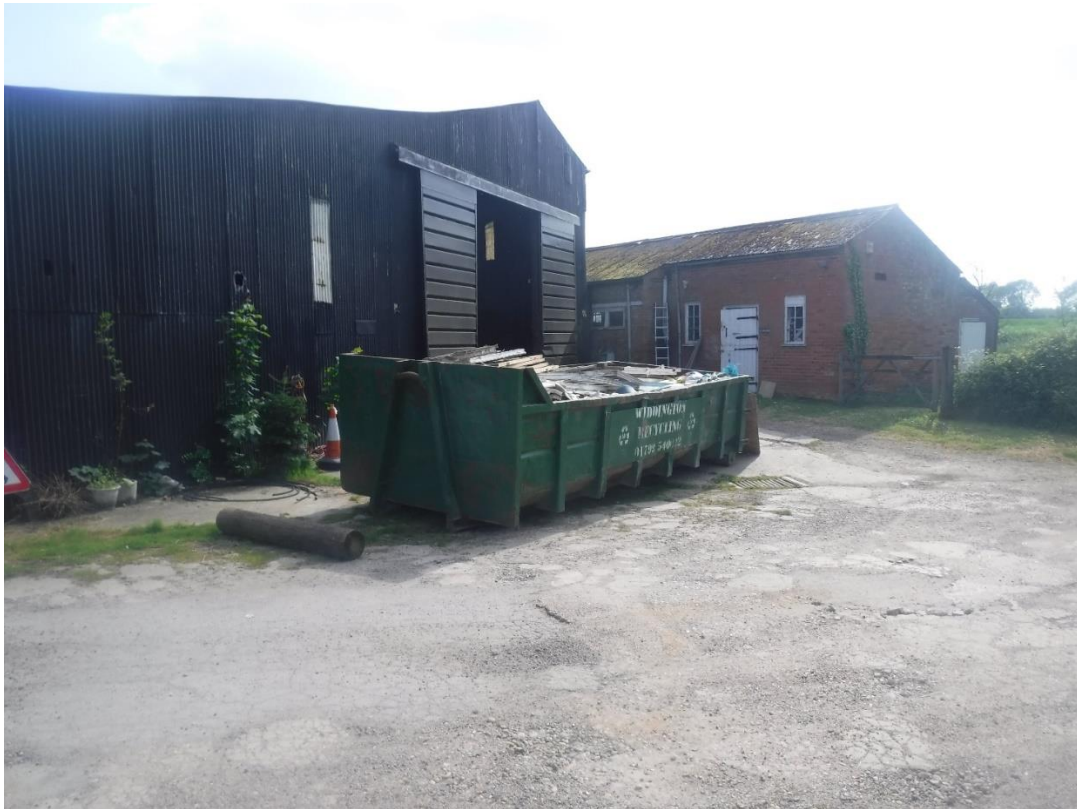
During the inspection materials suspected to contain asbestos were noted within the construction of the barns. No fragments were noted across the ground surface.

Northern end of barn

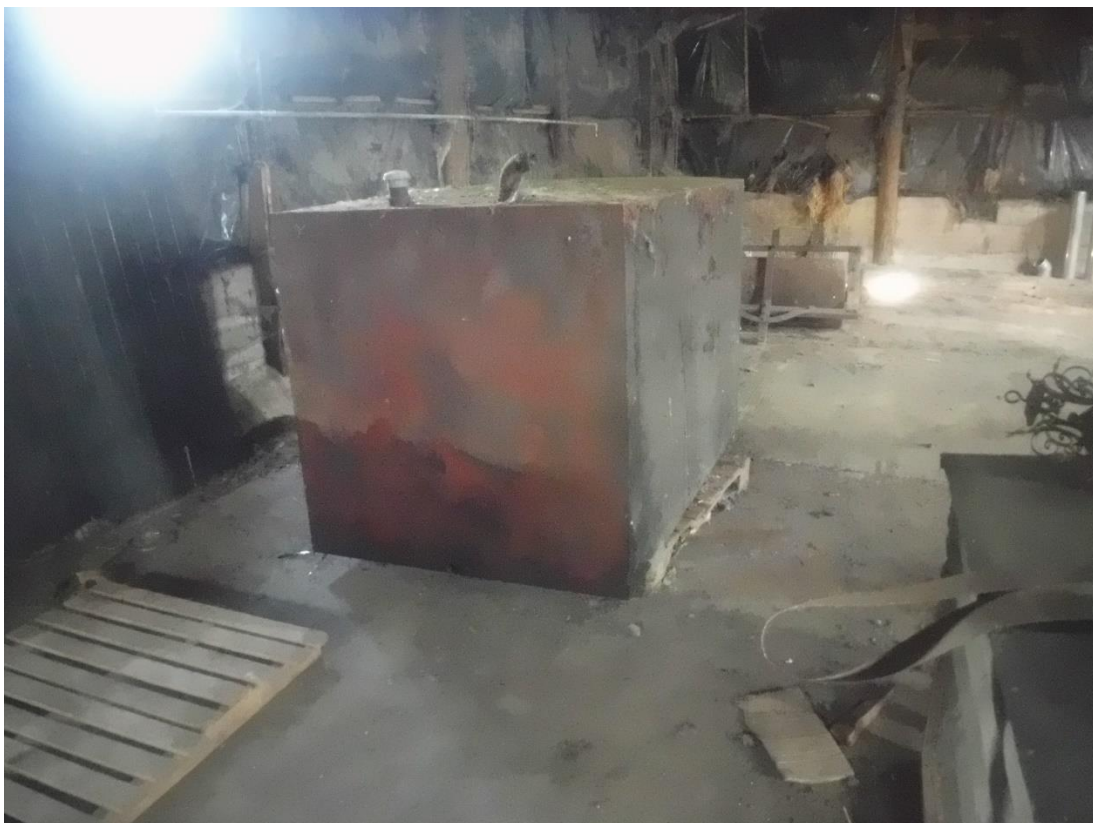
Two above ground storage tanks (ASTs) were observed at the site. These being a decommissioned tank that was being stored in the large barn and an empty tank that was located adjacent to the

Tank stored in barn

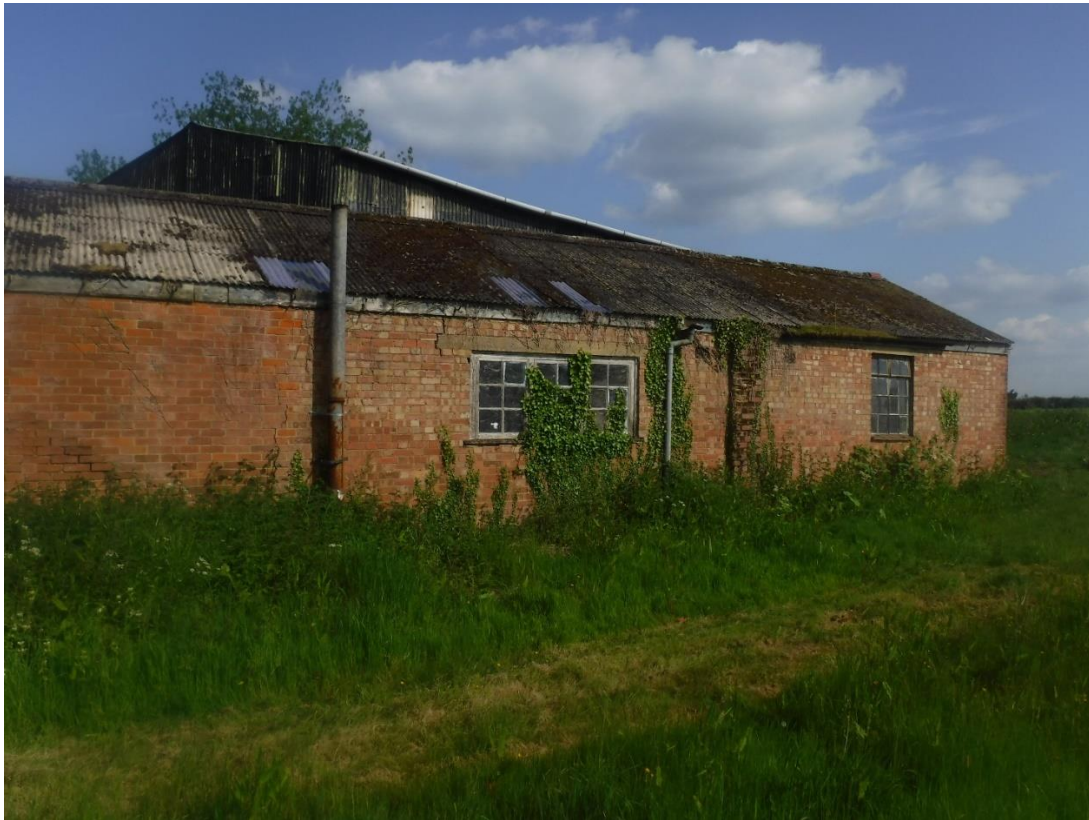
Barn in north west corner.

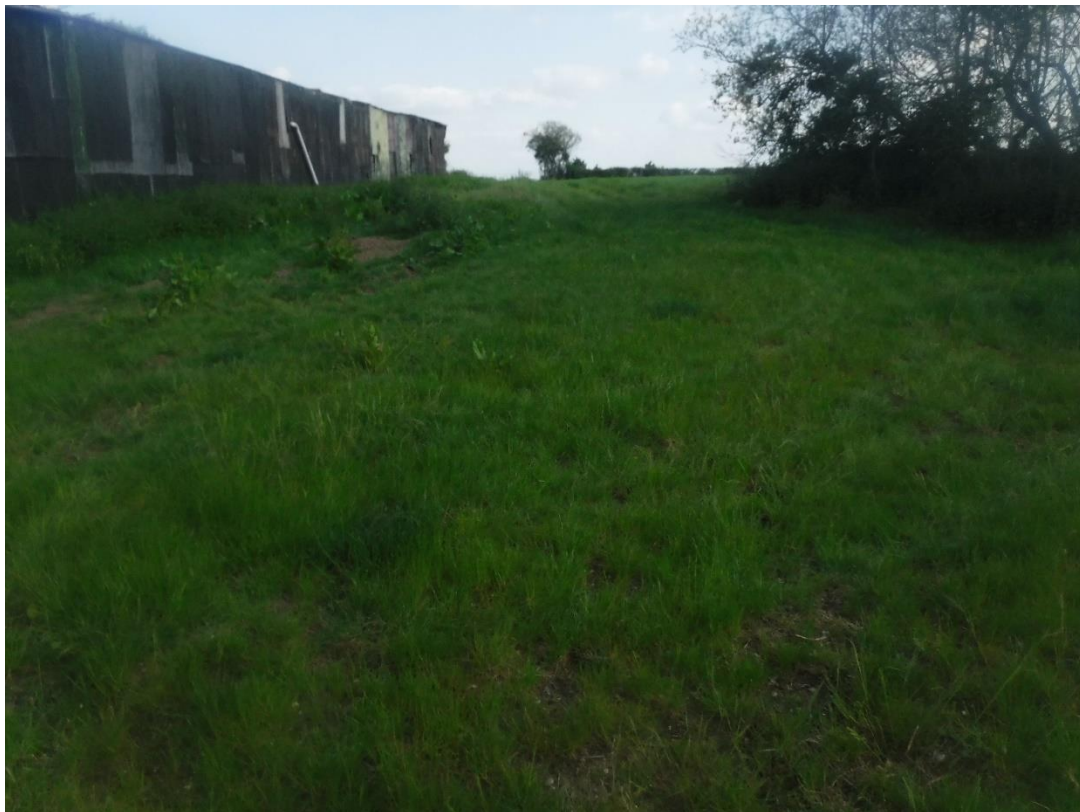
- General quality of the made ground and stockpiles.
- Historical use of the site for agricultural activities. Barn used for the storage of machinery and grain storage. No agrichemical storage noted.
- Storage and use of fuel in above ground storage tank.
- Backfilled pond.

Area of backfilled pond

To mitigate the risk posed by the presence of PAHs within the made ground used to backfill the pond, it is recommended that remediation should be undertaken. In summary, the remediation should consist of the removal of the made ground to a maximum depth of 600mm below finished garden level and the placement of clean suitable top and sub soil. The placement of the clean soil will act as a capping layer to break the pollution linkages.

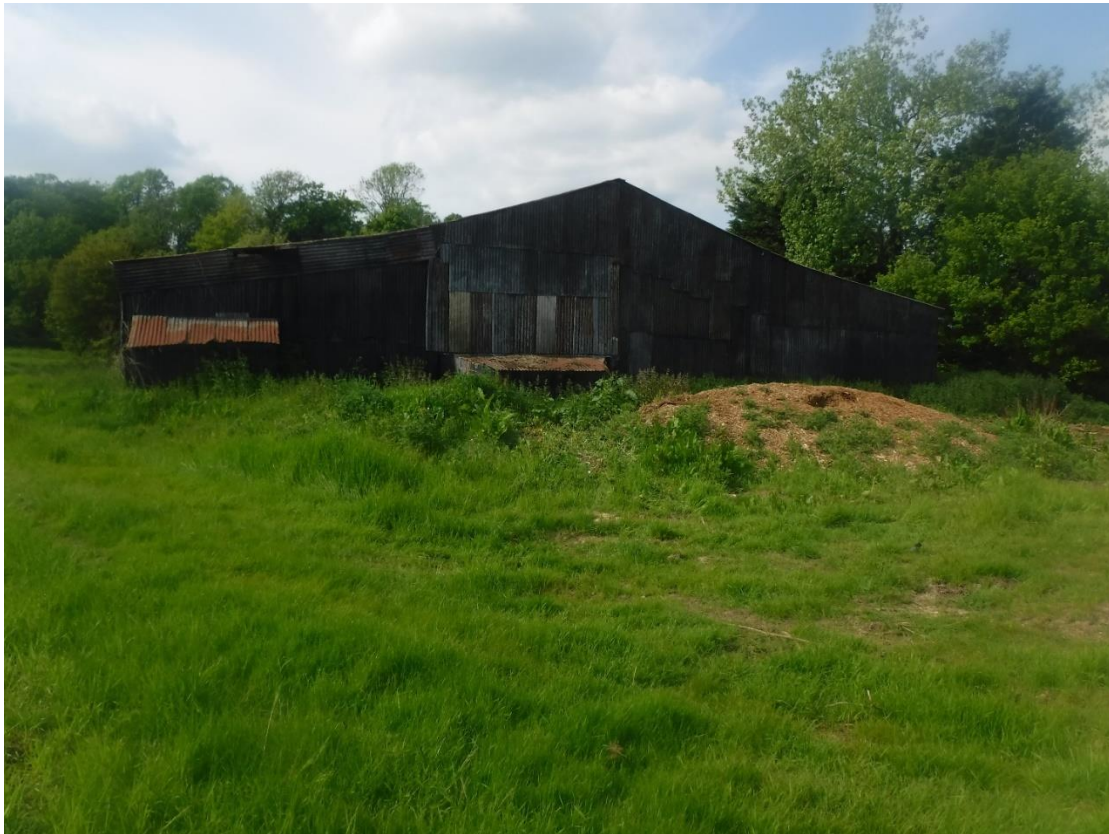
Southern end of barn with stockpile of wood chippings

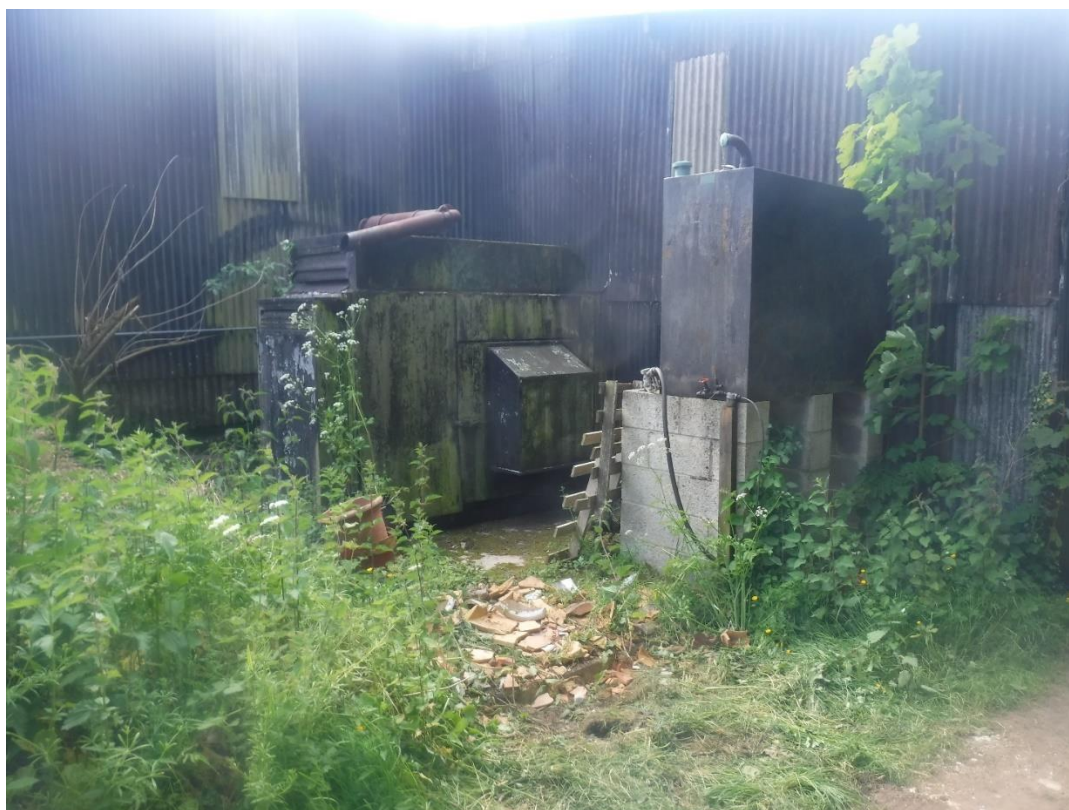
Above ground storage tank and grain dryer unit.
