PHASE 2 BAT ACTIVITY SURVEY

THE CHAINS, MUNSLOW

Project name: The Chains, Munslow
Date: 15/08/2023
Prepared by: William Prestwood BSc Director
Reviewed by: Phillipa Stirling MSc ACIEEM
Requested by: Simon Brandwood

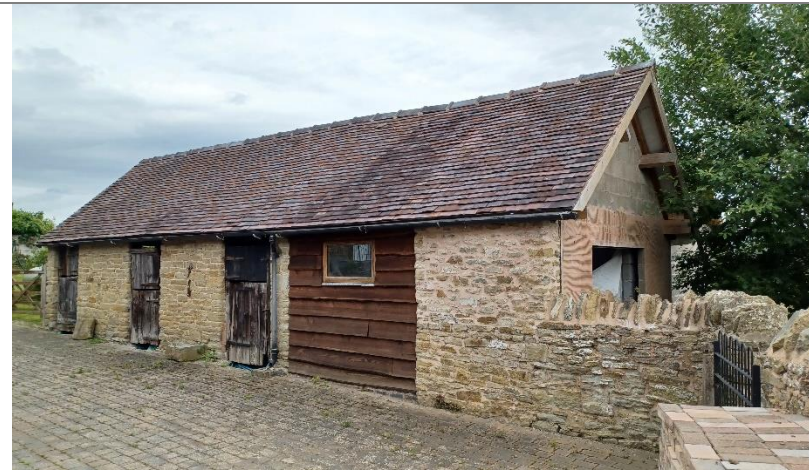
The outbuilding is a former block of stables. The single storey building is constructed from local limestone rubble. The tiled roof was repaired and restored in 2022 with partially new timber framing and new membrane roof lining. Adjacent to this is a recently completed garage block constructed from concrete breeze blocks.

FORMER STABLE BLOCK

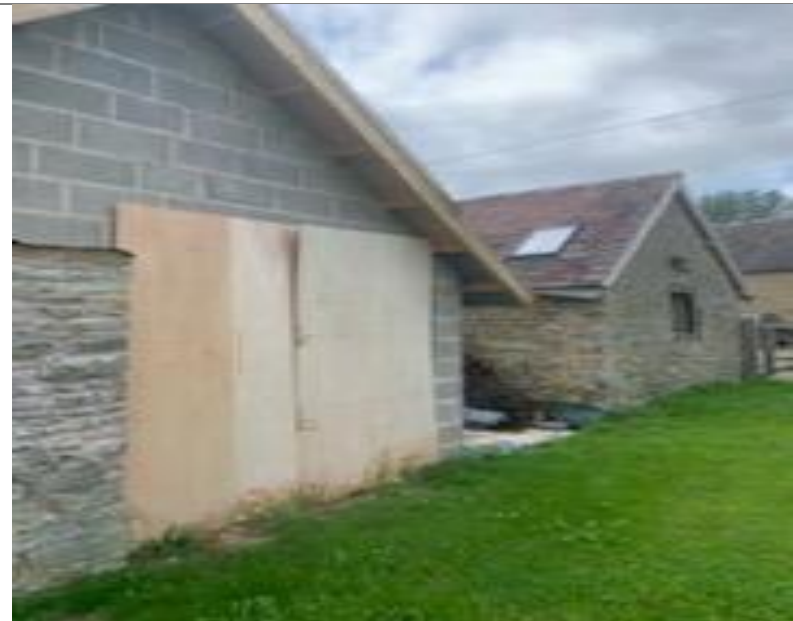
GABLE END OF RECENT GARAGE AND STABLE BLOCK BEYOND

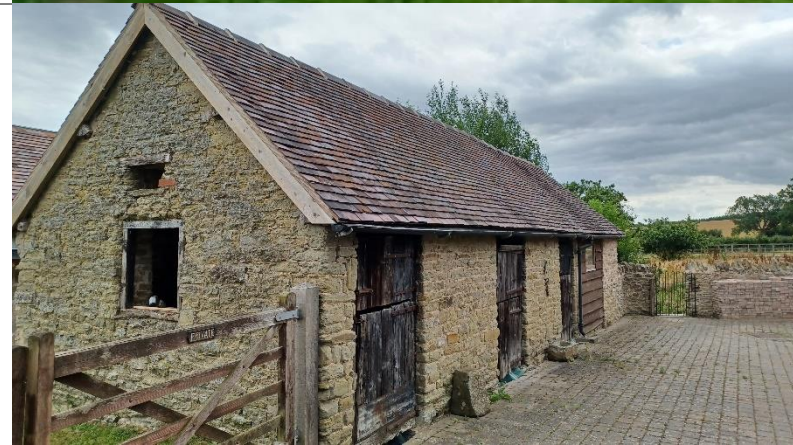
STABLE BLOCK

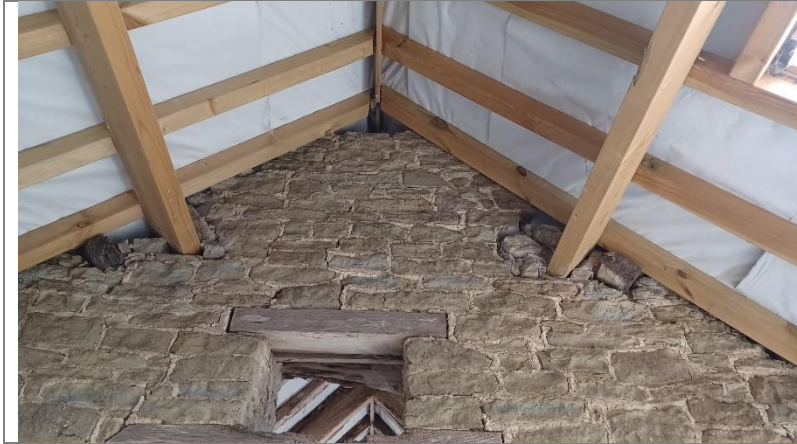
One pair of swallows was found to be nesting above the timber frame supporting the roof.

INTERNAL OF STABLE BLOCK
SHOWING REPAIRED ROOF
STRUCTURE

The proposals will result in the loss of a swallow nest site and appropriate mitigation will be required. This will comprise the installation of artificial nest ledges/ swallow cups inside another structure on the property. The siting will be discussed with the project ecologist.
