PHASE 2 BAT ACTIVITY SURVEY

TREWERN ISAF

Project name: Trewern Isaf, Nant, SY10 0DD

Date: 18/08/2023

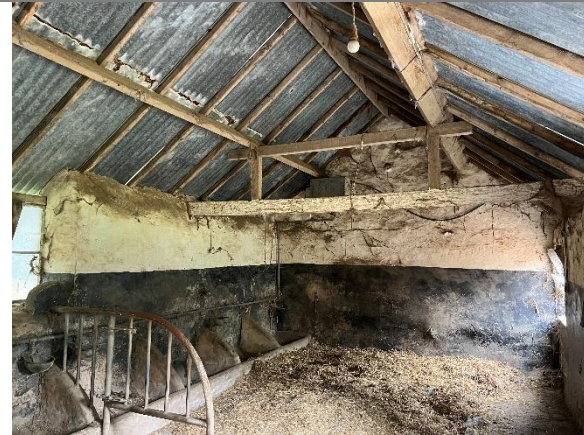
The internal space and undercrofts were closely searched for evidence of bats. No droppings were found and there was no evidence of feeding signs. Overall, the structure was assessed as providing 'low' suitability as a bat roost due to open access into the space and a small number of crevice roost features.

Internal of main agricultural building.

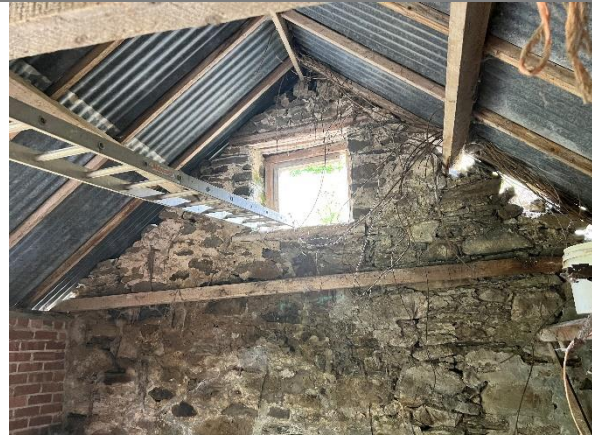
Notably, the north facing gable is built into the adjacent bank. Open apertures are present all around the building allowing entry points to the internal space.

Window present on the northern gable of the main building.

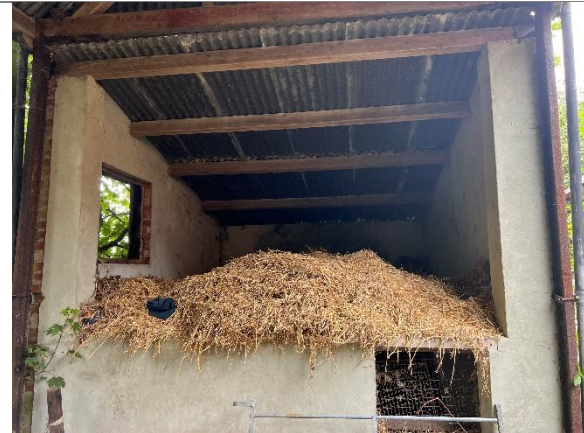
A single-storey timber frame shelter is present adjoined to the eastern elevation of the main building. Additionally, the lean-to roof is constructed from tin and the shelter is open at the north and east elevations.

The internal static detectors were placed in both the main building and the lean-to shelter present at the eastern elevation. The detector in the open-sided shelter recorded a brief common pipistrelle echolocation call at 21:10. However, as no emergences were recorded from the building in question, it is likely that the individual is roosting locally and its calls were recorded as it flew past the building.

Lean-to shelter adjoined to the east of the main building.

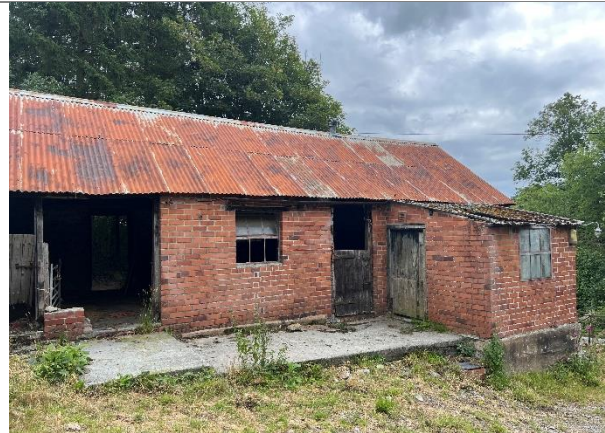
A small adjoined red brick section is present at the western elevation. The roof made from fiber-cement but is in very bad condition with a large opening.

Western elevation of the main building.

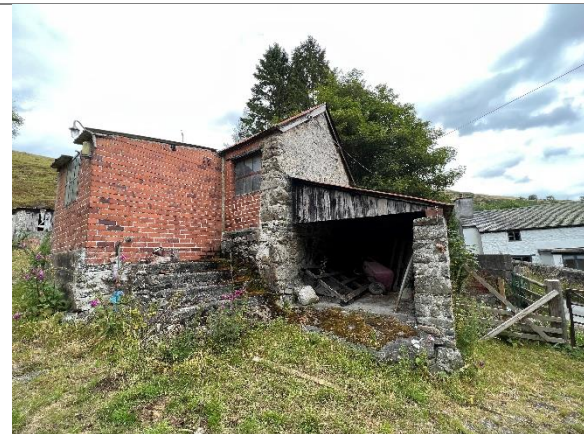
Finally, a stone constructed section is adjoined at the south facing gable-end of the main building. The roof is a lean-to design, the frame is timber and the roof paneling is tin.

Southern elevation with view of lean-to garage section.

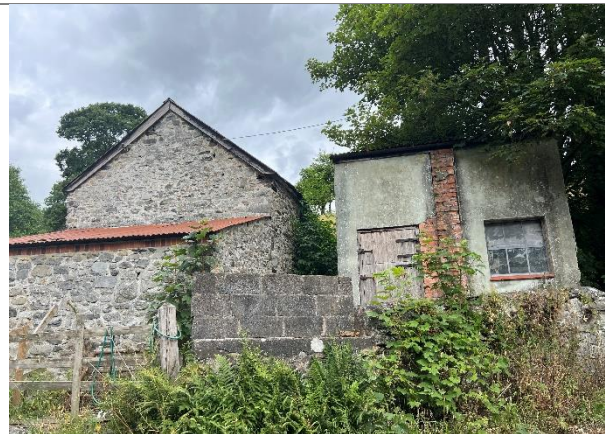
South-facing gable end of building.

- One woodcrete bat box to be installed on the gable end of the converted property once construction has concluded.
