WESTON CORBETT HOUSE, WESTON CORBETT, HAMPSHIRE

HERITAGE STATEMENT

PROJECT: Weston Corbett House, Weston Corbett, Hampshire

DOCUMENT TITLE: Heritage Statement

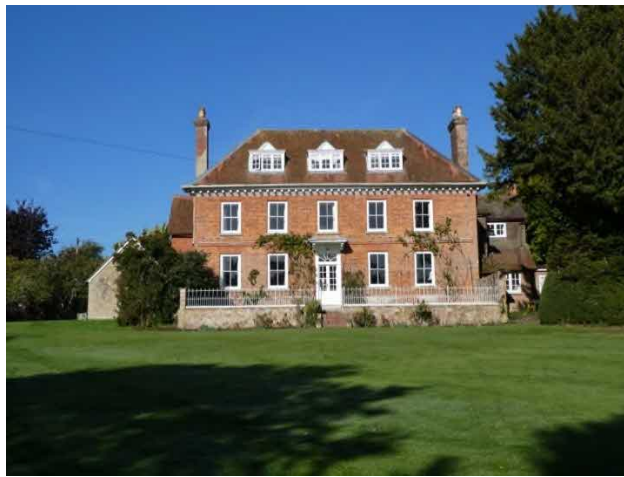
Figure 1: Front elevation of Weston Corbett House

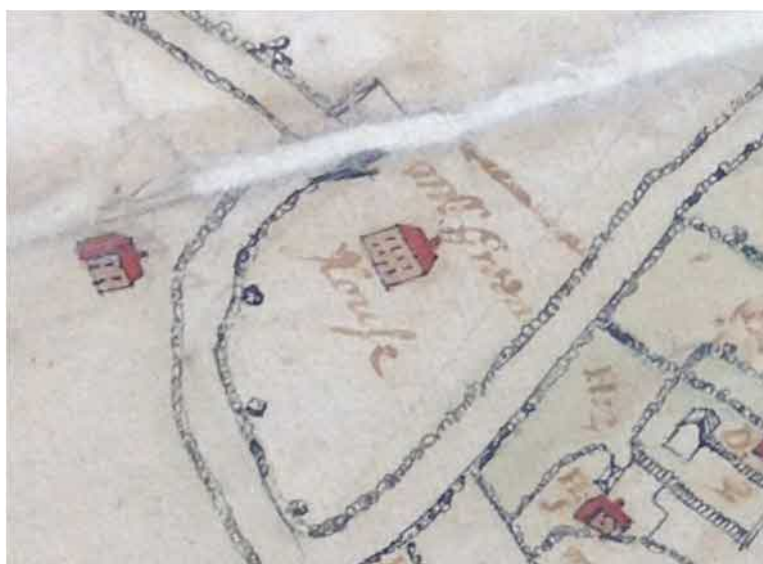
3.1.1 A map of Weston Corbett (c. 1750) entitled An Accurate Survey of the Mannour of Weston in the County of Southampton belonging to his Grace Charles Dke: of Bolton includes an elevational sketch of Weston Corbett House and is annotated with Mr Green, House.

Figure 6: Extract from a map of Weston Corbett showing the front elevation of Weston Corbett House

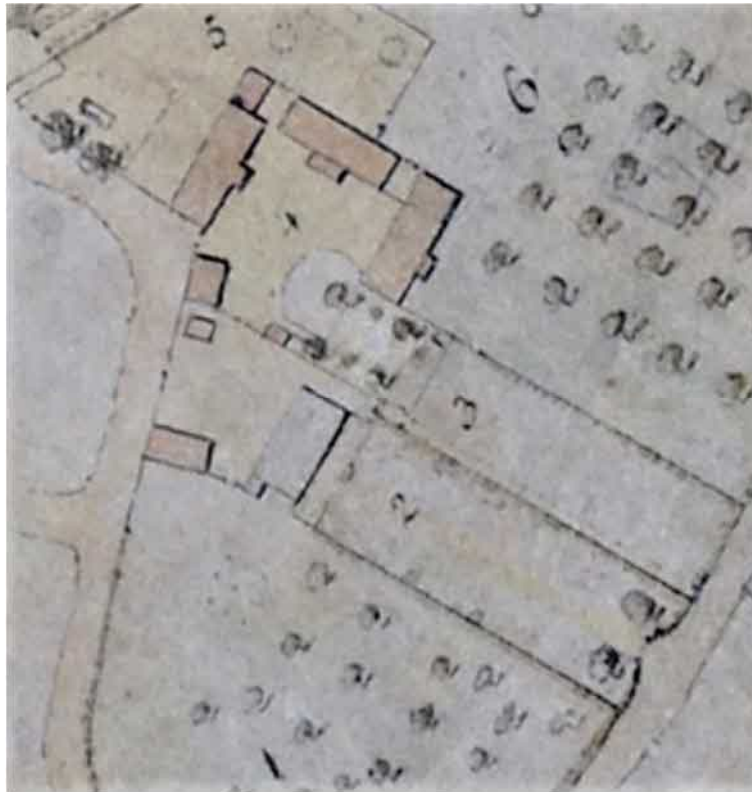
3.1.2 An estate map of Weston Corbett (1846) entitled Weston Corbett Estate. Hampshire. The Property of George Green Esquire. Surveyed by Thomas Wilson 1846 shows the layout of Weston Corbett House and gardens, a courtyard layout of farm buildings to the north and an

outbuilding to the west. The house is shaded grey and has a rectangular footprint with a small projecting element on the south-west side. There is a drive on the south-east side of the house which leads up to an enclosed space (terrace) on the south-east side of the house. There is an outbuilding with a rectangular footprint in the yard on the north-west side of the house. To the north lies a courtyard layout of farm buildings. The structure on the north-west side of the yard is shown with a central porch and an extension on the north-east side. The other two structures enclosing the yard are of a similar scale. There are smaller structures shown along the south-west boundary.

Figure 7: Extract from an estate map of Weston Corbett (1846)

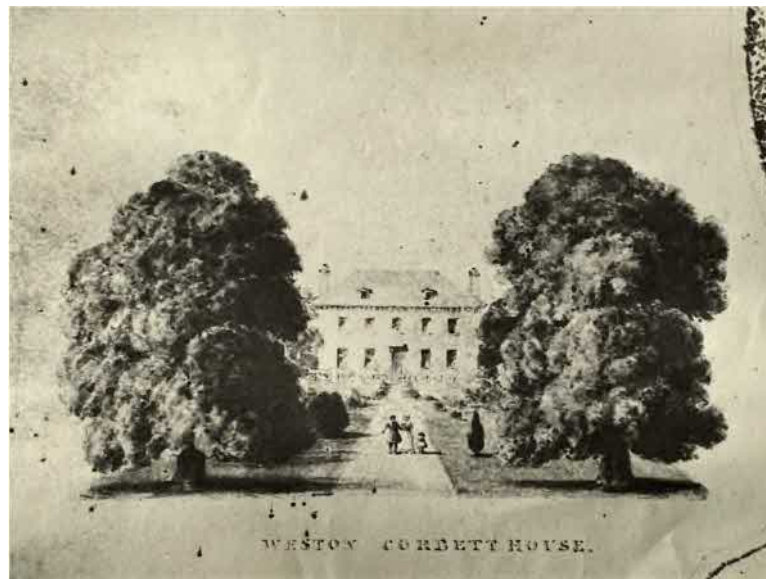
- 3.1.3 The estate map of Weston Corbett (1846) includes a drawing of Weston Corbett House. This drawing is a view of the front elevation (south-east facing) looking north-westwards along the drive. This drawing shows the central drive flanked by trees and the terrace in front of the house. The front elevation of the house is shown as symmetrical with a central door flanked by windows with a vertical emphasis. The hipped roof includes two small dormer windows which appear to each include two casement windows.

Figure 8: Drawing of Weston Corbett House that appears on the estate map of Weston Corbett (1846)

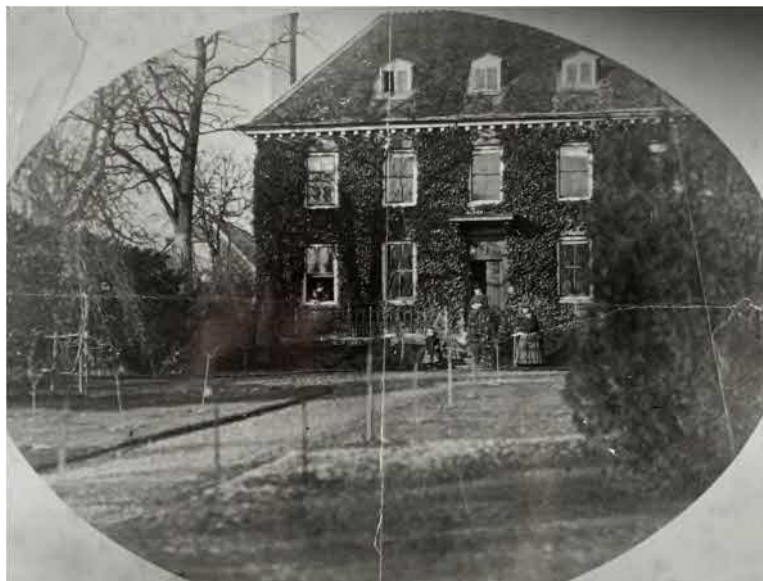
- 3.1.6 A c. late 19th century photograph of the front elevation of Weston Corbett House shows a number of details relating to windows. Firstly, the original, probably sash, windows had been replaced with 2-over-2 sash windows by this time. There are three dormer windows shown (only 2 are shown on the 1846 drawing) and these are leaded light casements.

Figure 11: Photograph of the front elevation of Weston Corbett House in the c. late 19th century

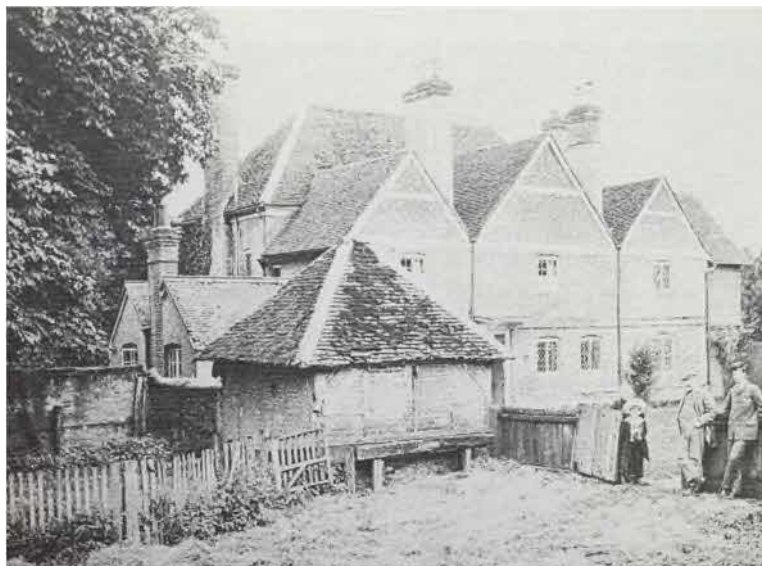
- 3.1.8 An early 20th century photograph of Weston Corbett House provides details of the late 19th century extension on the north-east side of the house. This shows a granary which was apparently a well house (demolished) and a section of wall and fence separating the house from the farm buildings. The north-east extension is shown as single storey with an M-profile roof and an end chimney. The two gable ends include window openings with segmental arched brick heads.

Figure 13: Early 20th century photograph of the rear and north-east elevations of Weston Corbett House

3.2.10 Window F4 is not shown in the early 20th century photograph (figure 13) but is present in the c. mid-20th century photograph (figure 15). Window opening F4 includes a segmental arch brick head with wide joints and evidence of repair. There are no closer bricks. The ovolo glazing bars are slightly wider than F1 and F3 and there is no apparent distortion in the glass. The window catches and stays are however of the same design as F1 and F3 which suggests a broadly contemporary date for this window.

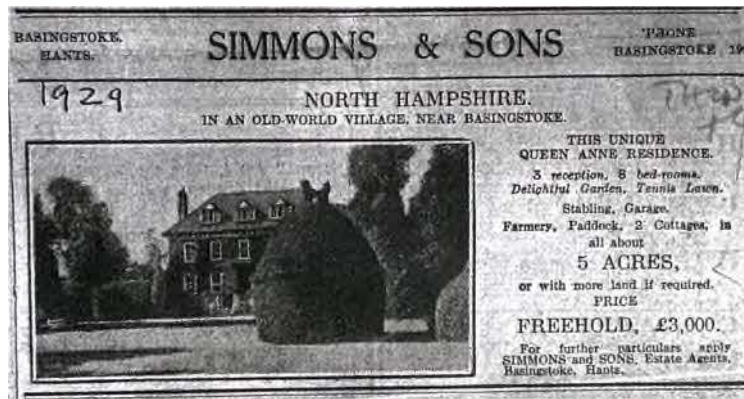
- 3.1.9 A newspaper advert for the sale of Weston Corbett House (1929) shows that the original dormer windows on the front elevation had been enlarged to their current form.

Figure 14: A newspaper advert for the sale of Weston Corbett House in 1929

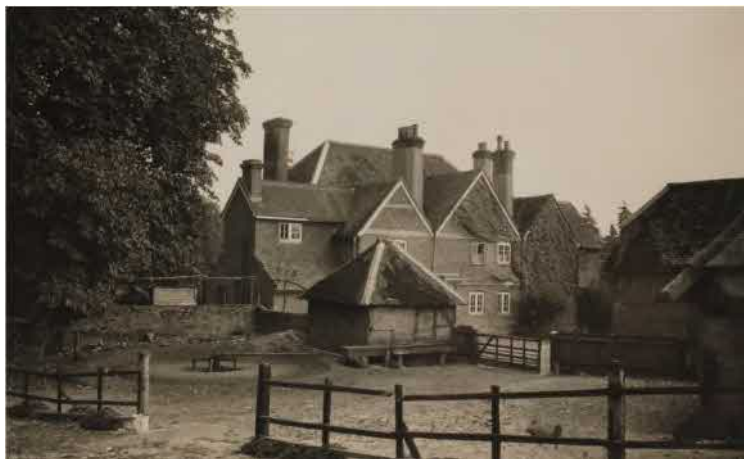
3.1.10 An undated photograph (c. mid-20th century) shows the rebuilt north-east extension. The 1977 edition of the Ordnance Survey map shows that the flat roofed extensions had been constructed by this time.

Figure 15: Photograph showing the rebuilt north-east extension before the flat roof elements were added

- 3.2.8 Window opening F2 post-dates the c. mid-20th century photograph of the north-west elevation of the house (figure 15). The window opening includes a segmental arch brick head and irregular closer bricks on the right hand side. The window is a 2-light casement with a 6-pane pattern and a wooden frame with no clear evidence for pegged joints. The glass is smooth and mirror-like when observed from the exterior. This window has relatively wide ovolo glazing bars and no window fittings.

3.2.12 The dormer window is not shown on the c. mid-20th century photograph (figure 15). This window is a 2-light casement. The ovolo glazing bars are relatively wide and the window fittings include modern brass catches and stays.

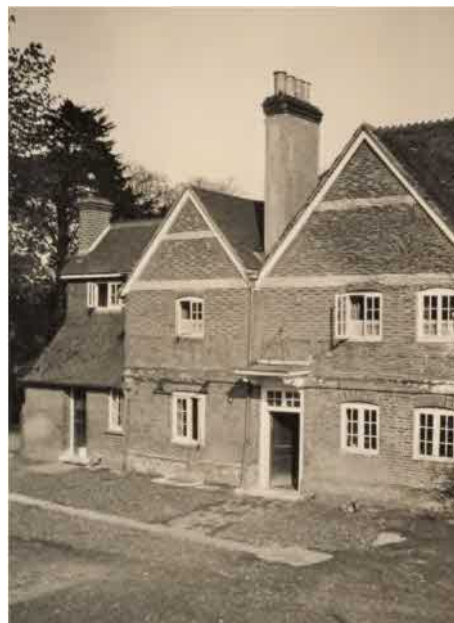
Figure 16: View of the left hand side of the north-west elevation of the house before the flat roof extension was added

3.2.2 Windows G1 and G3 are not shown in the c. mid-20th century photograph of the left hand side of the north-west elevation (figure 16). These windows are 6-pane side opening casements with pegged frames and a timber sill, all painted white. Both have a brick on edge head and an absence of closer bricks. There is some slight linear distortion in the glass of G1 and obscure glass in G3. No bubbles were observed in the glass. The glazing bars are approximately 22mm wide with a crisp finish. The window catches and stays are typical 1950s-1960s style.

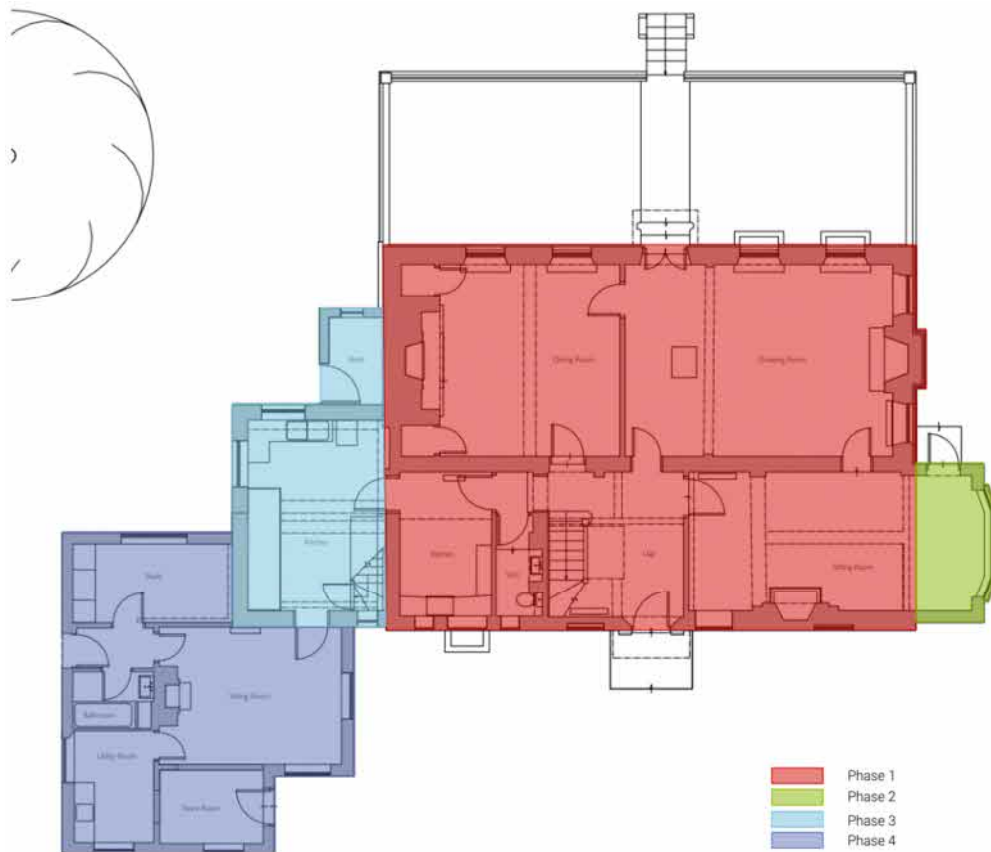
Figure 17: Suggested ground floor phase plan

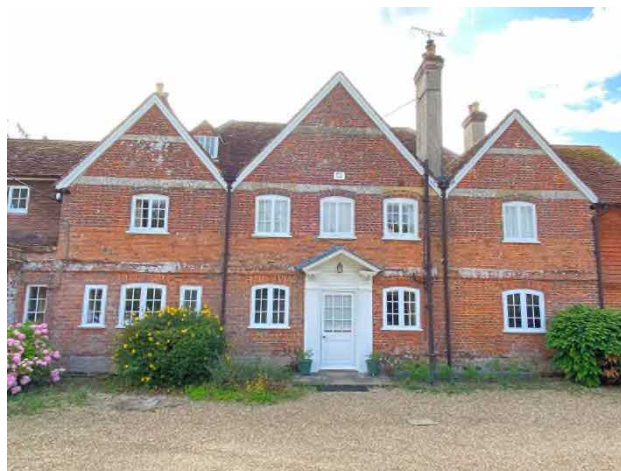
- 3.2 Understanding the form of the heritage asset – windows (north-west elevation and south-east dormers) – Refer to figure 42 for window locations
- 3.2.1 The windows on the north-west elevation are located within the Phase 1 part of the house at ground floor level and within the 19th century first floor gabled extension to Phase 1. There is a dormer within the Phase 1 roof on the left hand side of the north-west elevation. There are three dormer windows on the south-east elevation.

Figure 18: Central portion north-west elevation of Weston Corbett House

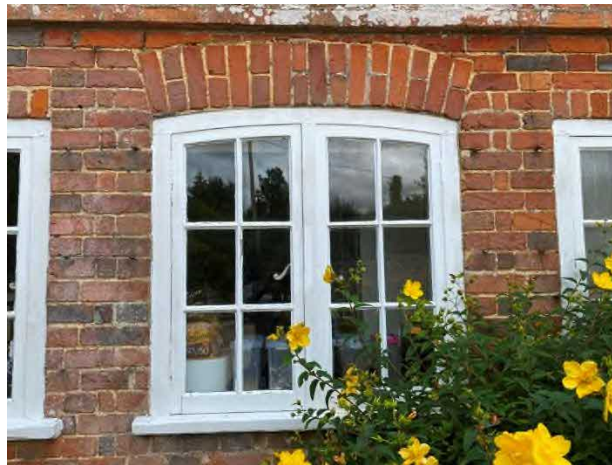
Figure 22: Exterior of window G2

3.2.3 Window opening G2 includes a segmental arch brick head and closer bricks. The window is a 2-light casement with 6-panes, a pegged frame and a timber sill. The glass is smooth and mirror-like. The glazing bars are 22mm ovolo style with a central ovolo mullion with crisp mouldings. The window catches and stays of the same style as G1 and G3. Comparison of the size of the current window opening with the c. mid-20th century photo (figure 16) shows that the level of the sill has been raised. This corroborates with the position of closer bricks which extend below the current sill level.

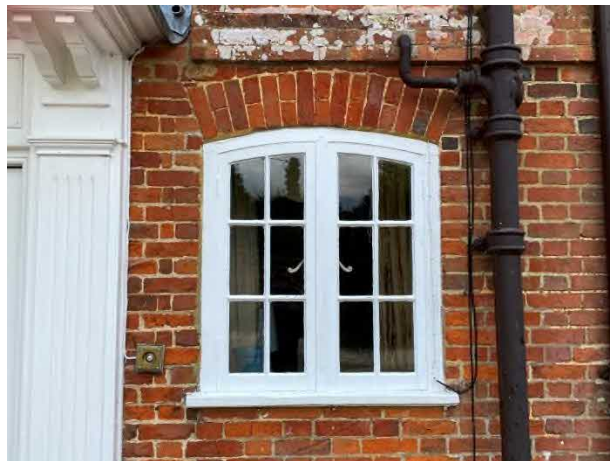
Figure 24: Exterior of window G5

3.2.5 Window opening G5 includes a segmental arch brick head and closer bricks on the left hand side. The window is a 2-light casement with a 6-pane pattern and a pegged frame with a wooden sill. The glazing bars and central mullion are of the same dimensions and style as G2. The window catches and stays are also of the same design as G1, G2 and G3. The glass is smooth and mirror-like.

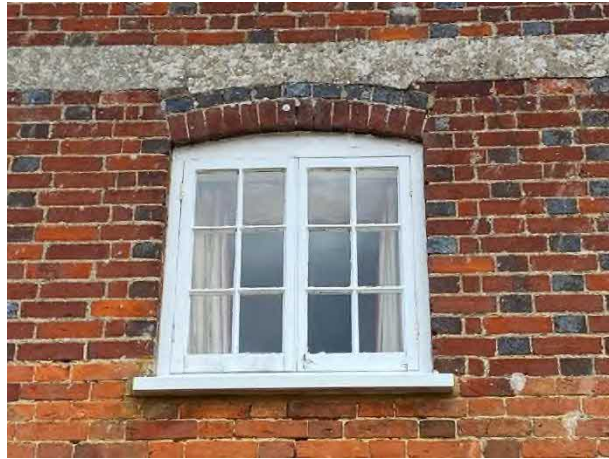
Figure 27: Exterior of window F1

3.2.7 Window opening F1 includes a segmental brick arch of two courses of brick and there are closers on both sides of the opening. The window is a 2-light casement with 6-panes for each light. The frame is pegged. Externally there is some irregularity observable in the glass. Some linear distortion and small bubbles can be observed from the interior. The glazing bars are relatively narrow at around 16-18mm and have an ovolo with fillet profile. The bronze and brass window furniture, including telescope casement stays and catches are of a design that is reminiscent of the 1930s. There are some Philips screws but this likely to represent repairs as opposed to later fitting of the stays and catches.

3.3.2 Two first floor windows on the north-west elevation include telescope stays and bronze catches that are consistent with late 1920s to 1930s style. The glass includes some distortion and bubbles which indicates pre-1950 glass. The overall form of the windows and their apparent presence on the 20th century photographs reinforce this evidence. These windows are of relatively recent date and are considered to be of low heritage value. Window F4 is of a similar style to windows F1 and F3 but had wider glazing bars and modern glass. This suggests a c. mid-20th century date for this window.

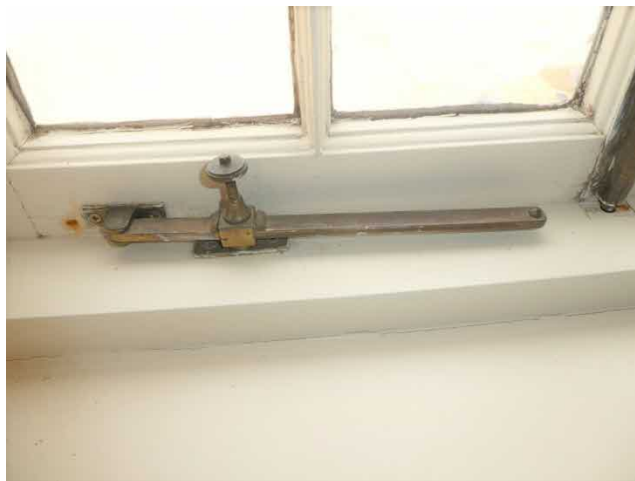
Figure 29: Detail of a brass telescope casement stay – window F1

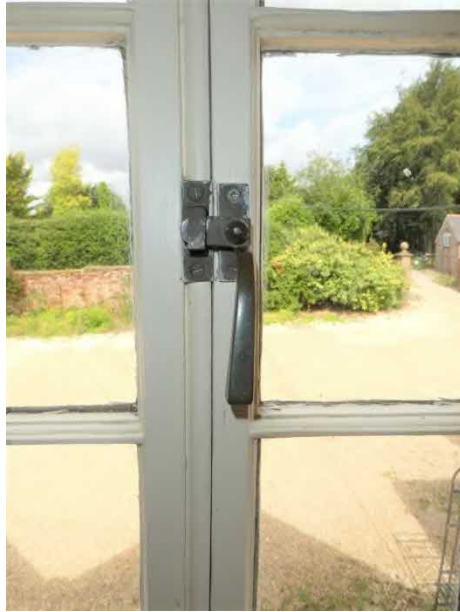
Figure 30: Detail of a bronze casement catch – window F1

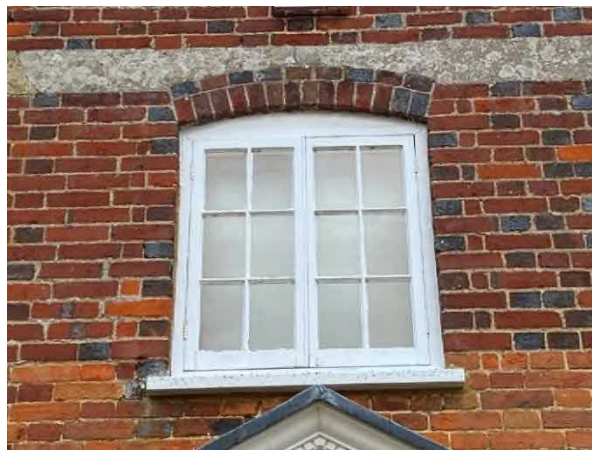
Figure 33: Exterior of window F3

3.2.9 Window opening F3 includes a segmental arch brick head and closer bricks on both sides. This window is a 2-light casement with 6-pane pattern lights and a wooden frame with pegged joints. Internal details for F3 are the same as F1, including distortion and bubbles observable in the glass.

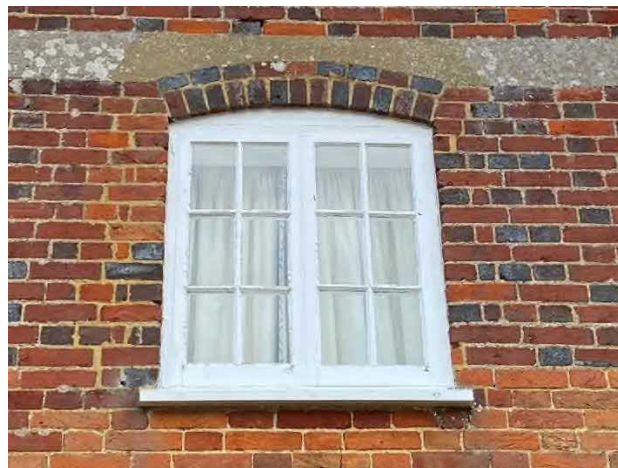
Figure 36: Exterior of window F5

3.2.11 Window opening F3 includes a segmental arch brick head. There are closers on both sides of the opening but the brickwork on the left hand side has been heavily repaired. There are no apparent peg joints in the wooden frame. The ovolo glazing bars are 20mm wide. There are no window fittings such as catches or stays.

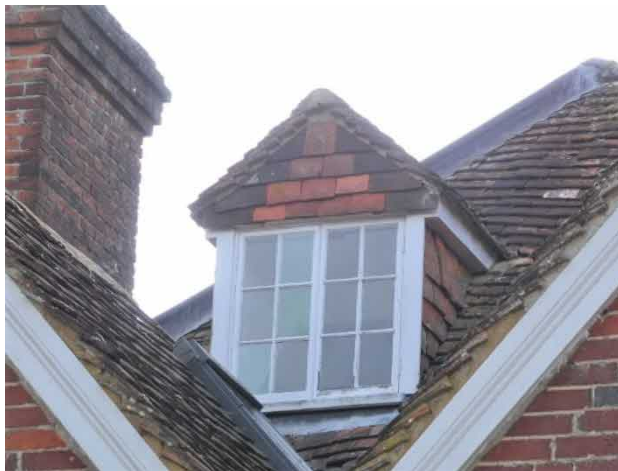
Figure 38: Exterior of window S1

3.3.4 Dormer window S1 is modern and of no heritage value.

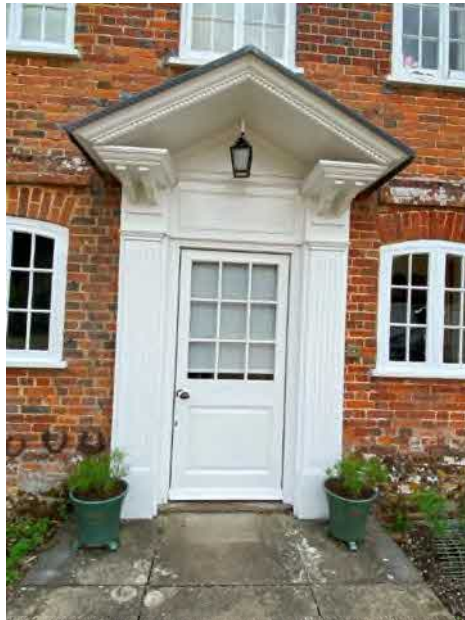
Figure 40: External view of the front door on the north-west elevation

3.2.13 The current front door occupies the position of a former window opening. This alteration from window to door appears to have taken place in the c. mid-20th century. The door itself is of mid-late 20th century date and includes a single lower panel and a glazed upper panel with multiple panes.

4.3.2 It is proposed to replace the existing windows on a like for like basis in terms of style. There are two options that could be considered: A slim-profile with integral glazing bars or a slim profile option with stuck on glazing bars with a bead to imitate the appearance of an integral glazing bar. The failure rate of some slimline double-glazed units is recognised. For this reason, it is proposed to bed the glass on a fine silicon and then to use a heritage putty that does not contain linseed. One of the reasons for failure of slim-profile units appears to be the use of linseed putty. This option would essentially reference the existing windows, which are considered to be sympathetic to the character of the house, and would include the traditional detail of integral glazing bars. The stuck on glazing bars approach would also reference the design of the existing windows with a bead to imitate the appearance of an integral bar. Both approaches seek to improve the energy performance of the listed building and resolve the condensation issues whilst preserving the established character of the listed building. The door would be replaced on a like-for-like basis but with a double glazed upper panel.
